MINERALS PROGRAM INSPECTION REPORT
PHONE: (303) 866-3567

MINE NAME: Pikeview Quarry	MINE/PROSPECTING ID#: M-1977-211	MINERAL: Limestone (general), granite gneiss and do	COUNTY: El Paso
INSPECTION TYPE: Monitoring	INSPECTOR(S): Zach Trujillo	INSP. DATE: May 16, 2022	INSP. TIME: 10:00
OPERATOR: Continental Materials Corporation	OPERATOR REPRESENTATIVE:	TYPE OF OPERATION: 112c - Construction Regular Operation	
REASON FOR INSPECTION: Normal I&E Program	BOND CALCULATION TYPE: None	BOND AMOUNT: \$13,389,784.00	
DATE OF COMPLAINT: NA	POST INSP. CONTACTS: None	JOINT INSP. AGENCY: None	
WEATHER: Clear	INSPECTOR'S SIGNATURE:

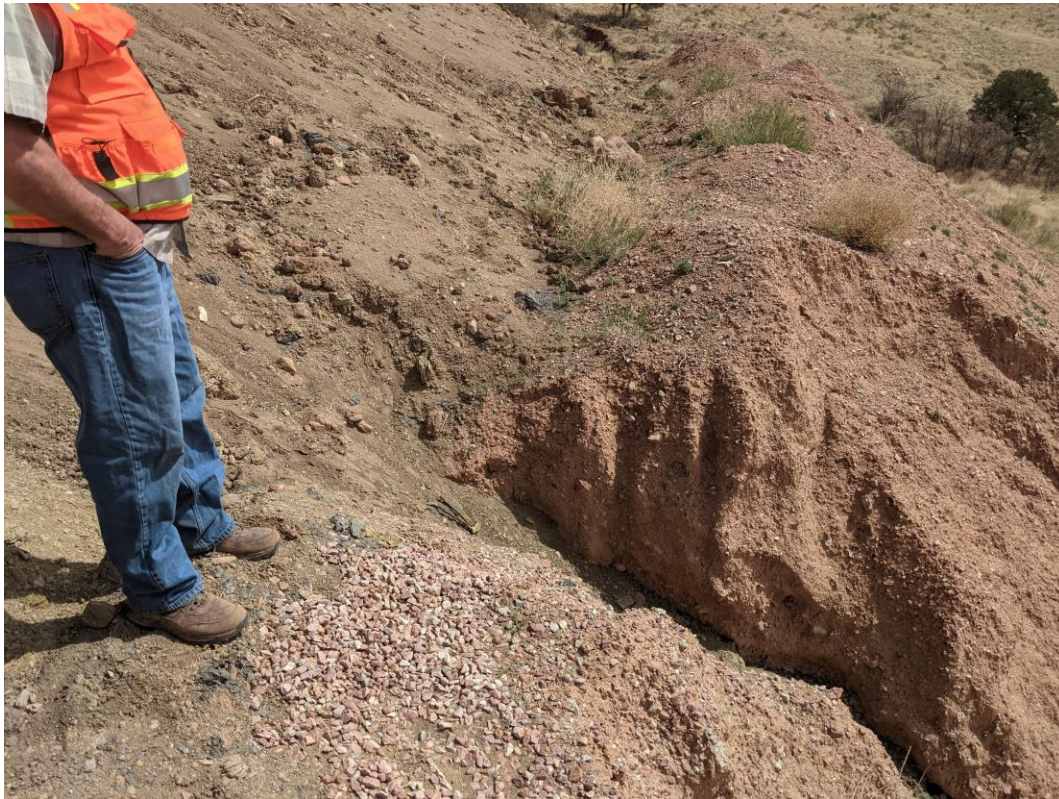
The topsoil pile area located just north of the primary office building was inspected. The pile was mostly bermed in to ensure topsoil preservation. Cutting was observed along the outer slope of the berm which was allowing minor sloughing of topsoil through the berm (Photo 1). CMC was aware of the erosion and committed to implementing best management practices to ensure topsoil is maintained within the footprint of the pile.

Photo 1. Erosion along topsoil pile berm.

Closeout Meeting: Minor maintenance was discussed in regards to topsoil pile berm and the use of best management practices to be implemented. No major concerns or problems were observed by the Division during this inspection.

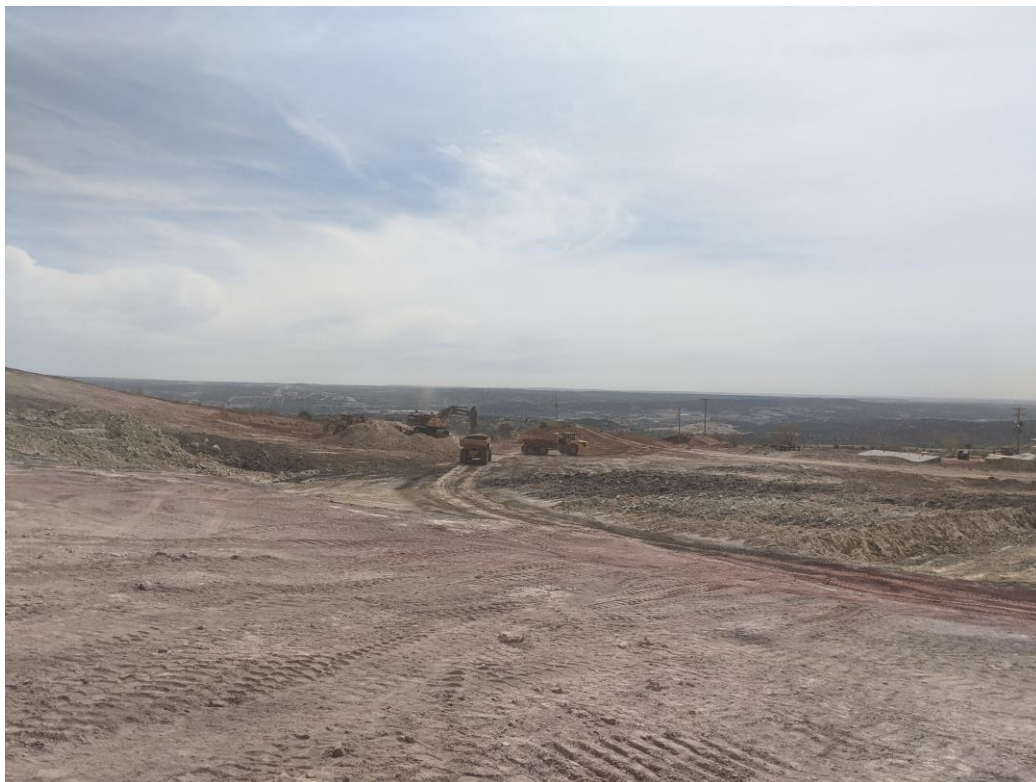
Backfill placement was occurring along base of the slide area. Material was being excavated north of the storage building (Photo 2) and transported to the current placement area where dozers were spreading (Photo 3). Backfill was being placed in a manner to ensure safety below the loose rubblized material along the slope of the slide area. A temporary trough area is being created along the intersection of the backfill and the slope of the slide area. This is to catch any sloughing from above that may occur. Compacting of the current backfill placement was not observed during the inspection. CMC stated that the equipment operator splits time between the compactor and water truck as site operations need. Watering of the backfill area was occurring during the inspection. Slope roughening along the southern extent of the backfill area was observed. The material from this area is being prepped for backfill use in the adjacent area and to scale back the slope to meet the approved post-mining topography (Photo 4).

Photo 2. Excavation for backfill material.

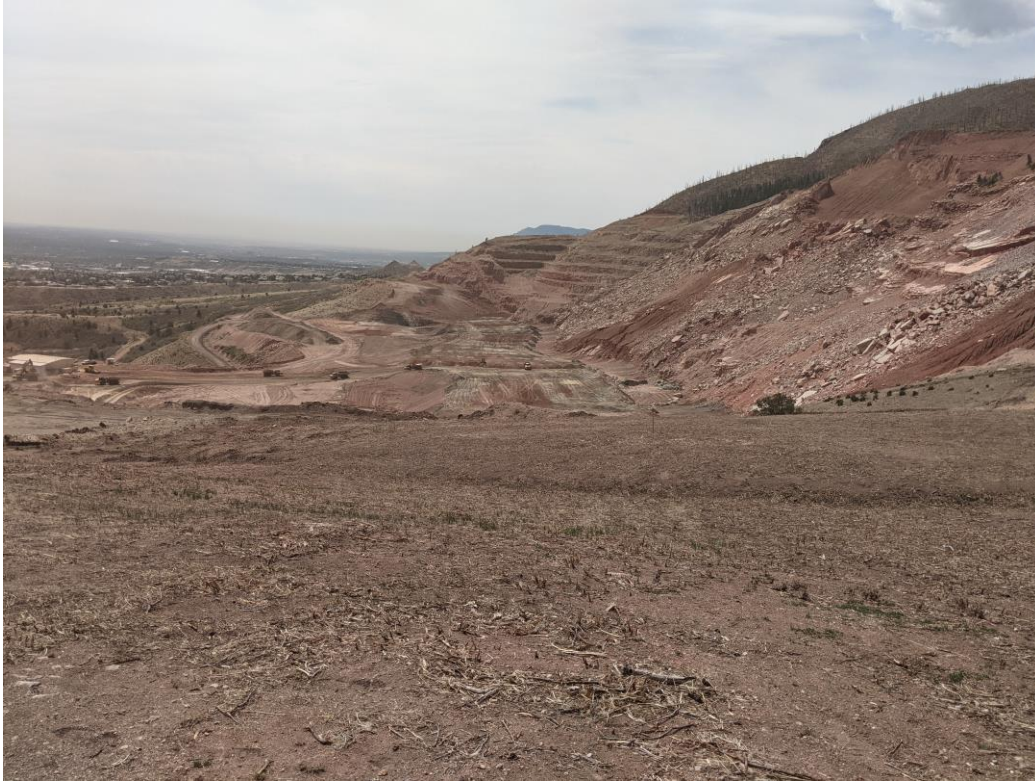
Photo 3. Backfill placement.

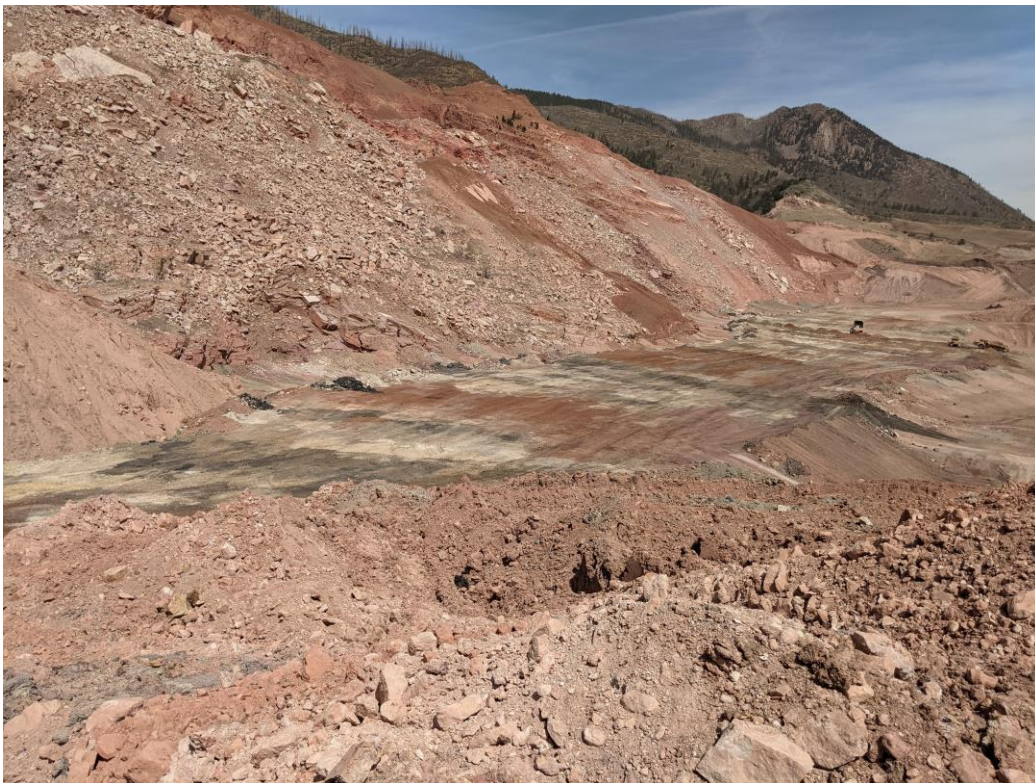
Photo 4. Roughened slope.
