MINERALS PROGRAM INSPECTION REPORT
PHONE: (303) 866-3567

MINE NAME: Goose Haven Reservoir #2- Complex Expans	MINE/PROSPECTING ID#: M-2010-071	MINERAL: Borrow material for d	COUNTY: Boulder
INSPECTION TYPE: Preoperation Inspection	INSPECTOR(S): Brock Bowles	INSP. DATE: May 10, 2022	INSP. TIME: 10:00
OPERATOR: The City of Lafayette	OPERATOR REPRESENTATIVE: Doug Bokelman	TYPE OF OPERATION: 112c - Construction Regular Operation

INSPECTION TOPIC: Topsoil

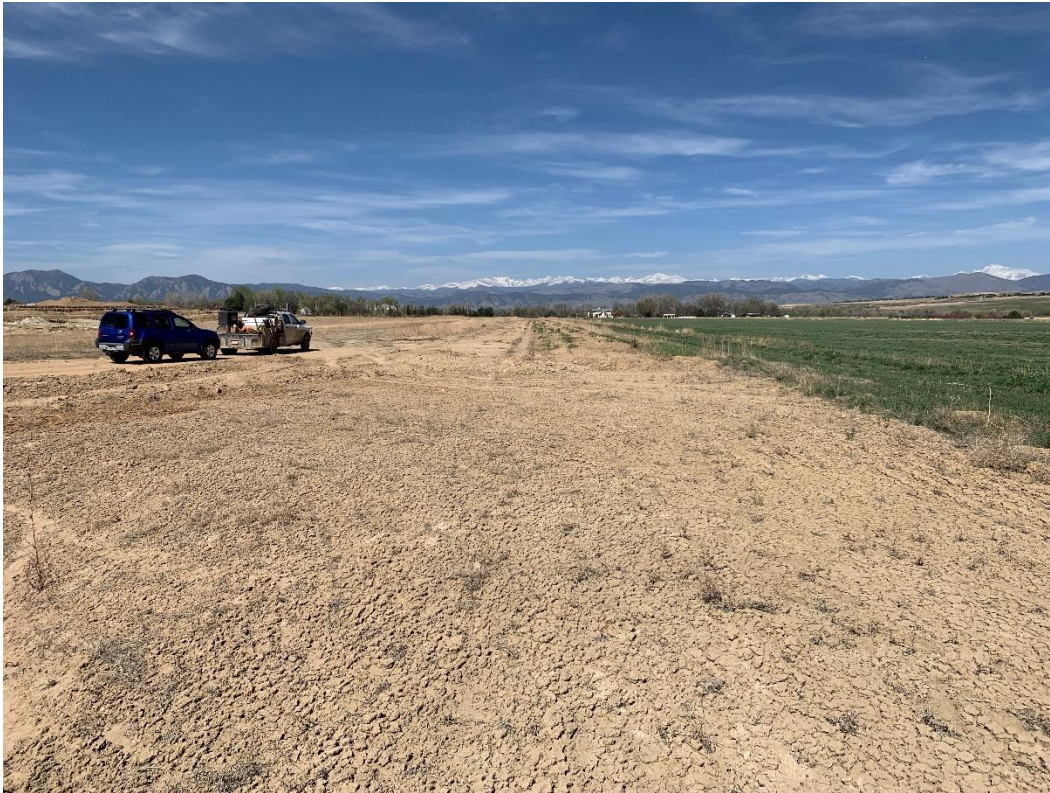
No mining was taking place in the Cell 2A area. The pit is about 80% complete as noted in the previous April 7, 2021 inspection report. The pit is about 35 acres in size and 30 feet deep on the east side and 10 feet deep on the western side. The west, north and east sides of the reservoir is proposed to be a dam with a 15 foot maximum height above natural grade. No work has been done on the dam above natural grade (photo 1). with an access road at the toe of the dam (photo 1).

Photo 1 – Proposed north embankment dam area, facing west

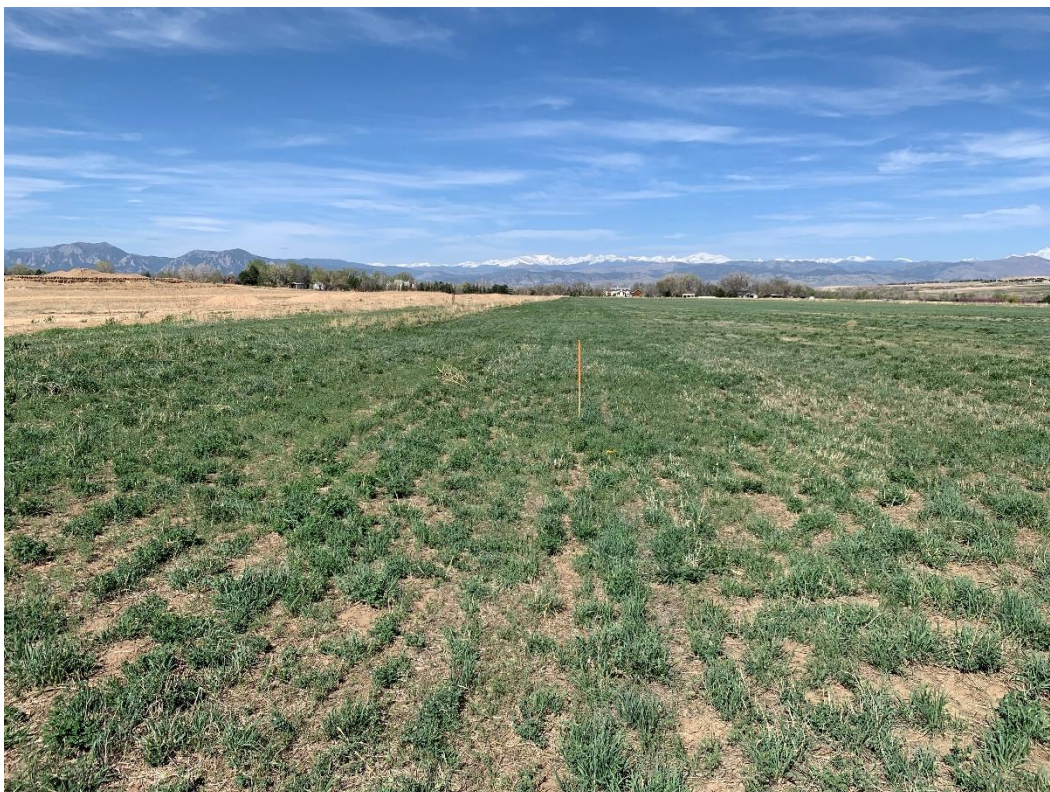
The north toe of the dam will be 15 feet away from the permit/property boundary. This area will contain an access road for dam inspection and maintenance. A surface water drainage swale directing water around the reservoir is proposed to be installed north of the access road, on the adjacent property beyond the permit boundary (photo 2). The details are still being worked out with the adjacent landowner. The Division will determine if the area of the swale needs to be incorporated into the permit after the swale design is submitted and reviewed as part of the AM2 permitting process.

Photo 2 – Stakes marking easement area for surface water swale.

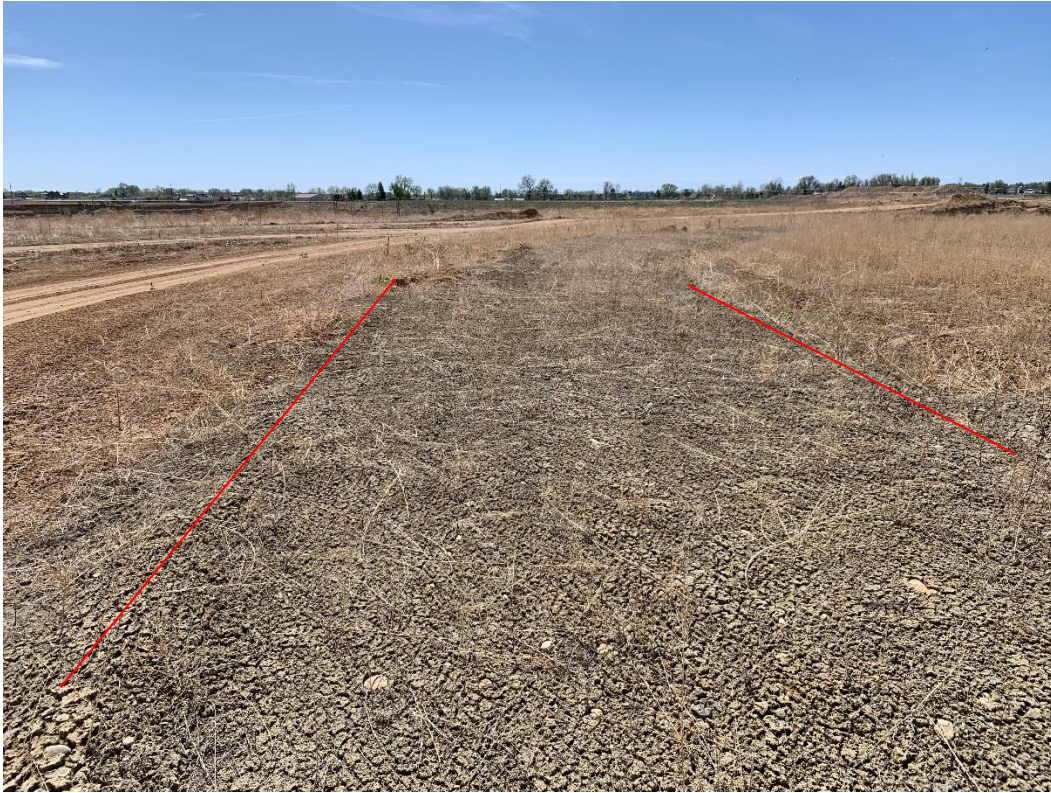
The clay liner has been installed up to natural grade on the northeast, northern and western sections of the pit area (photo 3). The northeast inside corner of the pit area has been graded to approximately 3h:1v (photo 4). Some final grading will done before riprap is installed.

Photo 3 – Top of clay liner at natural grade

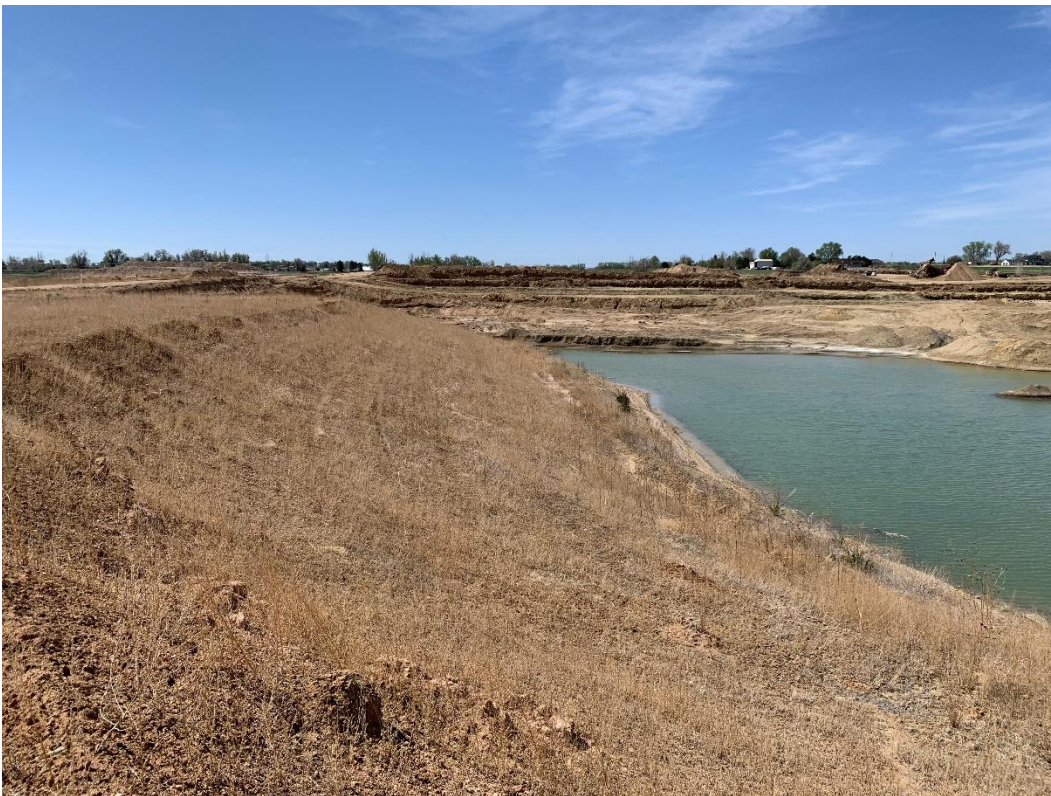
Photo 4 – Northeast corner of pit area

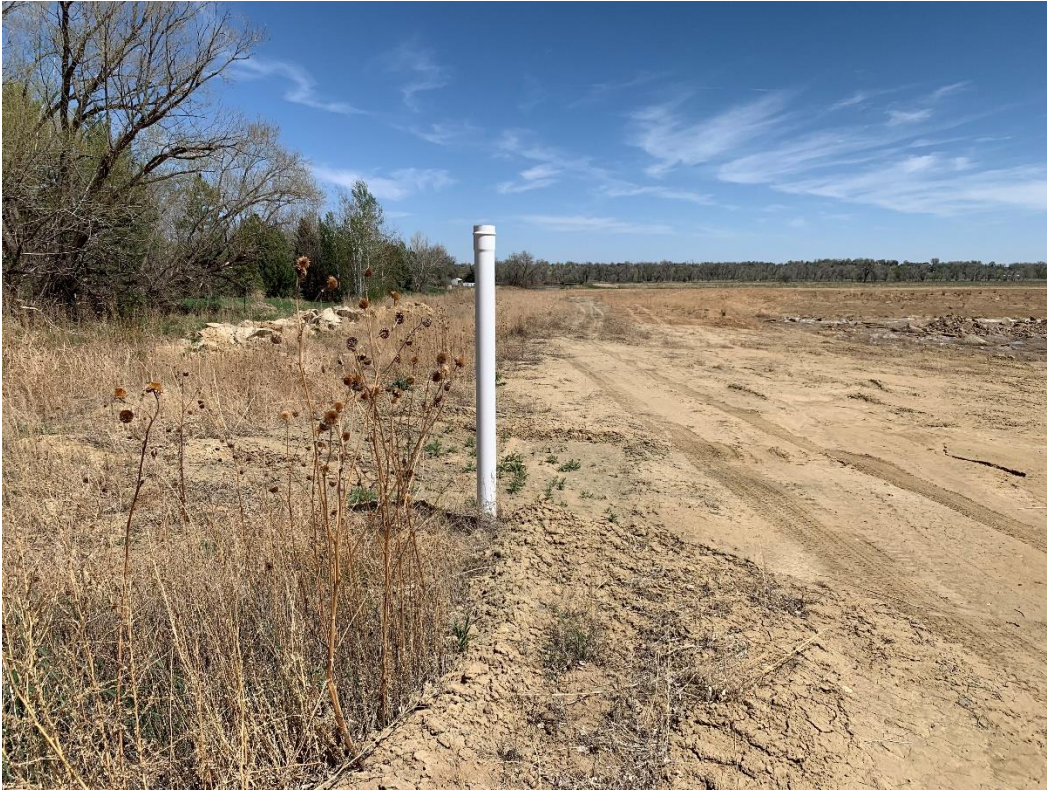
A perimeter drain was installed on the outside of the clay liner at the bottom of the liner, near bedrock (photo 5). The purpose of the pipe is to drain any ground water that may accumulate next to the clay liner. The pipe directs the water to the northeast corner of Cell 2A to a pump, where it is discharged. This drainage system was not described in the AM2 application and needs to be added to the application as part of the AM2 adequacy questions process.

Photo 5 – Vertical cleanout pipe indicating location of subsurface perimeter drain

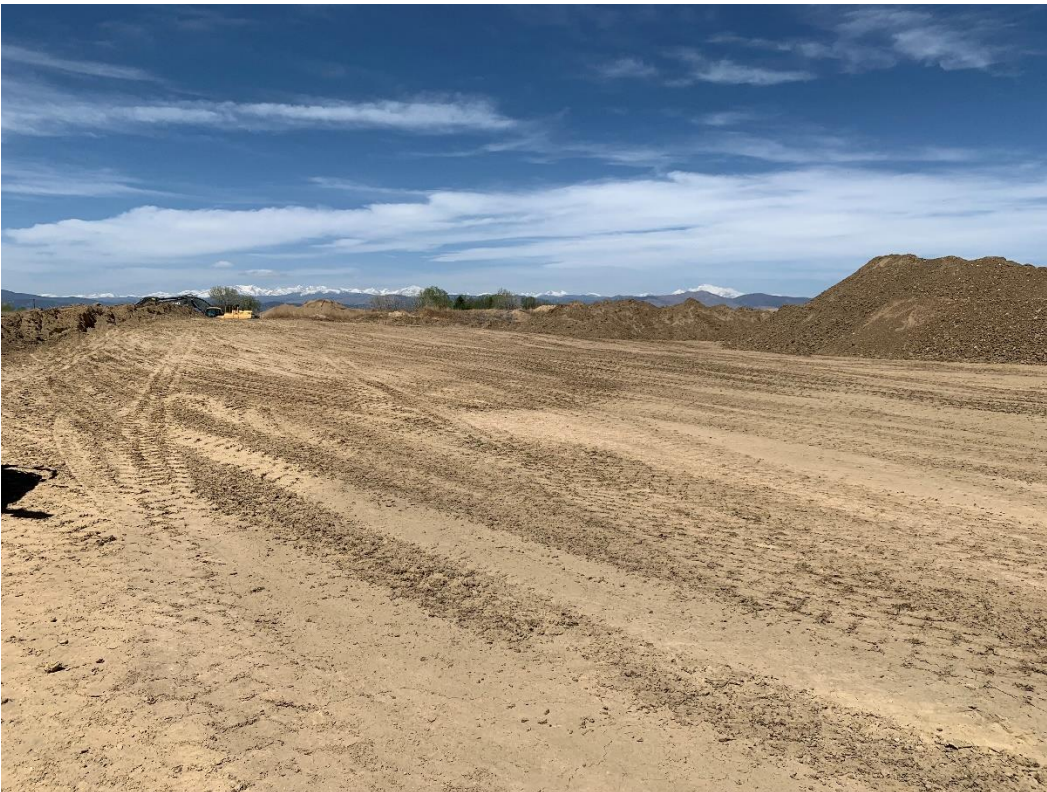
The topsoil stockpiles are located on the south side of the permit area. The pile is several acres is size, graded flat for most of the area with a couple of small piles on the perimeter (photo 6). The stockpile was being used to store equipment, tractors, screening equipment (photo 7) and a diesel generator and fuel tank (photo 8). According to Mr. Bokelman, topsoil was being run through the screen.

Topsoil stockpiles are required to be stored in places and configurations which minimize erosion and located in areas where disturbance by ongoing mining operations are minimized (Rule 3.1.9(3)). Topsoil stockpiles are also required to have established vegetation to protect them from erosion (Rule 3.1.9(1)). Stockpiles are to be

Topsoil is a valuable asset needed for the reclamation of a mine site. Topsoil contains organic matter and microbes which need air, water and living vegetation to survive. Without these components, the topsoil will not support vegetation and any reclamation effort will be hampered. This topsoil has been damaged by excessive compaction, excessive handling, exposure to toxic materials, being run through a screen and a lack of vegetation.

Photo 6 – Topsoil stockpile graded flat and compacted.

The permittee needs to submit a technical revision to the permit along with the appropriate \$216 revision fee to the Division by the corrective action date outlining a plan addressing the following: how much topsoil is required for reclamation, a map showing location and quantity of each stockpile, the expected timeline for topsoil redistribution, de-compaction, steps/amendments to revitalize the topsoil (testing may be required to determine what is needed), seed mix, stockpile signs, and erosion control measures (berms, wattles, mulch etc.)

The Division requires that the topsoil plan be created with the assistance of a qualified soils expert, NRCS or CSU Extension.

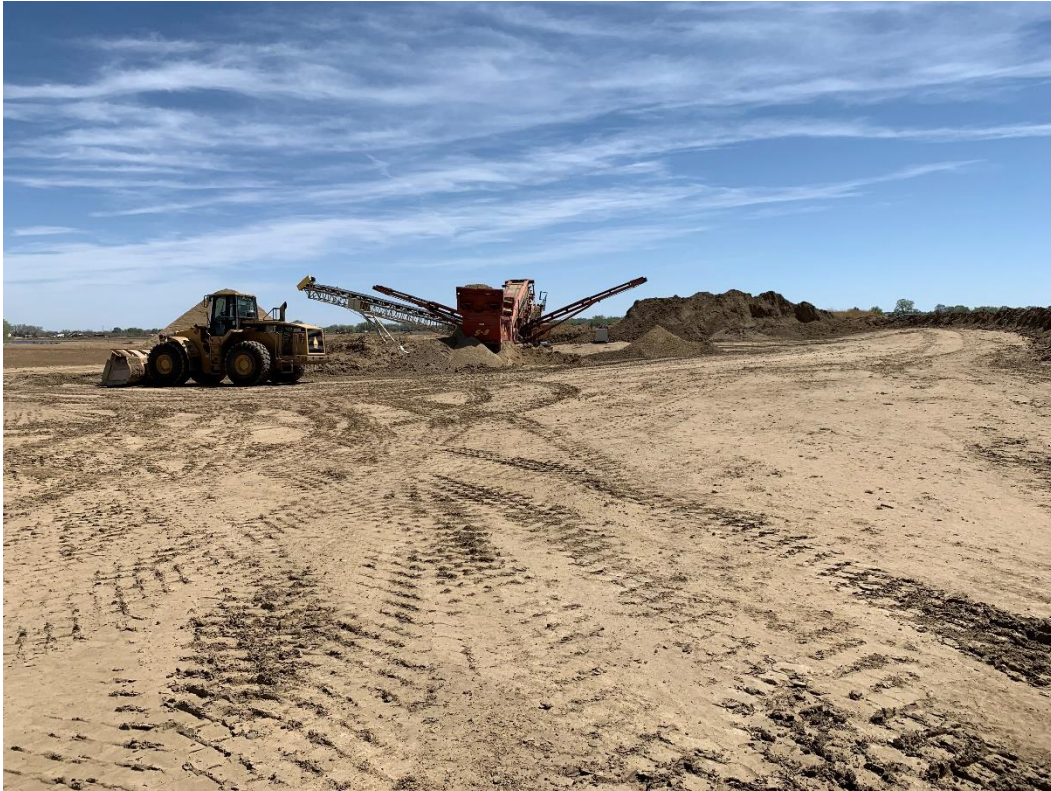
protected from toxic materials such as diesel fuel (Rule 3.1.9(1)). Stockpiles need to be handled as little as possible and should not be run through screening equipment (Rule 3.1.9(4)).

Photo 7 – Screening equipment and tractor parked on topsoil pile.

Mr. Bokelman was asked to remove the equipment from on top of the topsoil pile but **don't do anything else until the City of Lafayette obtains an approved plan by the Division.**

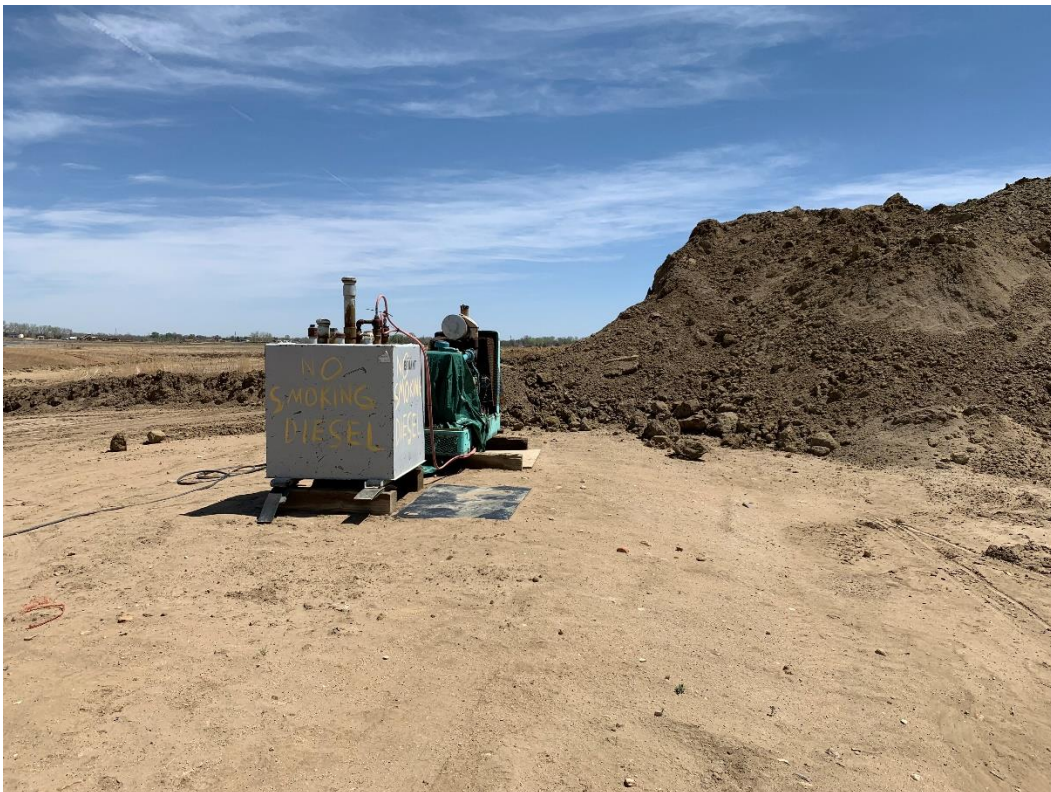
Photo 8 – Diesel generator and tank on topsoil pile
