MINERALS PROGRAM INSPECTION REPORT

MINE NAME: Monarch DENM Mine	MINE/PROSPECTING ID#: M-2022-009	MINERAL: Sand and gravel	COUNTY: Weld
INSPECTION TYPE: Preoperation Inspection	INSPECTOR(S): Robert Zuber, P.E.	INSP. DATE: May 16, 2022	INSP. TIME: 09:00
OPERATOR: Monarch Mountain Minerals and Aggregates,	OPERATOR REPRESENTATIVE: Eric Leigh, Kyle Regan	TYPE OF OPERATION: 112c - Construction Regular Operation	
REASON FOR INSPECTION: Preoperation Inspection	BOND CALCULATION TYPE: None	BOND AMOUNT: No Bond Held	
DATE OF COMPLAINT: NA	POST INSP. CONTACTS: None	JOINT INSP. AGENCY: None	
WEATHER: Clear	INSPECTOR'S SIGNATURE:

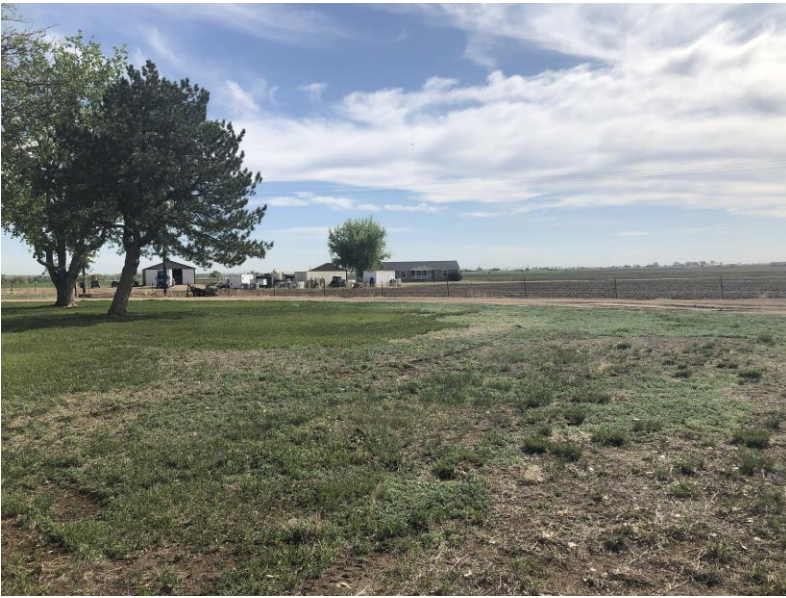
Most permanent man-made structures within 200 feet of the proposed affected area appear to have been identified by the Applicant (Map C-3). The structures that are not on this map all appear to be owned by the landowner, including an irrigation pipeline and offices and outbuildings. **Map C-3 should be revised to include these structures. This should be done as part of the adequacy process.**

Looking northeast at the landowners' small office and out buildings near northwest corner of the site.

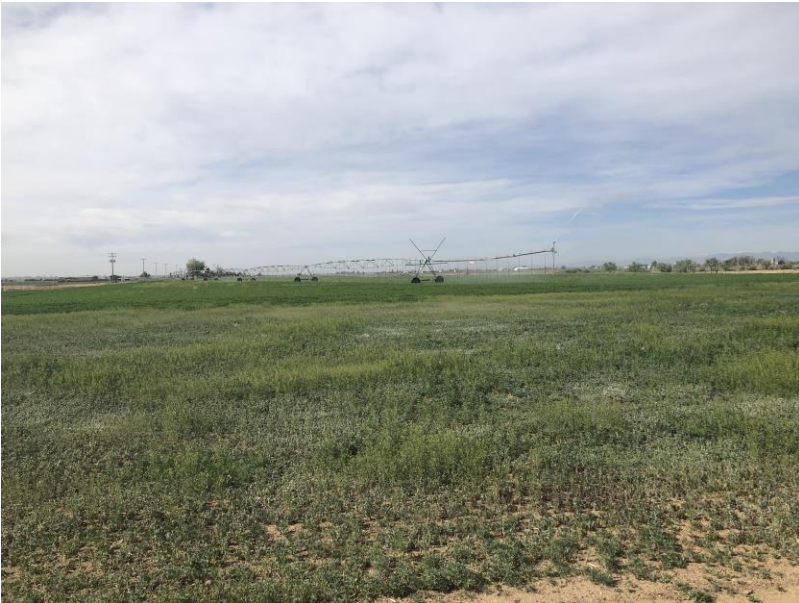
Looking south at irrigation of alfalfa field, near center of site.

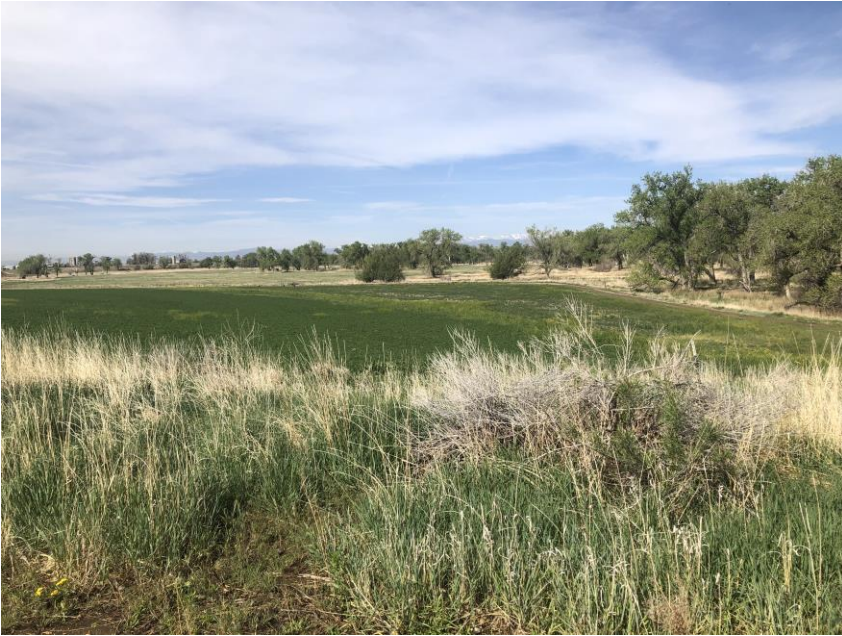
Looking south along the western boundary, approximate center of site in the north/south direction.

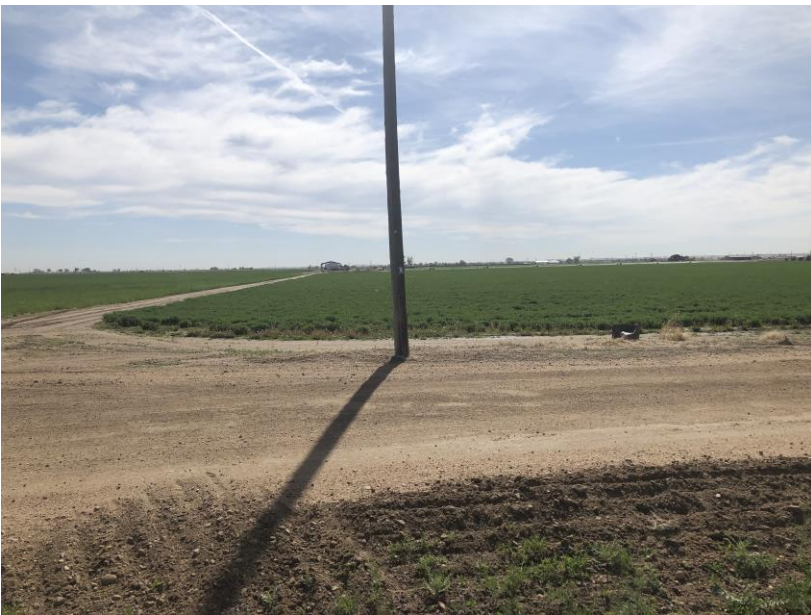
Looking east towards landowners' main office.

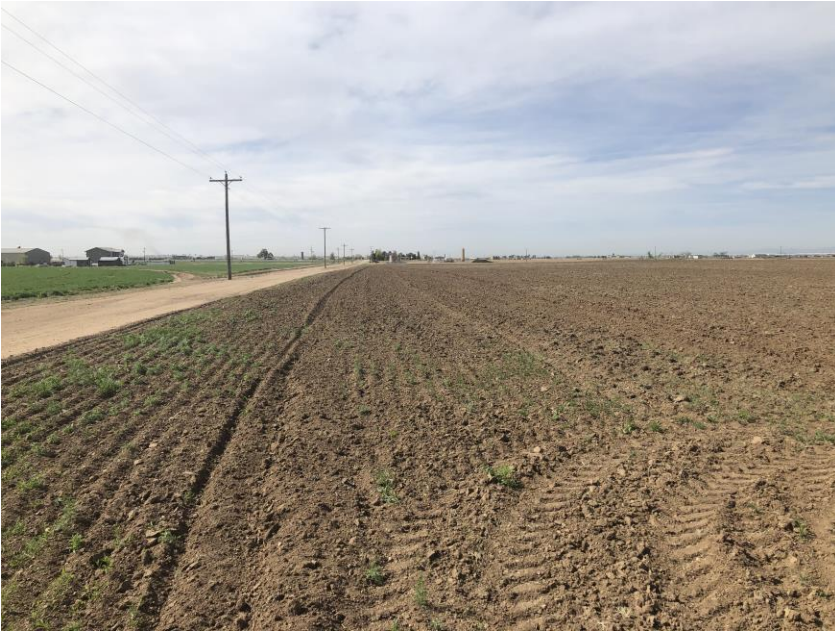
Looking south towards WCR42 with United Power lines along road.

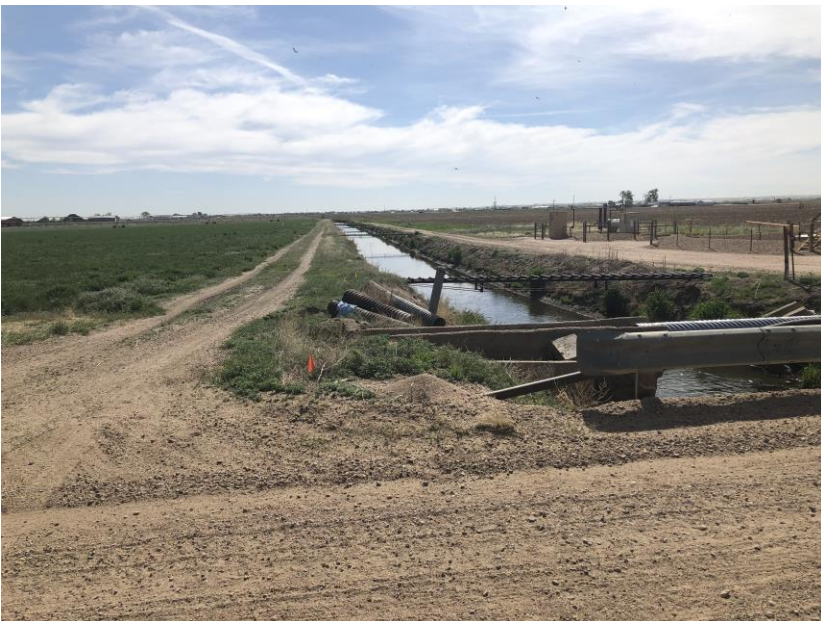
Looking east at Western Mutual Ditch, near south end of site.

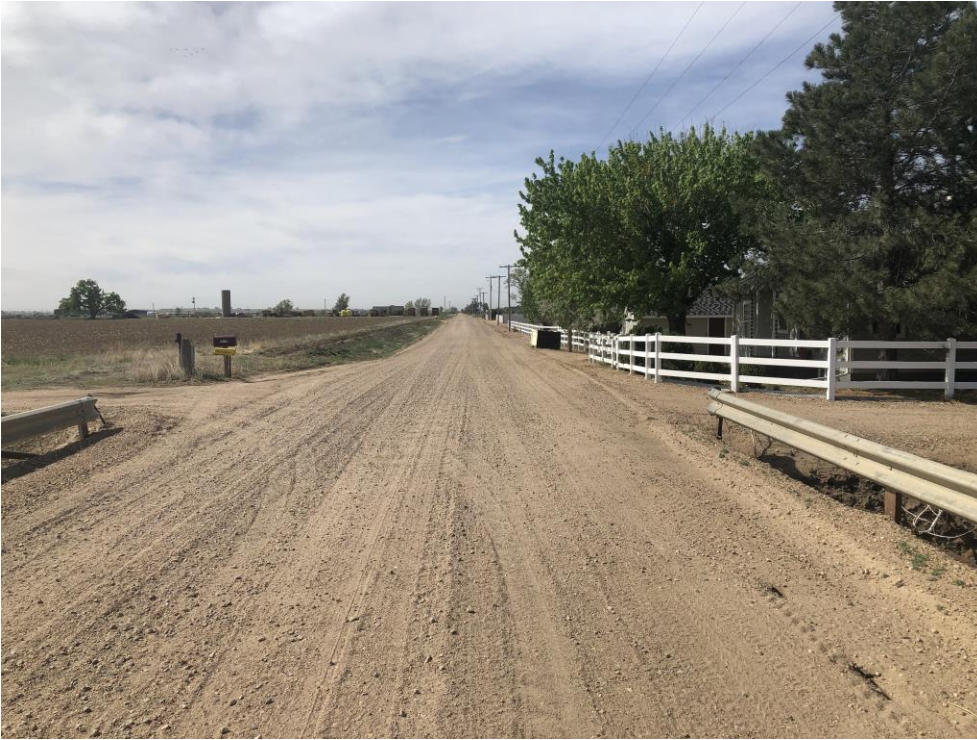
Looking south at road near Doolittle house, near south end of site.
