MINERALS PROGRAM INSPECTION REPORT
PHONE: (303) 866-3567

MINE NAME: Barnhart Pit	MINE/PROSPECTING ID#: M-1984-008	MINERAL: Sand and gravel	COUNTY: Pueblo
INSPECTION TYPE: Monitoring	INSPECTOR(S): Patrick Lennberg	INSP. DATE: May 18, 2022	INSP. TIME: 11:30
OPERATOR: Continental Materials Corporation	OPERATOR REPRESENTATIVE: Jerry Schnabel and Dan Tucker	TYPE OF OPERATION: 112c - Construction Regular Operation

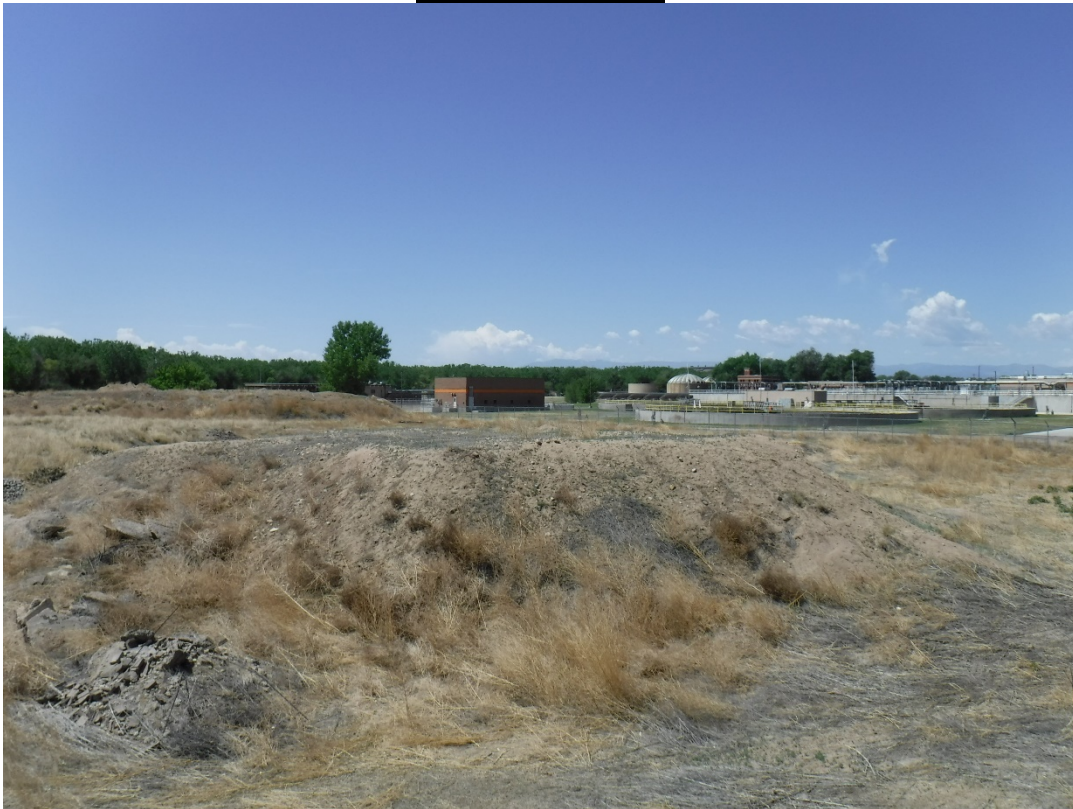
There are a few stockpiles of remaining material from the original mining operation. These piles are located to the west and southwest of the south pond. The piles are near the angle of repose but are not overly eroded and have sparse vegetation growing on them. Further to the southwest of the permit boundary there are numerous debris piles that appear to be related to the adjacent sewage treatment plant. The debris piles are on property owned by the City of Pueblo but it appears some may have spilled into the permit area.

Photo 1: Concrete and miscellaneous debris piles, piles in foreground within permit boundary

During the inspection it was discussed what remained to be done at the site to achieve permit release. The main item is grading of the stockpiles that are within the permit boundary to a 3H:1V slope or shallower. Once the operator and landowner agree on how the piles will be graded out and what the final configuration of the

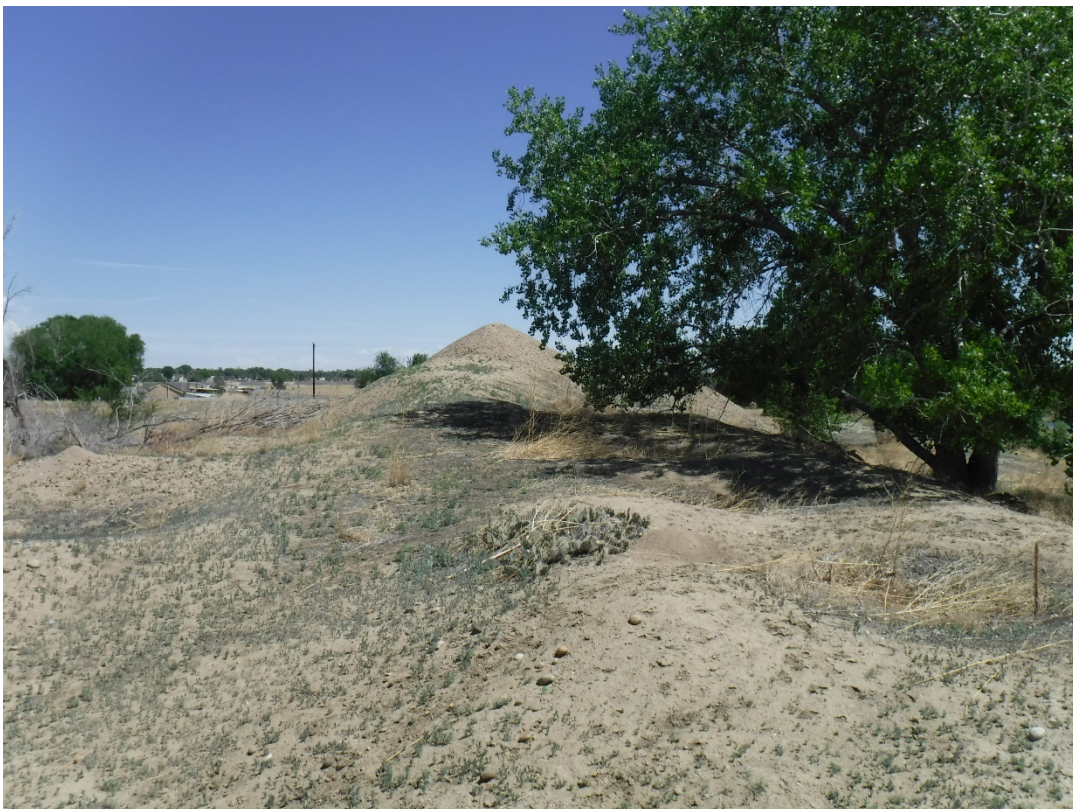
Photo 2: Dredge material spoils pile immediately west of the southern pond

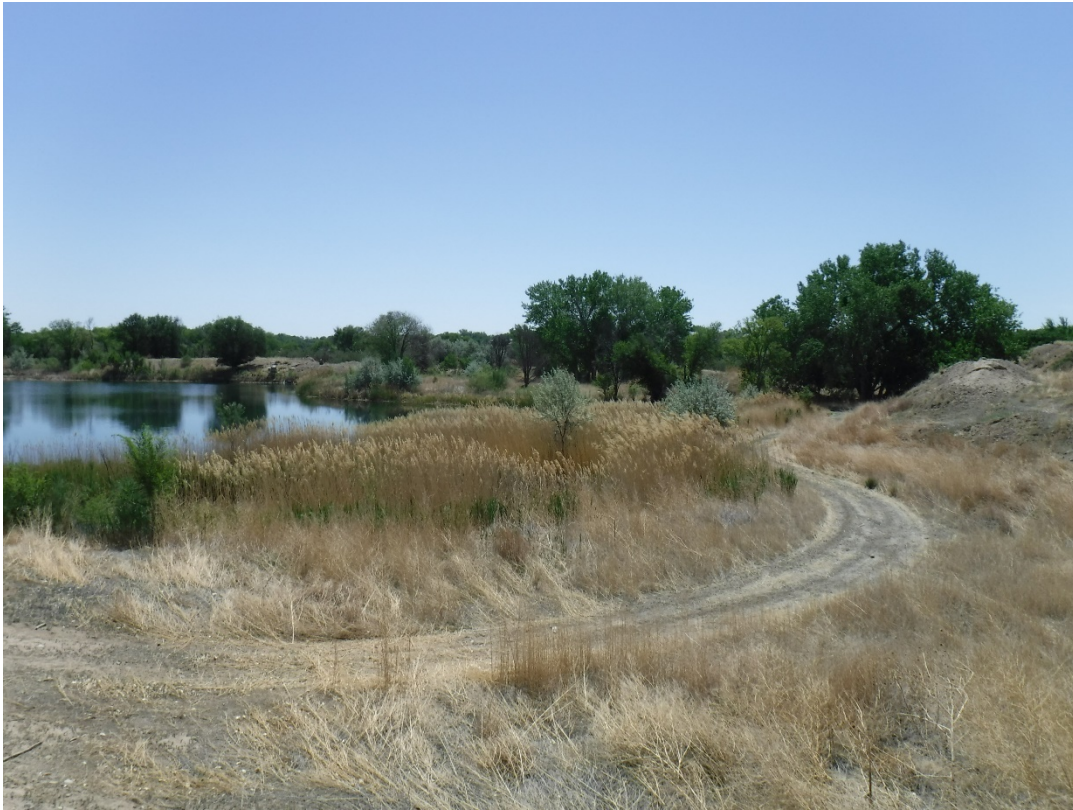
Photo 3: Spoil pile south of the south pond right of picture

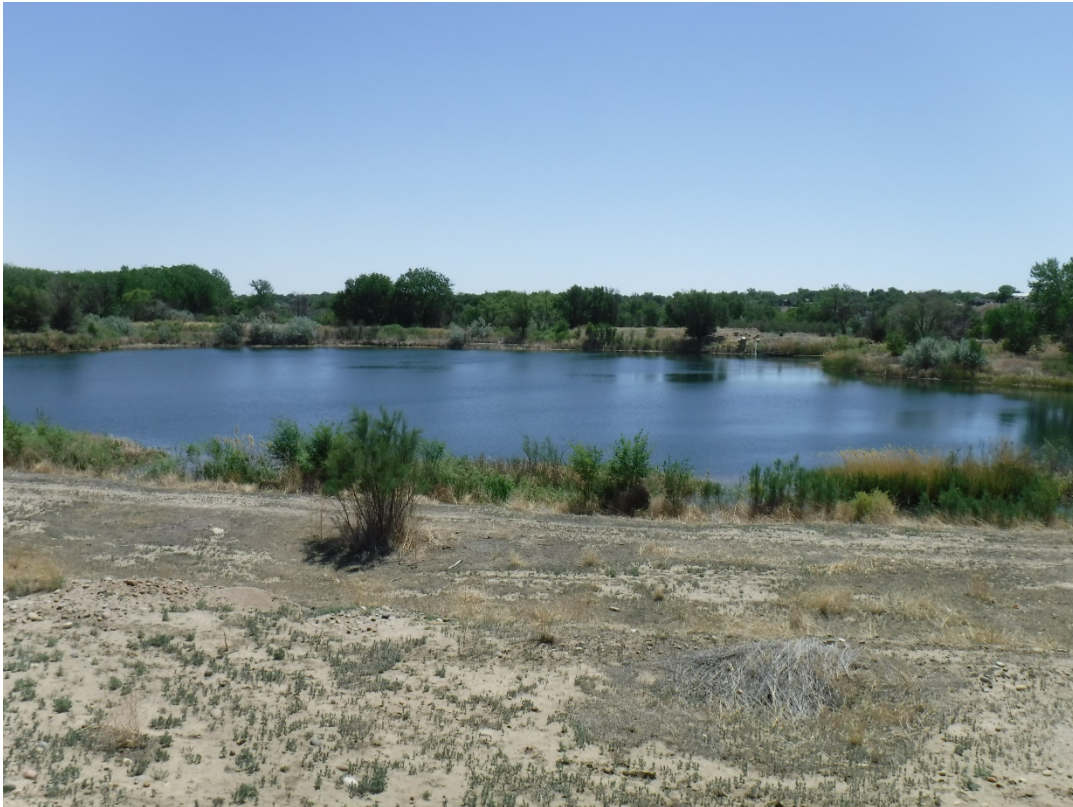
Photo 4: South Pond Area looking east

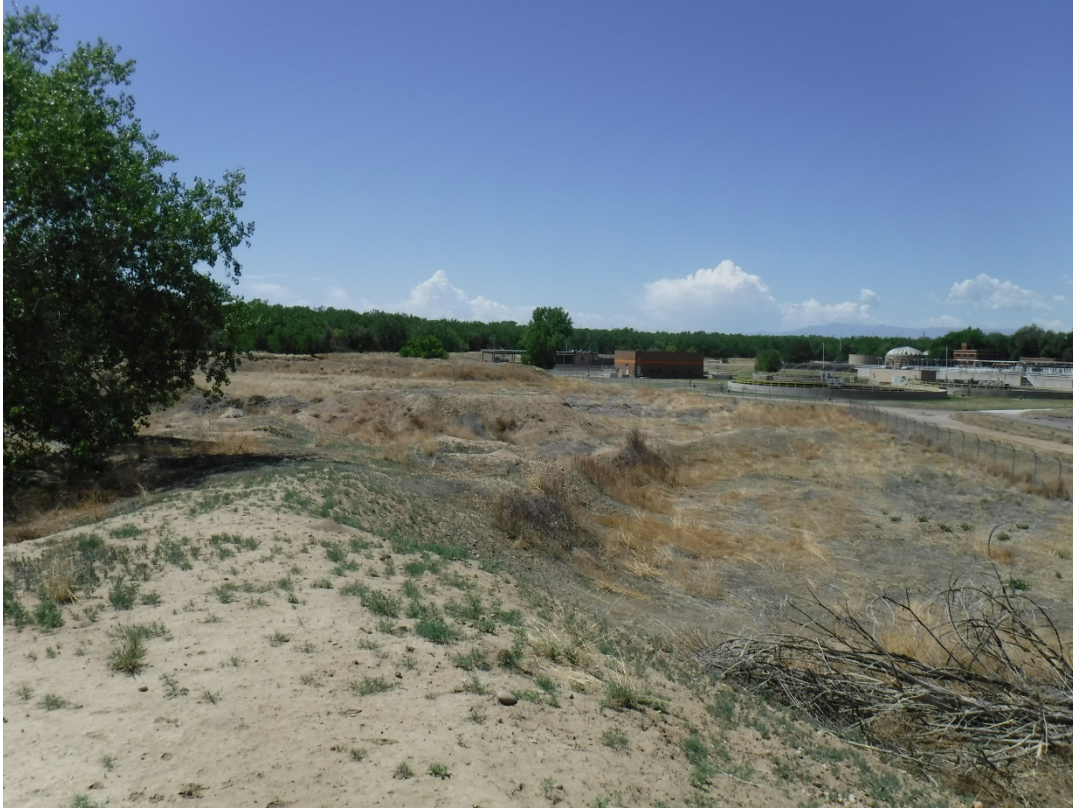
Photo 5: Looking south from the dredge pile, City of Pueblo Sewer Treatment Plant

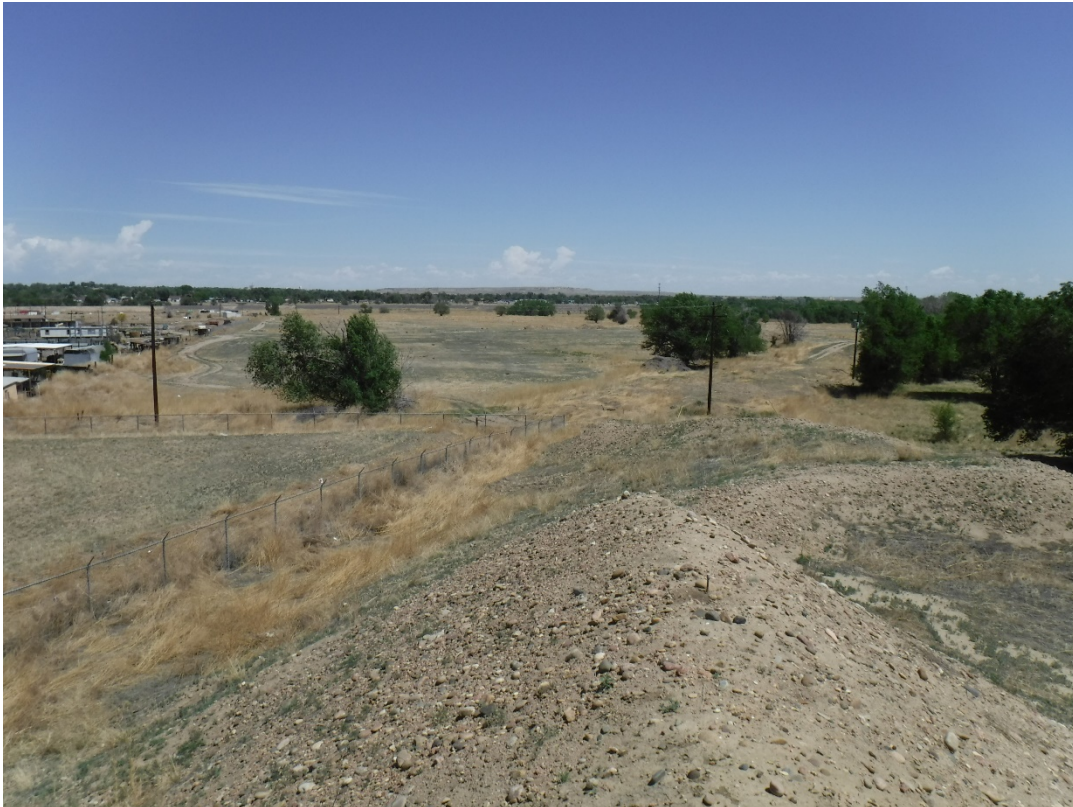
Photo 6: Looking north from the dredge pile

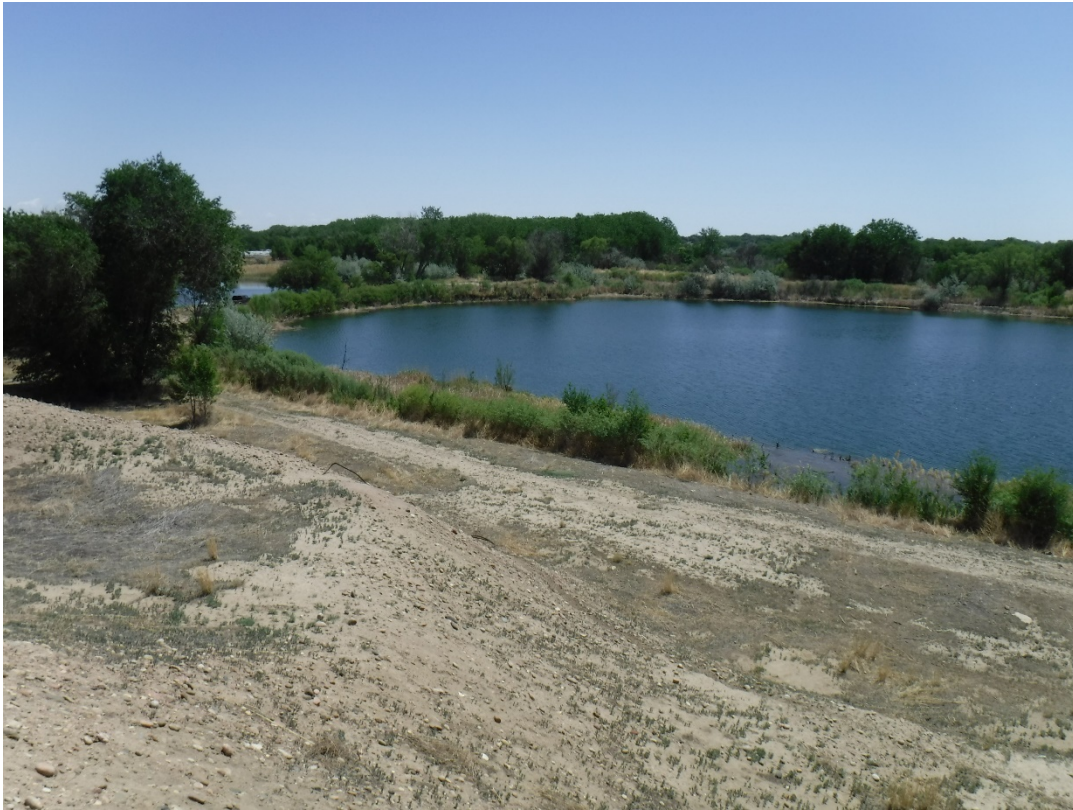
Photo 7: Looking northeast from dredge pile, northern portion of southern pond and southern tip of north pond

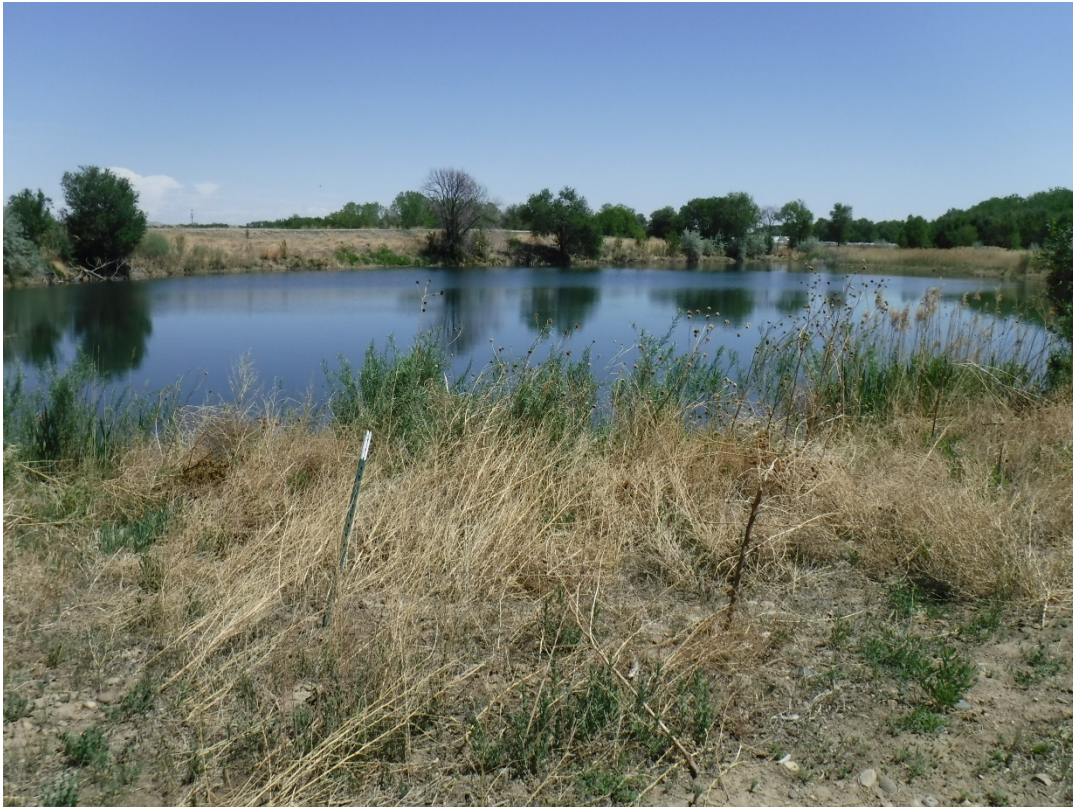
In the previous inspection it was noted there were areas along the ponds where the banks were near vertical. The operator has since that time reworked the banks in those areas to a 3H:1V slope. The remaining pond banks appear to be at 3H:1V slope, per the requirements of Rule 3.1.5(7), with slopes 3H:1V 5 feet above and 10 feet below the expected waterline.

Photo 8: Looking north along the northern pond, recently graded area in foreground

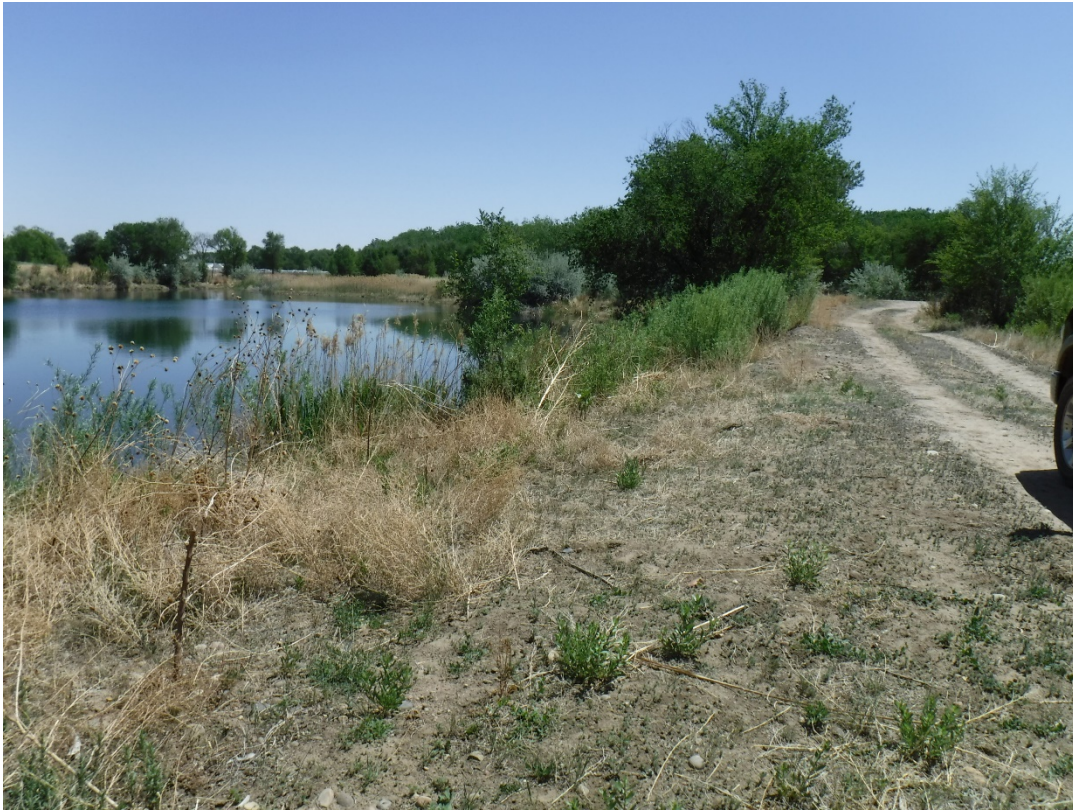
Photo 9: Looking east along the northern pond

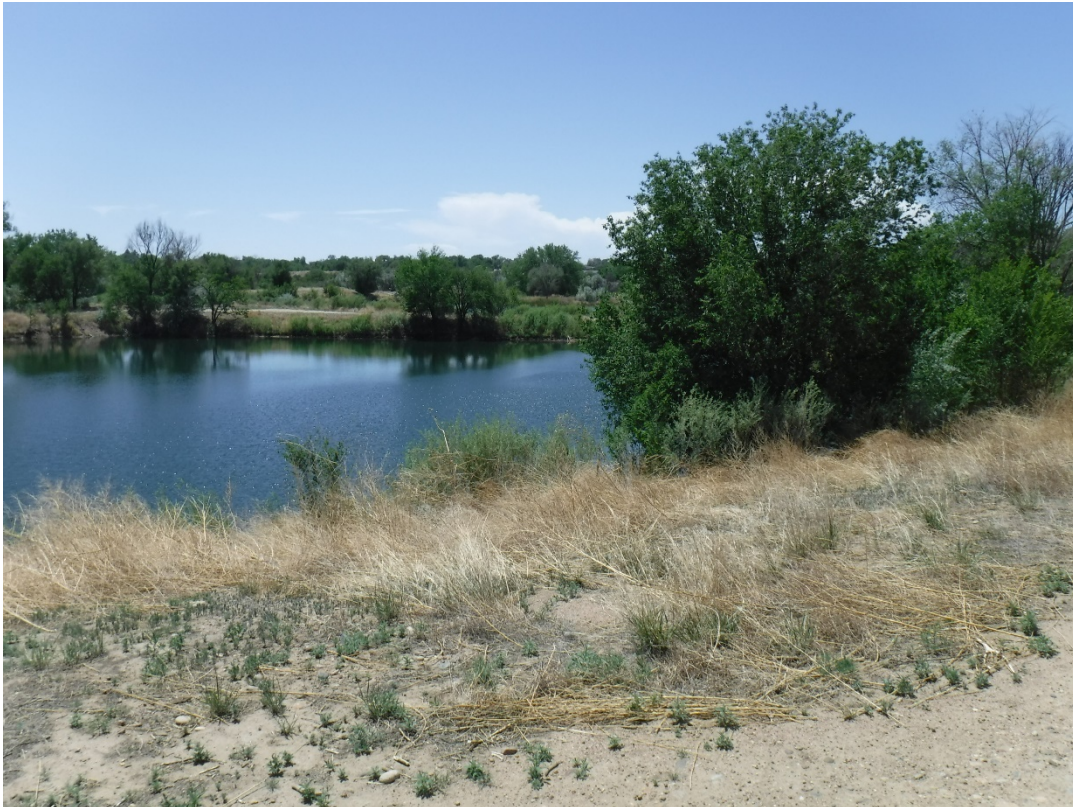
Photo 10: Looking south across the northern pond
