Minerals 3600 Mine and Reclamation Inspection
U.S. Department of the Interior
Bureau of Land Management
Royal Gorge Field Office

Date: March 18, 2022 Time: 11:03 Weather: Sunny	Operation Name: Fremont Co - Qaugmire Pit Case Number: COC-078247 CDRMS #: M-1990-047
<u>Attendees</u> BLM: A. Pike Operator(s): Not Present Other(s): None	<u>General</u> Operation(s) are in compliance with documentation on file <input checked="" type="checkbox"/> Yes <input type="checkbox"/> No <input type="checkbox"/> N/A Operation(s) and disturbance on-site coincide with the operations and access on file <input checked="" type="checkbox"/> Yes <input type="checkbox"/> No <input type="checkbox"/> N/A

Inspection Purpose: ☐ Pre-Operations ☐ General ☒ Final ☐ Trespass ☐ Complaint

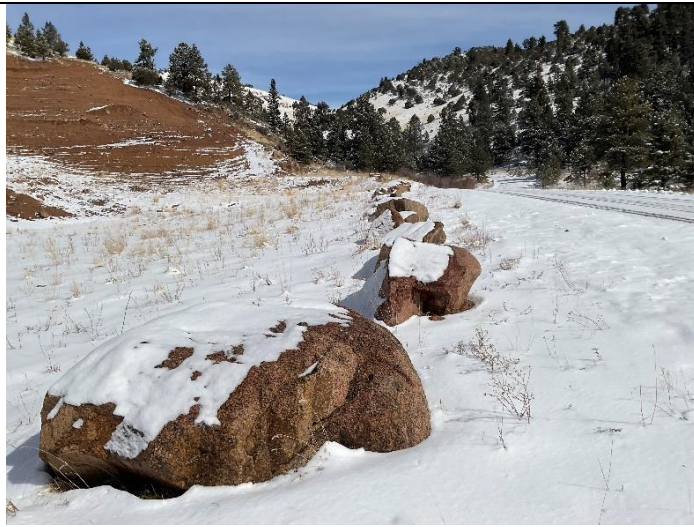
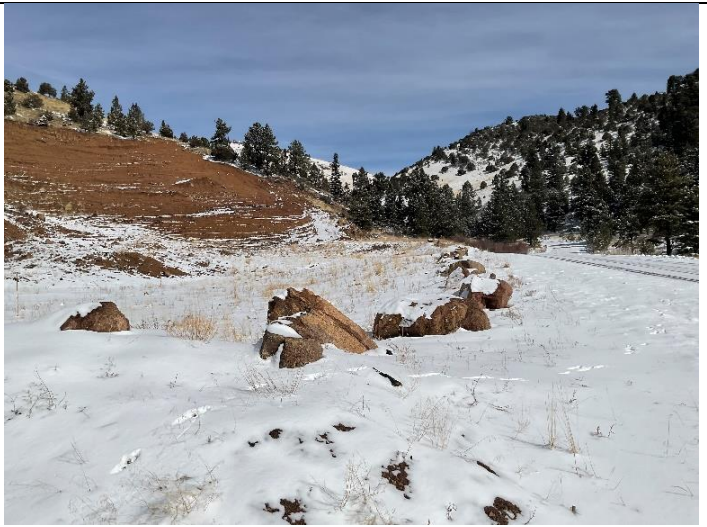
Image(s) 1-2:

- Boulders were placed along the edge of the county road right-of-way (ROW) to deter the public/road users from disturbing the reclamation work conducted last spring/summer (ref. images 1-2). BLM will require these boulders to be removed prior to finalizing reclamation and releasing reclamation obligations.
- A small pull trailer potentially is located on BLM lands along the southern reclamation boundary near the mine sign (ref. image 3-4). Is this trailer owned by Fremont County? If so, this trailer needs to be removed in order to meet reclamation requirements.

Comment: Boulders were placed between the mine boundary and C.R. 12 right-of-way pullout. These boulders need to be removed to meet final reclamation requirements.

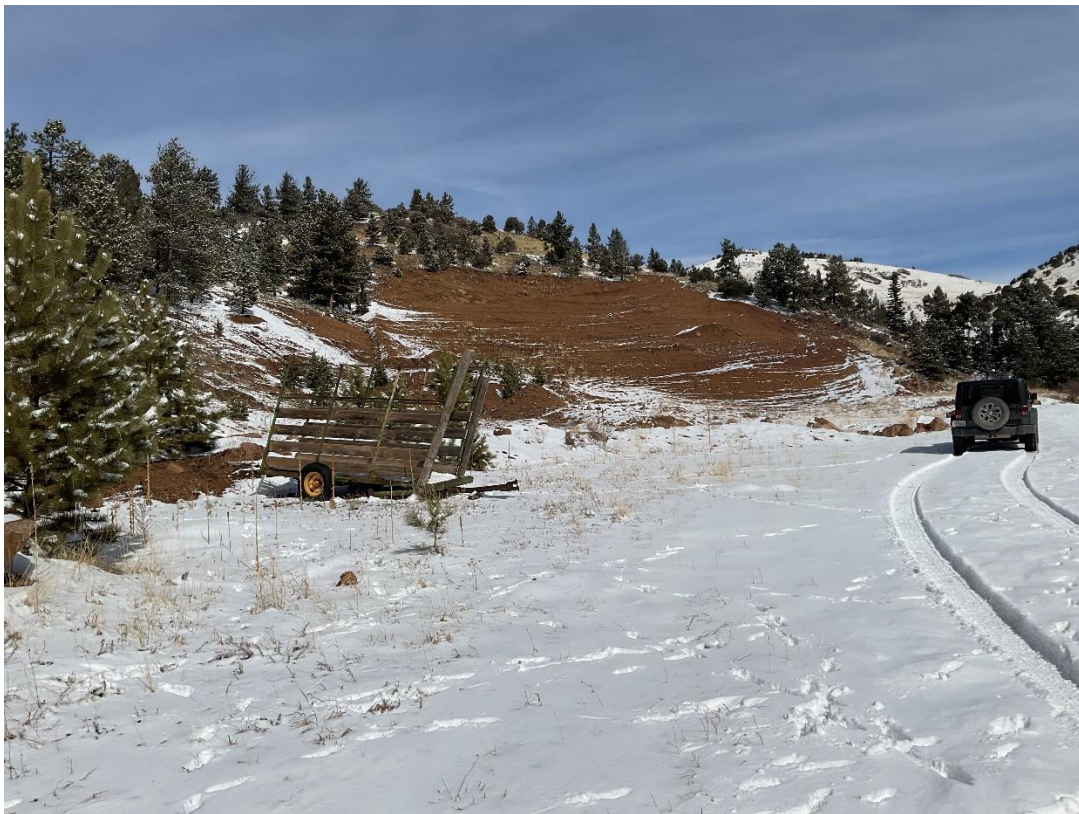
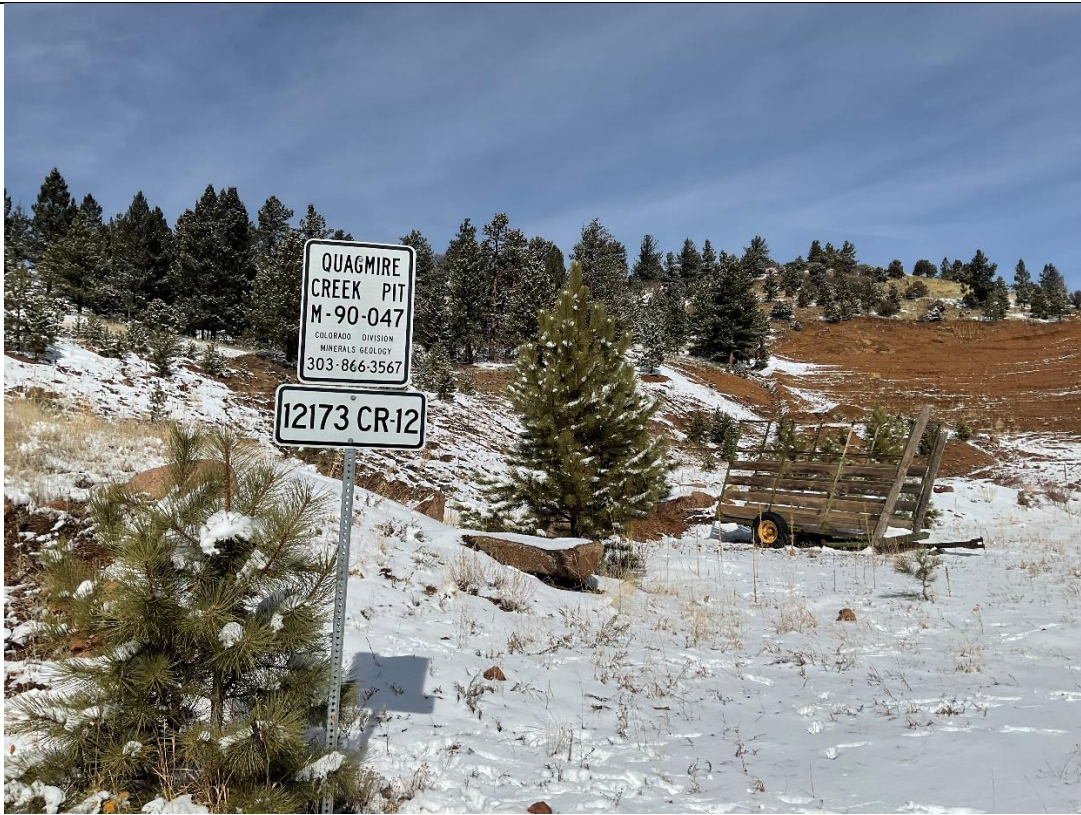
Image(s) 3-4:

Comment: A small pull trailer potentially is located on BLM lands along the southern reclamation boundary near the mine sign. The pull trailer will need to be removed, if this structure is property of Fremont Co.

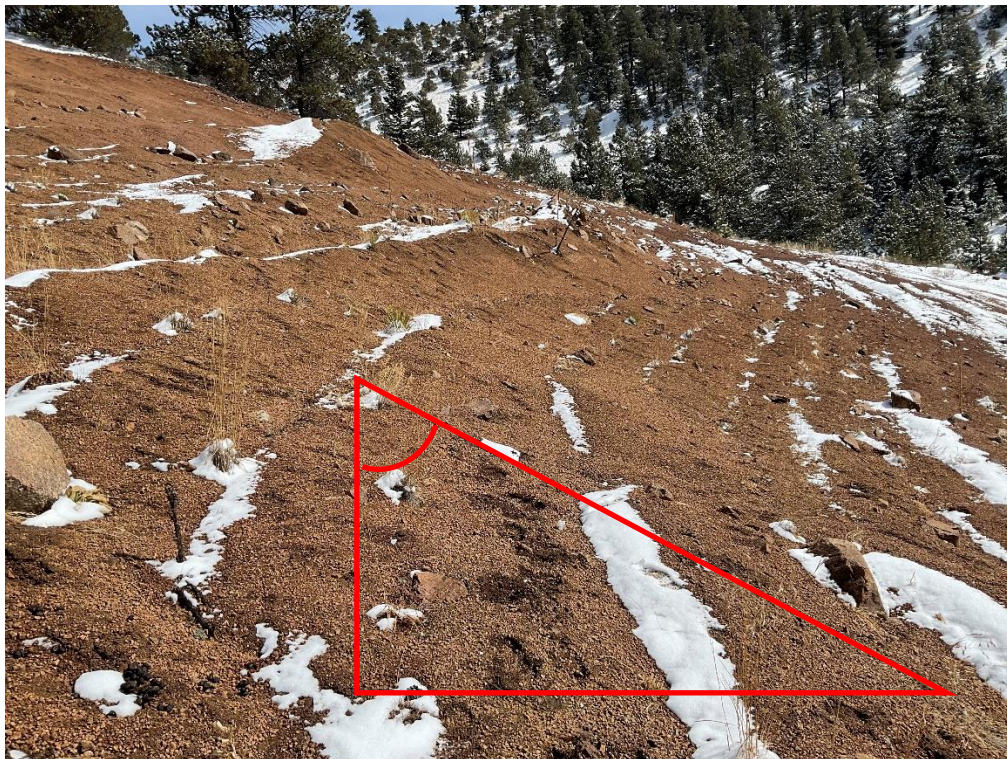
Image(s) 5:

- NE highwall slope is adequate (reclamation plan states at least 2.5H:1V final slope) - calculated slope from images taken during inspection = 2.4:1 slope (ref. image 5).
- Ponderosa pine saplings along the southern disturbance area have grown to ~2-4 ft tall (ref. image 6).
- Tentative inspection scheduled for August 2022 to inspect the revegetation progress and determine if all reclamation requirements have been met per the reclamation plan.

Comment: Per the reclamation plan, the final highwall will have an $\sim 2.5:1$ slope which is a 40% gradient with an angle = 21.8° . Per the images measured slope in the field, the reclaimed highwall slope is $\sim 2.4:1$ with

a slope angle of 24° . Therefore, the slope of the reclaimed highwall is considered adequate to meet the reclamation standards outlined in reclamation plan. Scale = 9 inches : 0.25 inches

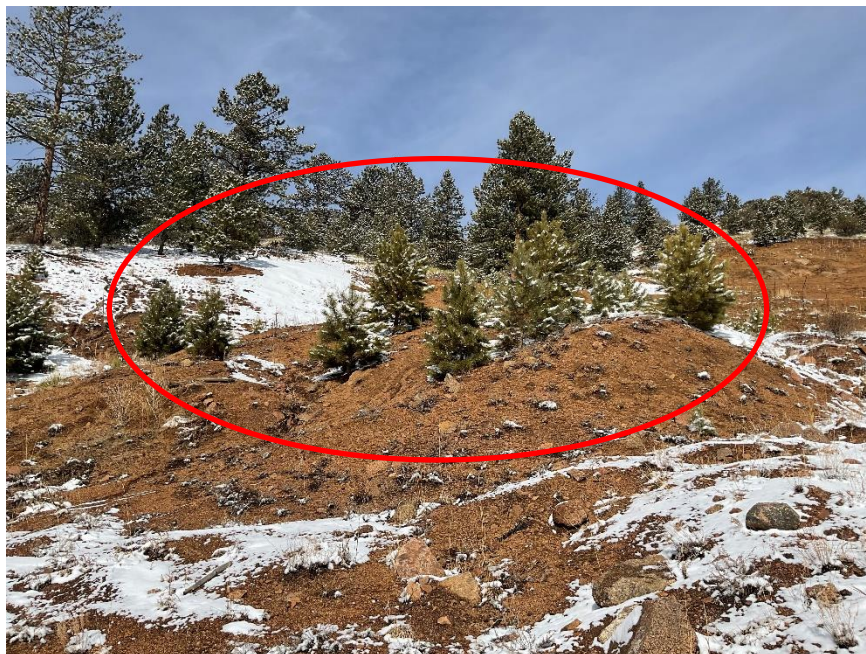
Image(s) 6:

Comment: Ponderosa pine trees along the ridge of the southern reclaimed area

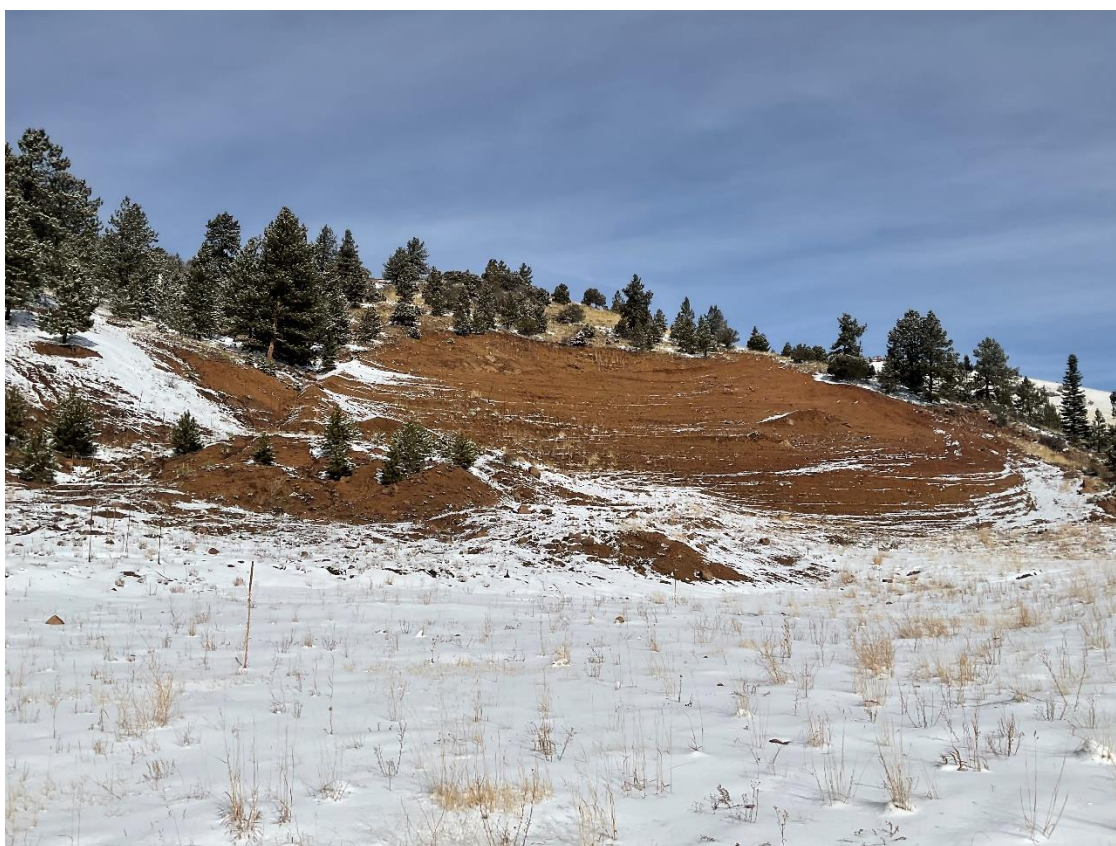
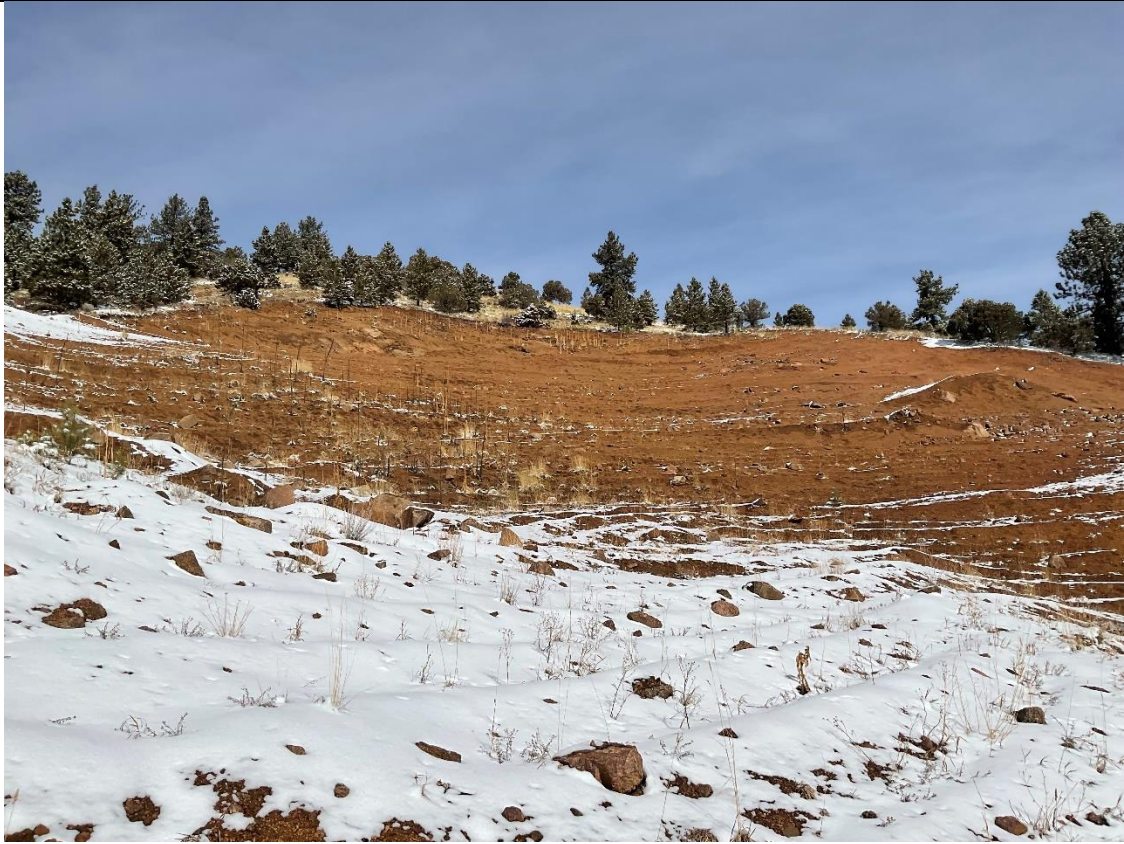
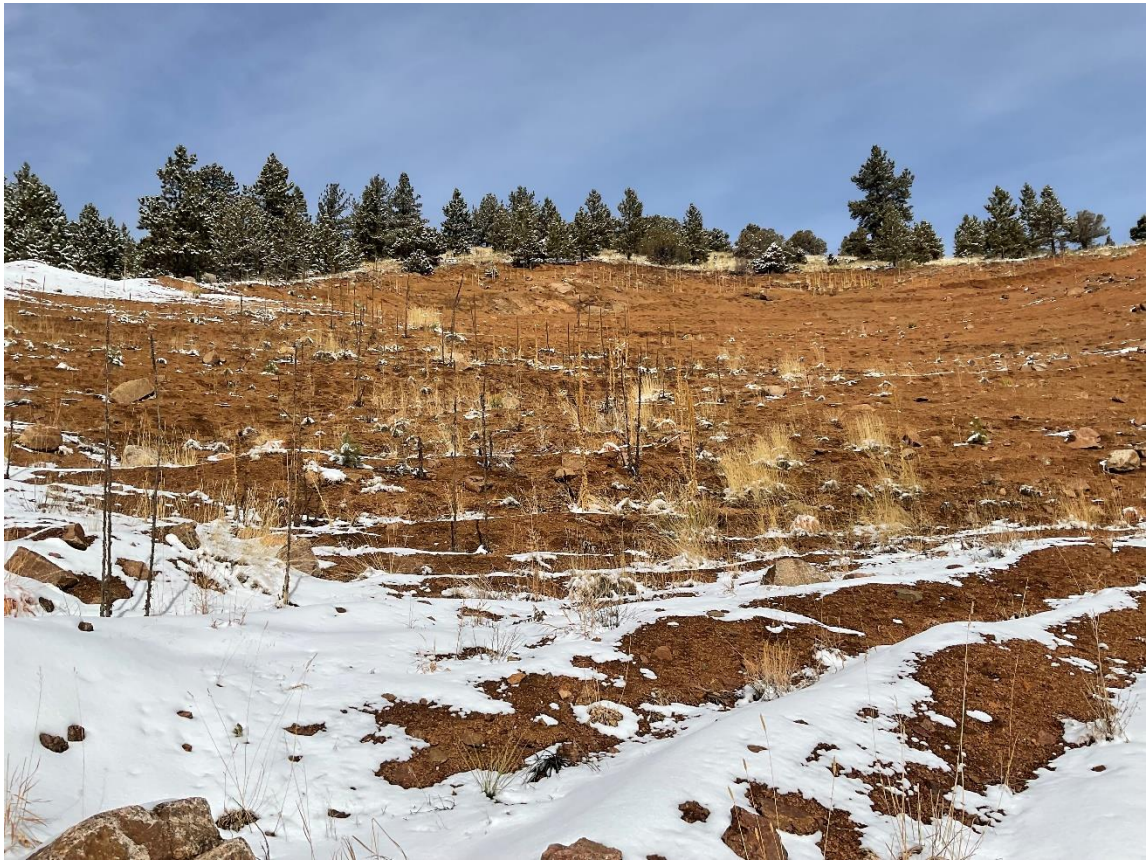
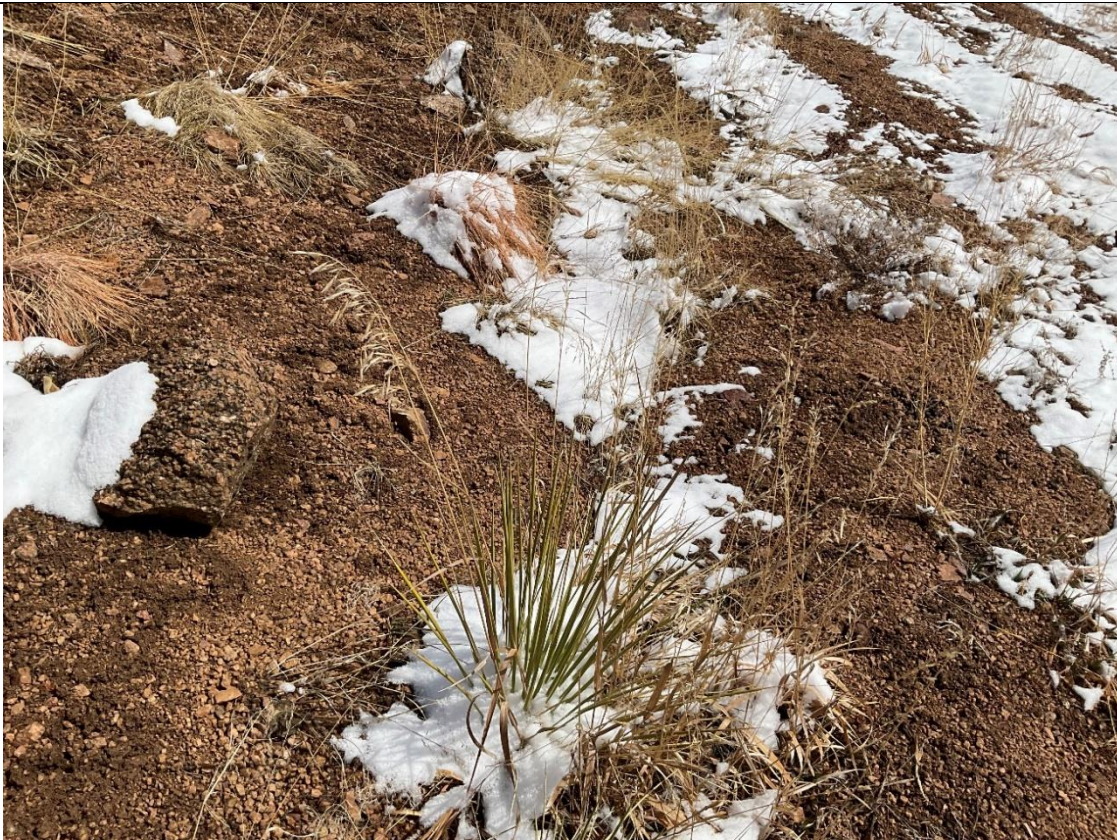
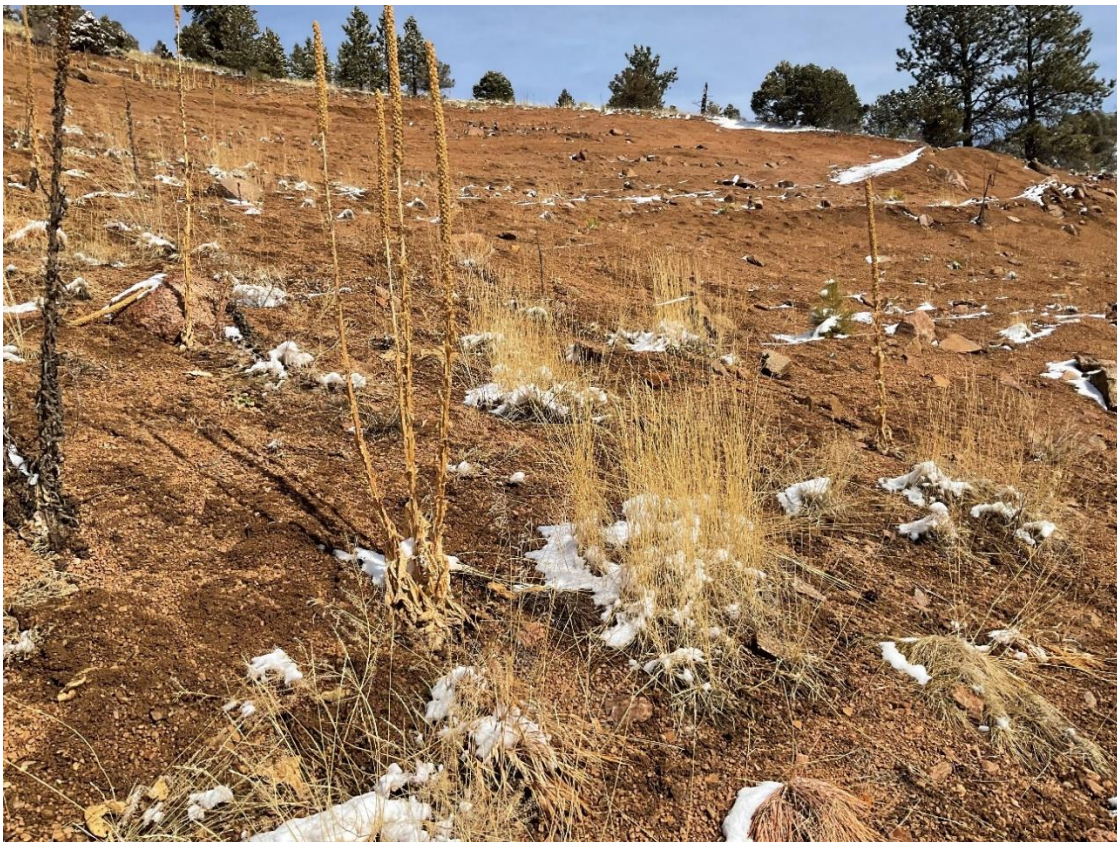
Images 7-11:

- Revegetation is still inadequate along the regraded highwall. Vegetation is visible including native grasses and trees; however, adequacy has not been met per the reclamation requirements (ref. images 7-11). Reseeding was conducted in 2019 and fall 2020 on the upper highwall. NOTE - Adequate vegetation is based on 80% of the surrounding undisturbed desirable vegetative canopy area. Desirable vegetation is vegetation that contains natural vegetation relative to the surrounding undisturbed vegetative species.
- Reclamation “Path Forward”:**
 - Future Inspection:* Watch revegetation efforts for an additional growing season. Tentative inspection scheduled for August 2022 to inspect the revegetation progress along the recontoured highwall.

- *05/06/22 BLM Range Specialist Consultation:* The top layer seems to be mostly decomposed granite vs organic matter which could cause the seed to resist germination/growth. Using some type of netting or tackifier or heavier mulch such as wood chips rather than straw could help germinate the seed when minimal soil is present. The seed mix is adequate for this area; however, going heavier on the native seed and adding an annual such as trilakalia or annual oat grass to serve as a cover crop could help build some organic matter. A little moisture wouldn't be beneficial as well.

Comment: Grass growth is improving since the last inspection in the lower (southern) section of the reclaimed area. The upper portion of the highwall still lacks vegetation.

- *05/02/22 CDRMS and BLM coordination:* Suggestion was presented to plant ponderosa trees along the barren highwall to provide soil stabilization, additional moisture and cover for grass regrowth. Cut timber scattered throughout the site was also suggested to help with moisture retention, erosion and deter other public land users from disturbing the reclaimed areas.

- *05/10/22 BLM Forester Specialist Consultation:* About 50 ponderosa seedlings would be a good start. Make sure to place logs along the hillside contour, as some soil stabilization will be needed before any trees will take.
