MINERALS PROGRAM INSPECTION REPORT
PHONE: (303) 866-3567

MINE NAME: Ghost River Gravel Pit	MINE/PROSPECTING ID#: M-2003-002	MINERAL: Sand and gravel	COUNTY: Huerfano
INSPECTION TYPE: Monitoring	INSPECTOR(S): Patrick Lennberg	INSP. DATE: May 18, 2022	INSP. TIME: 09:30
OPERATOR: HCR High Country Repair	OPERATOR REPRESENTATIVE: Natasha Goldberg	TYPE OF OPERATION: 110c - Construction Limited Impact	
REASON FOR INSPECTION: High Priority	BOND CALCULATION TYPE: None	BOND AMOUNT: \$19,112.00	
DATE OF COMPLAINT: NA	POST INSP. CONTACTS: None	JOINT INSP. AGENCY: None	
WEATHER: Clear	INSPECTOR'S SIGNATURE:

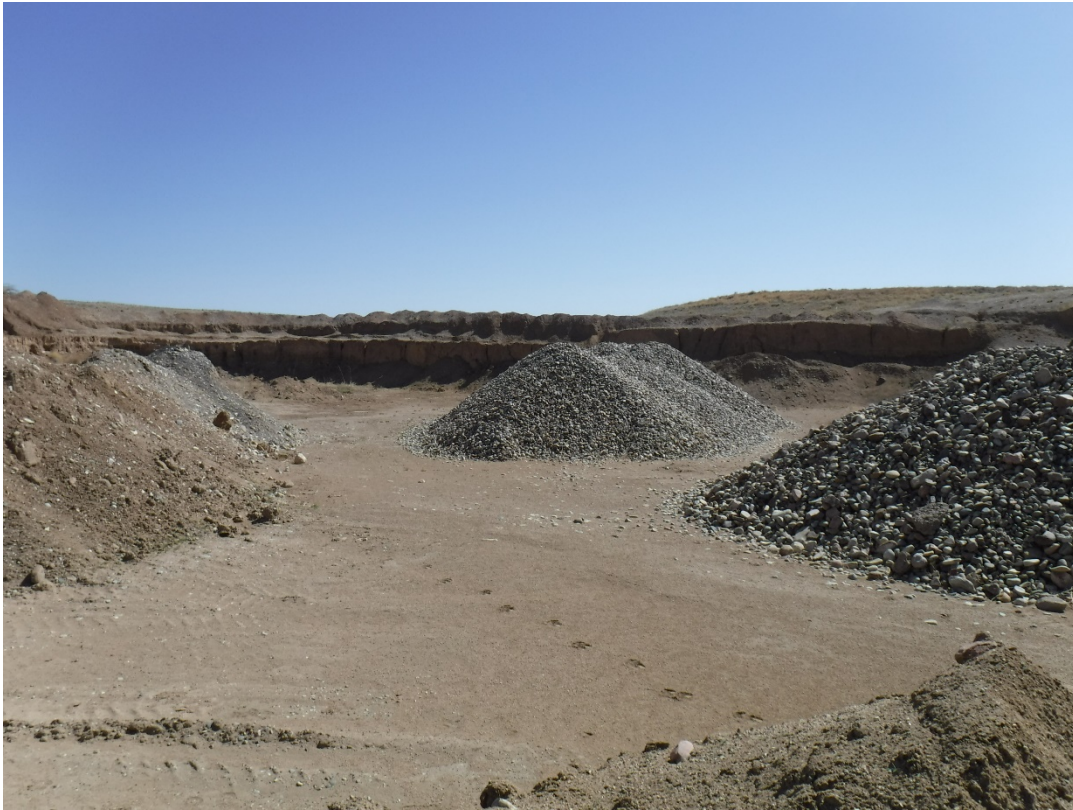
Photo 3: Looking northeast from main pit area, note near vertical highwalls

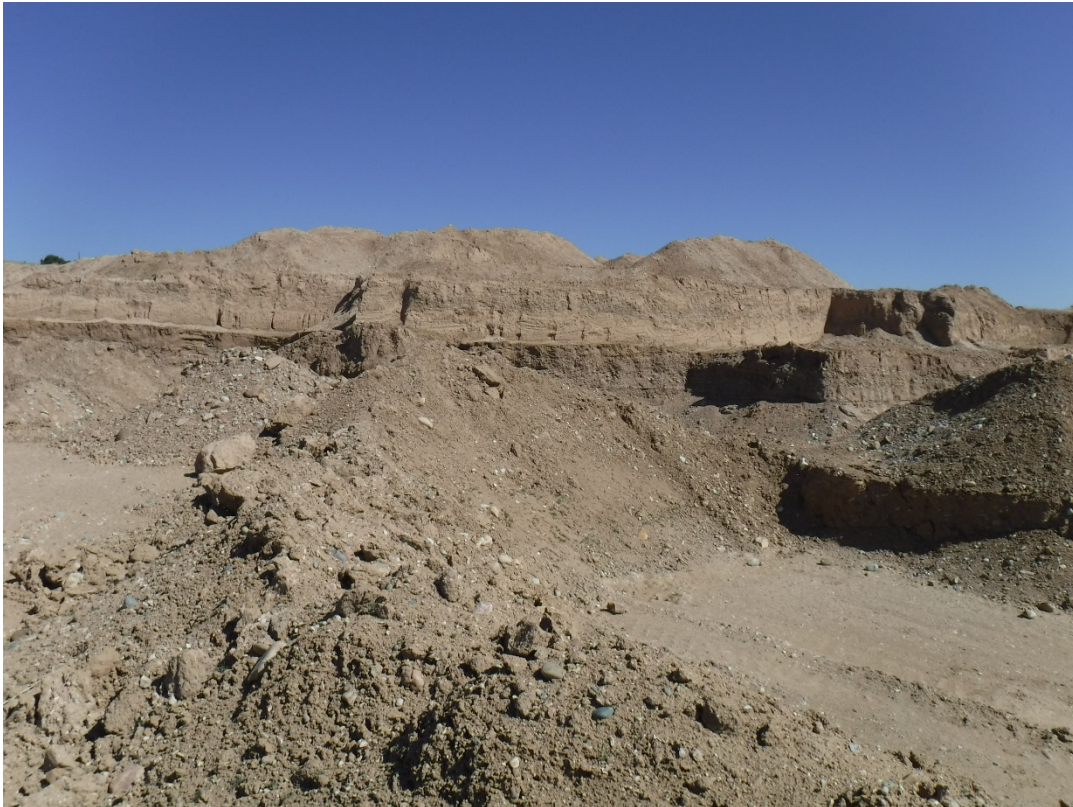
Photo 4: Looking northwest from main pit area, note near vertical highwalls and stockpile overburden
