MINERALS PROGRAM INSPECTION REPORT

MINE NAME: Hale Pit aka Earl's Pit	MINE/PROSPECTING ID#: M-1981-121	MINERAL: Sand and gravel	COUNTY: El Paso
INSPECTION TYPE: Surety-Related Inspection	INSPECTOR(S): Timothy Cazier, P.E.	INSP. DATE: May 4, 2022	INSP. TIME: 10:45
OPERATOR: Atticus Land, LLC	OPERATOR REPRESENTATIVE: Jake Decoto	TYPE OF OPERATION: 110c - Construction Limited Impact	
REASON FOR INSPECTION: Surety Related	BOND CALCULATION TYPE: Complete Bond	BOND AMOUNT: \$17,570.00	
DATE OF COMPLAINT: NA	POST INSP. CONTACTS: None	JOINT INSP. AGENCY: None	
WEATHER: Cloudy	INSPECTOR'S SIGNATURE:

This inspection was conducted by Tim Cazier (DRMS) as part of a surety reduction request. The Permittee (Atticus Land, LLC) was represented by Mr. Jake Decoto during the inspection. The purpose of this inspection was to determine if the previously observed highwalls had been adequately re-sloped to 3H:1V or flatter. The Hale Pit site entrance is located at the intersection of Spencer Rd and McClelland Rd, approximately five miles southeast of Peyton, CO. This is a 110c sand and gravel mine and is in final reclamation.

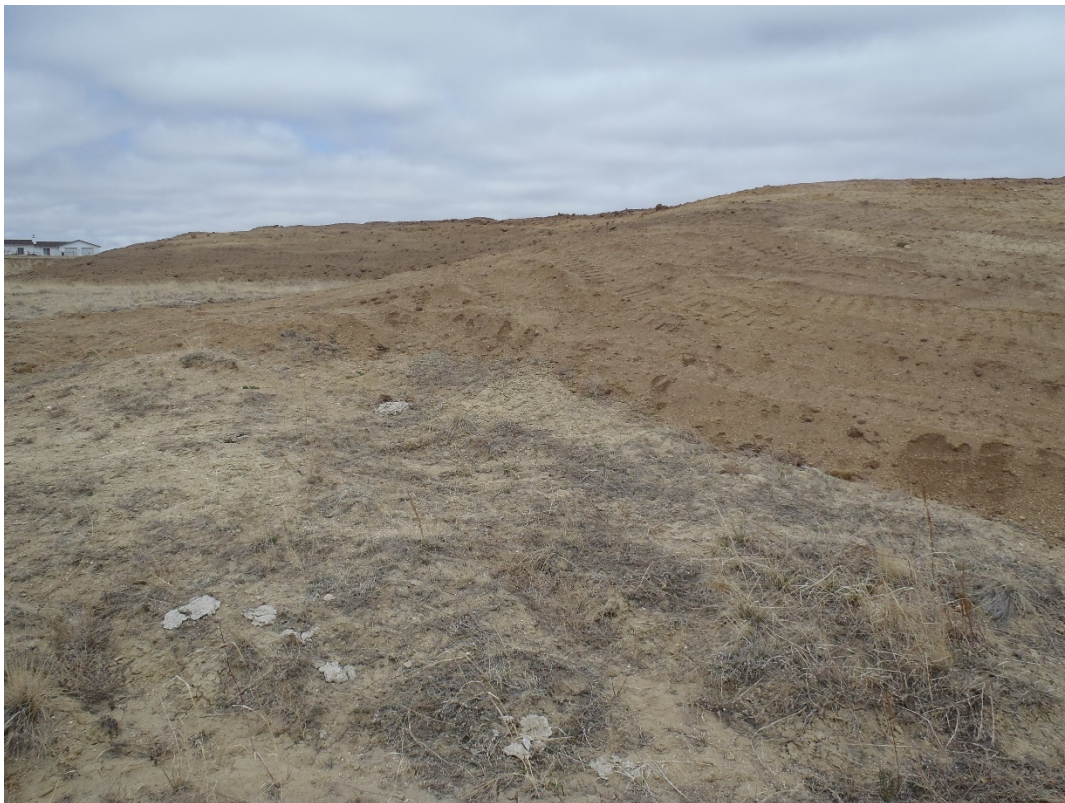
Backfilling and Grading: Backfilling and grading of the slopes requiring attention during the previous inspection were observed to have been adequately sloped (see **Photos 1, 2 and 3**).

Photo 1. Regraded north west and central highwalls (looking west).

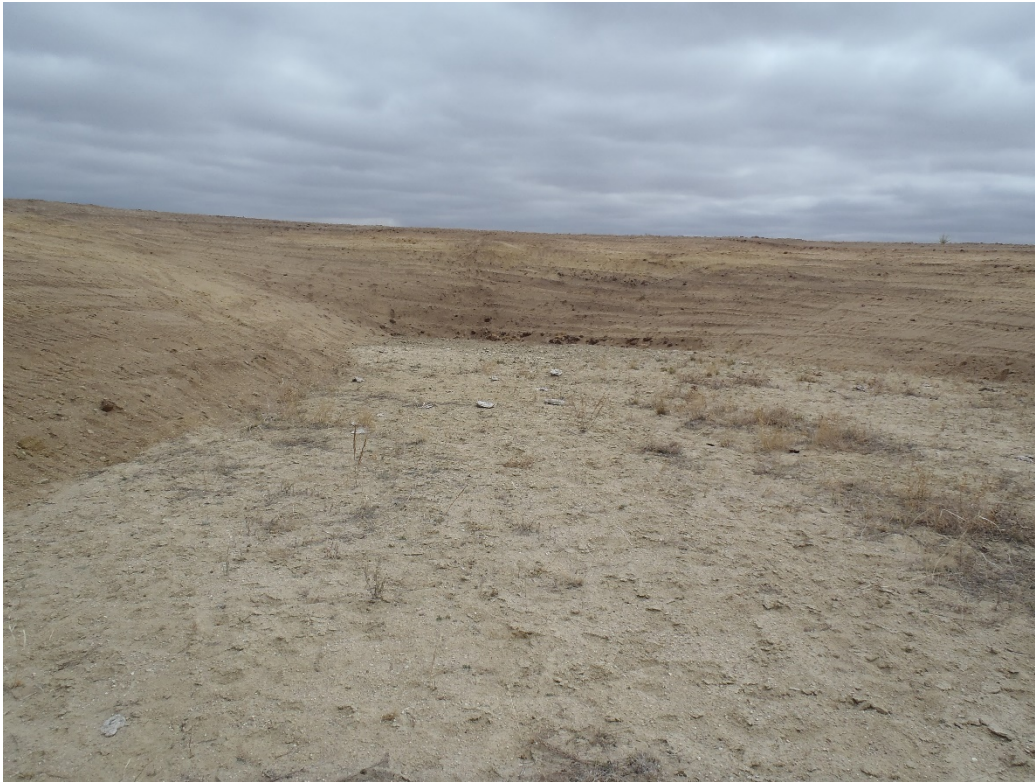
Photo 2. Completed grading of northeast highwall (looking north).

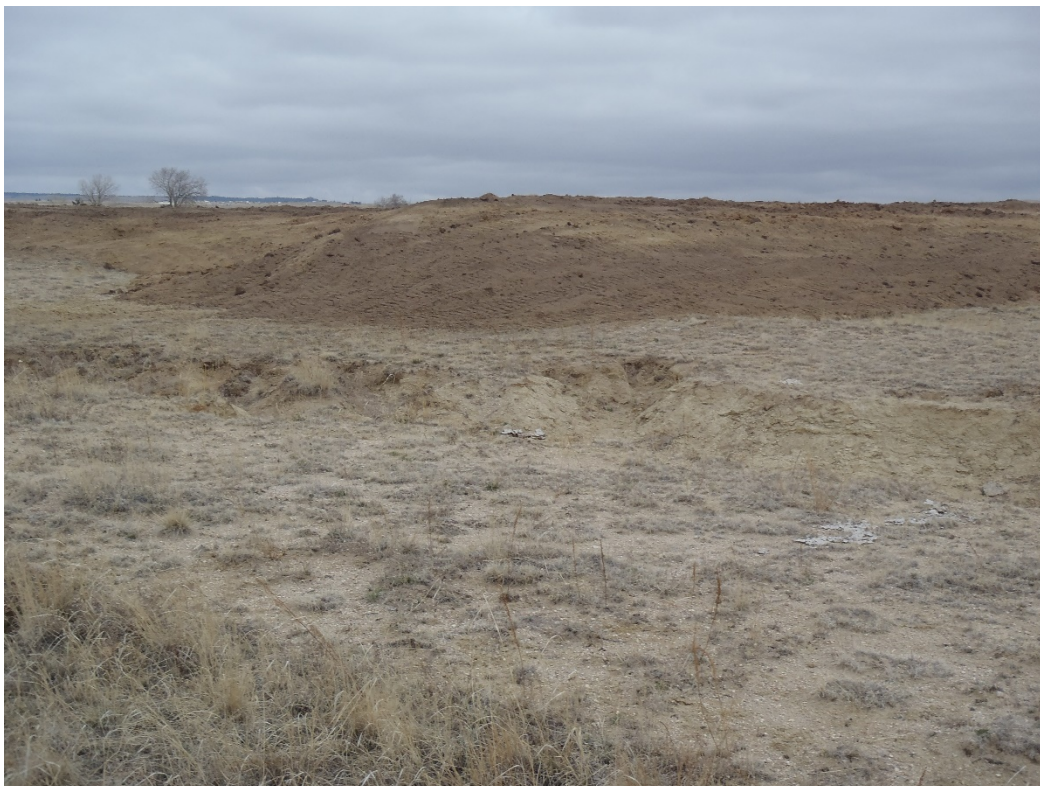
Photo 3. Regraded north central highwall (looking NW).

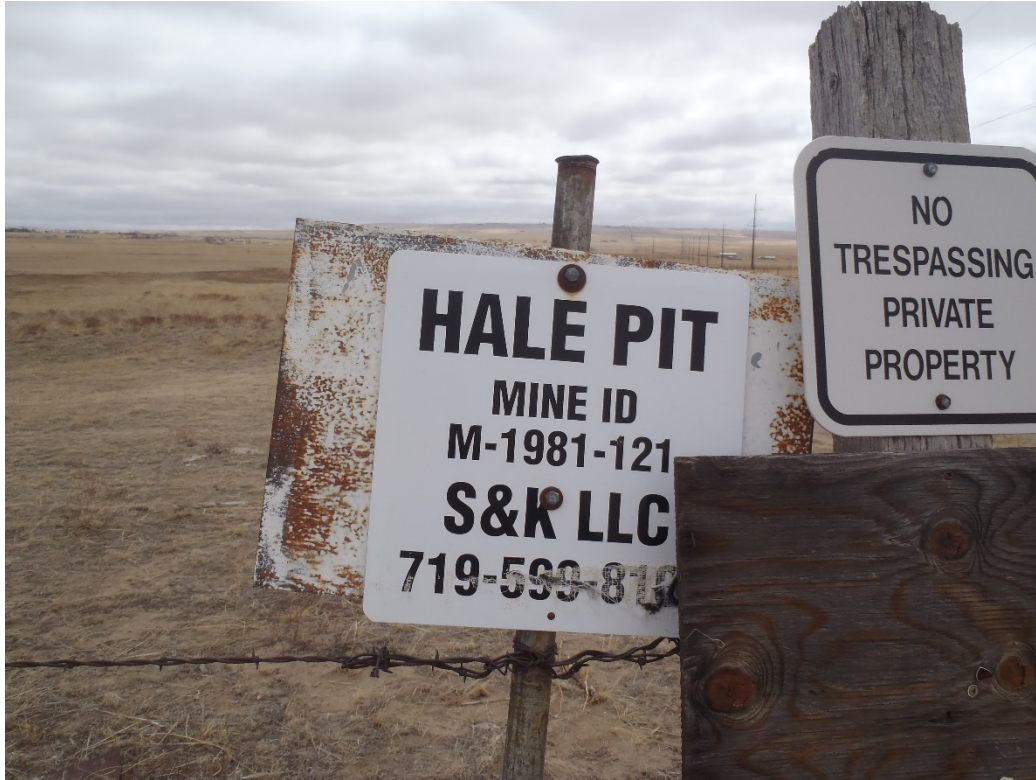
Signs and Markers: The previous permittee's sign was still posted at the site entrance (see **Photo 4**). [The sign should be replaced to reflect the new Permittee's name.](#) The DRMS has defined requirements (reference Rule 3.1.12) for permit signs since the previous Permittee posted the permit sign. These are as follows:

Photo 4. Permit sign (with previous Permittee's name).

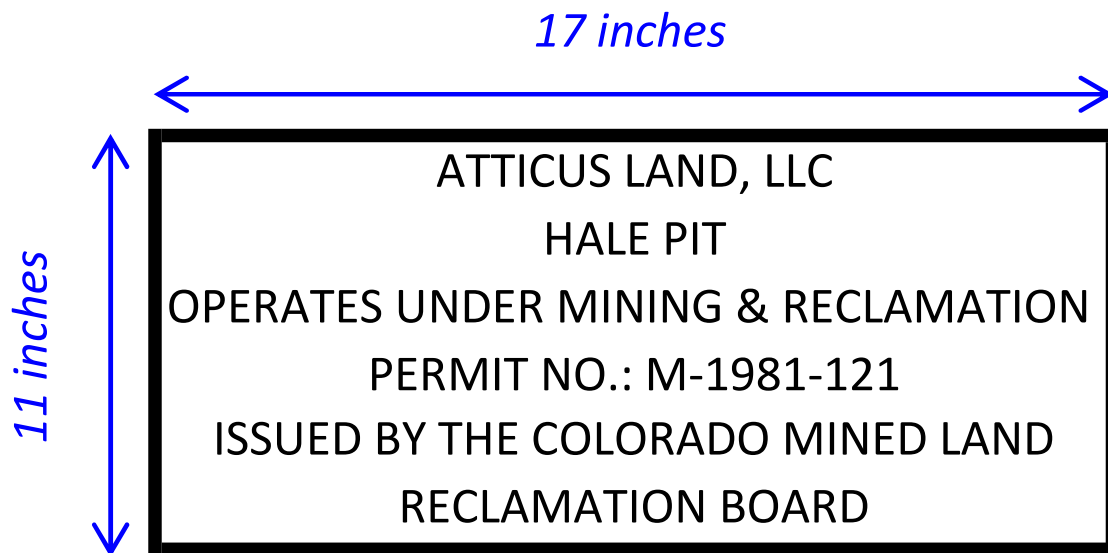
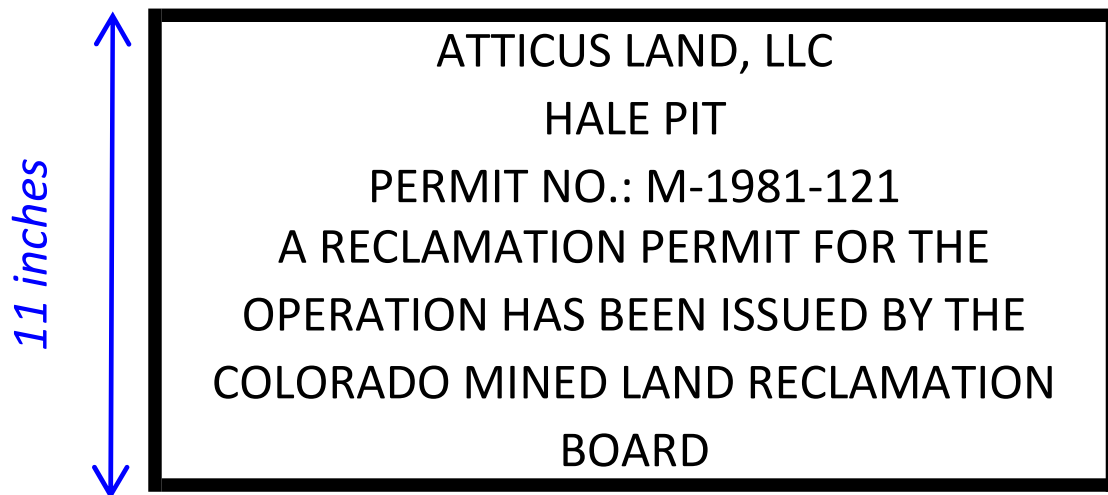
Figure 1. Example Permit Signs

Example signs are shown in **Figure 1**. The previous Permittee did not place boundary markers as recommended in the previous inspection report. The site was in temporary cessation with the permit boundary expected to be expanded, so this was not cited as a problem at the time. As the site is now in final reclamation, with only revegetation remaining to be completed; and only in areas well inside the approved permit boundary, placing markers is not considered critical at this time. For reference, Atticus Land should be aware the southwest corner of the permit boundary is 200 feet east of McClelland Road and 200 feet north of the fence on the south side of the property. The southeast permit boundary corner is 660 feet east of the southwest corner and 200 feet north of the aforementioned south property fence. The permit boundary is square with the northwest and northeast corners being 660 feet north of their respective southern corners.
