PERMIT INFORMATION

Permit Number: C-1981-038 Mine Name: Bowie No. 1 Mine Operator: Bowie Resources, LLC Operator Address: Mr. Basil R Bear P.O. Box 1488 Paonia, CO 81428	County: Delta Operation Type: Underground Permit Status: Active Ownership: Private
	Operator Representative Present: None
Operator Representative Signature: (Field Issuance Only)

Inspection Start Date: May 26, 2022 Inspection Start Time: 11:50 Inspection End Date: May 26, 2022 Inspection End Time: 12:40	Inspection Type: Coal Partial Inspection Inspection Reason: Normal I&E Program Weather: Clear
Joint Inspection Agency: None	Joint Inspection Contacts:
Post Inspection Agency: None	Post Inspection Contacts:
Inspector(s): Robert Zuber, P.E.	Inspector's Signature:

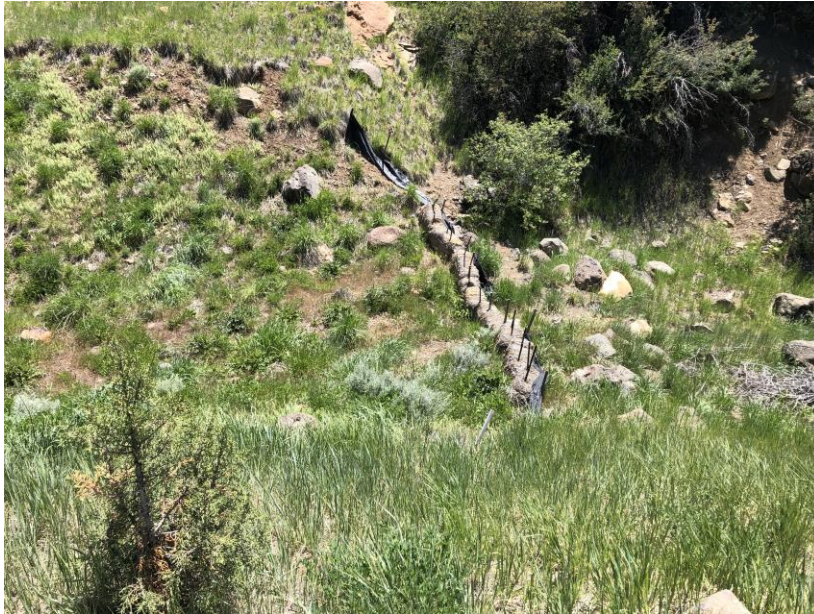
- The main area along the haul road and around the old portals
- The RDA
- The Old Waste Disposal Area
- The drainage where the reclaimed ponds (Ponds 1 – 4) are located.

BMPs at the reclaimed Pond 4 (East Mine)

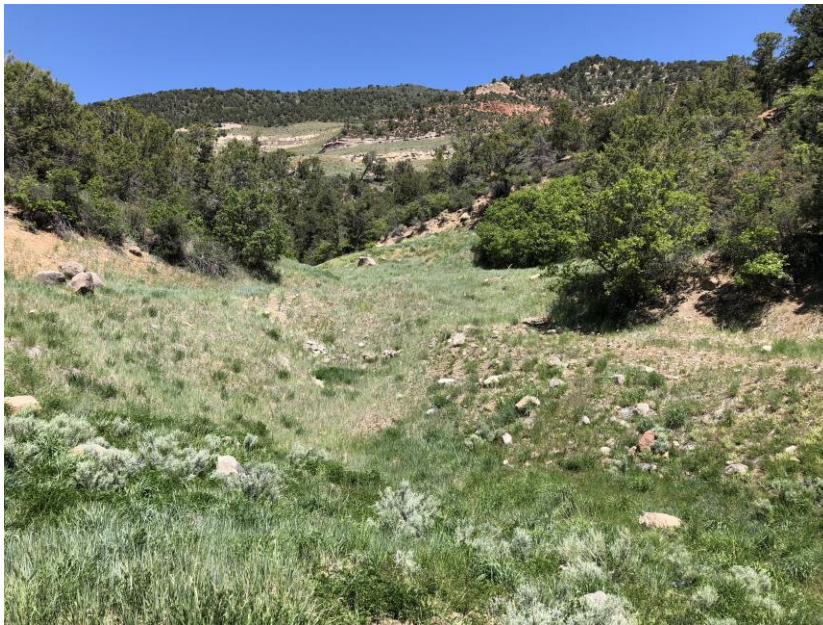
Looking up the drainage above reclaimed Pond 4 towards the Old Waste Storage Area

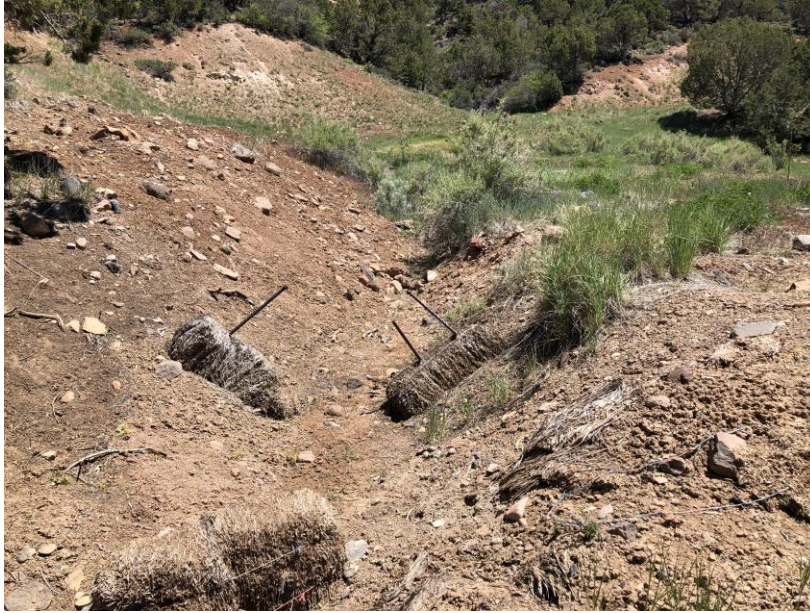
At the first bend in the haul road west of the RDA, the slope below the road was inspected. No erosion control practices are in place here, but the slope is generally stable.

**Maintenance need along the haul road at East Mine
(next to western switchback west of RDA)**

Near the first bend in the haul road west of the RDA, the straw bales in the ditch need to be replaced. Up the hill from this (just northwest of the RDA), the large culvert is mostly clear of obstructions, and no maintenance is needed.

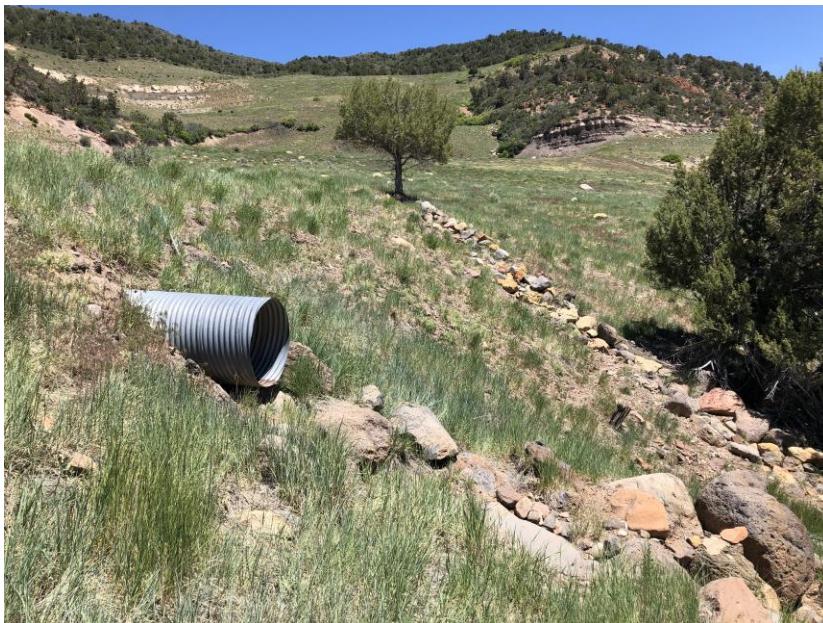
Culvert west of RDA
