PERMIT INFORMATION

Permit Number: C-1996-083 Mine Name: Bowie No. 2 Mine Operator: Bowie Resources, LLC Operator Address: Mr. Basil Bear P.O. Box 1488 Paonia, CO 81428	County: Delta Operation Type: Underground Permit Status: Active Ownership: Private
	Operator Representative Present: None
Operator Representative Signature: (Field Issuance Only)

INSPECTION INFORMATION

Inspection Start Date: May 26, 2022 Inspection Start Time: 10:20 Inspection End Date: May 26, 2022 Inspection End Time: 11:40		Inspection Type: Coal Partial Inspection Inspection Reason: Normal I&E Program Weather: Clear	
Joint Inspection Agency: None		Joint Inspection Contacts: 	
Post Inspection Agency: None		Post Inspection Contacts: 	
Inspector(s): Robert Zuber, P.E.	Inspector's Signature: <i>Robert D. Zuber</i>		Signature Date: 5/31/2022

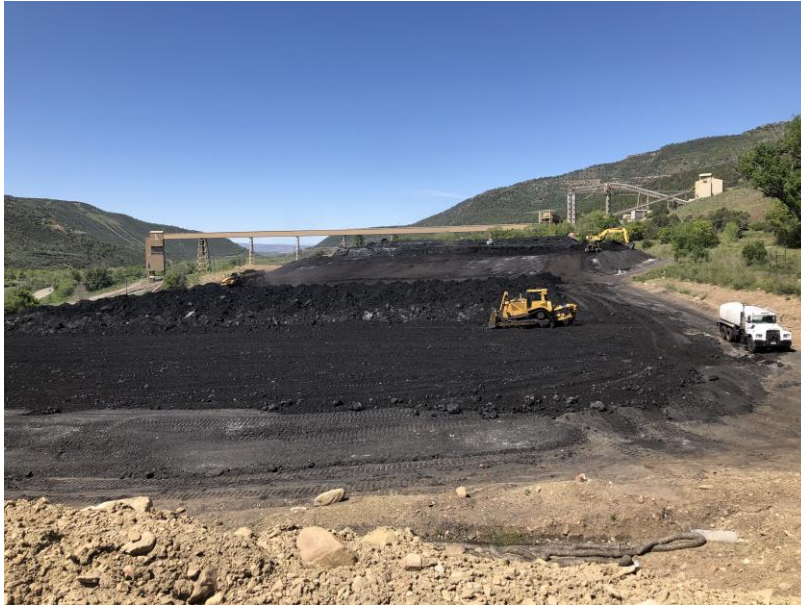
BRL continues to focus their efforts on Gob Pile #3, and significant progress has been made in 2022. During the inspection, piles of material were being dumped on the east side of the pile (approximately an acre of material had been dumped but not yet graded). Staff indicated that compaction testing was conducted on May 24, 2022, and the results were good.

Gob Pile #3, looking west

Overall the gob piles appeared stable. BRL should make a point of grading and compacting material on Gob Pile #3 in a timely way to avoid detaining water on the pile. This will contribute to minimizing the adverse effects of leachate on receiving waters. Signs of leaching through the pile can be seen along the road below.

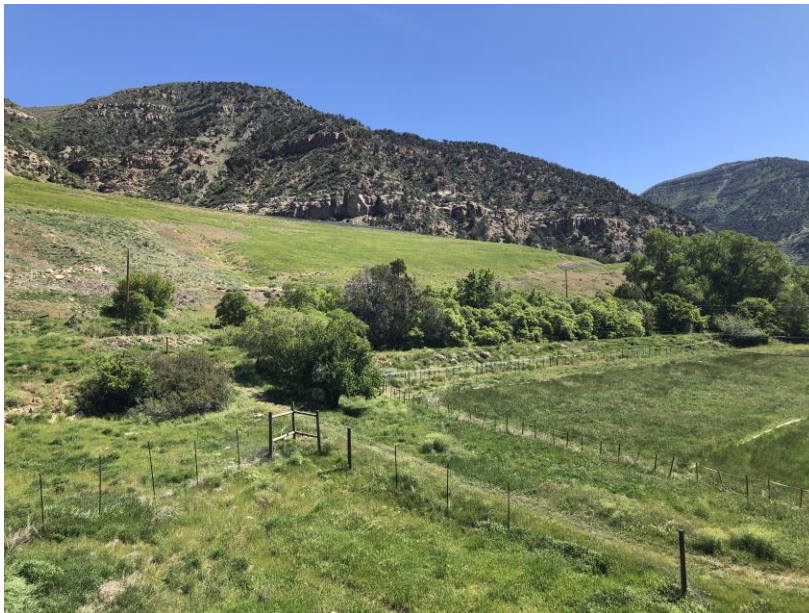
Rills were visible on the upper (bare) slopes of Gob Pile #2, but they are small. No puddles or other problems were observed on the upper, flat portion of this pile.

Gob Pile #2 from Gob Pile #3

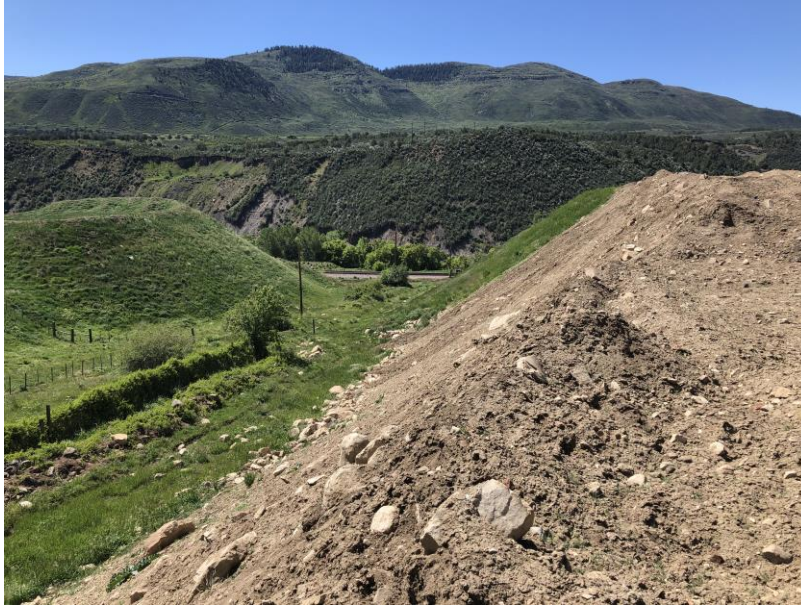
No problems were seen with topsoil stockpiles or coverfill piles. They were all well vegetated.

Soil piles east of Gob Pile #3

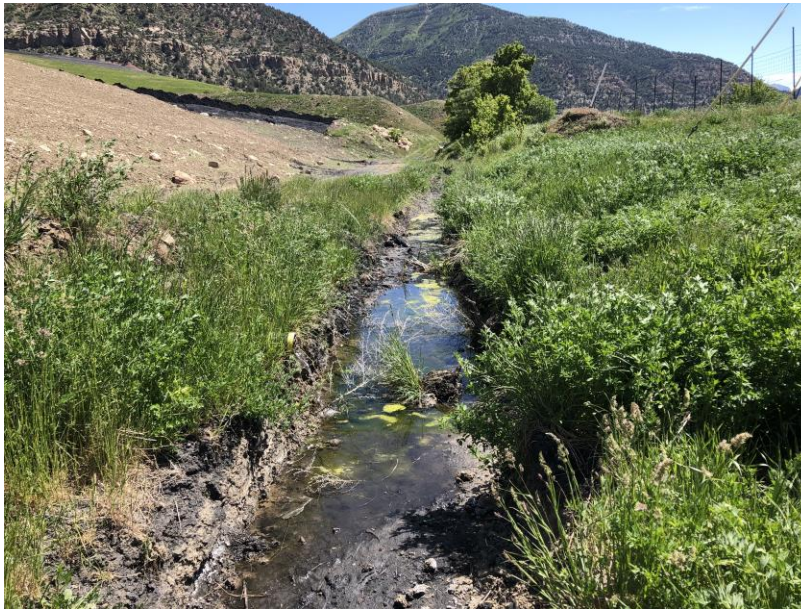
The two underdrains at Gob Pile #3 were flowing.

Discharge from underdrain at Gob Pile #3

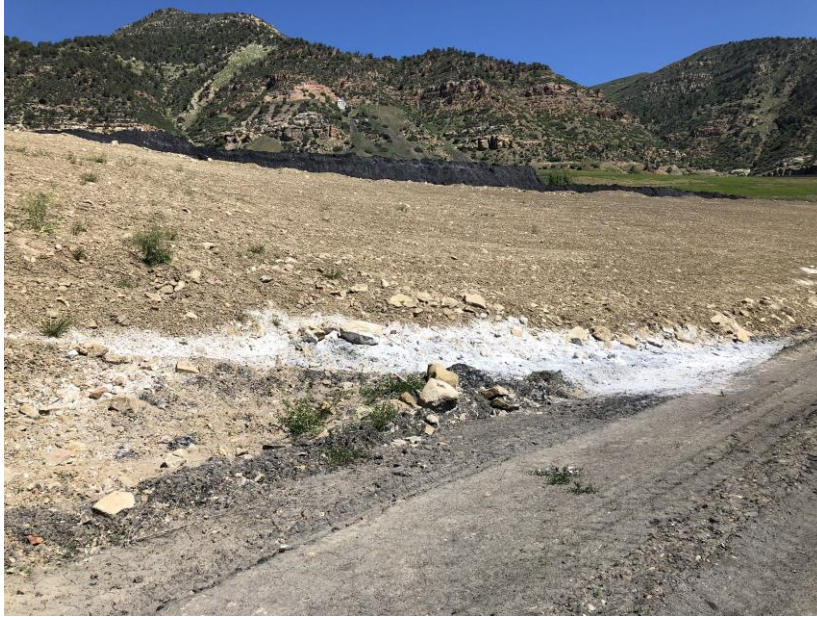
Evidence of leachate through Gob Pile #3

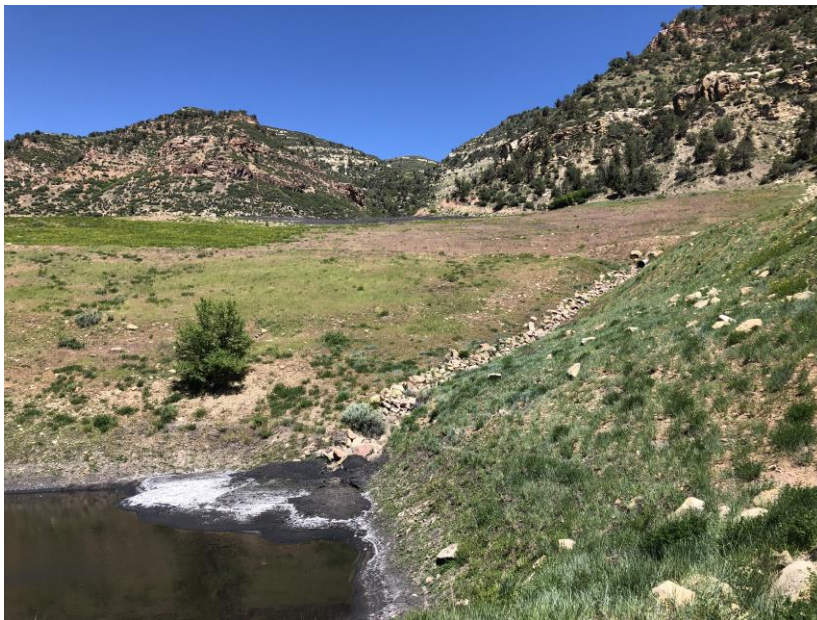
Pond F contained water well below the spillways. No significant problems were identified with embankments, spillways, inlet channels, or other features of the pond.

Pond F and lower part of Gob Pile #2
