## Response to Inspection April 19, 2022

**Re: Permit No. M-1980-244; Cripple Creek & Victor Gold Mining Company; Cresson Project; –April 19, 2022 Inspection Corrective Action Response**

**To:** Charles Bissue  
**From:** Jay Janney-Moore, P.E.  
**Reviewed By:** Keith Williams, P.E.  
**Project:** Ore Slope at the Mill Platform  
**Project No:** 475.0106.054  
**Subject:** Review of Ore Slopes at the Mill Platform  
**Date:** May 26, 2022

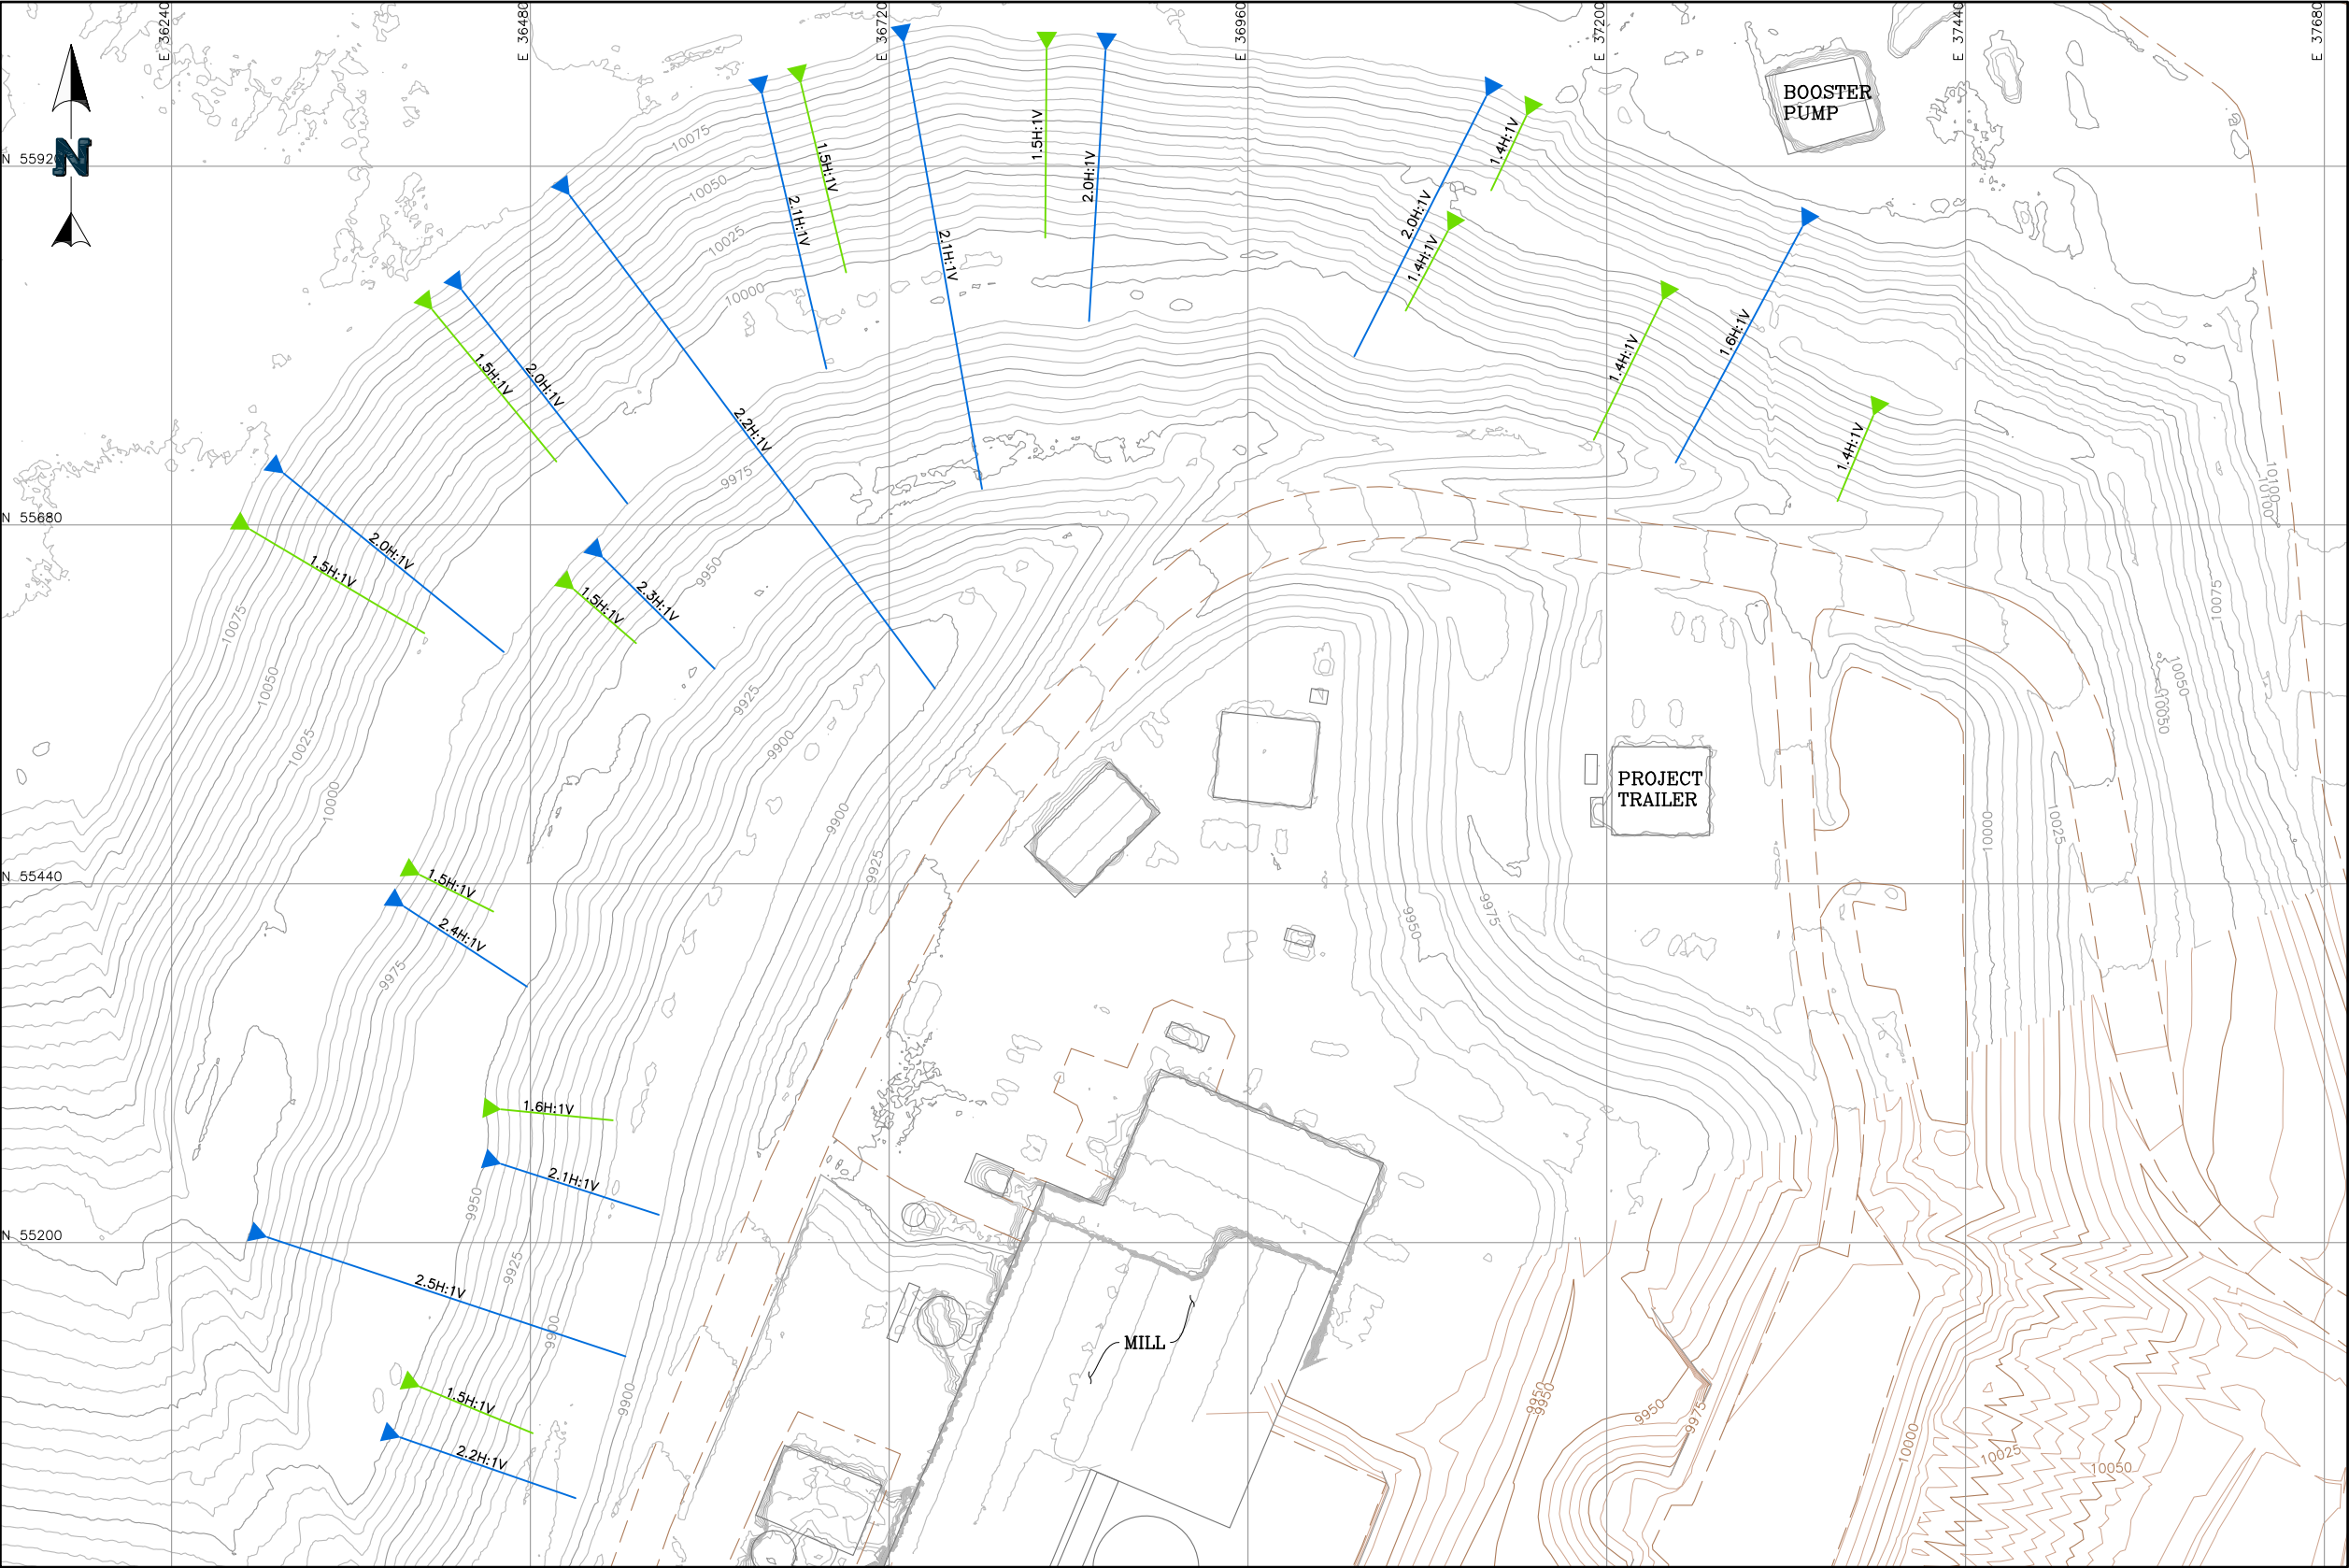
CLIENT CRIPPLE CREEK & VICTOR GOLD MINING COMPANY	
PROJECT		VLF2 HEAP ORE SLOPES	
TITLE HEAP ORE COMPOSITE SLOPES ABOVE MILL		FILENAME 0106.054.008F	
		FIGURE NO. 1	REVISION A

CC&V provided NewFields with a topography file, dated March 2, 2022, of the current as-built ore stacking above the HGM to determine if the stacking was following the guidelines or not. Using AutoCAD Civil3D, NewFields checked the overall slopes of the stacked ore, and checked actual dumped ore angle of repose. As shown on Figure 1, the overall slope of the ore generally varies between 2(H):1(V) and 2.5(H):1(V), except below the Booster Pump building. Based on the southern protrusion in the contours of the upper lift, it appears when the area for the Booster Pump building was regraded, the crest of the slope got pushed out and the overall slope was reduced to 1.6(H):1(V). Additionally, the actual dumped ore angle of repose varied between 1.4(H): and 1.5(H).

The bench width does vary and in some areas is less than 60 feet. This happened because the actual dumped slopes being flatter than the assumed angle of repose stated in Table 1 and not all lifts dumped are 100' thick. It appears CC&V did offset the crest of the subsequent lift to insure an overall slope of 2(H):1(V).

Based upon the reviewing the actual slopes of the ore above the HGM, it is NewFields opinion that CC&V has stacked the ore above the HGM in accordance with the intent of the guidelines outlined in TR-103 and the overall slopes are 2(H):1(V) or flatter. After subsequence lift of ore are placed above the booster pumps building, the overall slope will flatten out to less the 2(H):1(V).

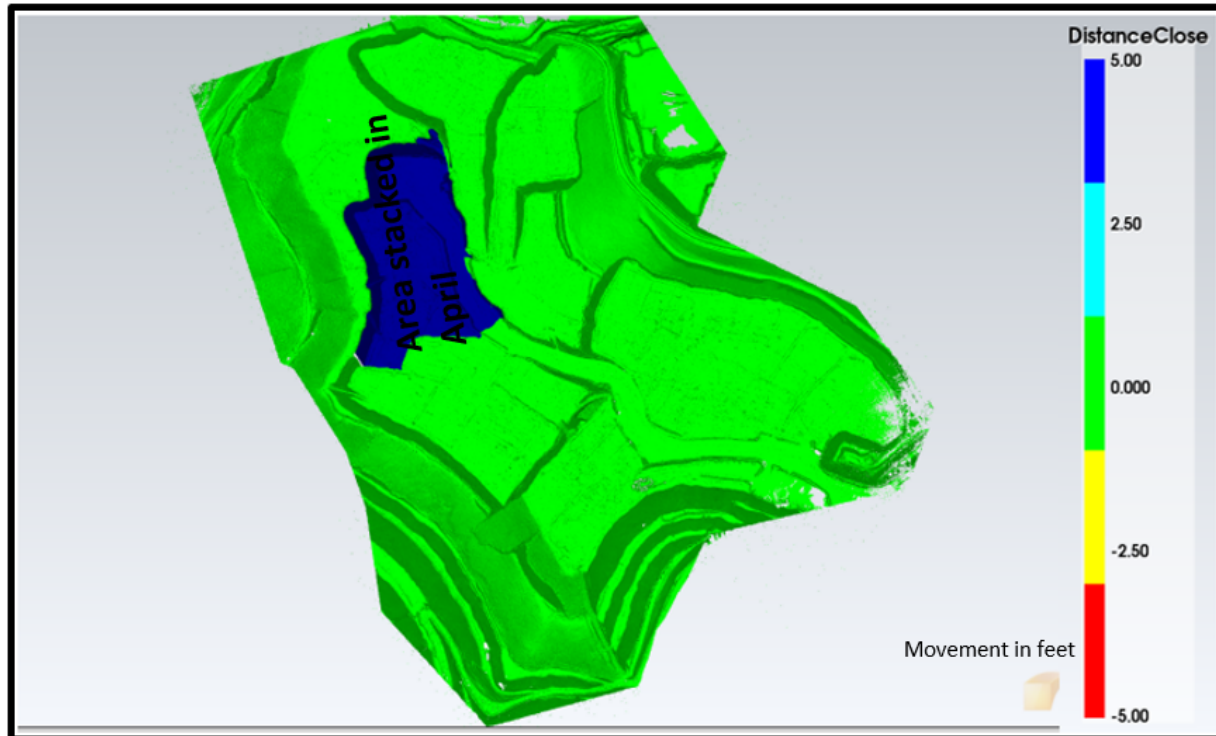
- A march flight of the VLF2 was compared to an April flight to detect displacements in feet
- NO major displacements were detected.

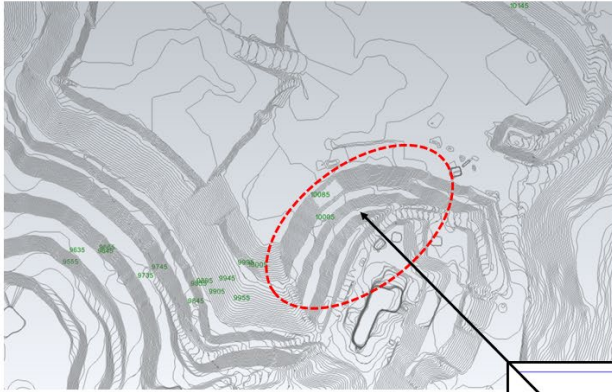
- Weekly scans were compared from April 5<sup>th</sup> to May 9<sup>th</sup>.
- Displacements are calculated in feet
- No major displacements are detected
