New Elk Mine, C-1981-012, May 26 2022 Inspection Report

COLORADO
Division of Reclamation,
Mining and Safety
Department of Natural Resources

Permit Number: C-1981-012 Mine Name: New Elk Mine Operator: New Elk Coal Company, LLC Operator Address: Mr. Mark Gray 12250 Highway 12 Weston, CO 81091	County: Las Animas Operation Type: Underground Permit Status: Active Ownership: Private
	Operator Representative Present: Mr. John Terry
Operator Representative Signature: (Field Issuance Only)

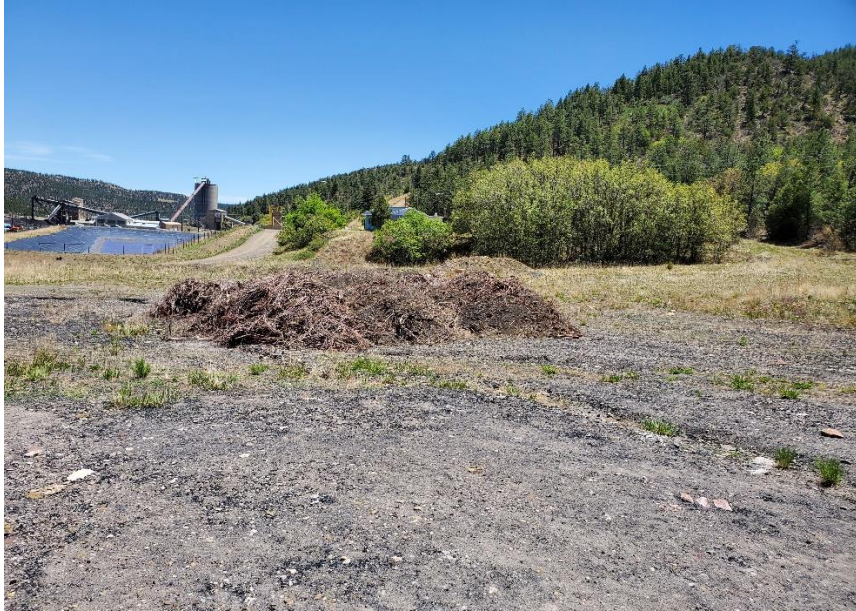
Figure 1. Grubbed vegetation stockpile southwest of Pond 001.

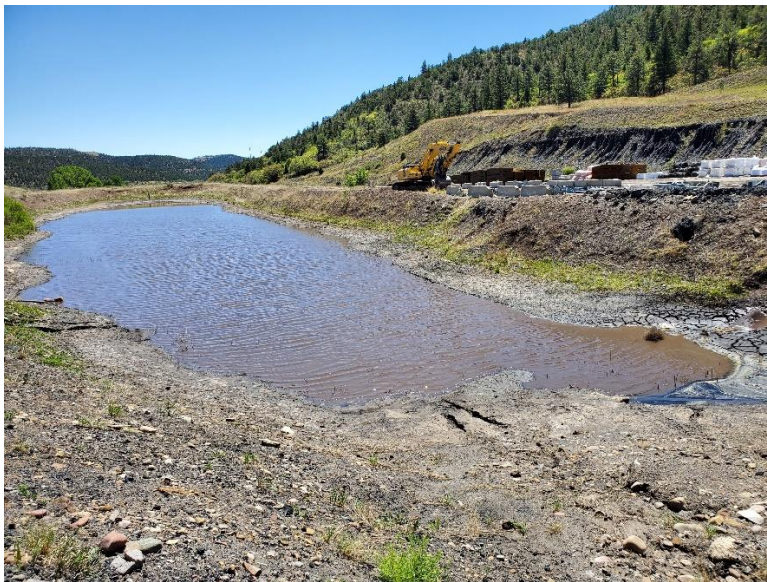
Figure 2. Pond 007. Looking east.

Pond 007 was not discharging and was holding water. The inlet culvert was discharging slowly. The embankment was stable and vegetated. The discharge structures were maintained and appeared functional.

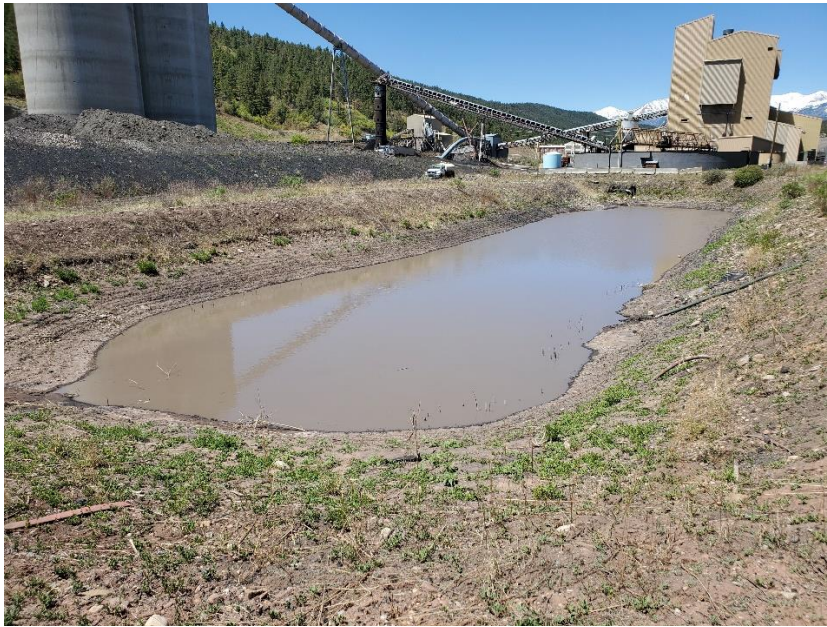
Figure 3. Pond 006. Looking west.

Pond 006 was not discharging and was holding water. The embankment was stable and vegetated. The discharge structures were maintained and appeared functional.

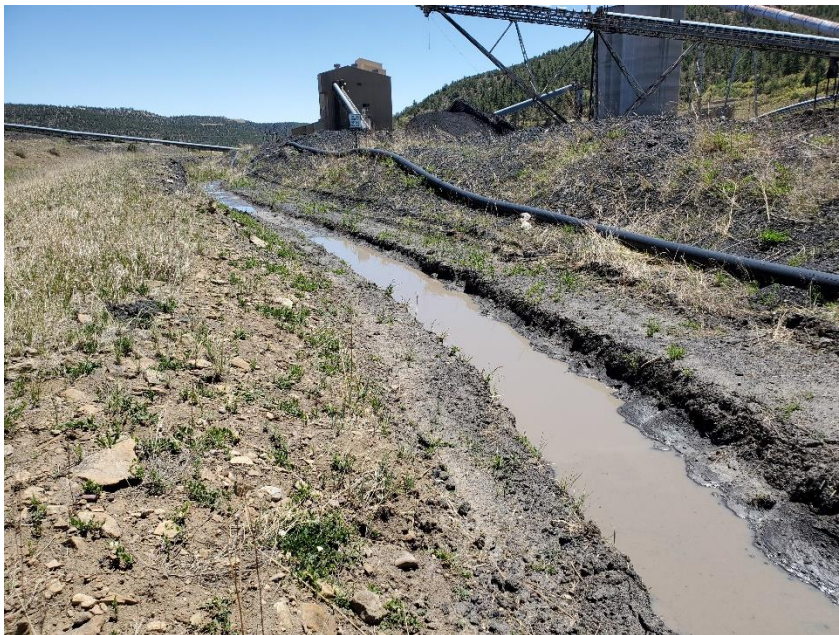
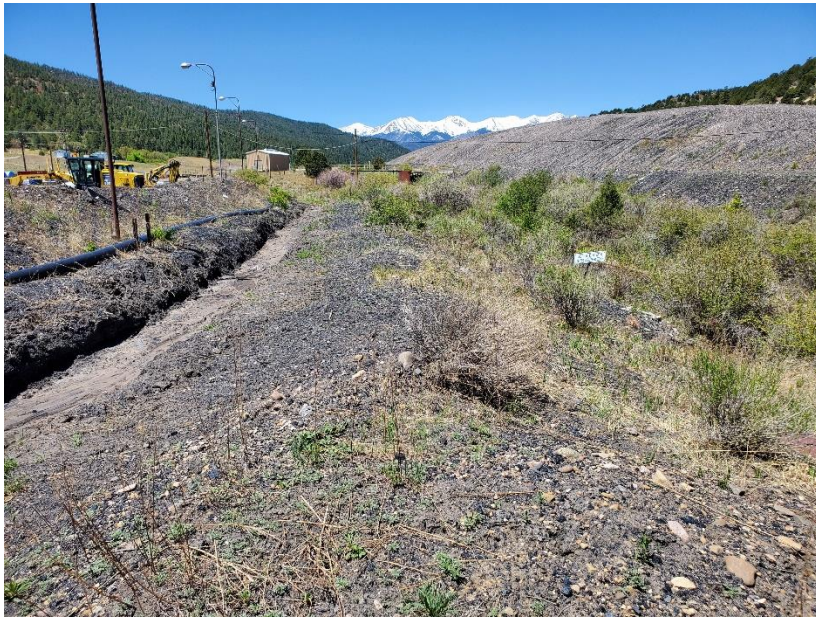
The maintenance item from the March 15, 2022 inspection regarding Ditch D15 just west of culvert C13 where sediment build up and some of the embankment of the ditch appears to be slightly eroding on the north side has been addressed.

Figure 4. Ditch D15 west of culvert C13. Looking east.

Figure 5. Ditch D15 west of culvert C13. Looking west.

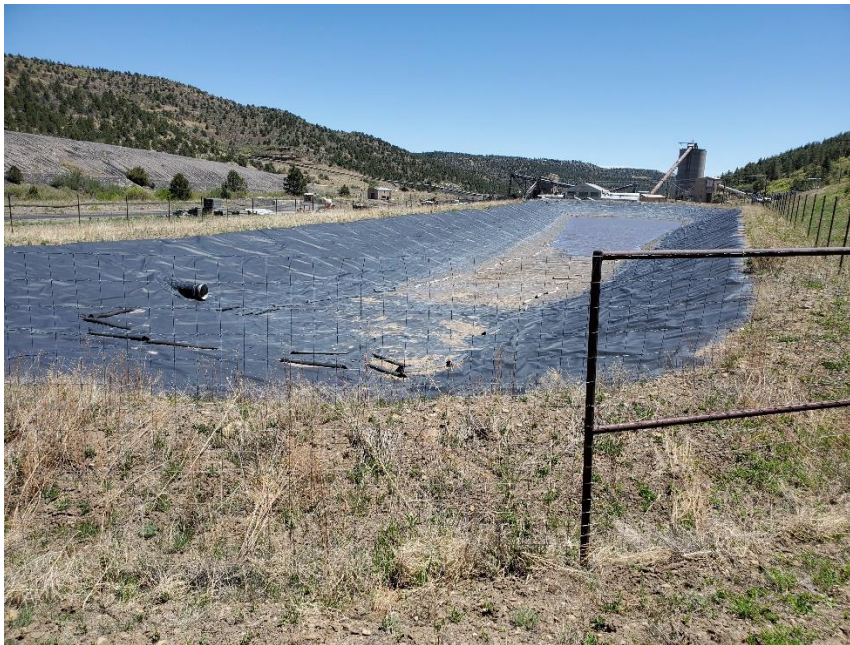
Figure 6. Pond 001. Looking east.

Pond 001 was not discharging and was holding water. The embankment was stable, The discharge structures were maintained and appeared functional.

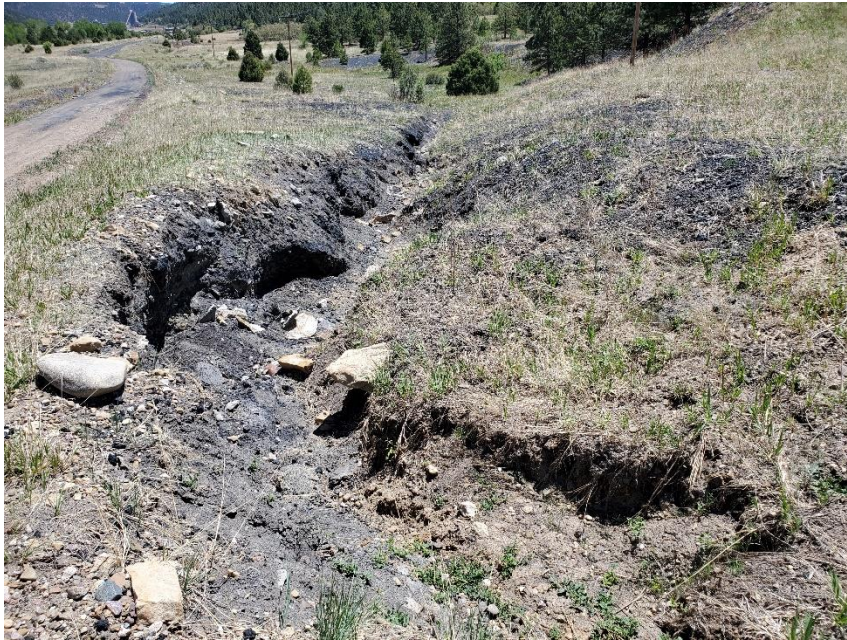
Figure 7. Ditch on south side of the road close to Containment Area 2. Looking east.

Ditch on the south side of the road close to Containment Area 2 is eroding heavily and in need of repair.

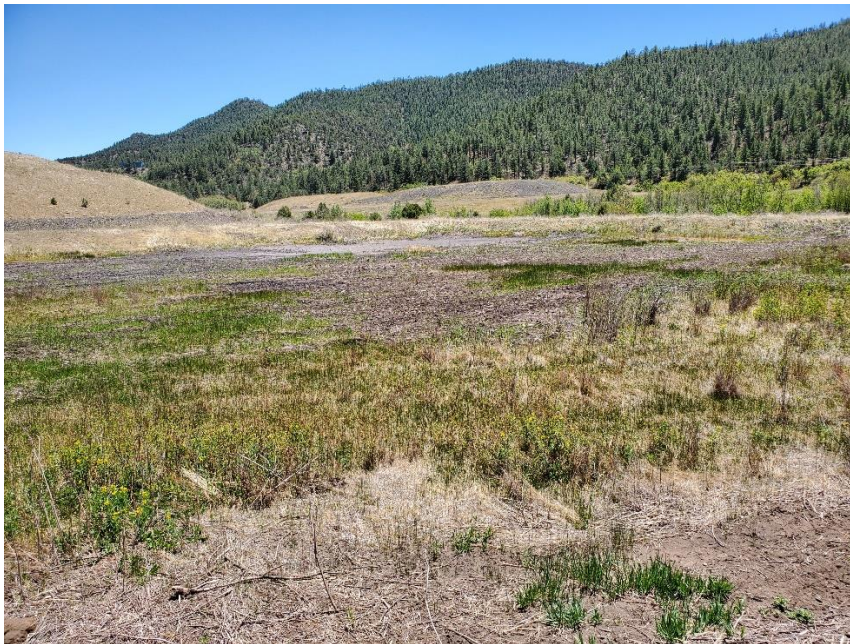
Figure 8. Pond 004. Looking southeast.

Pond 004 was not discharging and was holding no water. Most of the pond contains well-established vegetation. The embankment was stable. The discharge structures were maintained and appeared functional.

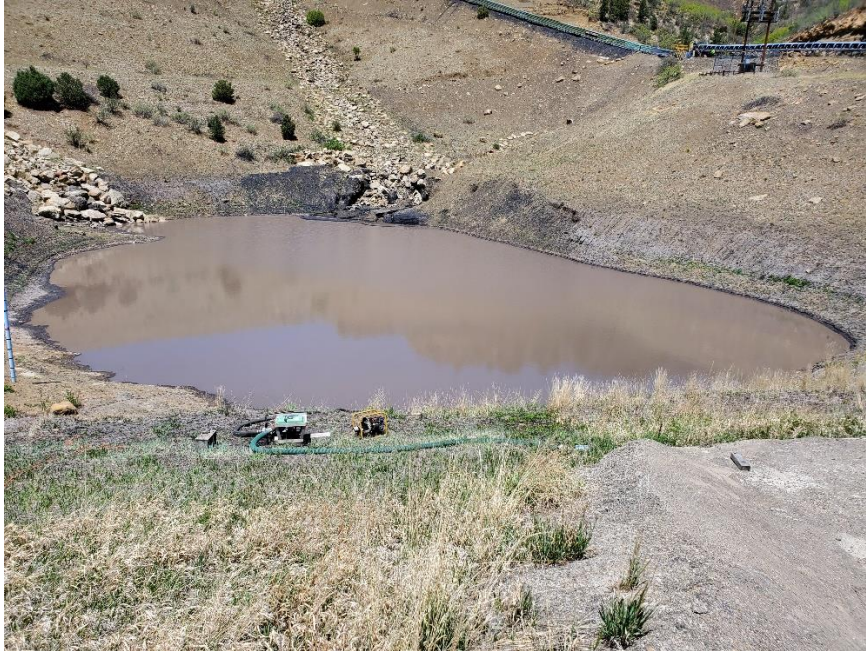
Figure 9. Pond 008. Looking northeast.

Pond 008 was not discharging and was holding water. The embankment was stable. The discharge structures were maintained and appeared functional.

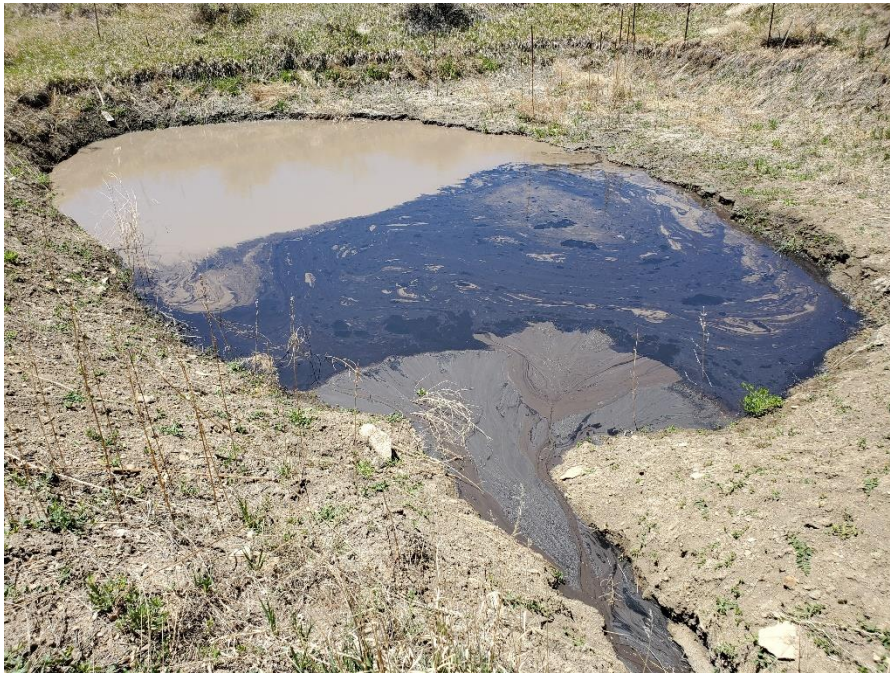
Figure 10. Containment Area 5. Looking west.

Containment Area 5 was holding water. Please monitor to ensure water continues to be contained.

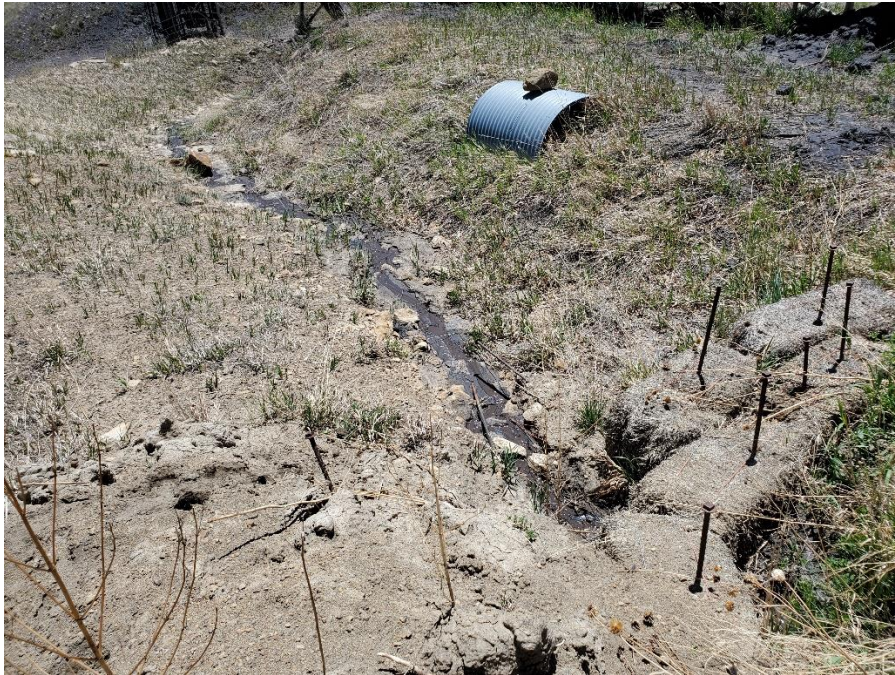
The drainage ditch that connects to Containment Area 5 has a section immediately east of the conveyor that needs to be enhanced. There is a large amount of sediment buildup behind the straw waddles that should be cleaned out and the robustness of the eastern berm of the ditch to the south of the waddles seems questionable at preventing potential

Figure 11. Drainage ditch section that connects to Containment Area 5 immediately east of the conveyor that needs to be enhanced.

breaches during heavy precipitation events. Please enhance this area.

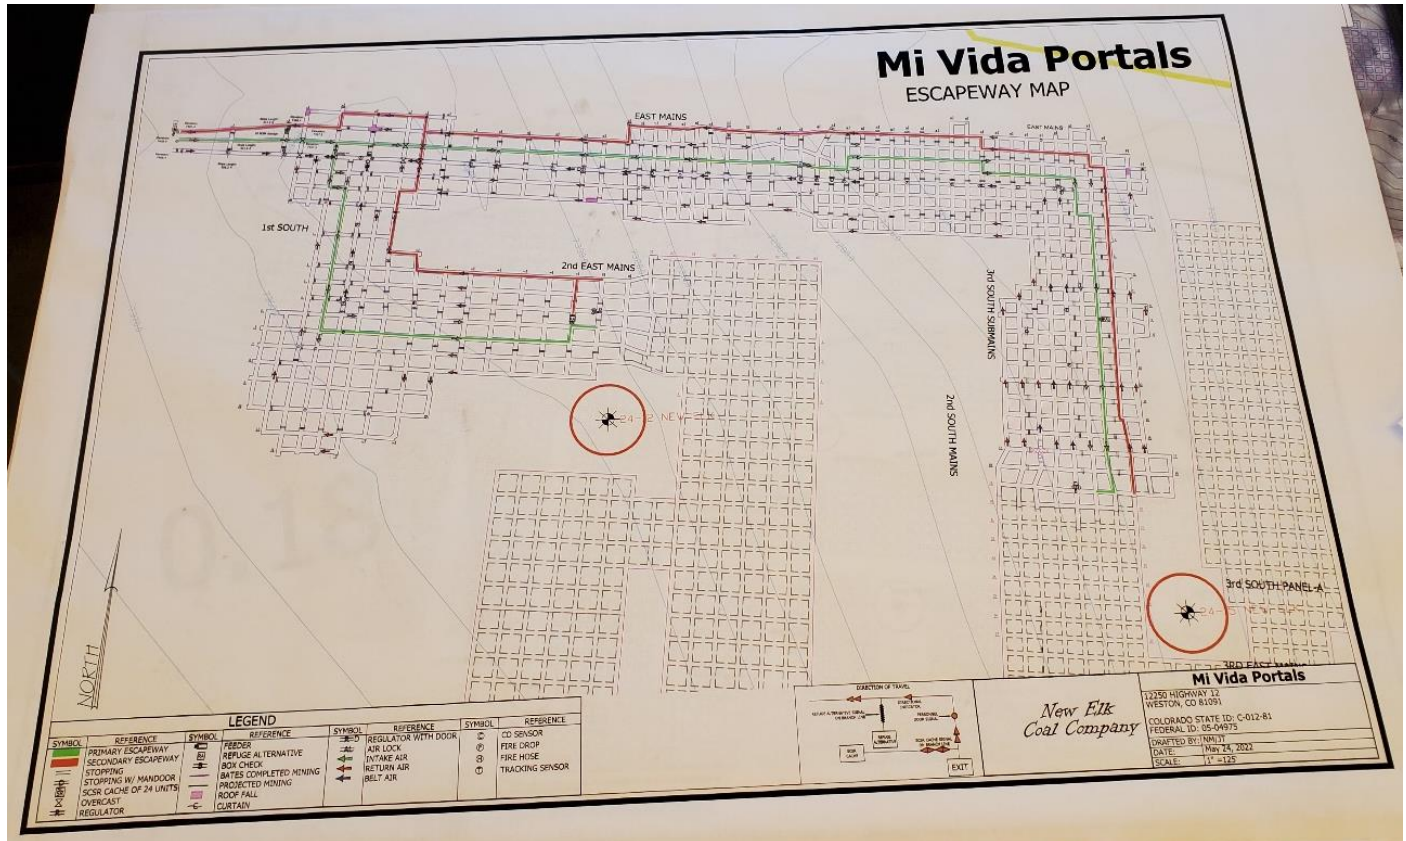
Figure 12. Escapeway Map dated 5/24/2022.

NECC was actively mining in the Blue Seam with access from the Bates Portal. Based on NECC's "Escapeway Map" dated 5/24/2022 located at the mine office, it appears they are actively mining in the 2022 Mining Area based on Map 03 in the Permit Application Package (PAP).

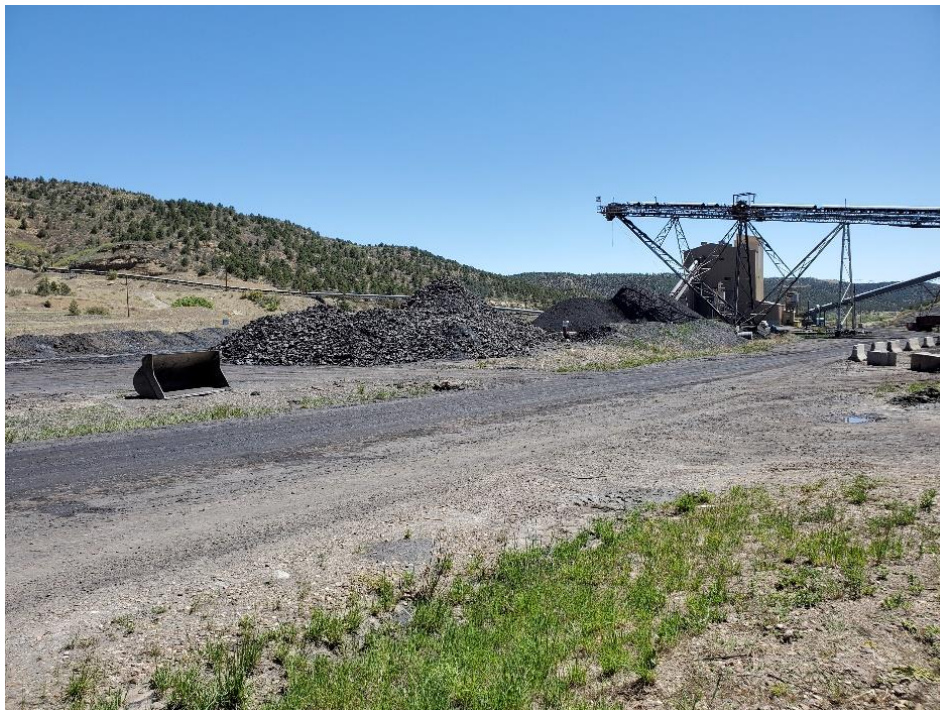
Figure 15. Looking northeast at stockpiles, wash plant, and conveyor. Conveyor was actively dumping coal.

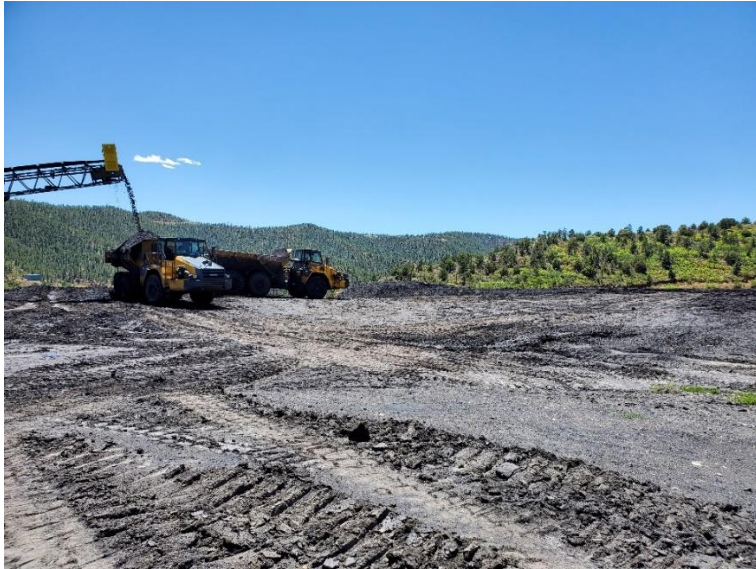
Figure 16. Waste transporting at RDA.

The Refuse Disposal Area (RDA) was observed. NECC was actively transporting and placing processing waste on the pile at the time of the inspection. Two articulated haul trucks were actively receiving the processing waste from the conveyor line and placing the waste in piles on the top bench of the RDA. A compactor was present.

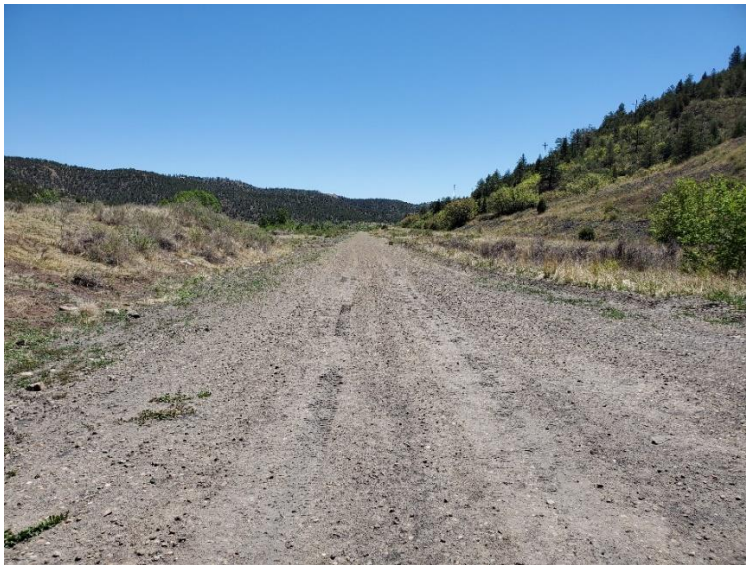
Figure 17. TR76 road.

The road that runs east from New Elk Mine along the southern side of the Middle Fork of the Purgatoire River was observed and appears to remain not in use to comply until TR76 is approved.

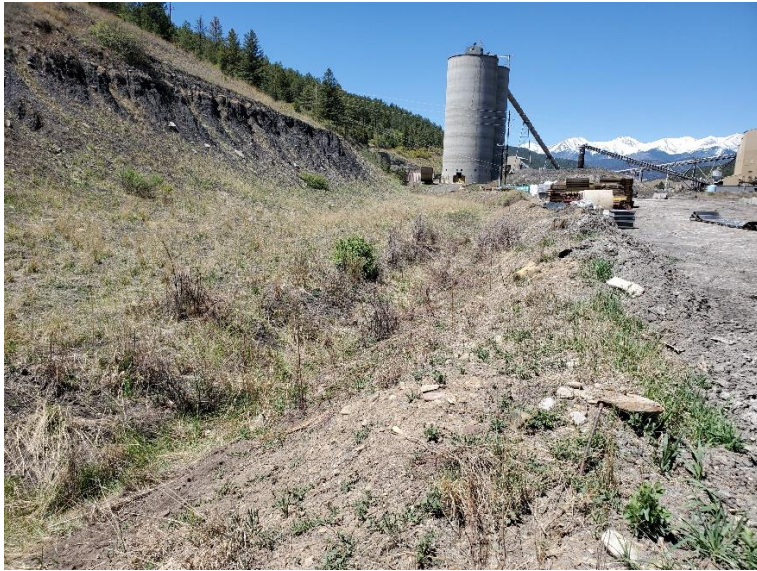
Figure 18. South drainage ditch of SAE south of Pond 007. Looking west.

The Small Area Exemption (SAE) located south of Pond 007 was observed. NECC is actively storing equipment and material to support the underground activity at the site. The area appeared clean and organized. The storm water Best Management Practices (BMPs) were observed and outfall 010 was not discharging. Overall the drainage ditches were clear and functional and the silt fence and culverts were well maintained and functional.

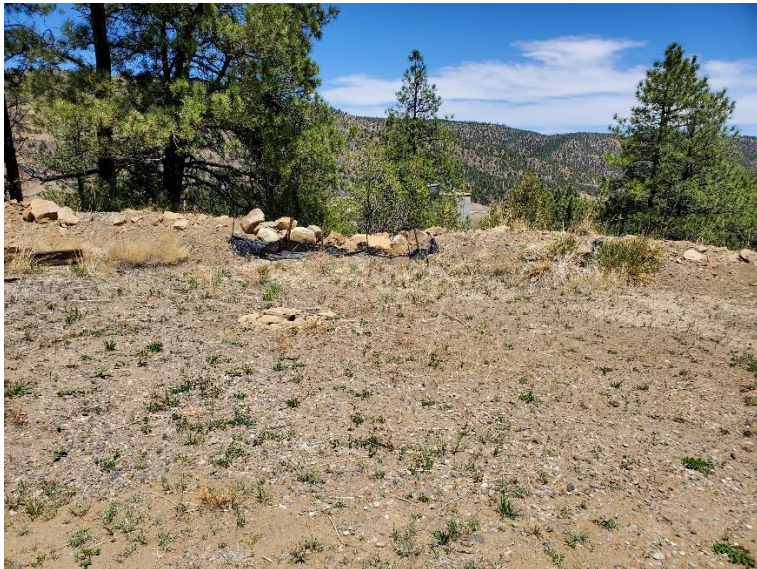
Figure 19. Stormwater berm of SAE with the water tank. Looking north.

The SAE surrounding the water tank south of the NECC facilities was observed. The stormwater berm surrounding the area was inspected and **the silt fence should be repaired**. No other problems were noted.

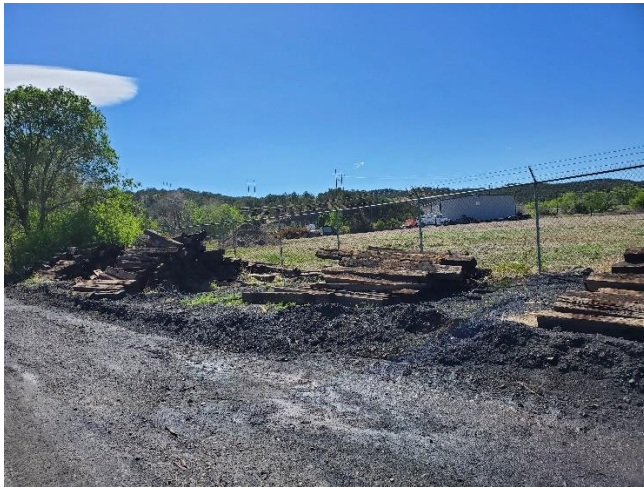
The Jansen Coal Loadout Facility was observed. Trash and debris are stored along the south side of the fence along the access road on the north side of the rail line. Coal haul trucks were stockpiling coal near the feeder conveyor.

Figure 20. Jansen Coal Loadout Facility. Debris stored south side of fence along the access road on the north side of the rail line.
