MINERALS PROGRAM INSPECTION REPORT
PHONE: (303) 866-3567

MINE NAME: Schneller Clay Pit	MINE/PROSPECTING ID#: M-1989-095	MINERAL: Clay (general)	COUNTY: Phillips
INSPECTION TYPE: Surety Release Inspection	INSPECTOR(S): Brock Bowles	INSP. DATE: May 18, 2022	INSP. TIME: 10:00
OPERATOR: Phillips County	OPERATOR REPRESENTATIVE: None	TYPE OF OPERATION: 112c - Construction Regular Operation	
REASON FOR INSPECTION: Surety Release Requested	BOND CALCULATION TYPE: None	BOND AMOUNT: \$0.00	
DATE OF COMPLAINT: NA	POST INSP. CONTACTS: None	JOINT INSP. AGENCY: None	
WEATHER: Clear	INSPECTOR'S SIGNATURE:

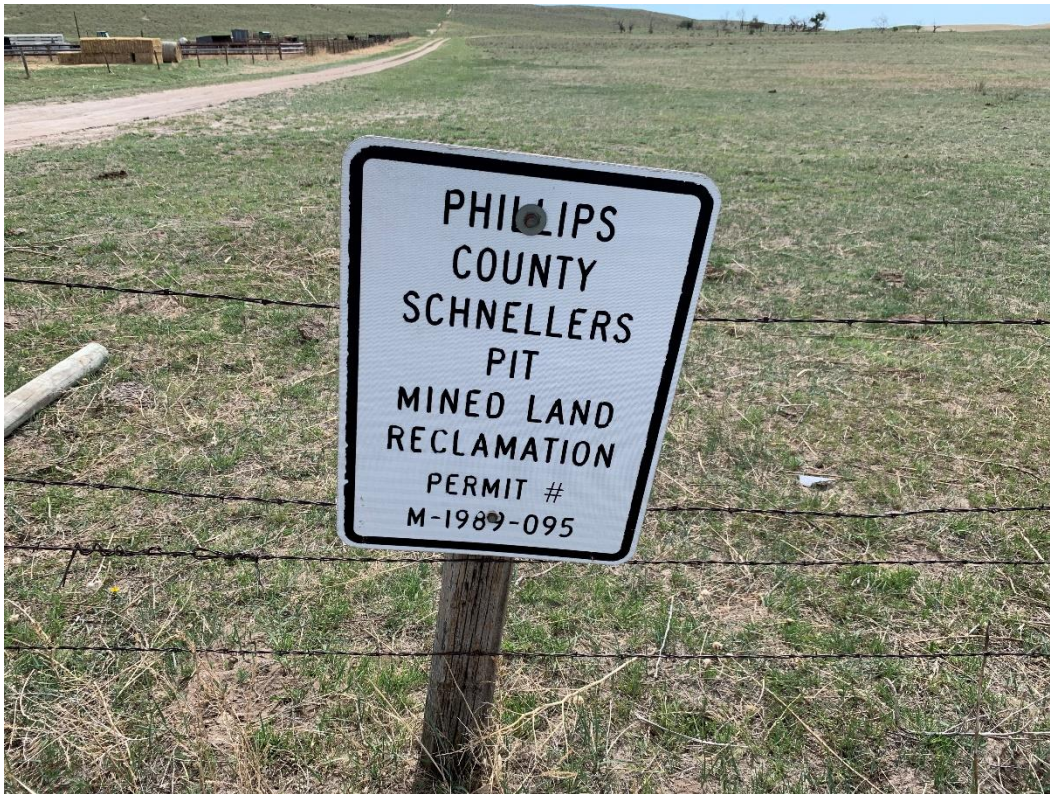
At the time of the inspection it was warm, partly cloudy and the ground was dry. No mining equipment was on-site, the gate was closed upon arrival and the mine entrance sign was in place facing CR 49 (photo 1). According to Mr. Salyards, the mined area was grazed and the cattle were removed from this area 2 days prior to the inspection.

Photo 1 – Mine entrance sign facing CR 49

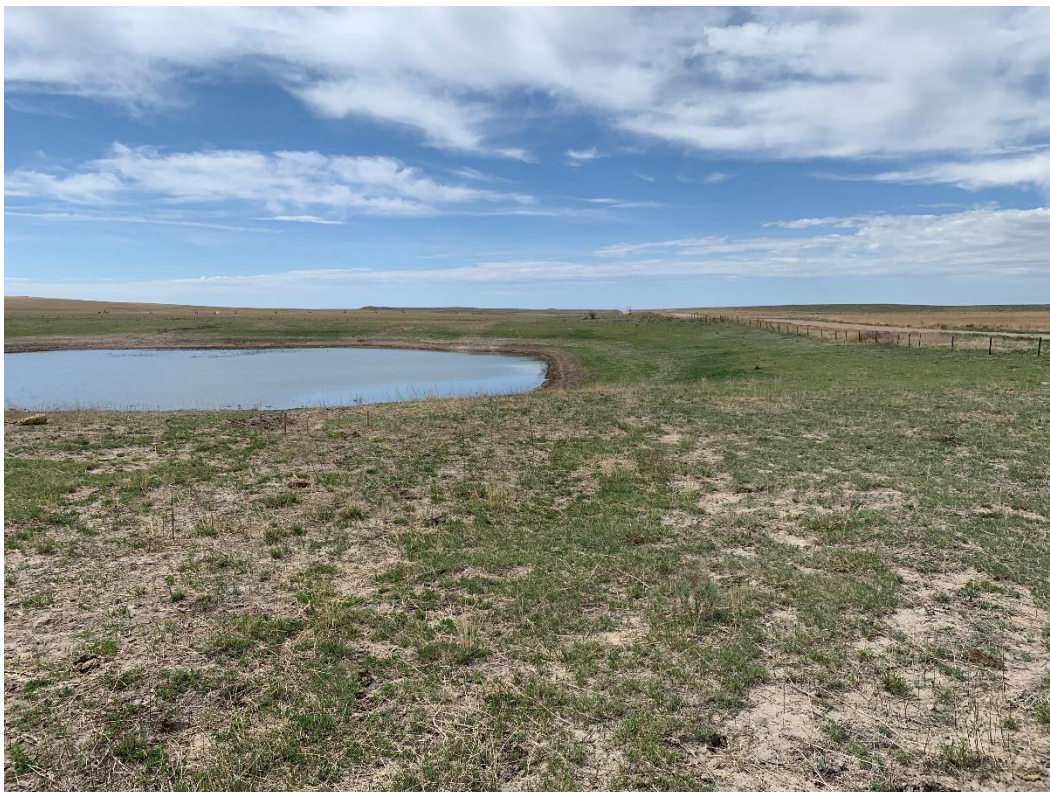
The north side of the pit area was the stockpile area during active mining. This area has been graded to less than 3h:1v and to slope toward the pit area (photo 2). The area is well vegetated and stable. The gully on the west side that was noted in the January inspection report had been repaired and seeded (photo 3). A wattle had been installed as part of the repair but was disturbed by the cattle.

Photo 2 – North and west side of pond area, photo facing south

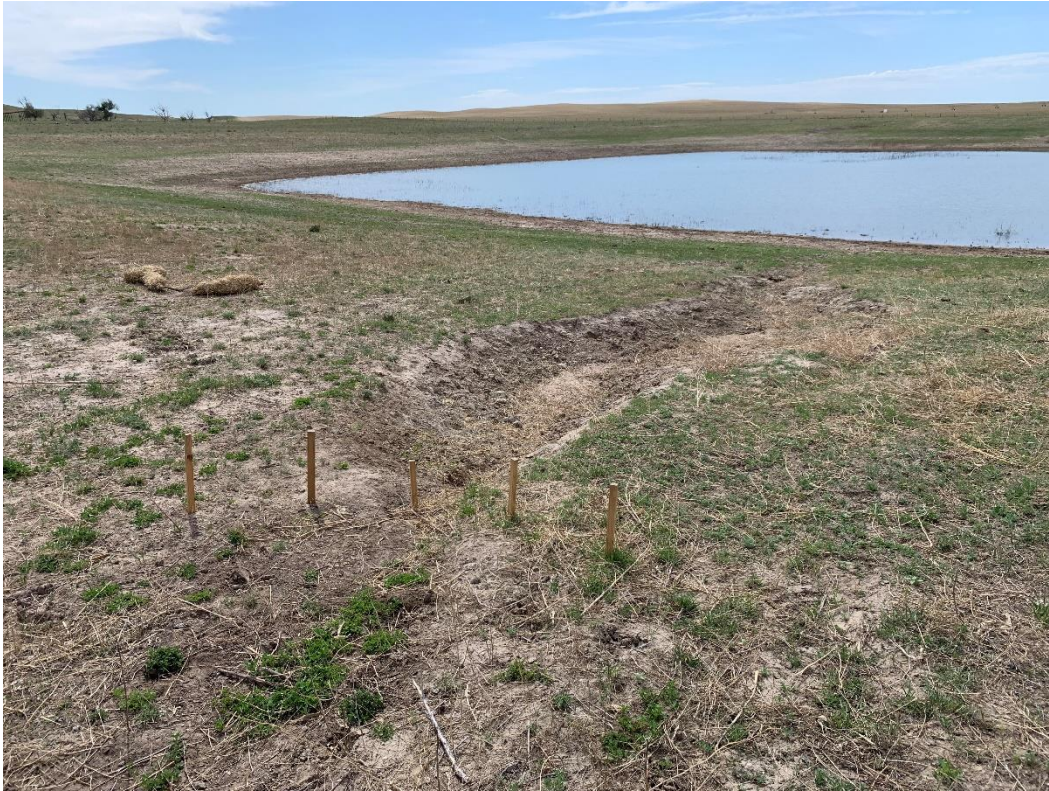
Photo 3 – Gully repair in the northwest section.

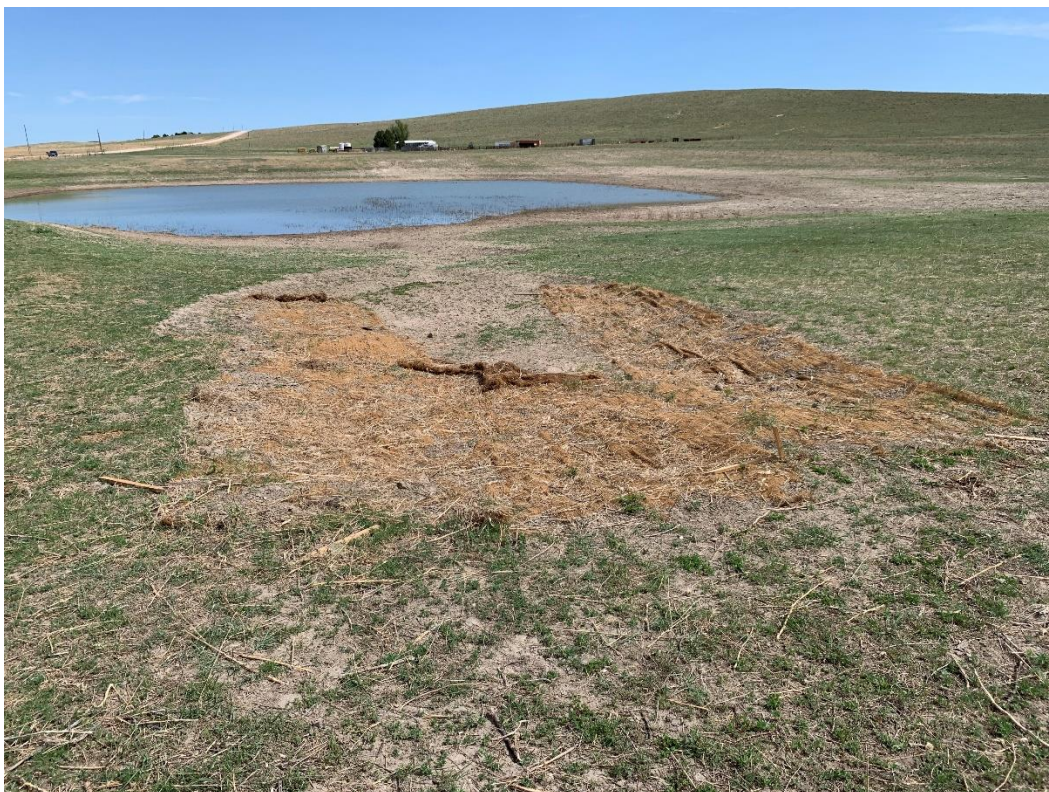
The south side of the pit area was the topsoil stockpile area. The topsoil has been replaced and the area has been graded and seeded. The area is well vegetated and stable. The gullies noted in the January 2022 inspection report had been repaired and seeded. Some of the erosion blanket used for the repair had been disturbed by the cattle (photo 4).

Photo 4 – Gully repair on the south side of the pond
