**MINERALS PROGRAM INSPECTION REPORT**  
**PHONE: (303) 866-3567**

<b>MINE NAME:</b> Pueblo East Pit	<b>MINE/PROSPECTING ID#:</b> M-1986-015	<b>MINERAL:</b> Sand and gravel	<b>COUNTY:</b> Pueblo
<b>INSPECTION TYPE:</b> Surety-Related Inspection	<b>INSPECTOR(S):</b> Patrick Lennberg	<b>INSP. DATE:</b> May 18, 2022	<b>INSP. TIME:</b> 12:30
<b>OPERATOR:</b> Colorado Water Protective and Development	<b>OPERATOR REPRESENTATIVE:</b> Jerry Schnabel Dan Tucker	<b>TYPE OF OPERATION:</b> 112c - Construction Regular Operation	
<b>REASON FOR INSPECTION:</b> Surety Related	<b>BOND CALCULATION TYPE:</b> None	<b>BOND AMOUNT:</b> \$3,758,100.00	
<b>DATE OF COMPLAINT:</b> NA	<b>POST INSP. CONTACTS:</b> None	<b>JOINT INSP. AGENCY:</b> None	
<b>WEATHER:</b> Clear	<b>INSPECTOR'S SIGNATURE:</b>

### **OBSERVATIONS**

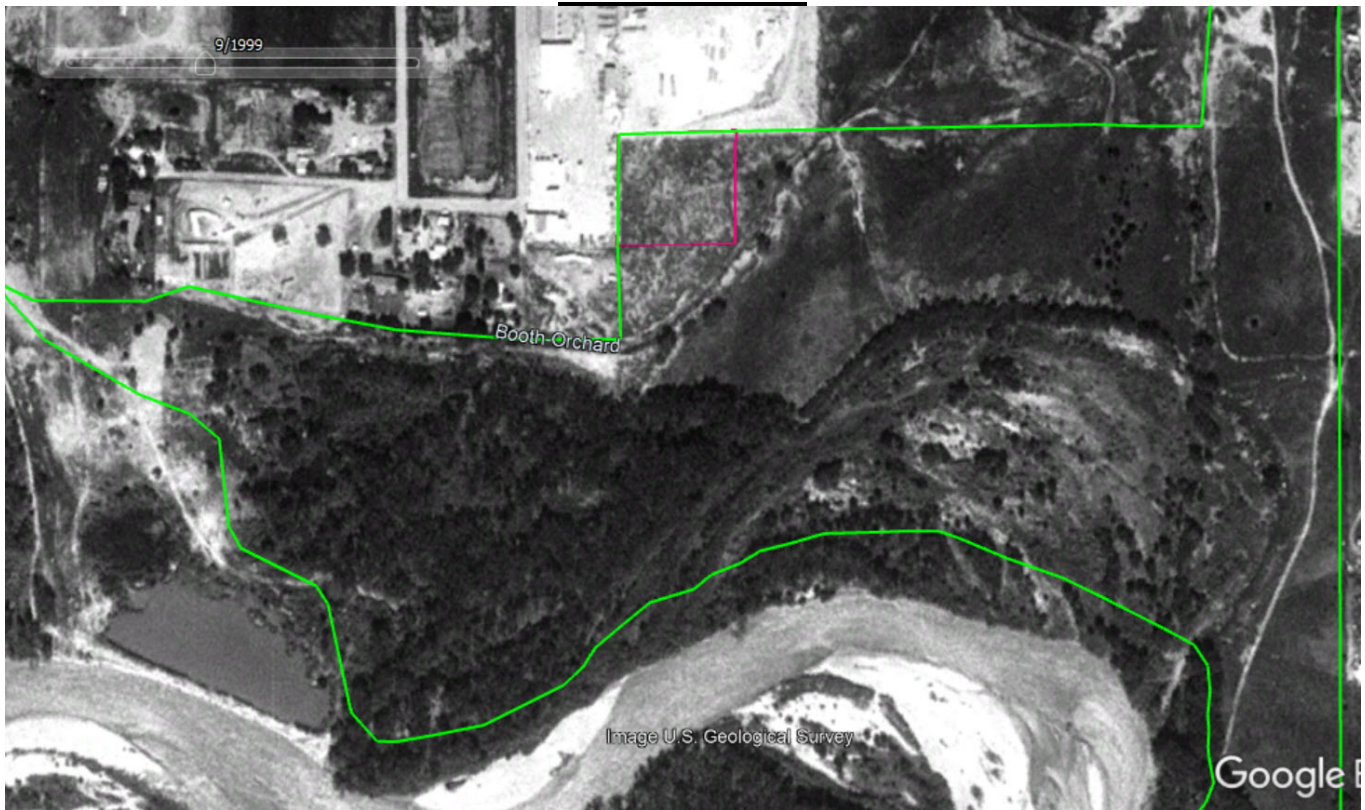
**Photo 1:** Aerial image from 1999, Phase 7 boundary in green and release area in magenta

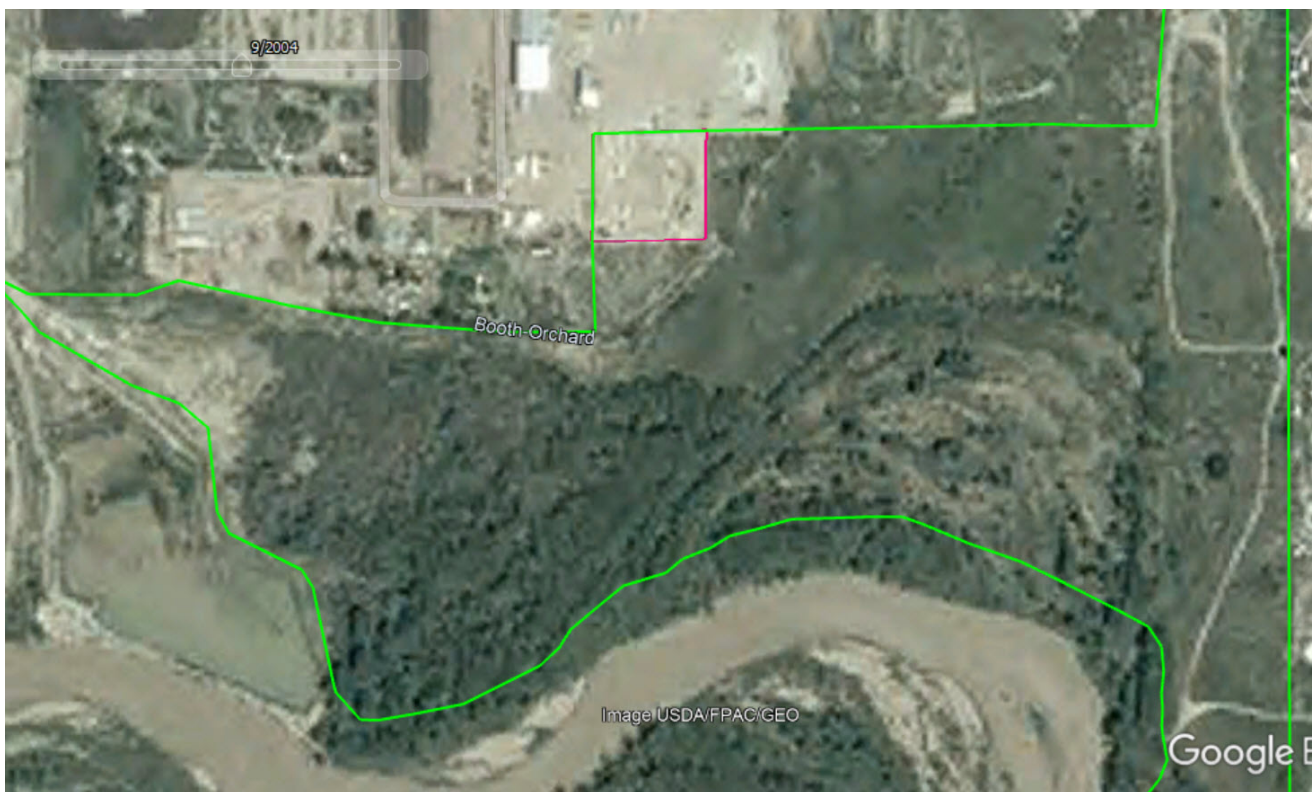
**Photo 2:** Aerial image from 2004, Phase 7 boundary in green and release area in magenta

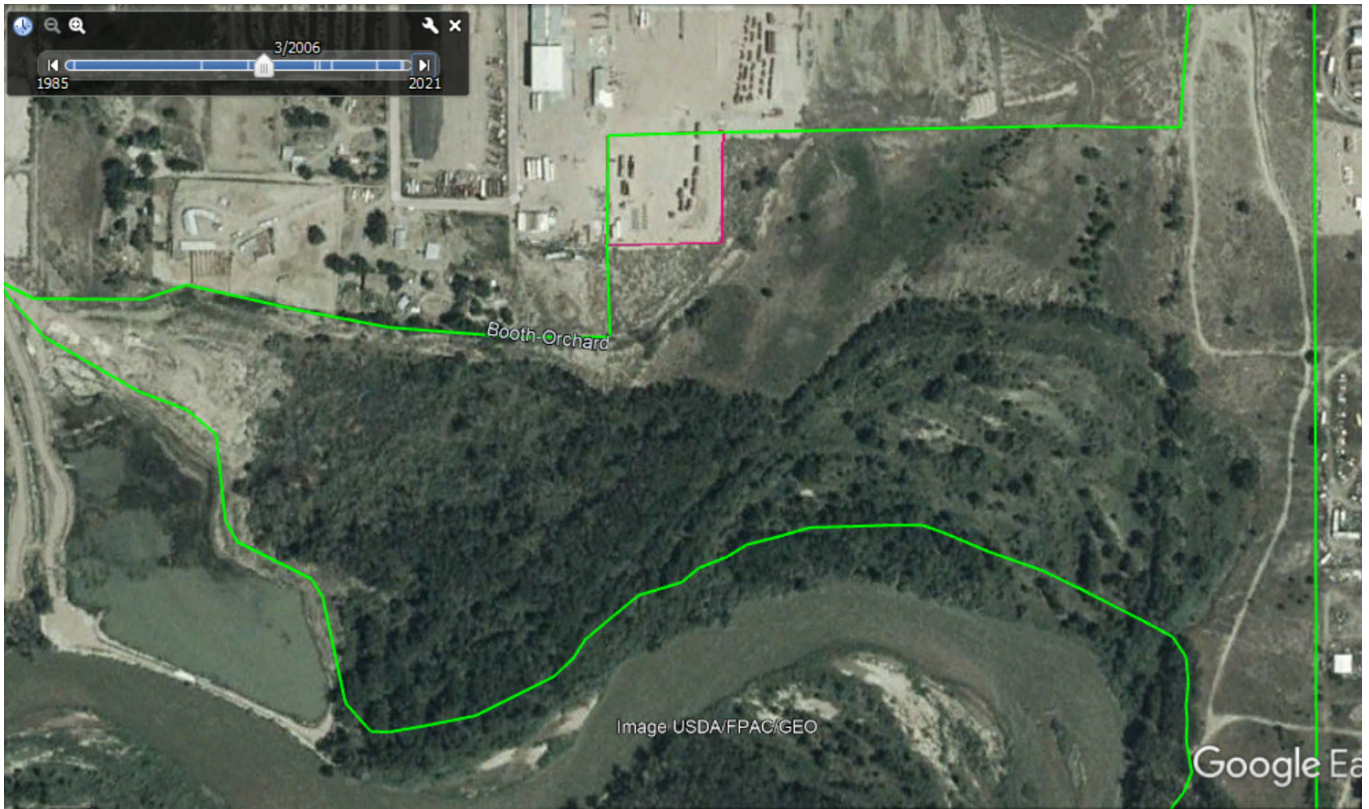
**Photo 3:** Aerial image from 2006, Phase 7 boundary in green and release area in magenta

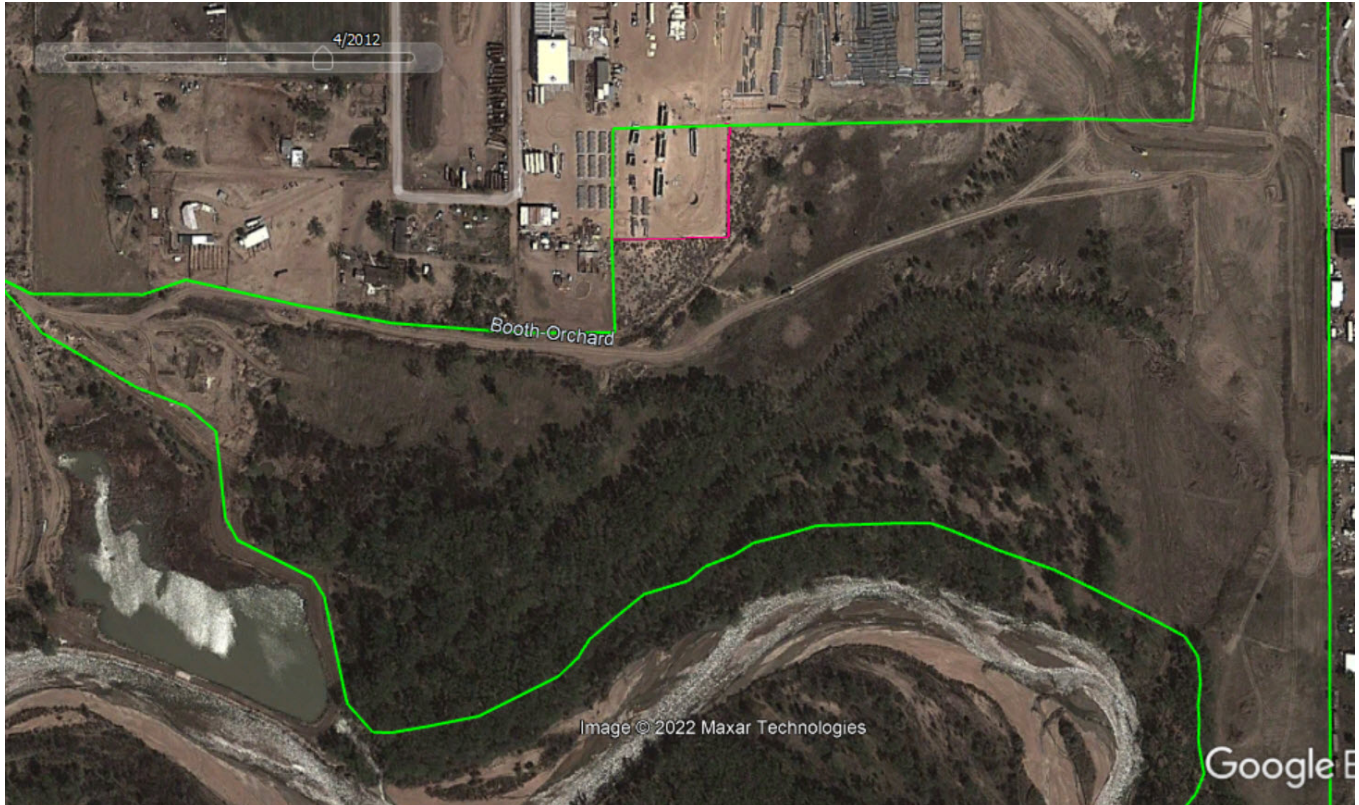
**Photo 4:** Aerial image from 2012, Phase 7 boundary in green and release area in magenta

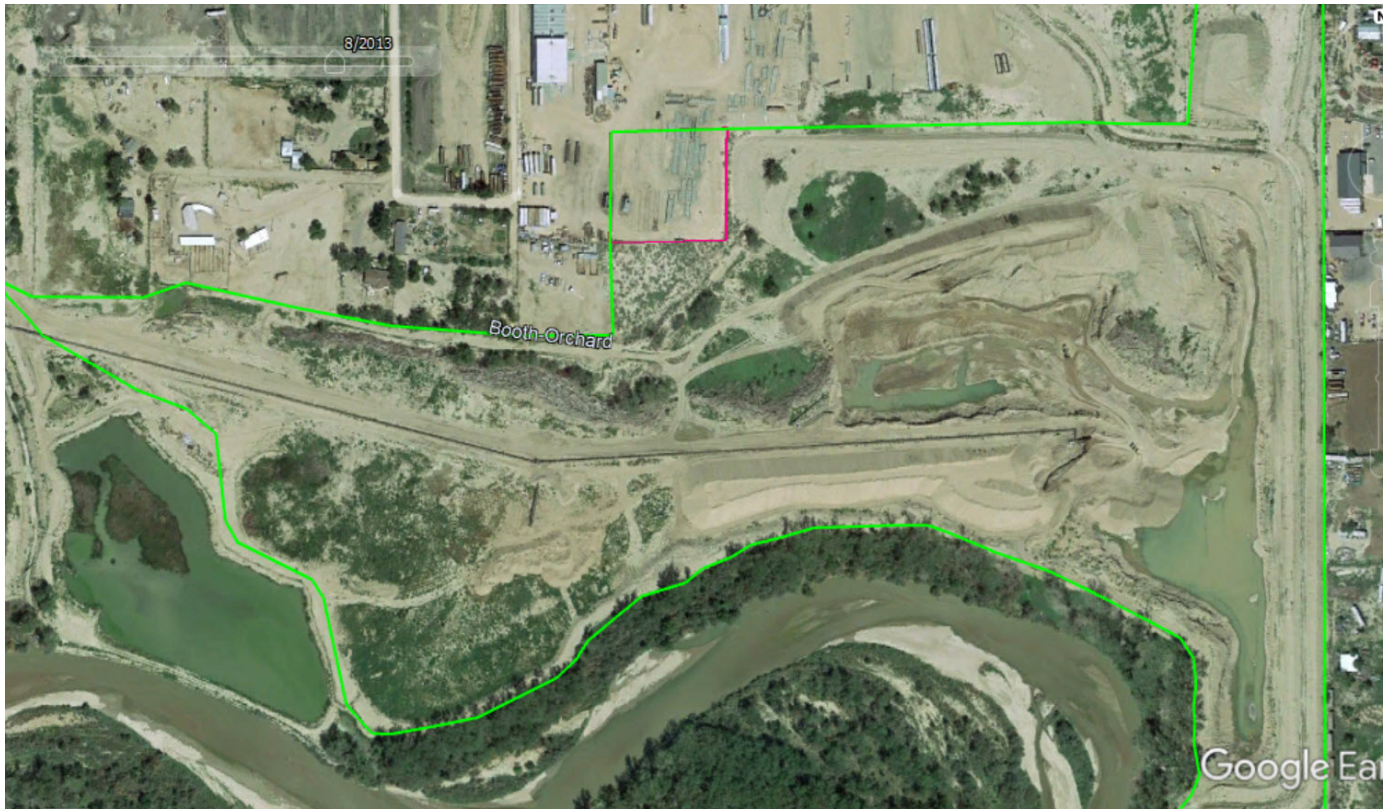
**Photo 5:** Aerial image from 2013, Phase 7 boundary in green and release area in magenta

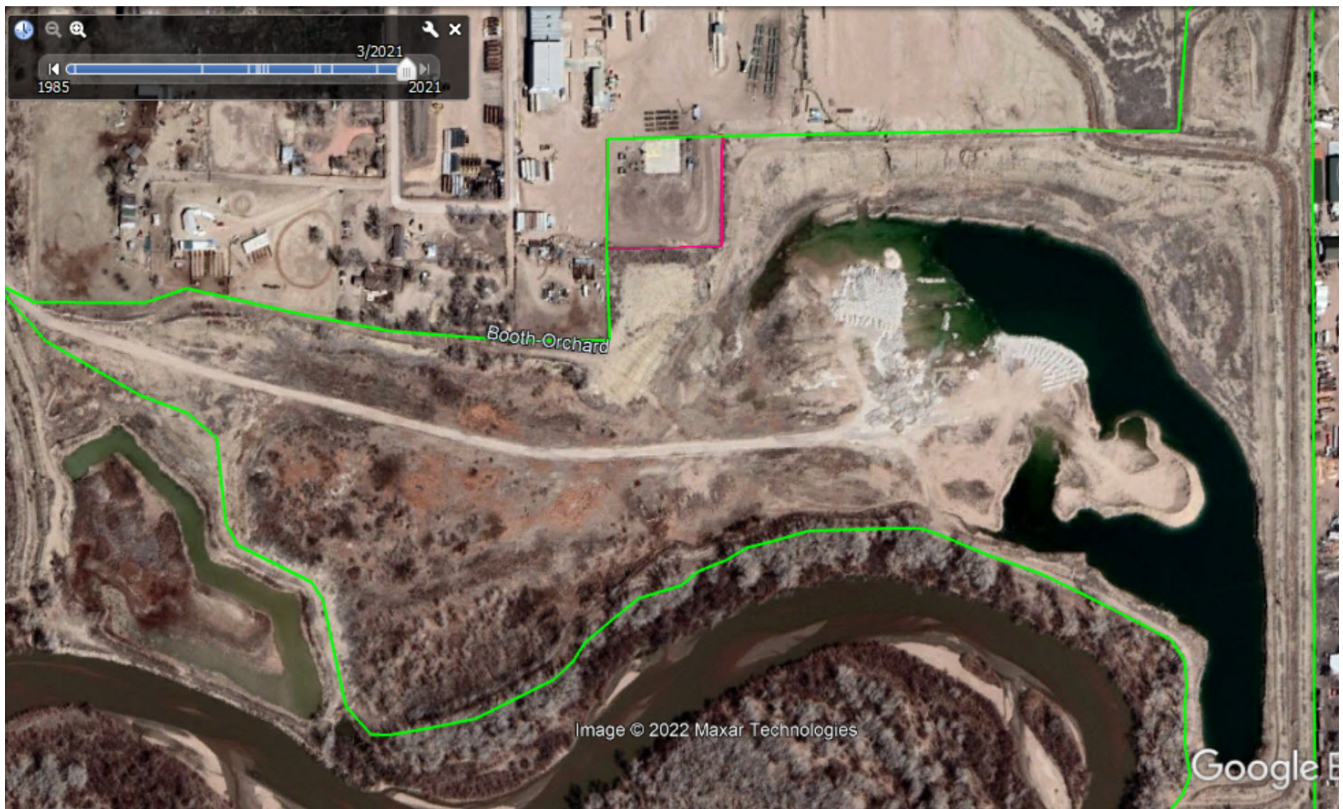
**Photo 6:** Aerial image from 2021, Phase 7 boundary in green and release area in magenta

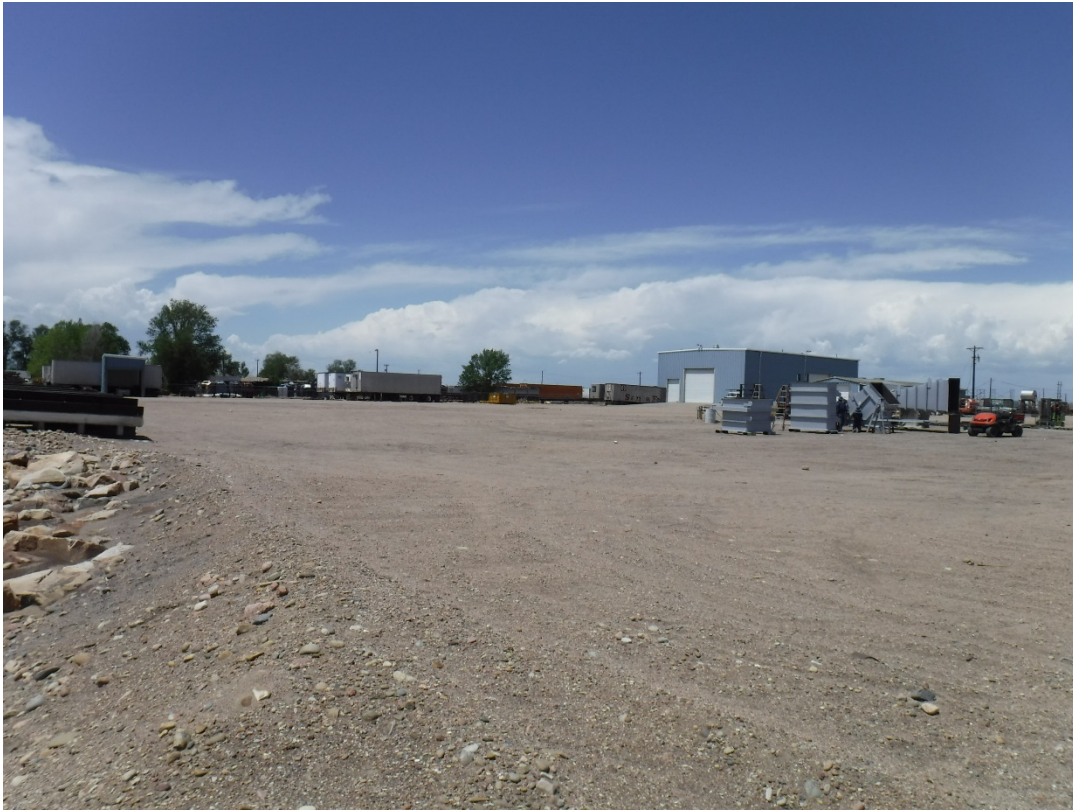
**Photo 7:** Looking northwest across the release request parcel

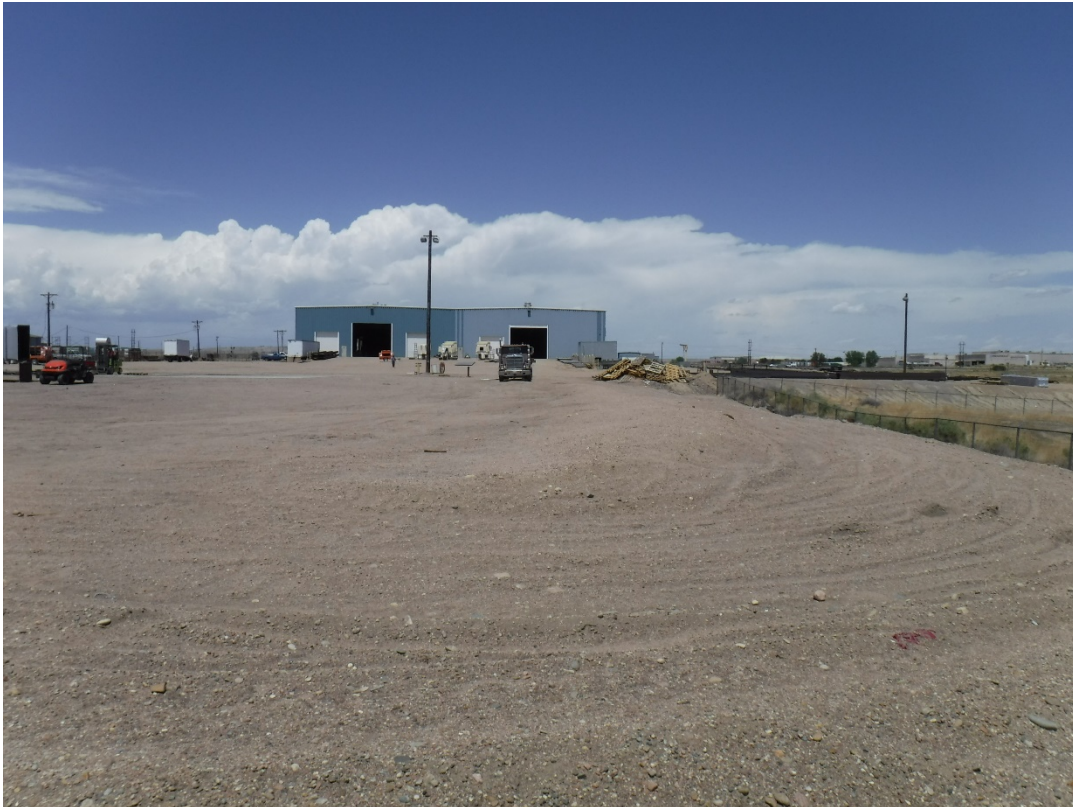
**Photo 8:** Looking north across the release request parcel

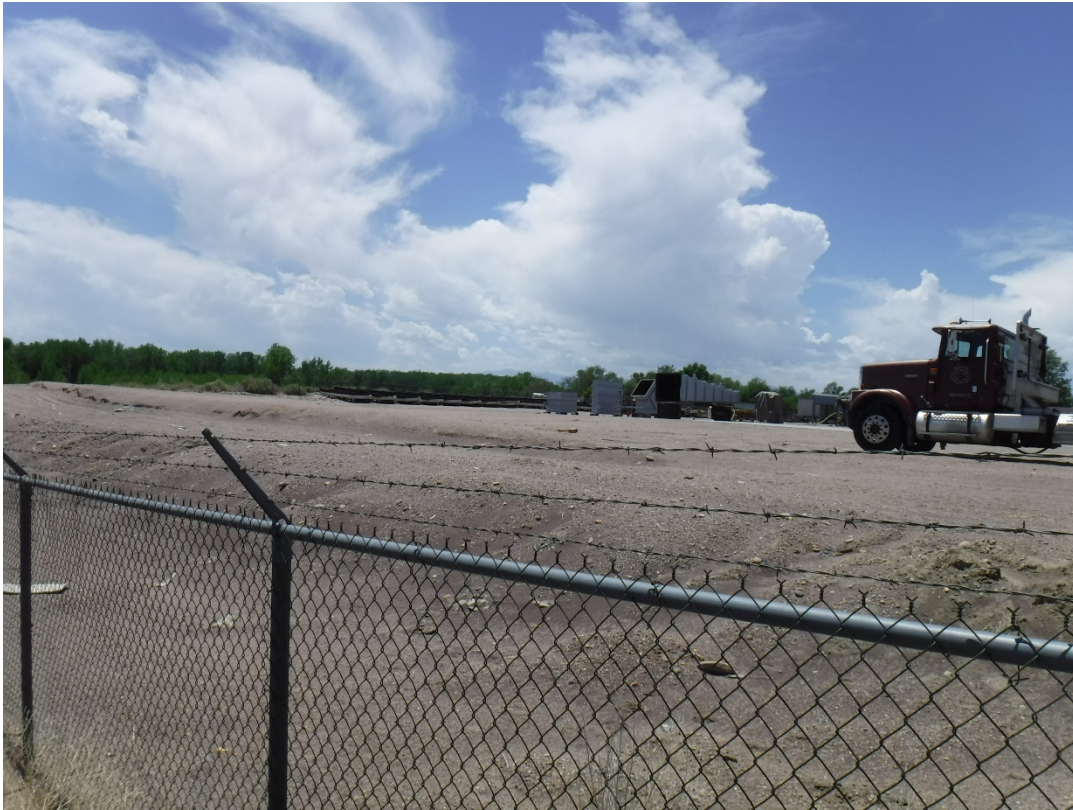
**Photo 9:** Looking southwest across the release request parcel

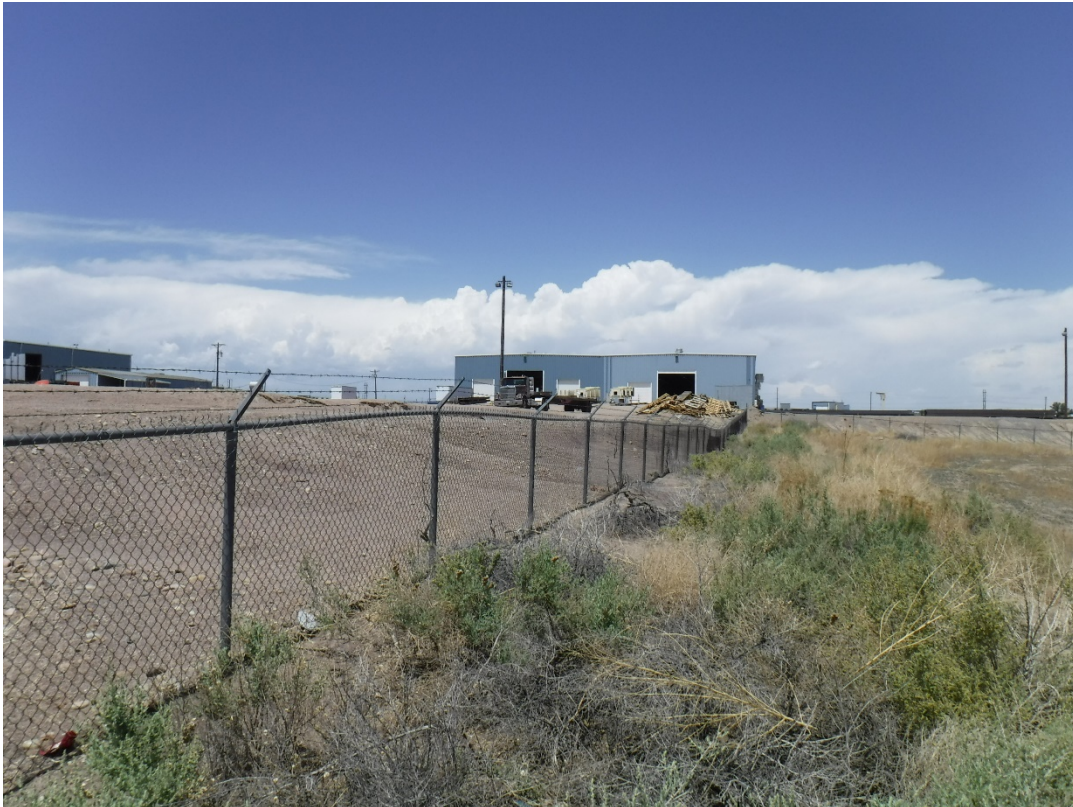
**Photo 10:** Looking north along the east boundary of the release request parcel
