To: Jerald Schnabel From: Paul Kos  
Continental Materials Corp. Denver, CO 80222  
File: April 2022 Monitoring Summary Date: May 31, 2022

**Reference: April 2022 Geotechnical Monitoring Summary Pikeview Quarry**

Client/Project  
CONTINENTAL MATERIALS  
CORP.  
PIKEVIEW QUARRY SLOPE  
MONITORING

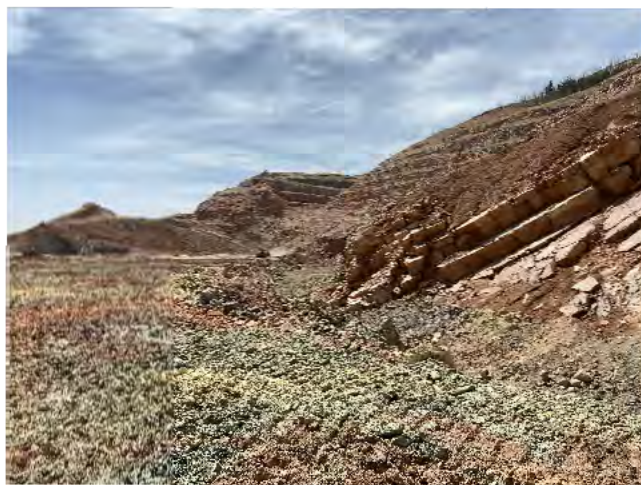
- A safety buffer zone is being kept between the active work areas and the toe of the slide to stop any rocks that might come loose during grading operations. Compacted fill is placed in the buffer zone as the buttress fill is placed, and this area is maintained approximately 5 feet lower than the working bench. (Photos 6 and 7)

6. Compacted area along safety buffer zone.

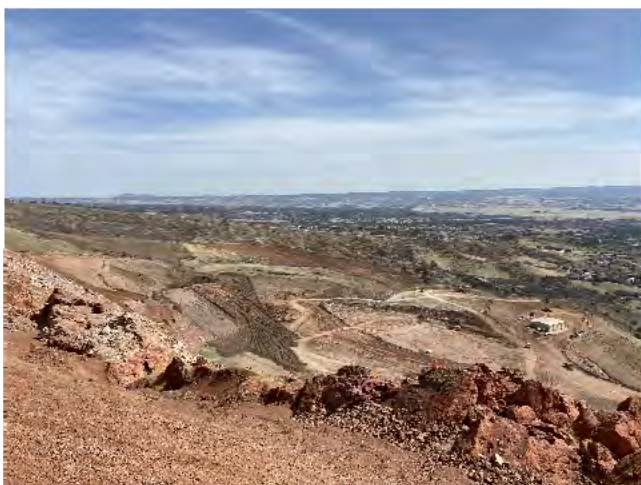
5. View to the north: Pit floor and North Borrow.

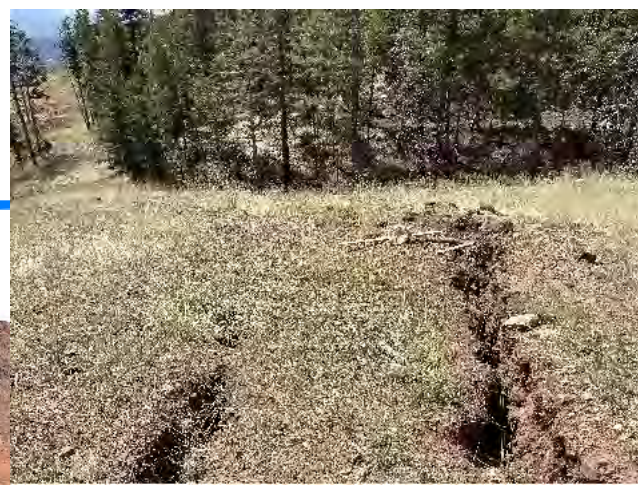
- No cracking was observed on the native granite slopes above the extents of the disturbed area.
- Previously Observed Cracks: Previously observed tension cracks remain on the production floor and at the crest of fill slopes. These cracks appeared the same as in previous inspections. (Photo 4)

- Known cracks were monitored for changes. Currently the cracks are not growing in any of the areas on the slopes of the site. The hummocky field in the area immediately above the southern extent of the slide shows evidence of cracking but they are not fresh or active. No new or open cracks were found immediately inside or next to the slide area. (Photo 4)

4. Old cracks being monitored on the south end.

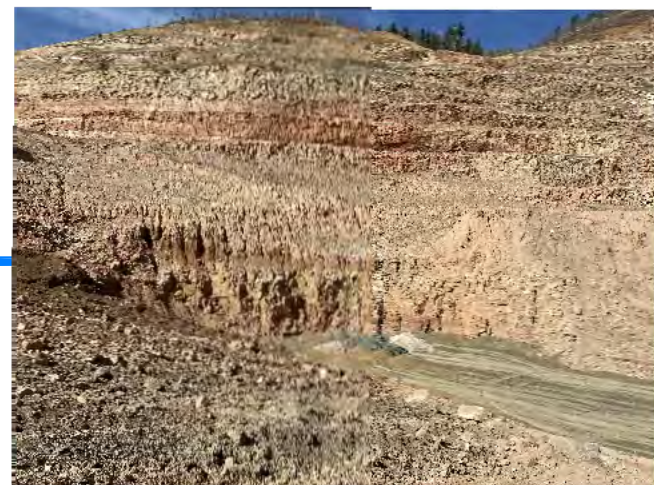
- Offsite fill was placed near the reclamation benches. The material was spread by dozers and compacted in one-foot lifts in accordance with the project specifications. (Photo 3)

3. Material piled at the toe of the bench.

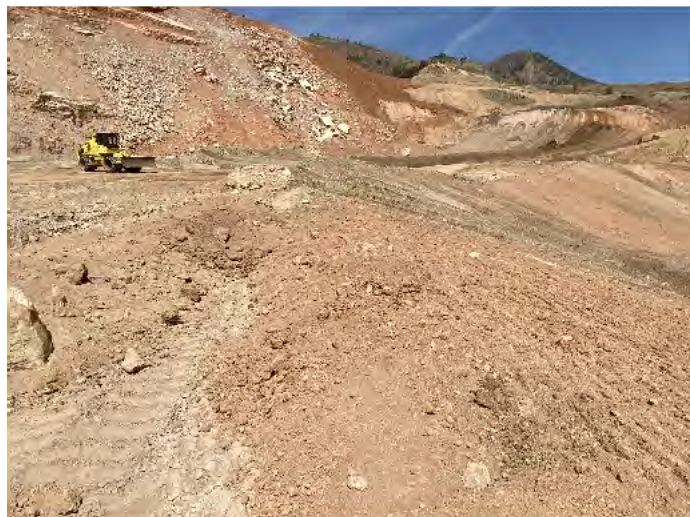
7. Compactor in the pit area.

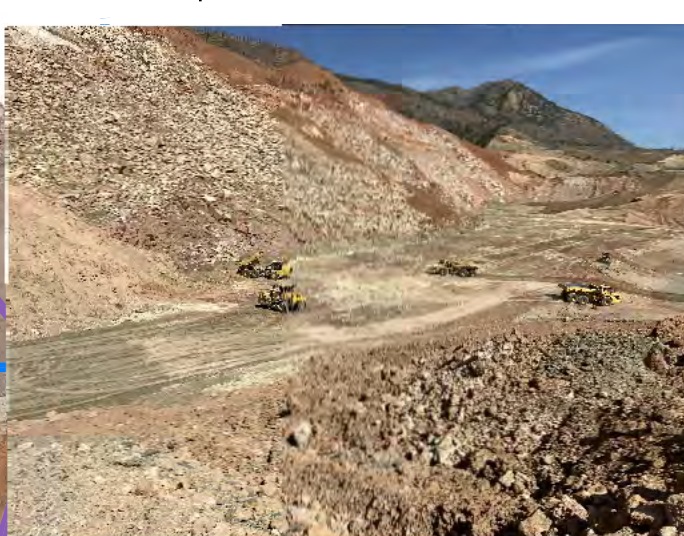
- Reclamation grading began in February 2022 and continued throughout April.
- Three excavators, five dozers and eight haul trucks are operating in a loop on the pit floor to move material from the North Borrow Area to the pit floor for compaction in one-foot lifts. Note that the North Borrow Area is a separate project associated with the City's plans for the property; this grading was permitted by El Paso County. (Photos 1 and 2)

2. Compaction zone in the pit as seen from the south.

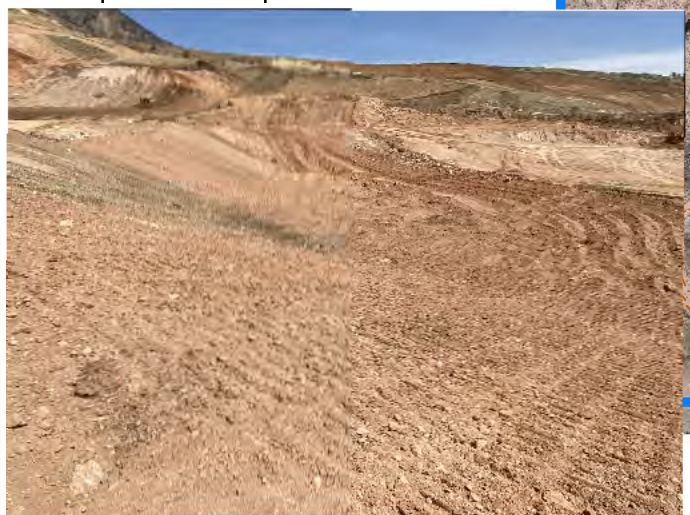
- The culvert remains cleared but mostly blocked inside. CMC has partially cleared the debris, but access limitations and supports within the culvert inhibit clearing all the debris. CMC has procured a pump and will begin pumping operations if any water collects behind the culvert. CMC inspects the culvert for ponded water following rain events, and should any water be observed, it will be removed using pumps. To date, no ponding has been observed. (Photo 8)

8. Culvert in the pit has been filled in.

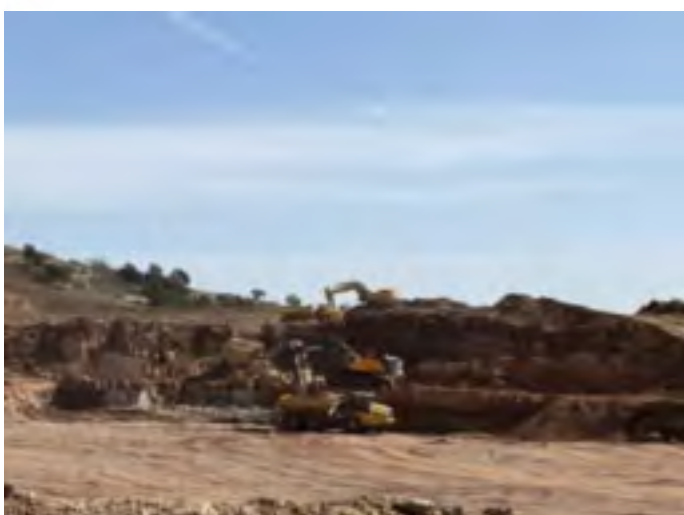
1. Excavators cutting a bench in the North Borrow area.

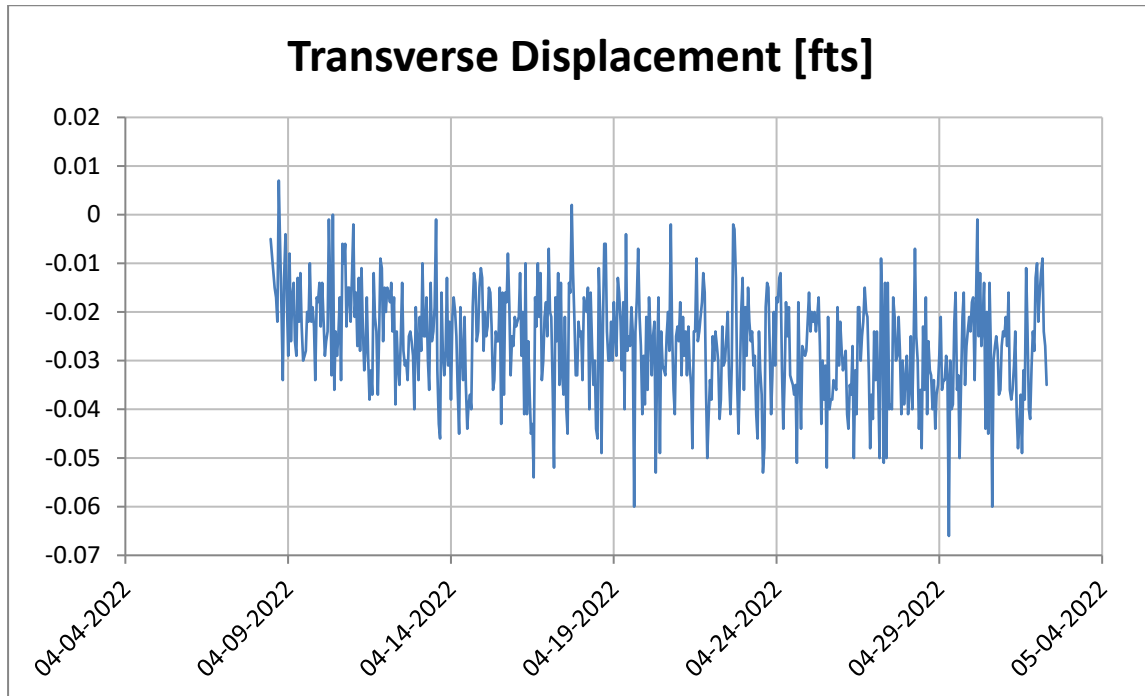
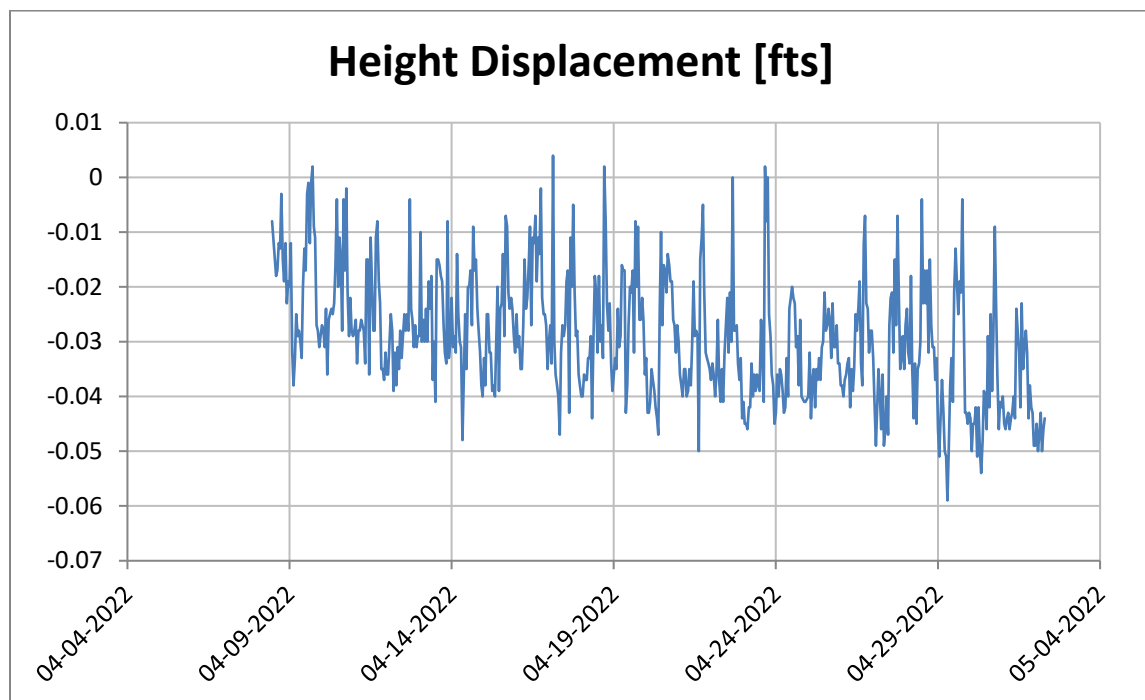
## Prism BR1

| Prism ID | Cumulative Transverse Displacement (ft) | Cumulative Height Displacement (ft) | Monthly Delta (ft) | Cumulative Delta (ft) | Notes / Recommendations |
|---|---|---|---|---|---|
| BR1 | -0.035 | -0.044 | 0.0516 | 0.0611 | New Prism. Slope creep movements. |

1. Survey accuracy is +/-0.016 feet.
2. Alarm threshold is +/-0.35 feet.
3. Transverse displacement is in the horizontal direction. Positive direction means closer to the robotic station.
4. Height displacement is in the vertical direction. Positive direction means higher in elevation.
5. Prism records slope creep movements with slow velocity.
6. Prism installed April 8, 2022.

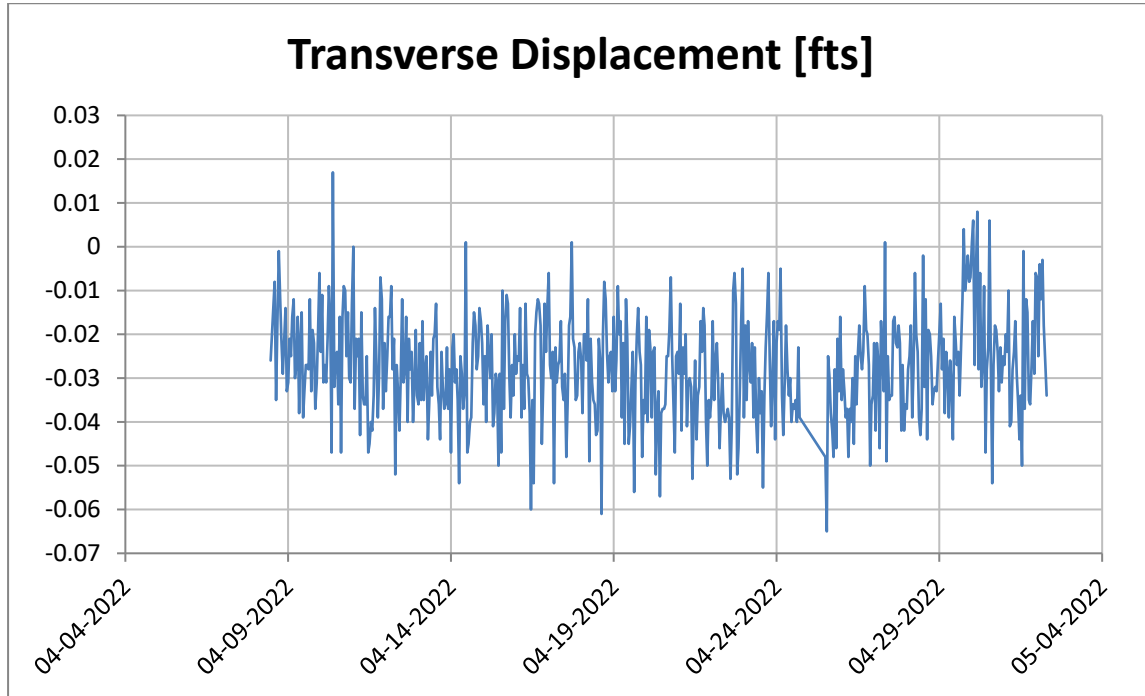
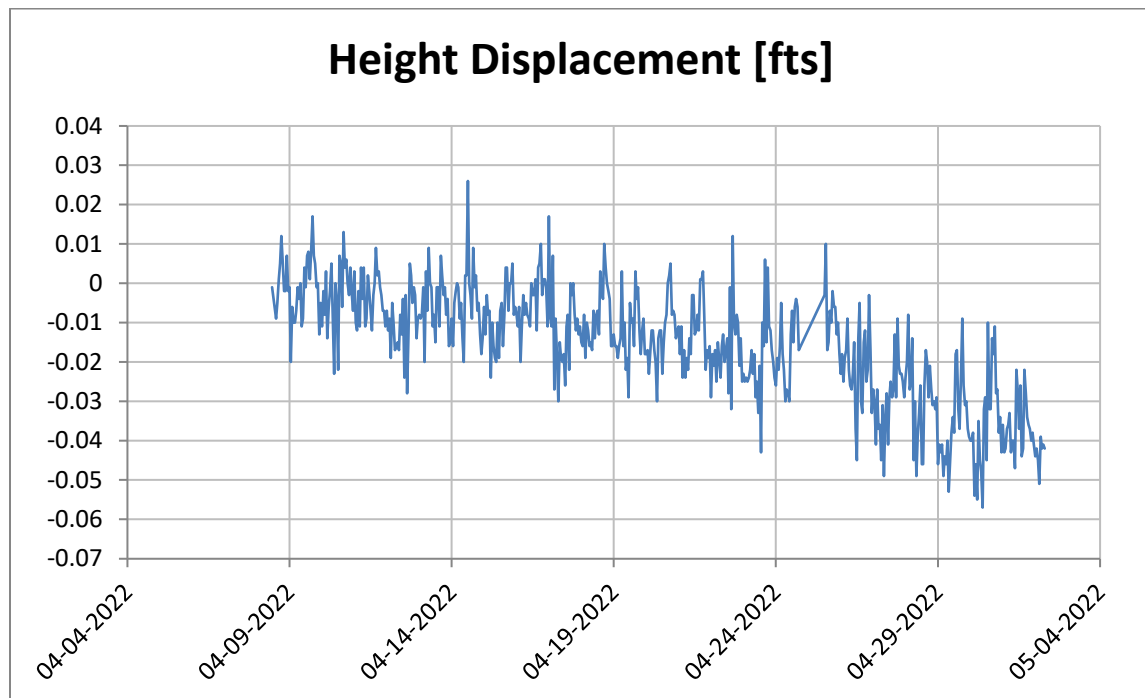
## Prism BR2

| Prism ID | Cumulative Transverse Displacement (ft) | Cumulative Height Displacement (ft) | Monthly Delta (ft) | Cumulative Delta (ft) | Notes / Recommendations |
|---|---|---|---|---|---|
| BR2 | -0.034 | -0.042 | 0.0921 | 0.1181 | New Prism. Slope creep movements. |

1. Survey accuracy is  $\pm 0.016$  feet.
2. Alarm threshold is  $\pm 0.35$  feet.
3. Transverse displacement is in the horizontal direction. Positive direction means closer to the robotic station.
4. Height displacement is in the vertical direction. Positive direction means higher in elevation.
5. Prism records slope creep movements with slow velocity.
6. Prism installed April 8, 2022.

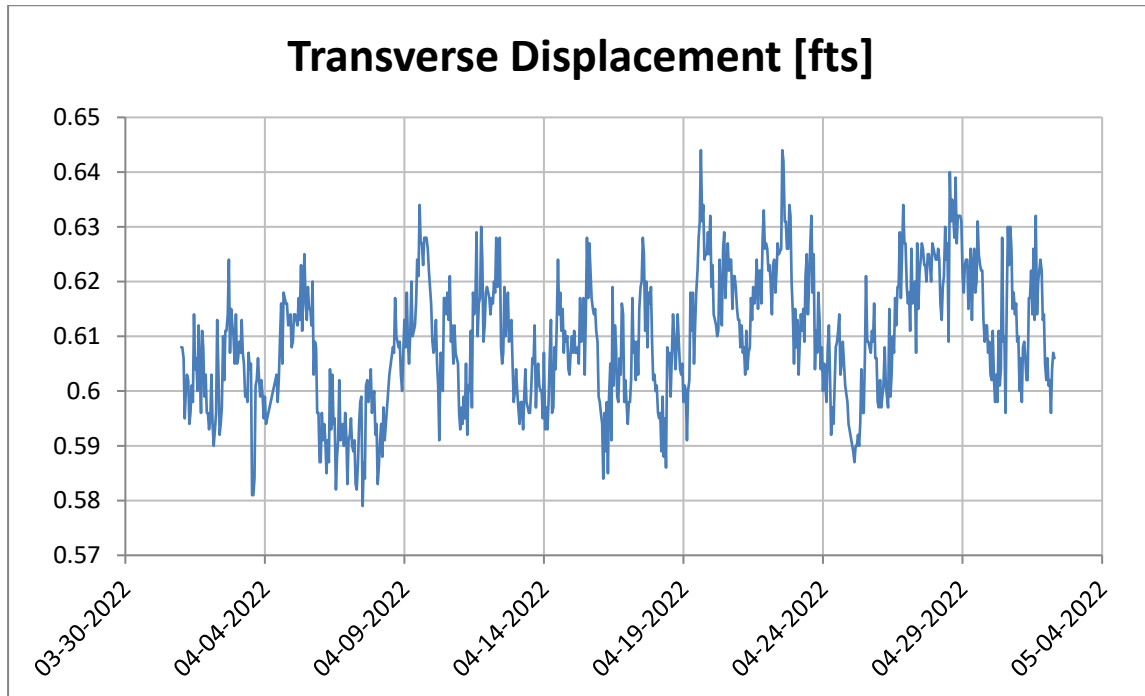
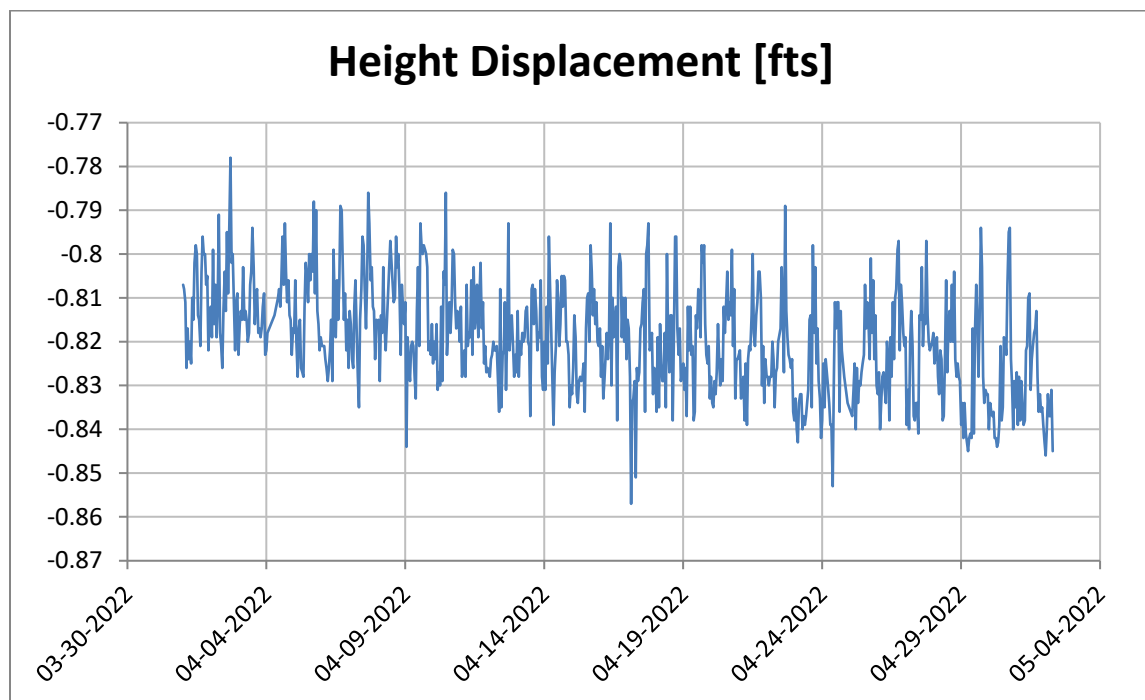
## Prism NP66

| Prism ID | Cumulative Transverse Displacement (ft) | Cumulative Height Displacement (ft) | Monthly Delta (ft) | Cumulative Delta (ft) | Notes / Recommendations |
|---|---|---|---|---|---|
| NP66 | 0.606 | -0.845 | 0.0339 | 1.2653 | Slope creep movements. |

1. Survey accuracy is  $\pm 0.016$  feet.
2. Alarm threshold is  $\pm 0.35$  feet.
3. Transverse displacement is in the horizontal direction. Positive direction means closer to the robotic station.
4. Height displacement is in the vertical direction. Positive direction means higher in elevation.
5. Prism records slope creep movements with slow velocity.

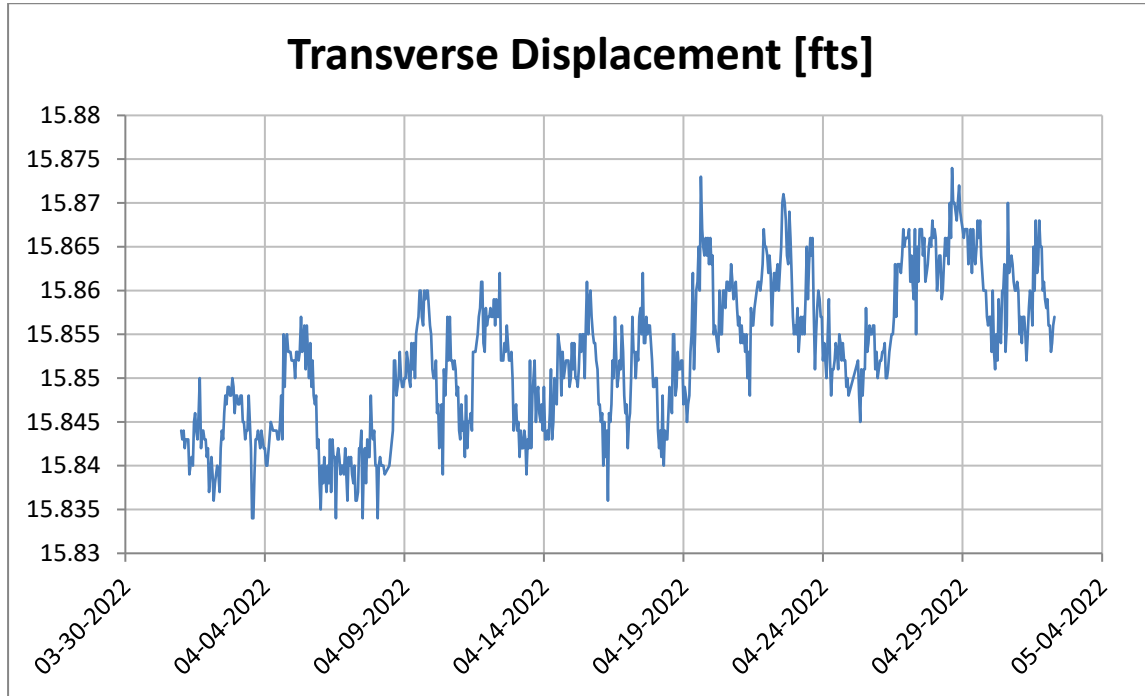
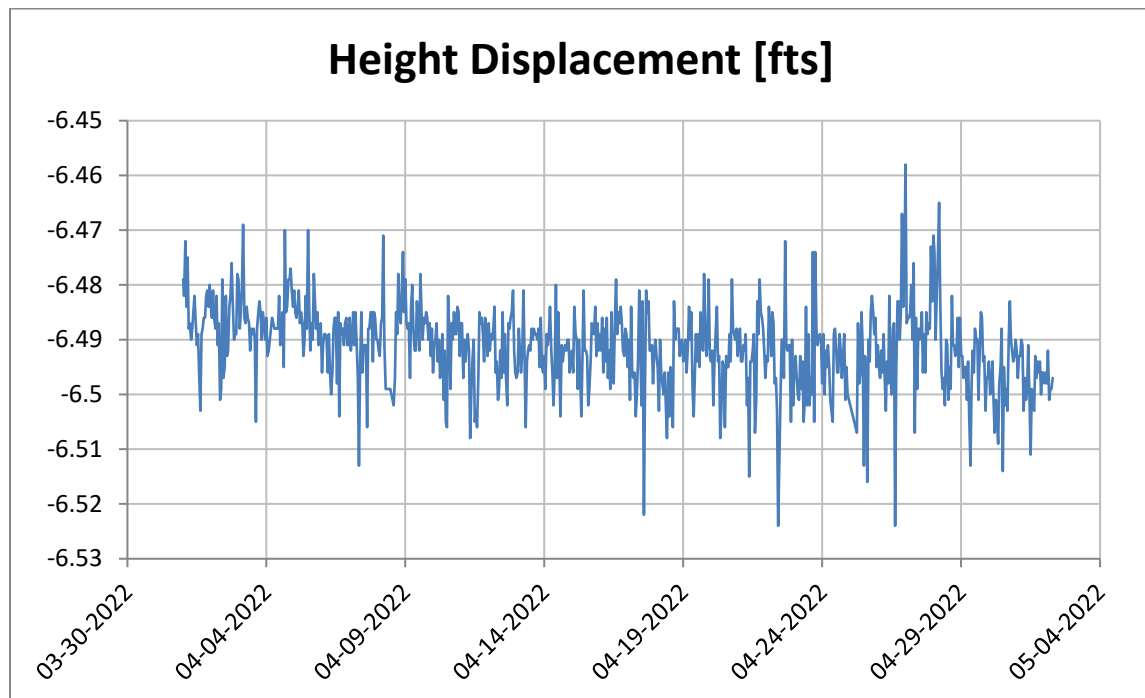
## Prism P63

The data show stable conditions with no movement for 17 of 24 prisms with recorded displacements limited to data scatter and not actual movements. Prisms P63, TOE4, and TOE5 are located at the toe of the landslide, and these locations showed slope creep movements at slow velocities. Prisms BR1, BR2, NP66, and TS1 are located above the landslide, and these prisms also recorded slope creep movements at slow velocity. This settlement is likely related to the landslide material consolidating under its own weight. New prisms are placed in areas where slope creep movements are likely to be recorded; therefore, slope creep movements being recorded at more locations is expected to occur. Plots of the transverse and height displacements for each prism are included in Appendix B.

| Prism ID | Cumulative Transverse Displacement (ft) | Cumulative Height Displacement (ft) | Monthly Delta (ft) | Cumulative Delta (ft) | Notes / Recommendations |
|---|---|---|---|---|---|
| P63 | 15.857 | -6.497 | 0.0189 | 17.1367 | Slope creep movements. |

1. Survey accuracy is  $\pm 0.016$  feet.
2. Alarm threshold is  $\pm 0.35$  feet.
3. Transverse displacement is in the horizontal direction. Positive direction means closer to the robotic station.
4. Height displacement is in the vertical direction. Positive direction means higher in elevation.
5. Prism records slope creep movements with slow velocity.

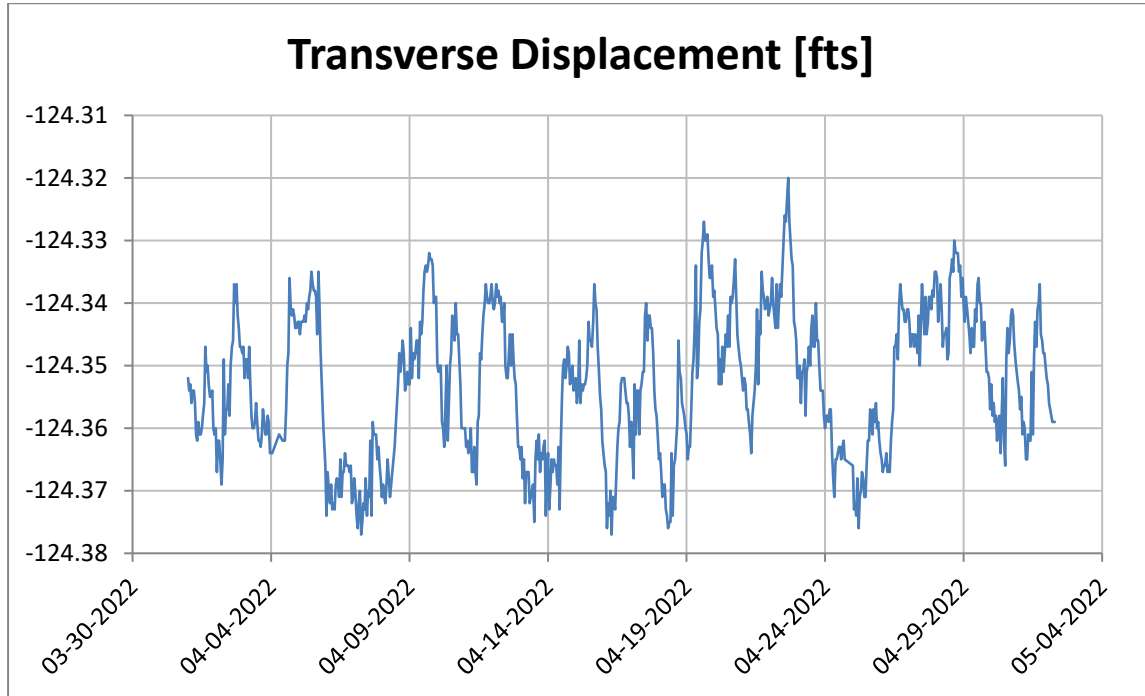
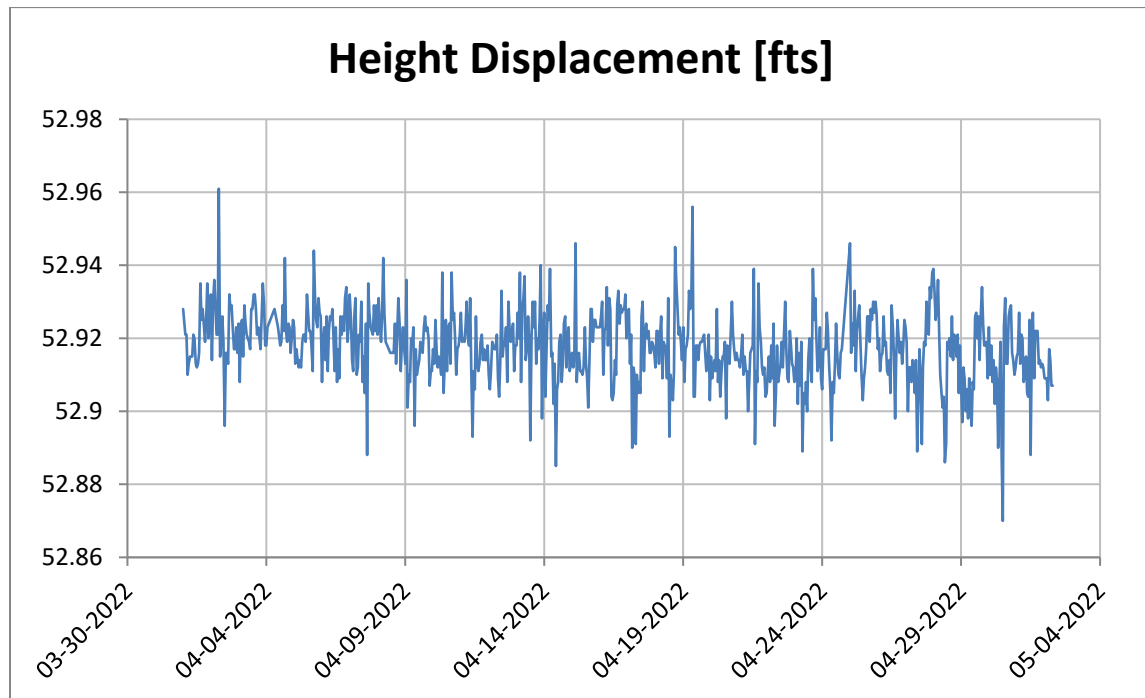
## Prism P69

1. Survey accuracy is  $\pm 0.016$  feet.
2. Alarm threshold is  $\pm 0.35$  feet.
3. Transverse displacement is in the horizontal direction. Positive direction means closer to the robotic station.
4. Height displacement is in the vertical direction. Positive direction means higher in elevation.
5. Prism records slope creep movements with slow velocity.

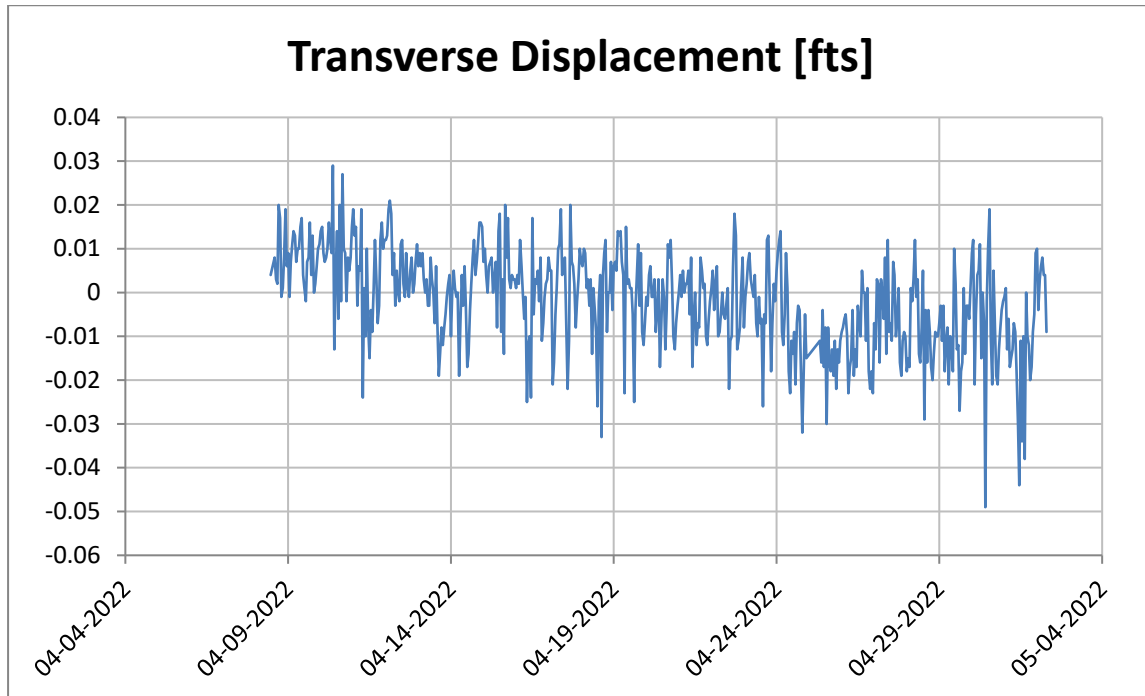
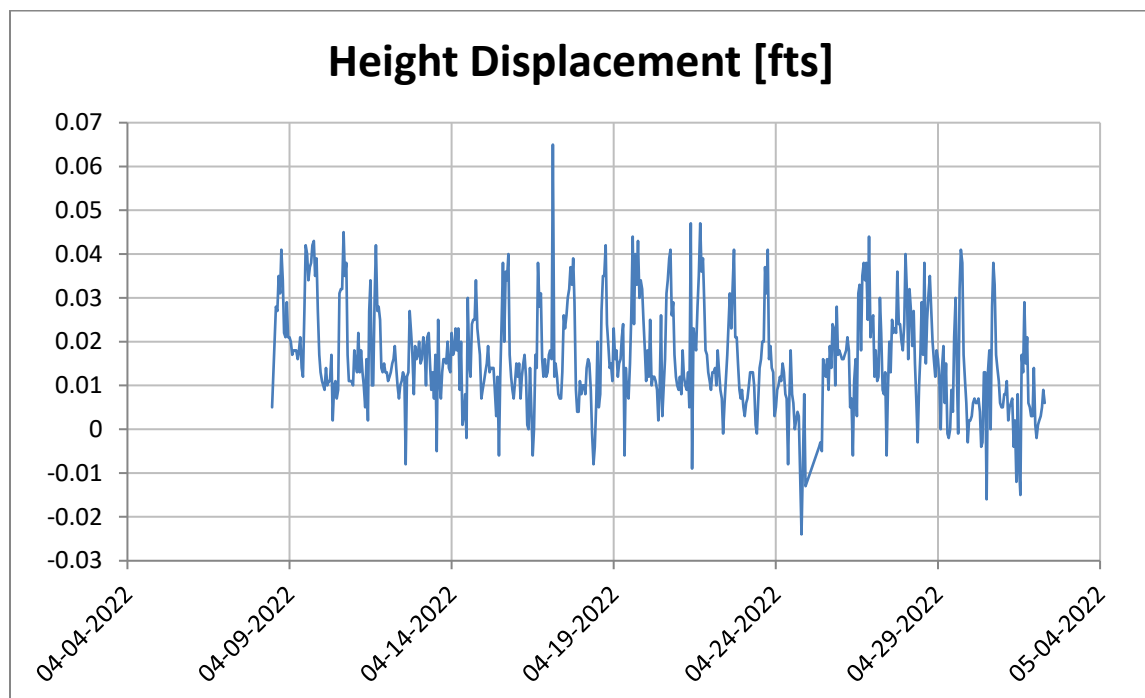
## Prism TOE4

| Prism ID | Cumulative Transverse Displacement (ft) | Cumulative Height Displacement (ft) | Monthly Delta (ft) | Cumulative Delta (ft) | Notes / Recommendations |
|---|---|---|---|---|---|
| TOE4 | -0.009 | 0.006 | 0.0196 | 0.0291 | New Prism. Slope creep movements. |

1. Survey accuracy is +/-0.016 feet.
2. Alarm threshold is +/-0.35 feet.
3. Transverse displacement is in the horizontal direction. Positive direction means closer to the robotic station.
4. Height displacement is in the vertical direction. Positive direction means higher in elevation.
5. Prism records slope creep movements with slow velocity.
6. Prism installed April 8, 2022.

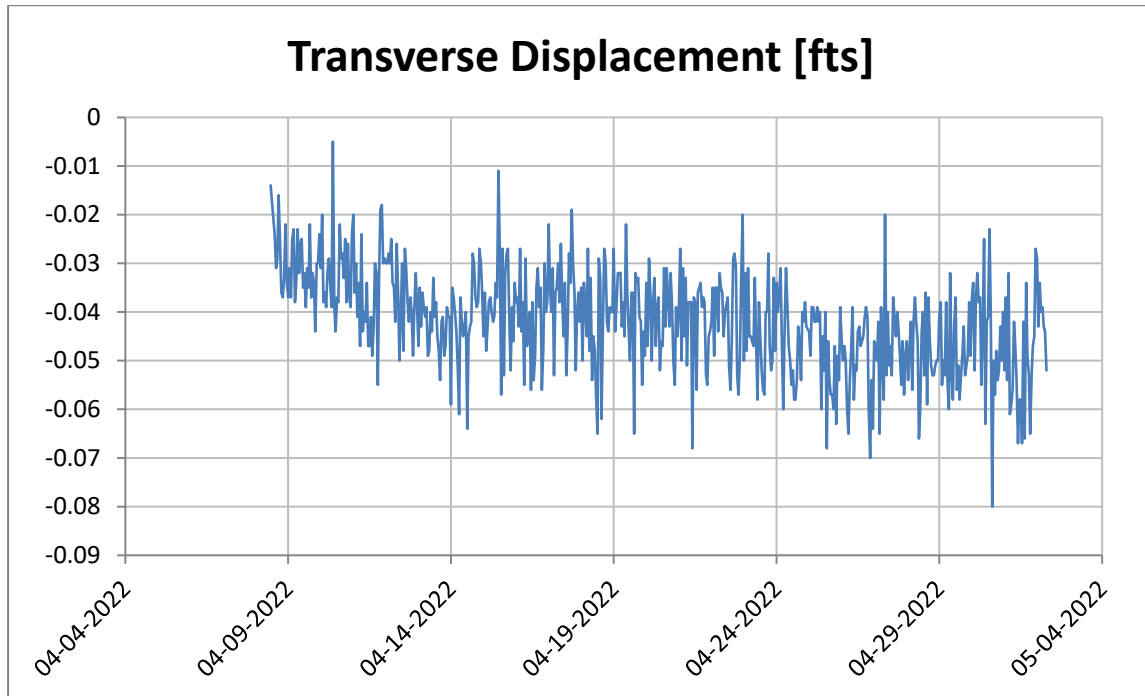
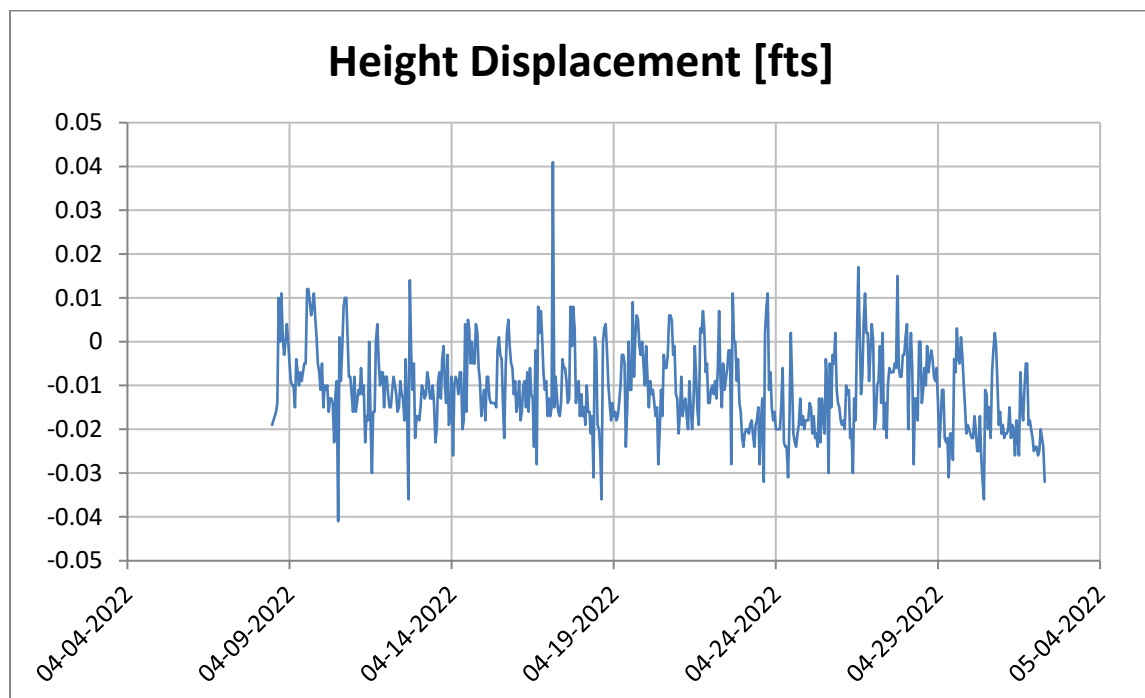
## Prism TOE5

| Prism ID | Cumulative Transverse Displacement (ft) | Cumulative Height Displacement (ft) | Monthly Delta (ft) | Cumulative Delta (ft) | Notes / Recommendations |
|---|---|---|---|---|---|
| TOE5 | -0.052 | -0.032 | 0.0412 | 0.0649 | New Prism. Slope creep movements. |

1. Survey accuracy is +/-0.016 feet.
2. Alarm threshold is +/-0.35 feet.
3. Transverse displacement is in the horizontal direction. Positive direction means closer to the robotic station.
4. Height displacement is in the vertical direction. Positive direction means higher in elevation.
5. Prism records slope creep movements with slow velocity.
6. Prism installed April 8, 2022.

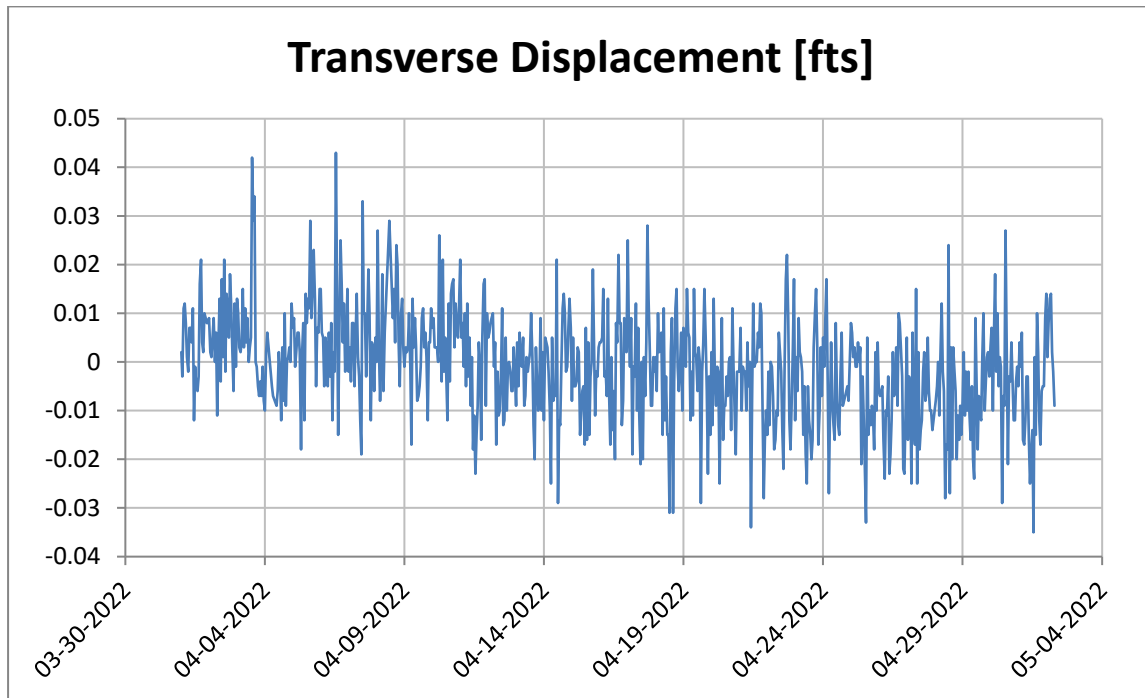
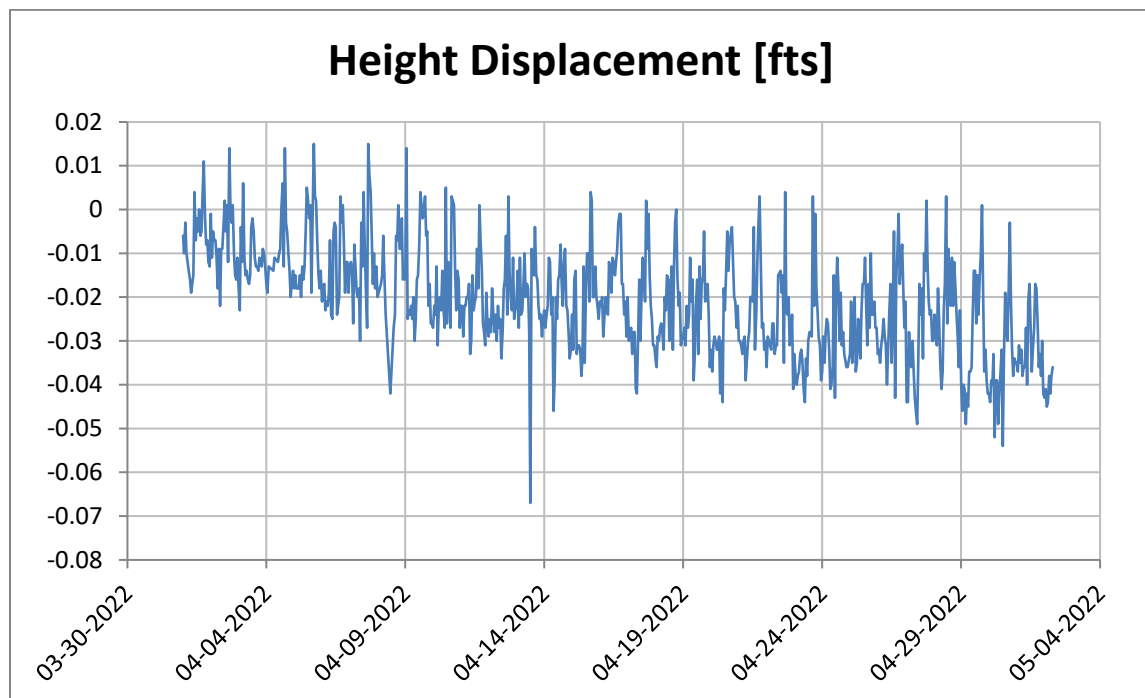
## Prism TS1

| Prism ID | Cumulative Transverse Displacement (ft) | Cumulative Height Displacement (ft) | Monthly Delta (ft) | Cumulative Delta (ft) | Notes / Recommendations |
|---|---|---|---|---|---|
| TS1 | -0.009 | -0.036 | 0.0424 | 0.0672 | Slope creep movements. |

1. Survey accuracy is  $\pm 0.016$  feet.
2. Alarm threshold is  $\pm 0.35$  feet.
3. Transverse displacement is in the horizontal direction. Positive direction means closer to the robotic station.
4. Height displacement is in the vertical direction. Positive direction means higher in elevation.
5. Prism records slope creep movements with slow velocity.
