MINERALS PROGRAM INSPECTION REPORT

MINE NAME: Caliche School Pit	MINE/PROSPECTING ID#: M-1989-023	MINERAL: Sand and gravel	COUNTY: Logan
INSPECTION TYPE: Monitoring	INSPECTOR(S): Nikie Gagnon	INSP. DATE: May 25, 2022	INSP. TIME: 10:00
OPERATOR: Kristine M Couch	OPERATOR REPRESENTATIVE: Andrew Johnson	TYPE OF OPERATION: 110c - Construction Limited Impact

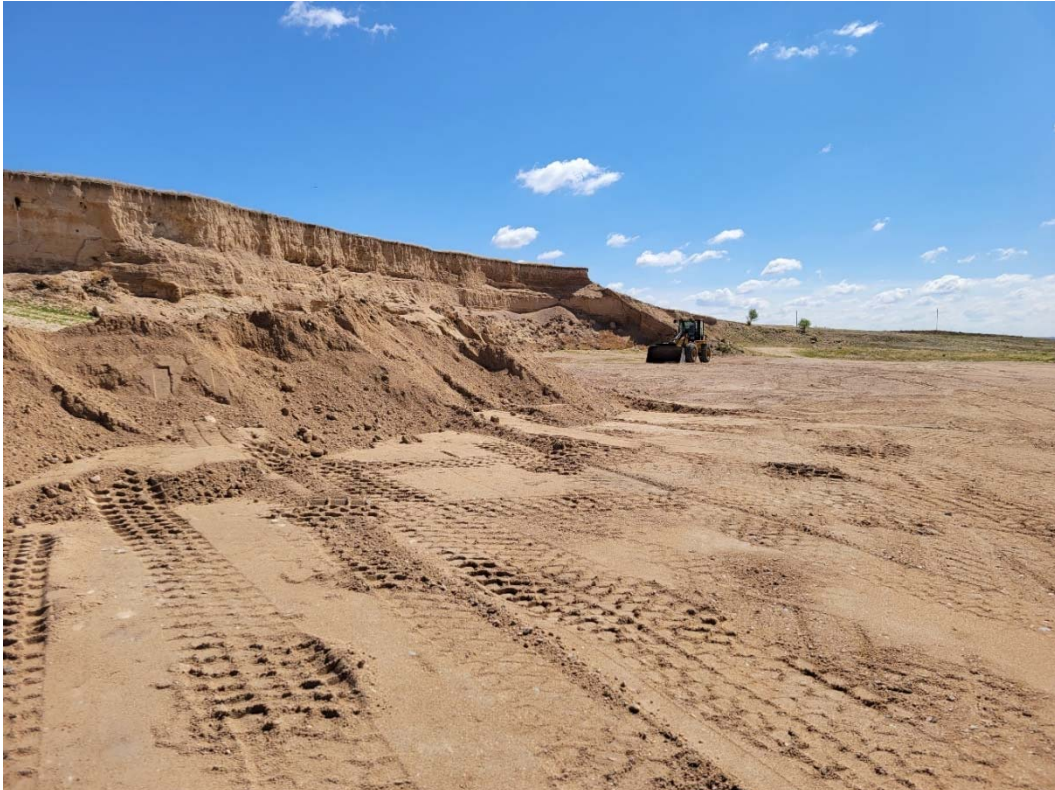
Looking east across excavated pit.

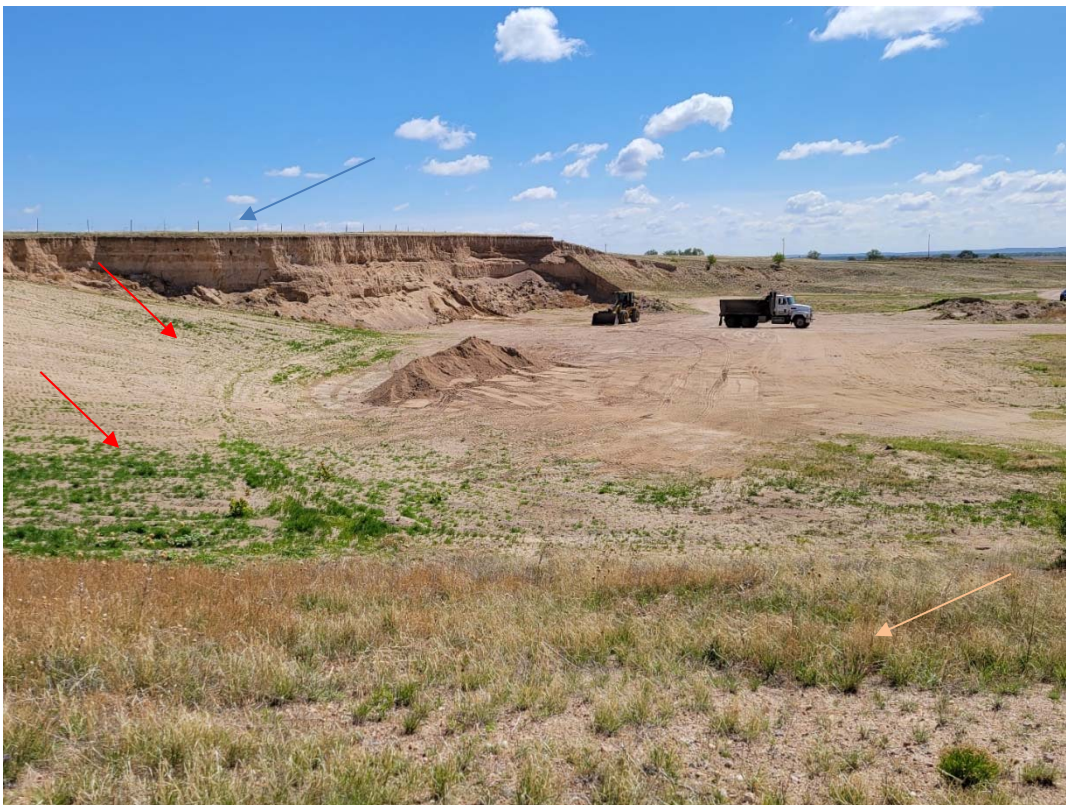
Gen. Compliance with Mine Plan: Mining at the site has created a 30 foot pit excavation. The active mining highwall is approximately 25 feet high along the north side and slopes to approximately 6 feet on the southwest side. There is some space between the top of the 25 foot highwall and the northern permit boundary. However there is not a lot of room to cut and fill the highwall on the north side. According to Mr. Johnson, the operator is considering moving the fence and using material from land north of the permit area to backfill the pit to the required 3H:1V angle. Prior to conducting this activity, the currently approved permit will require a revision to incorporate the proposed area to be excavated into the permit area.

Looking east across excavated pit. Red arrows point to recently graded and seeded area. Small stockpile of mined material in pit. Fence line at top of highwall is the northern permit boundary. Older reclaimed area in foreground.

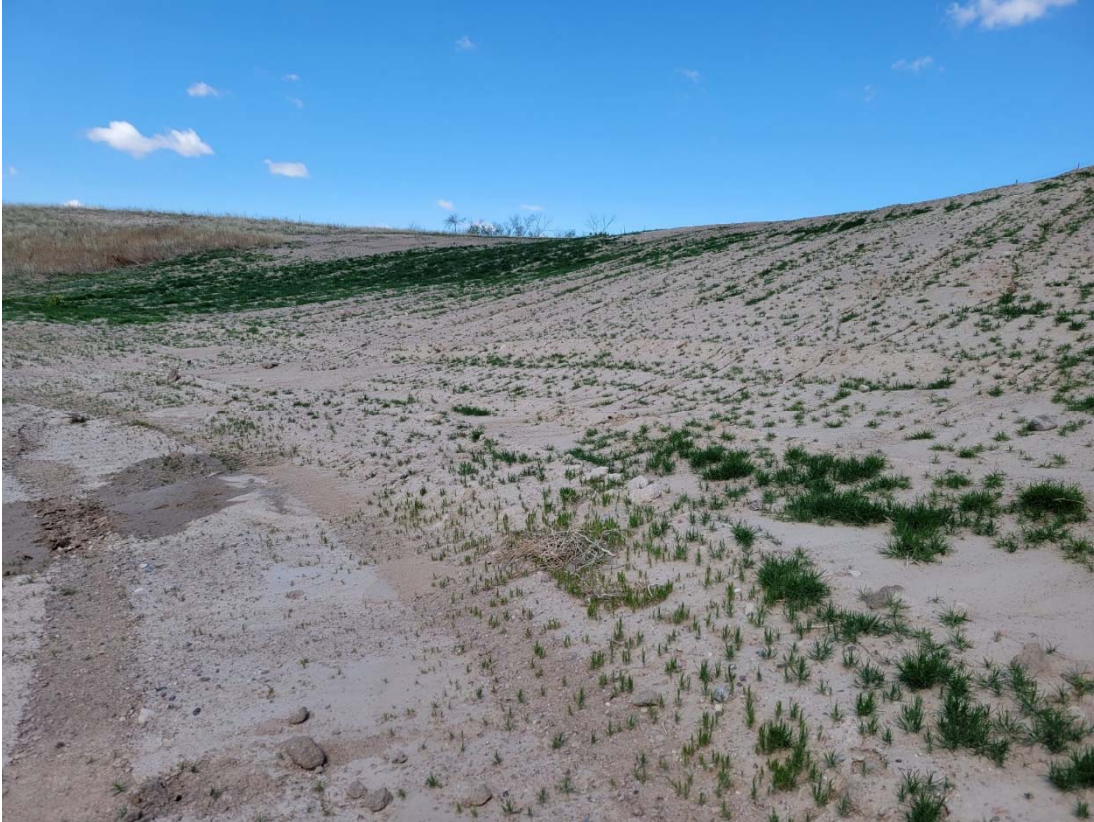
Reclamation Success: The site remains active. A small area on the west end of the pit has been regraded and seeded. Vegetation is starting to fill in across this area. Some rills were evident on the exposed areas. Weeds are currently controlled. Mr. Johnson asked about a bond reduction for this section. Before submitting a request for a bond reduction, the Division recommends waiting another growing season to allow time for native vegetation to fill in and better control water and wind erosion.

Close-up of graded and seeded area.

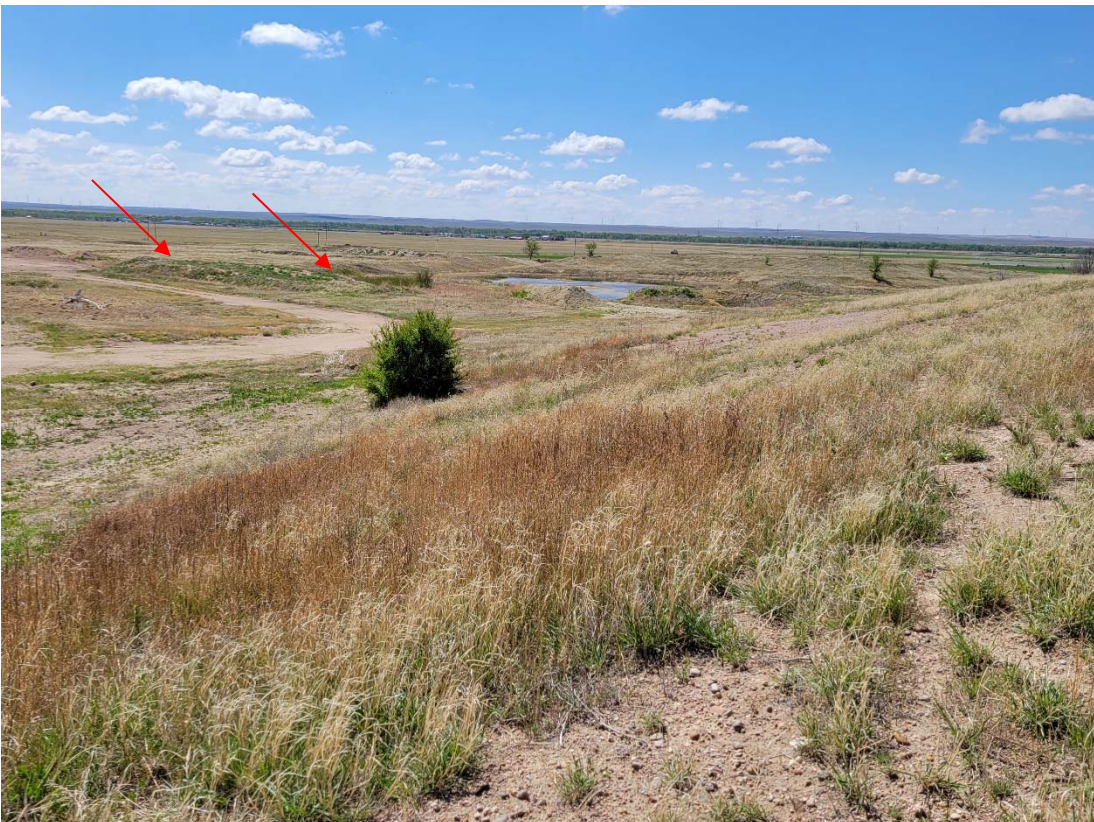
Topsoil: Topsoil has been stripped from the pit area and it is stockpiled in the pit area and along the southern corner of the site. The topsoil piles are stable and vegetated.

Looking south from reclaimed area on northwestern edge of pit. Arrows point to topsoil salvage in southern area of the permit boundary.

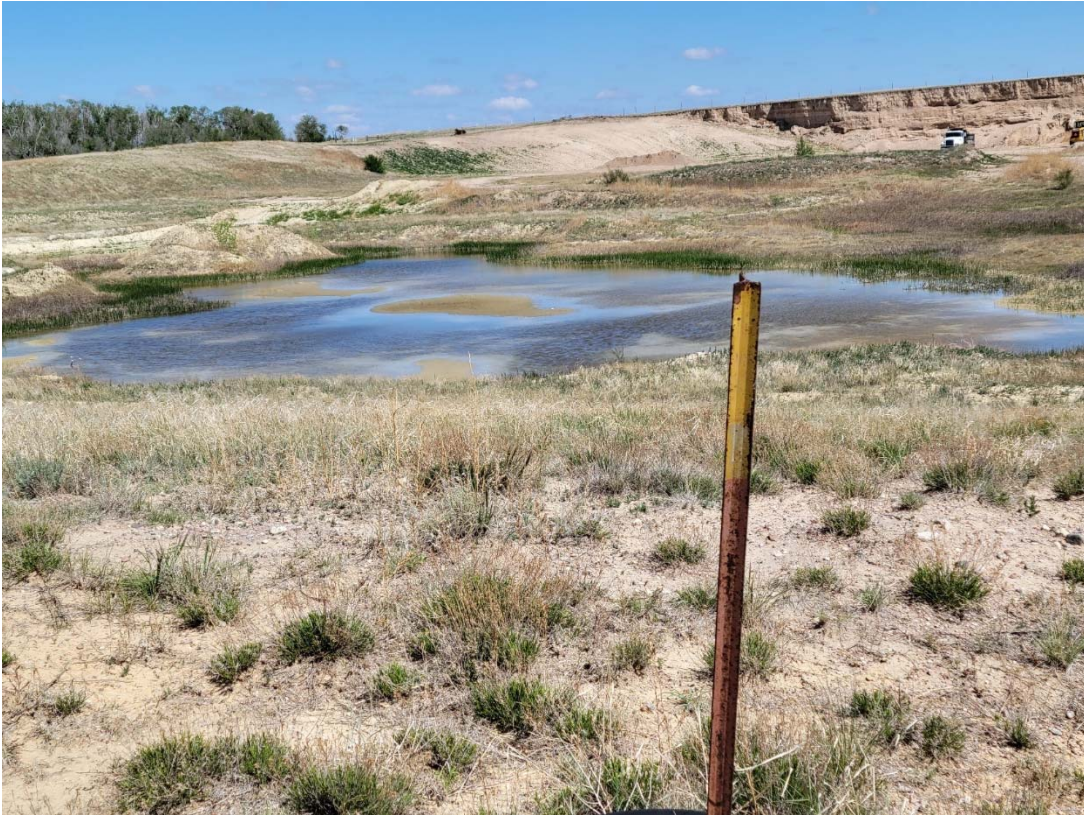
Stormwater Control: During this inspection, the pit excavation area was dry. However, surface area runoff and snowmelt has pooled in a low spot on the southern end of the permit area. An approved trench has been cut to help drain water to an adjacent ditch. However, the inlet to the trench is above the current level of water. The Division recommends excavating the trench deeper to help drain stormwater out of the pond.

Looking northwest. Reclaimed areas shown on the top left. Pool of water collecting in depression in southern end of permit area. Boundary stake along southern edge.

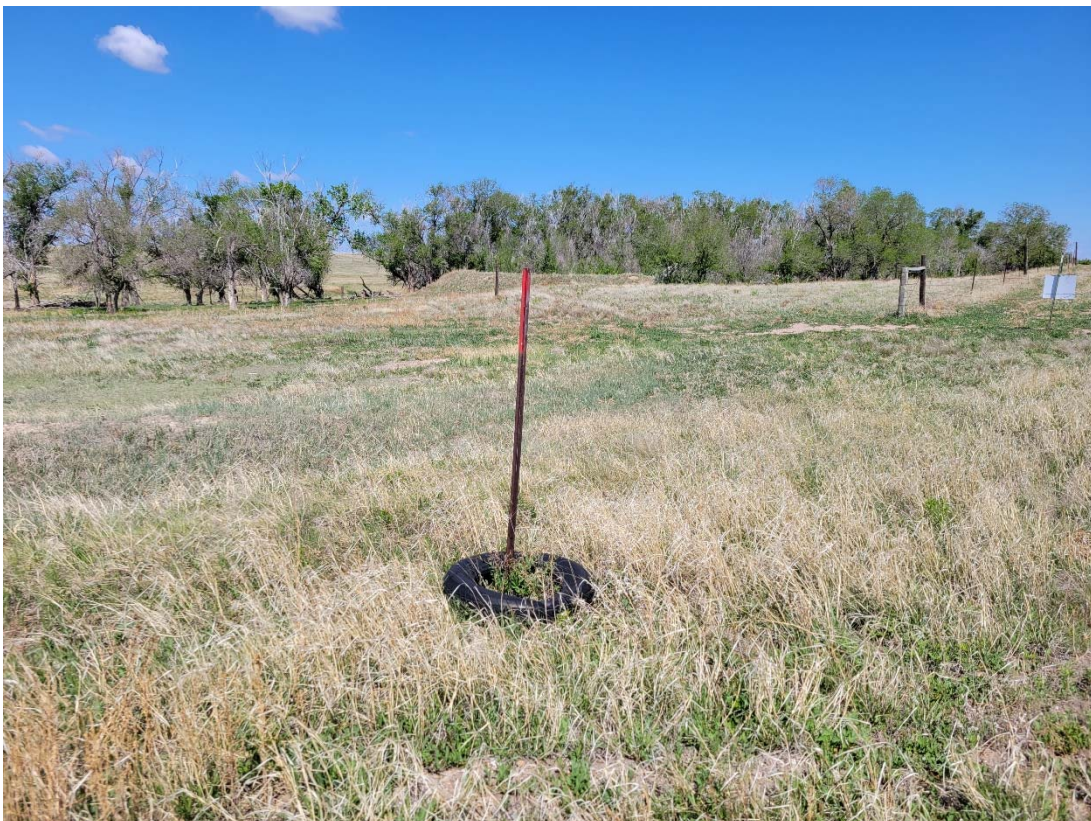
Signs and Markers: The mine entrance sign was in place and the boundary was clearly marked with t-posts. The southeast boundary marker was not observed and will require replacement.

Boundary marker along western edge of permit area.

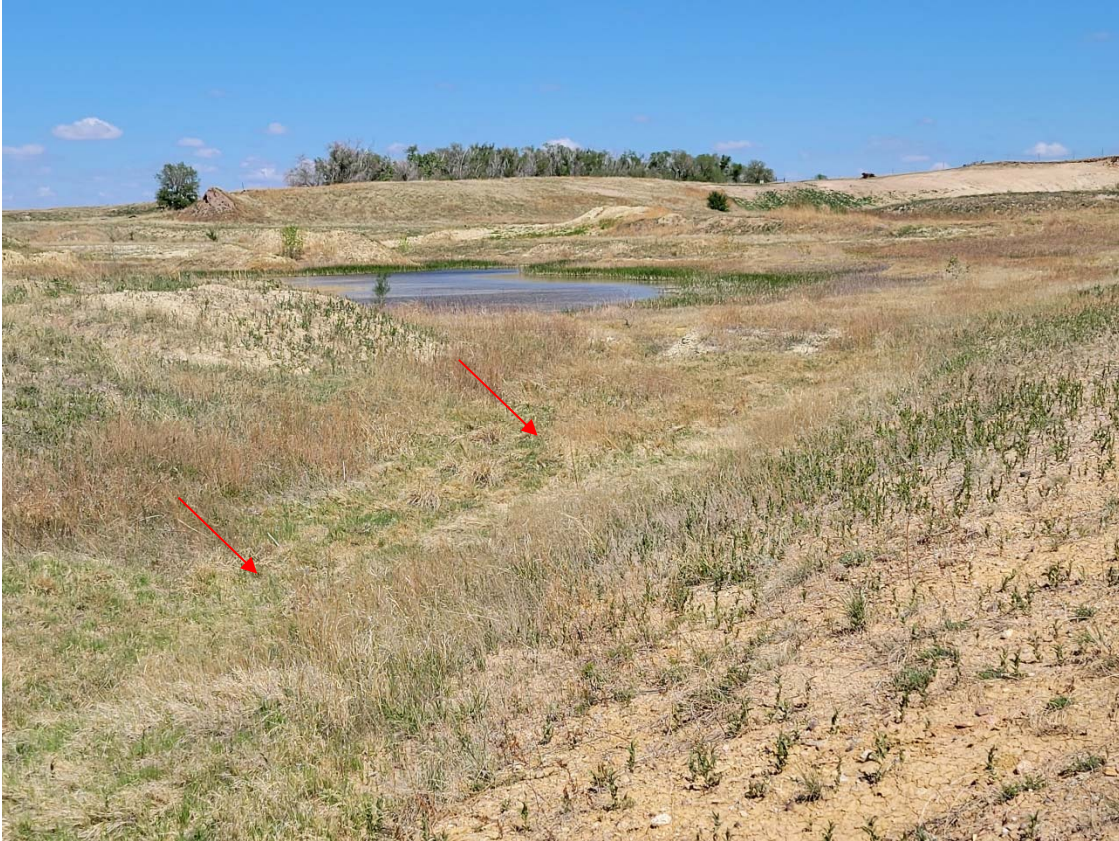
Looking northwest. Drainage ditch excavated to drain pond.

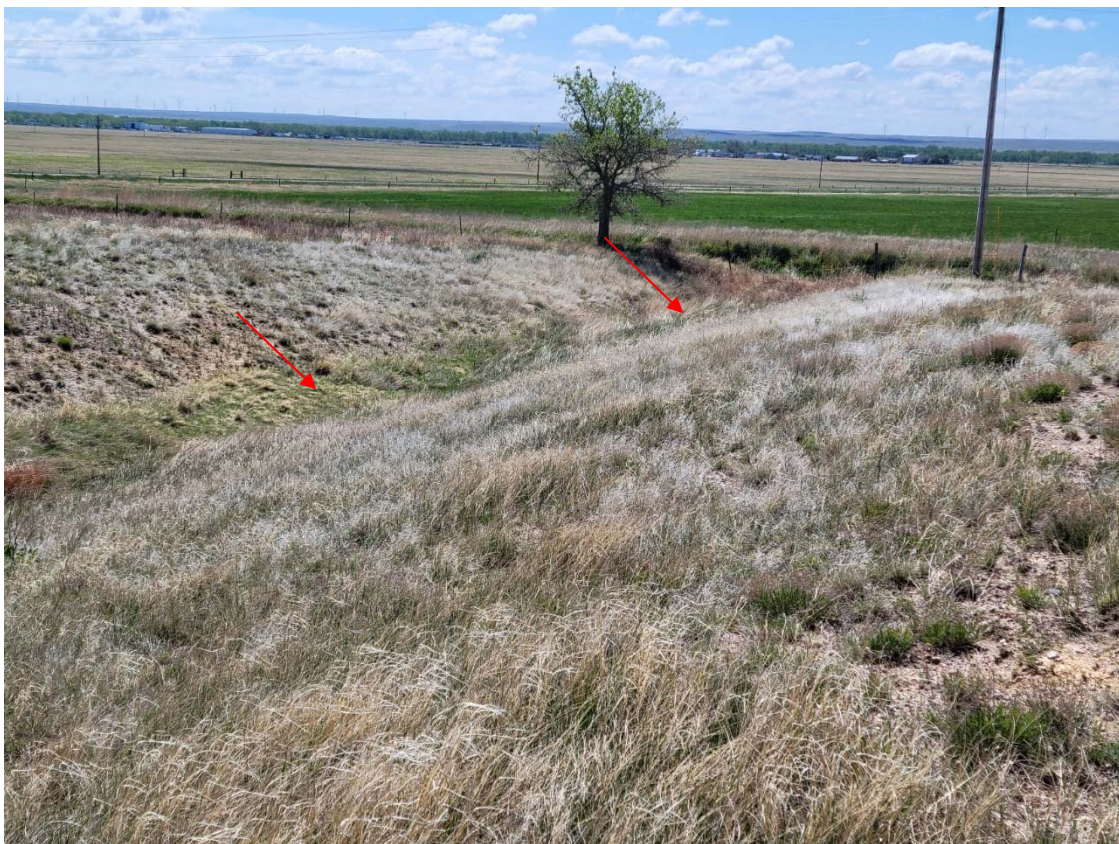
Looking south at excavated drainage and irrigation ditch.

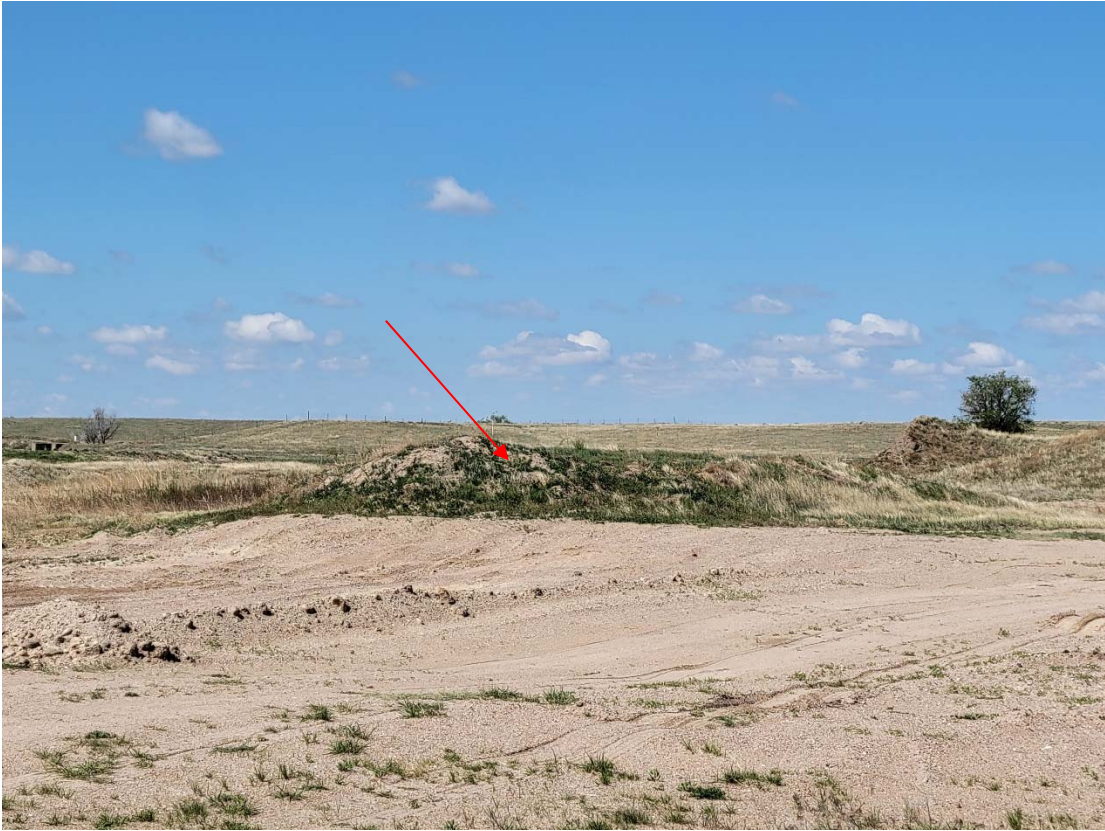
Topsoil pile along edge of active pit area.

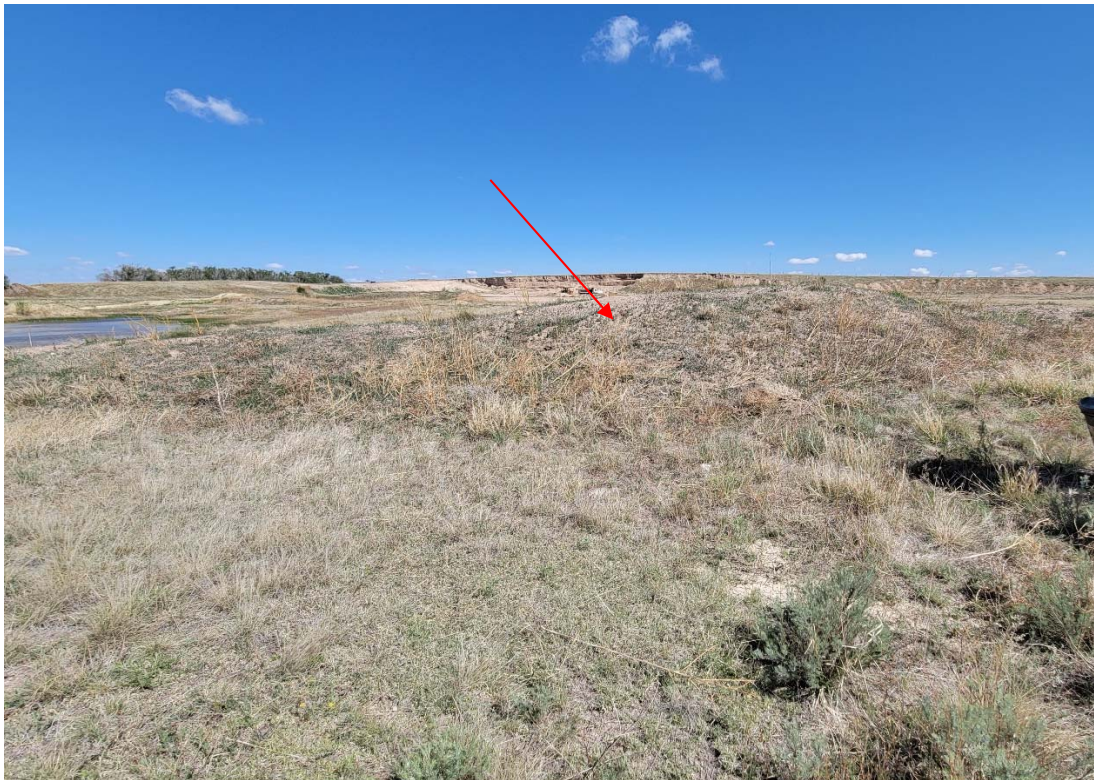
Older topsoil piles in southern end of permit area.
