MINERALS PROGRAM INSPECTION REPORT
PHONE: (303) 866-3567

MINE NAME: Dollerschell Pit	MINE/PROSPECTING ID#: M-1986-074	MINERAL: Sand and gravel	COUNTY: Logan
INSPECTION TYPE: Monitoring	INSPECTOR(S): Nikie Gagnon	INSP. DATE: May 25, 2022	INSP. TIME: 12:30
OPERATOR: Kym A. Schure	OPERATOR REPRESENTATIVE: NA	TYPE OF OPERATION: 112c - Construction Regular Operation	
REASON FOR INSPECTION: Normal I&E Program	BOND CALCULATION TYPE: Complete Bond	BOND AMOUNT: \$26,140.00	
DATE OF COMPLAINT: NA	POST INSP. CONTACTS: None	JOINT INSP. AGENCY: None	
WEATHER: Clear	INSPECTOR'S SIGNATURE:

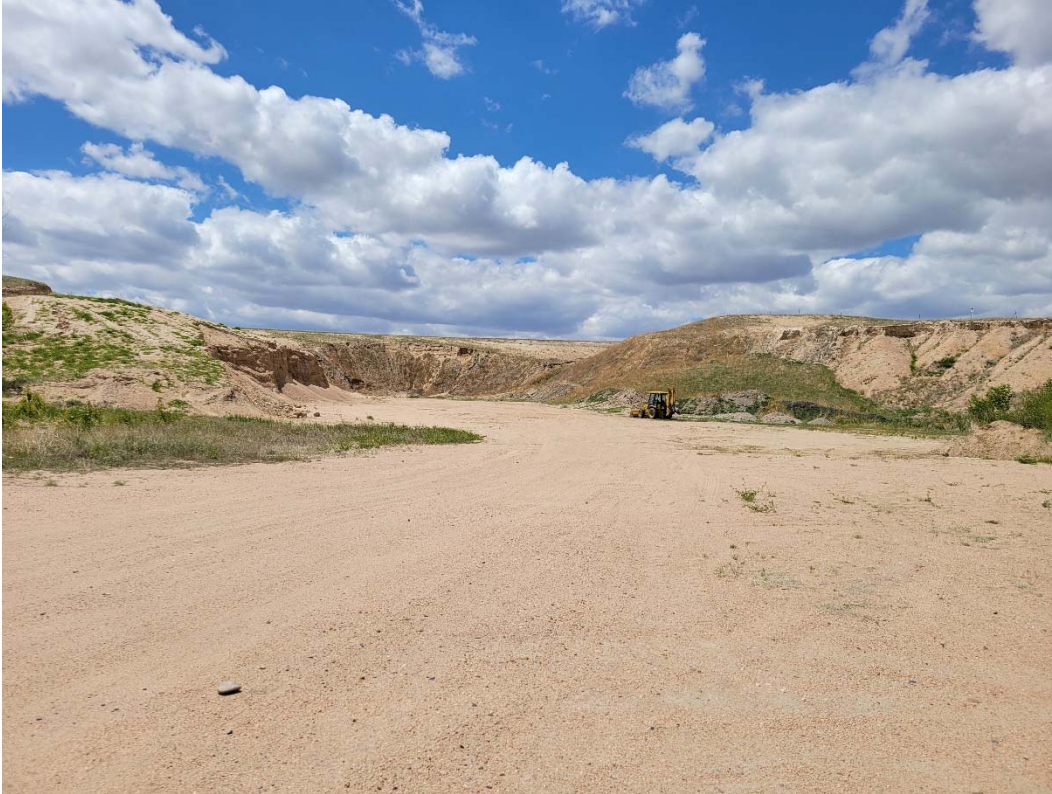
Looking west across laydown area from the entrance to the pit.

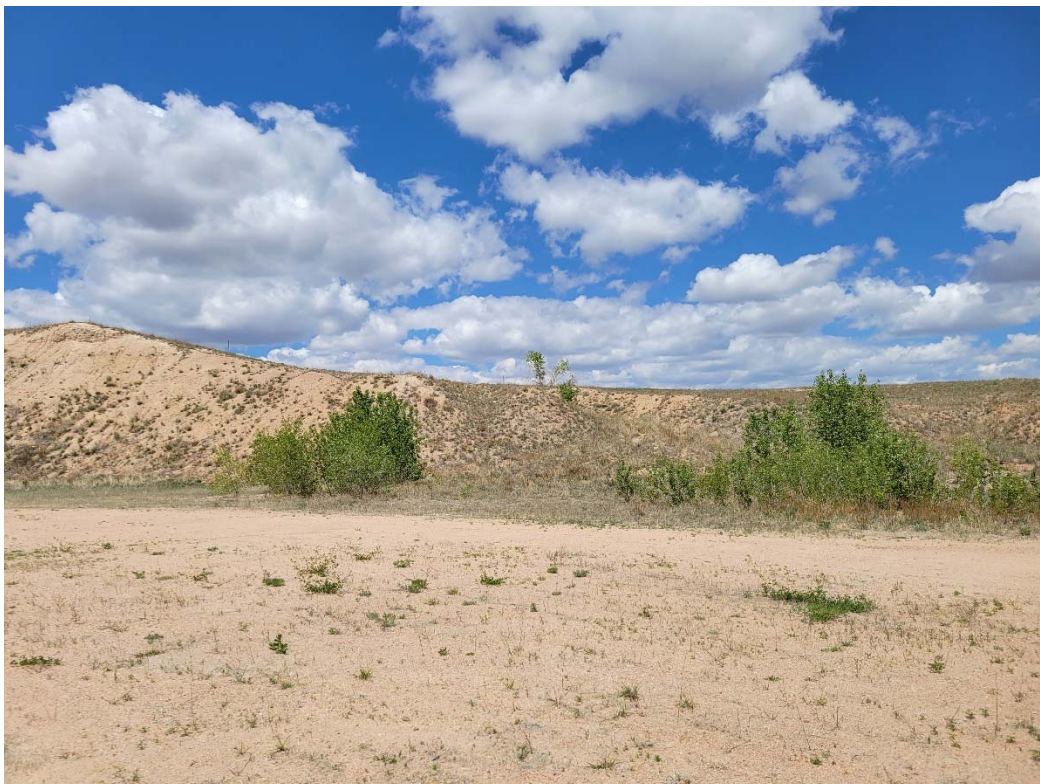
Looking at the northern pit wall from the entrance to the pit. Cottonwood trees established at the base of the pit.

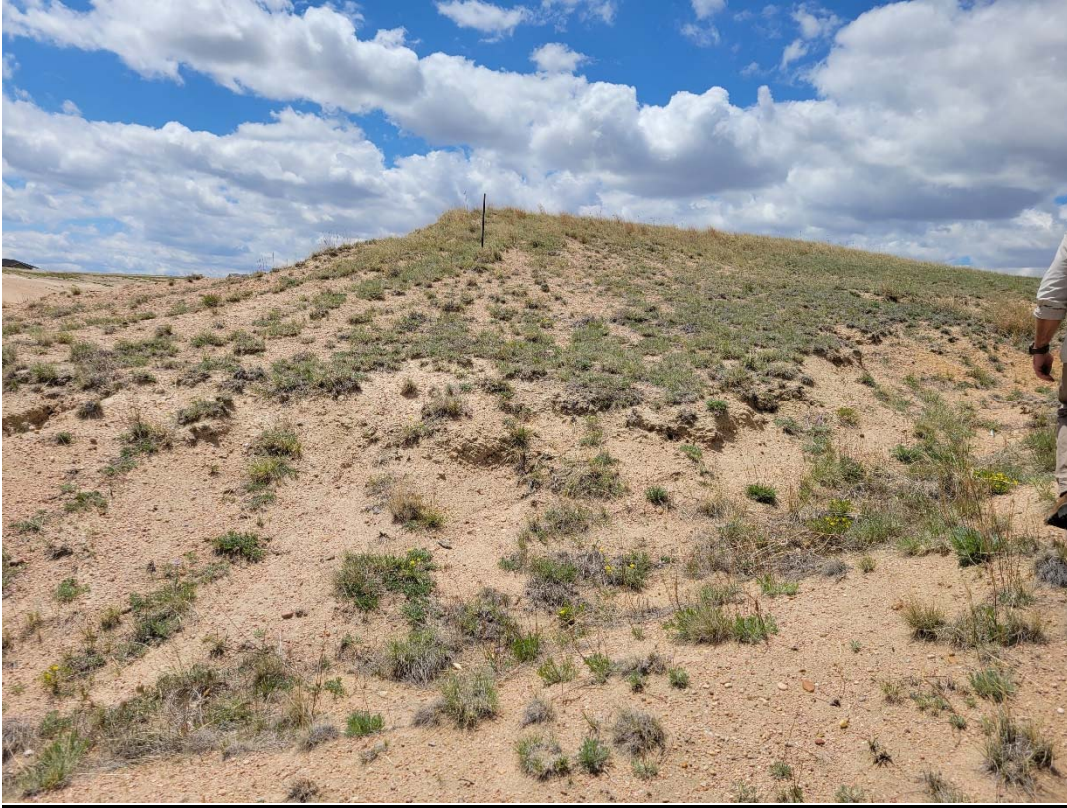
Looking west above the northern pit wall.

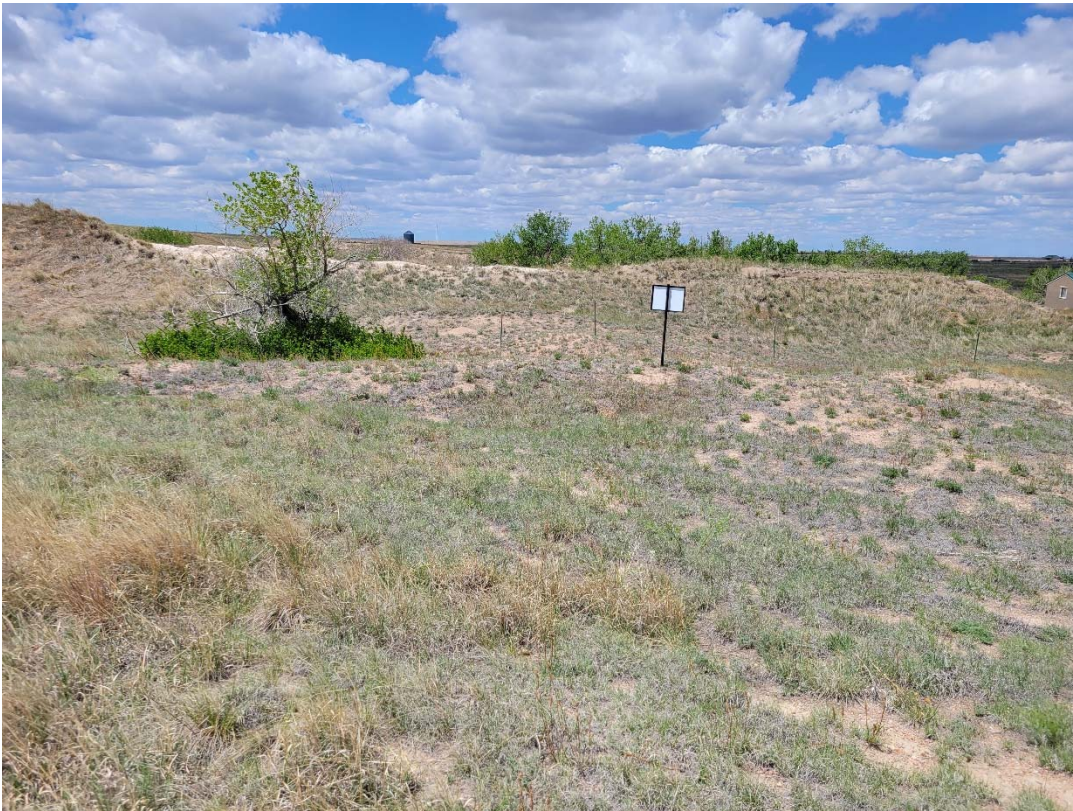
Northern permit boundary. No trespassing/Danger signs are posted around perimeter of site.

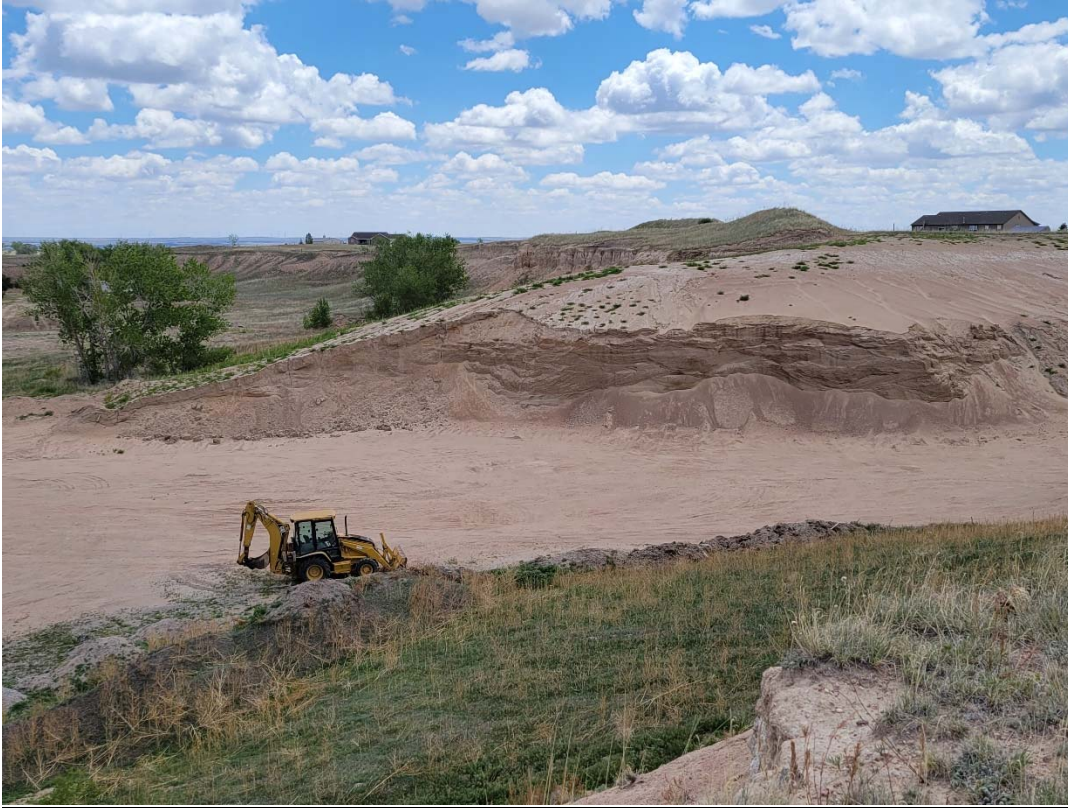
Looking at the south highwall.

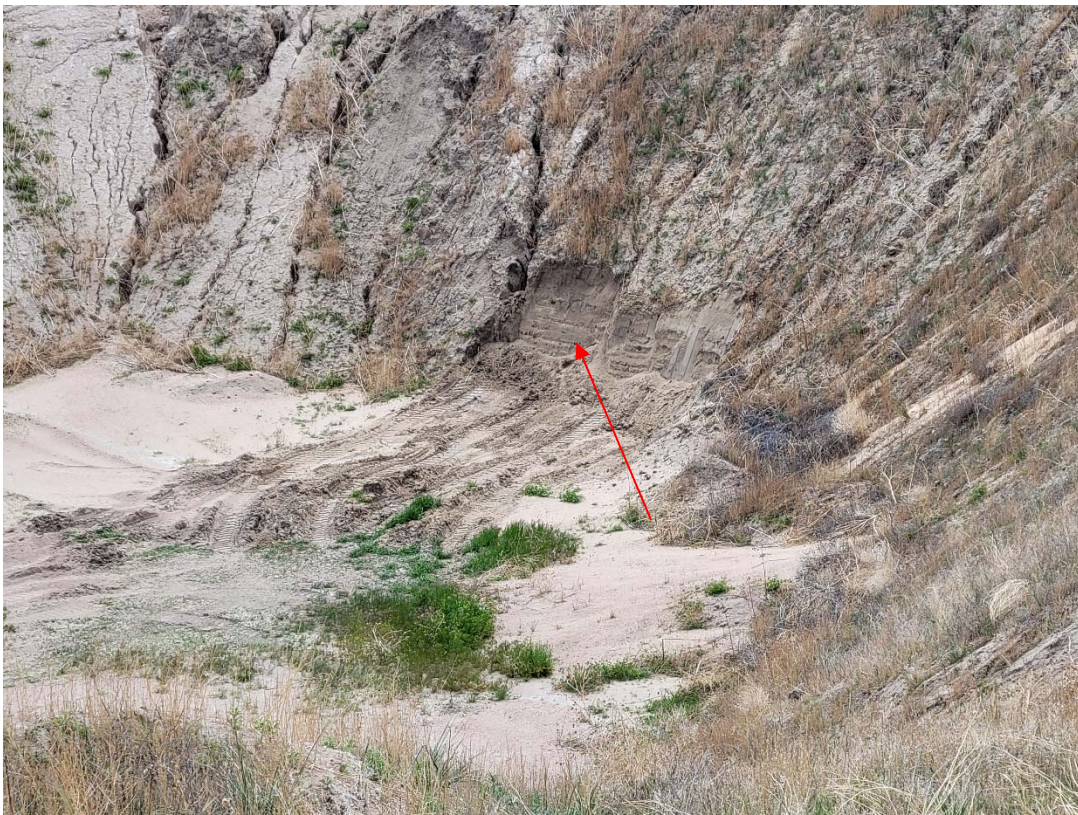
Looking at the base of the west highwall, small amount of material removed from this area recently.

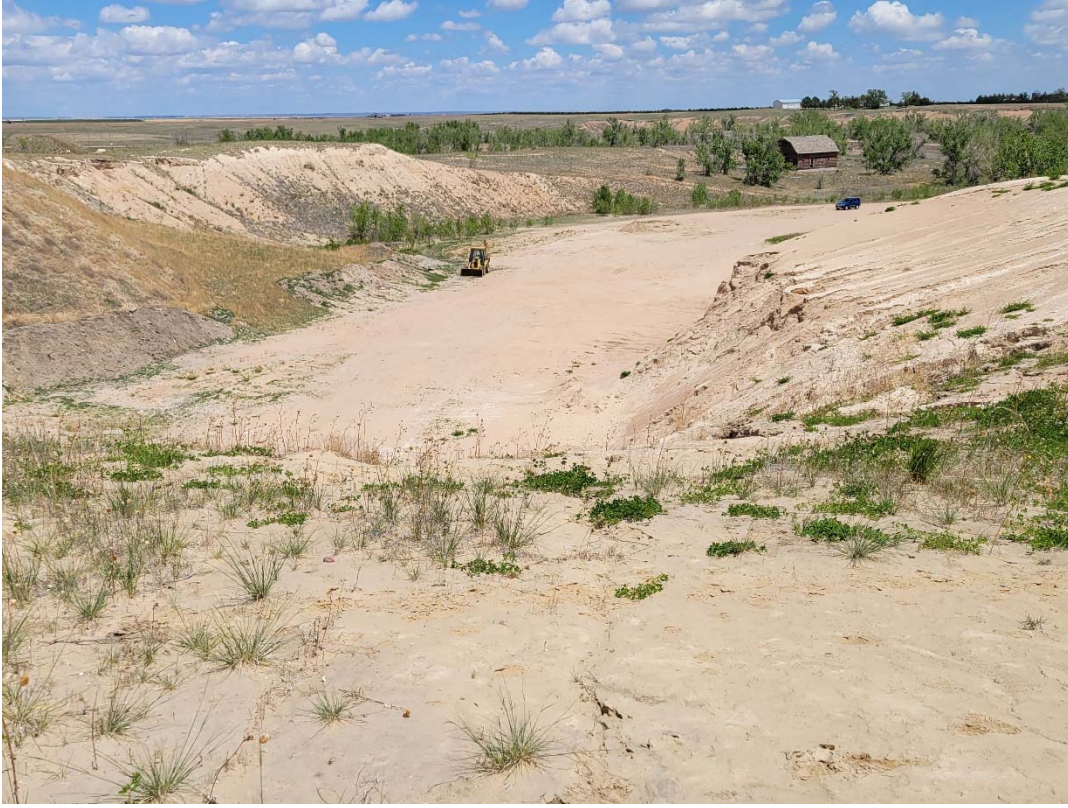
Looking east from above the west highwall.

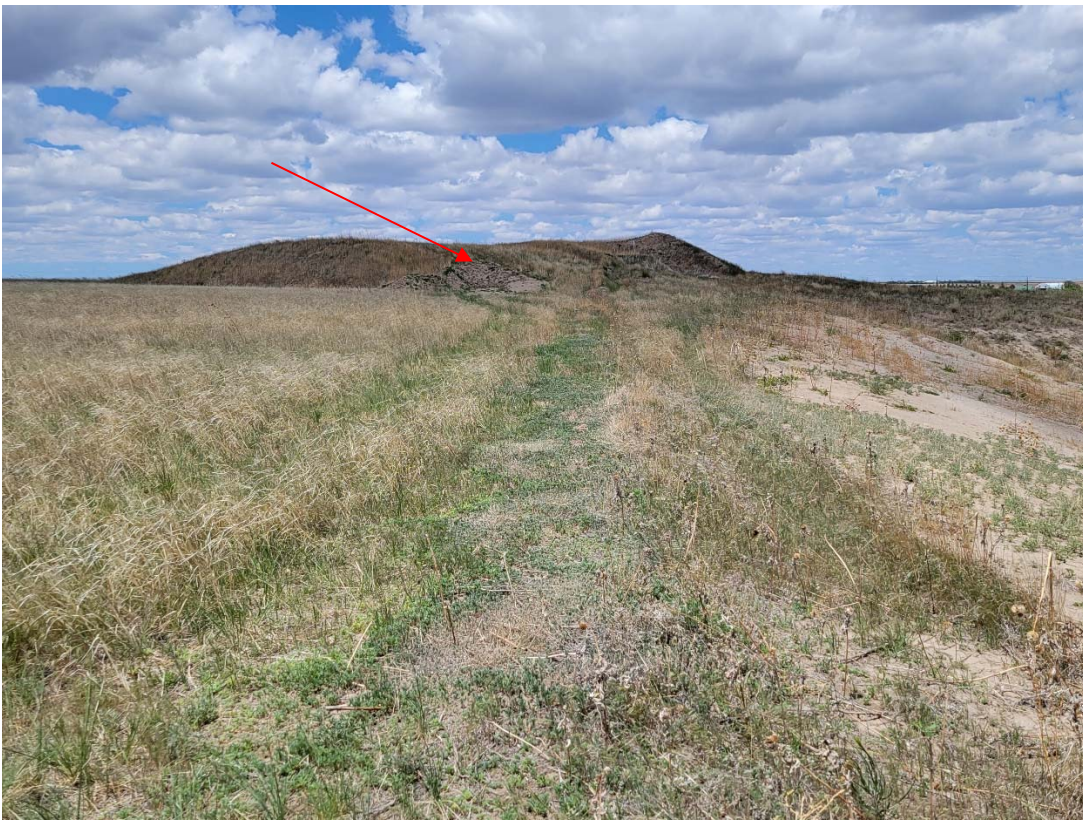
Above the southwest highwall. Arrow points to topsoil pile.

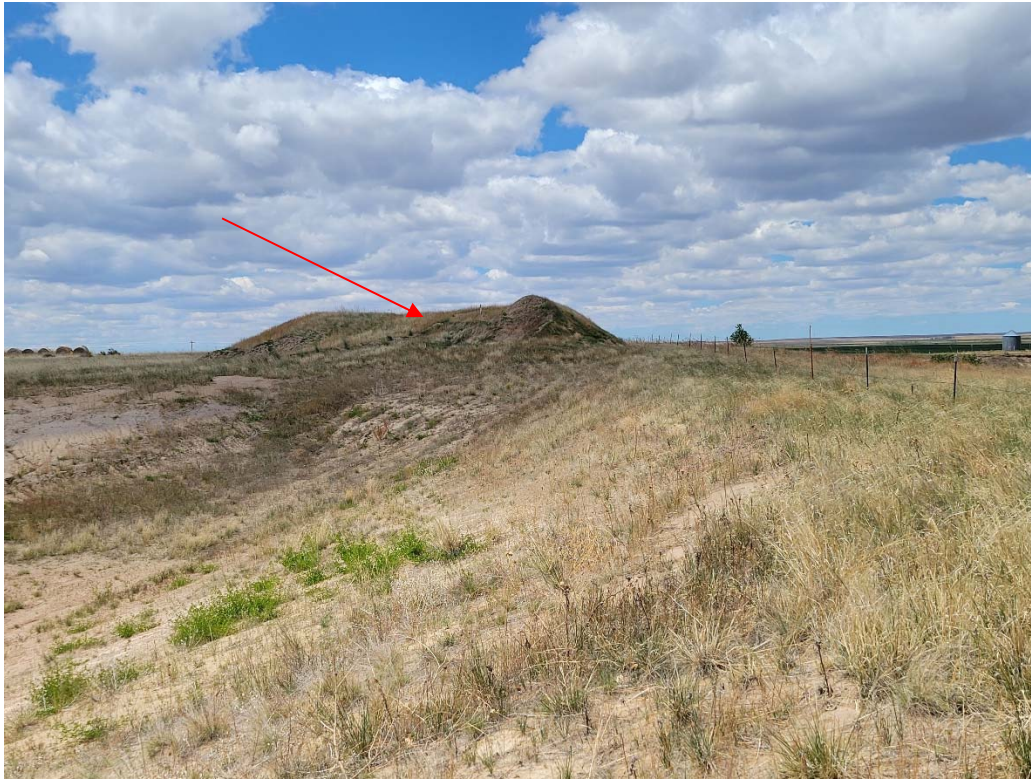
Western permit boundary. Arrow points to topsoil pile.

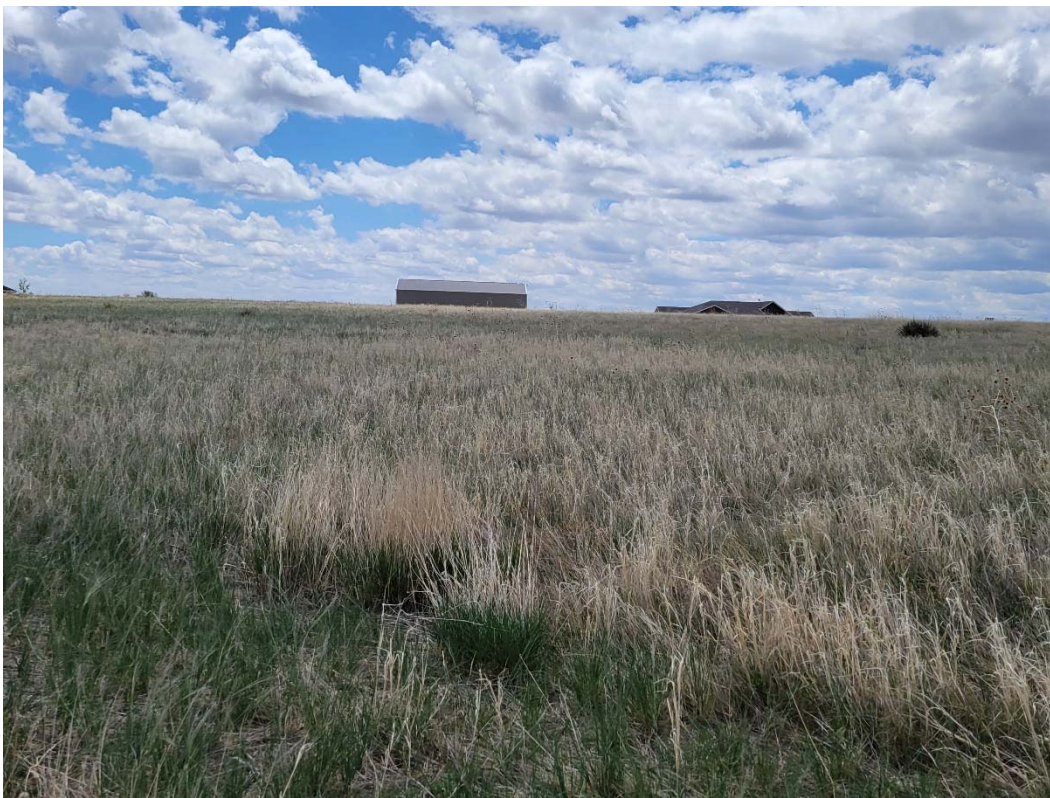
Undisturbed grassland in southern portion of permit area.

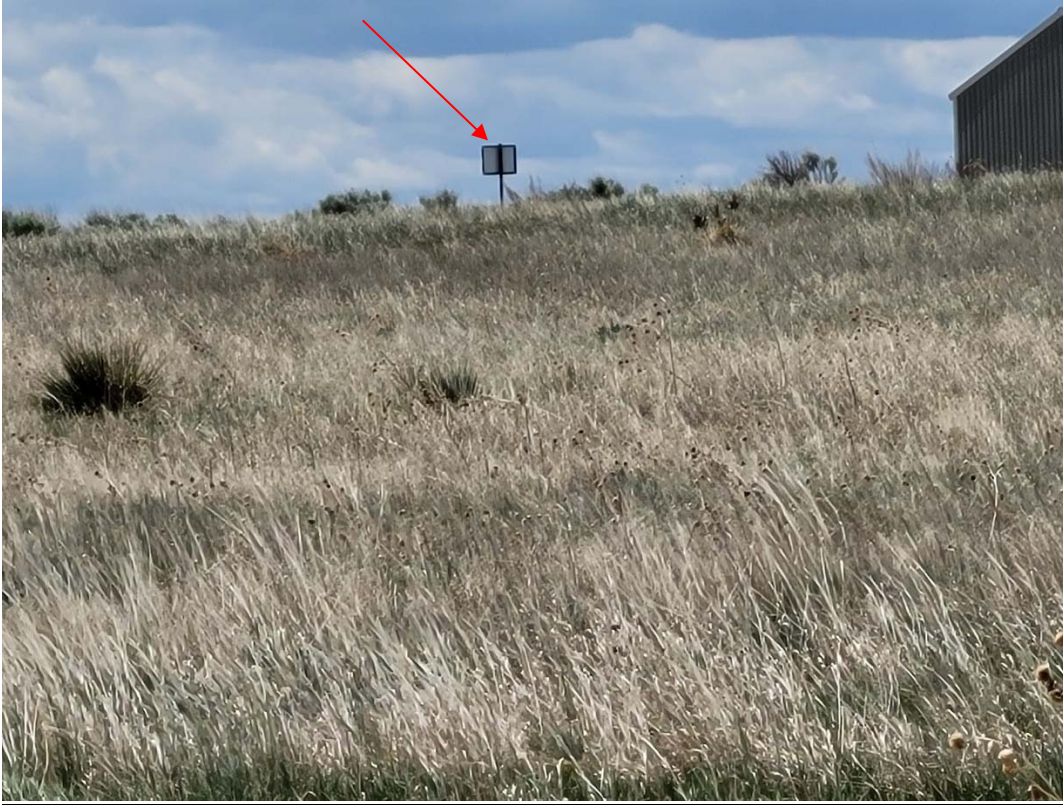
Undisturbed grassland in southern portion of permit area. Warning sign posted along southern boundary.

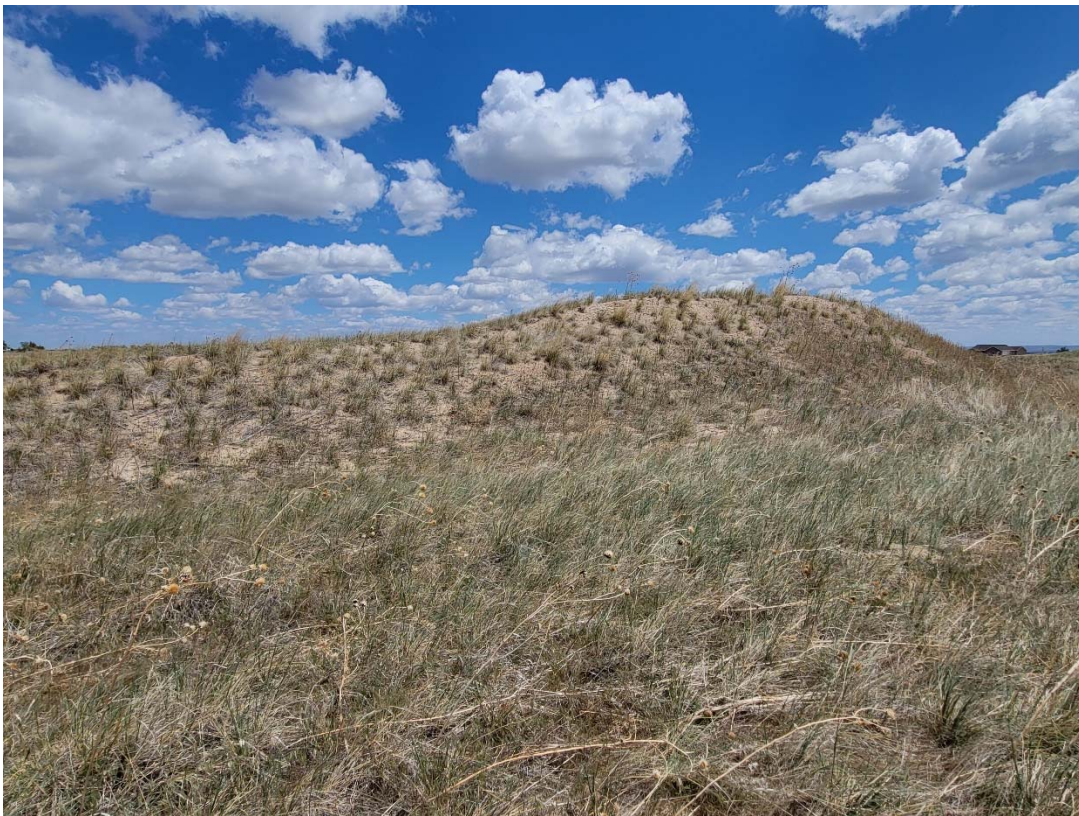
Topsoil: Topsoil is stored above the highwall in the southeast section of the permit area. The piles are vegetated and erosion is controlled.

Topsoil pile in southeastern area of permit boundary.

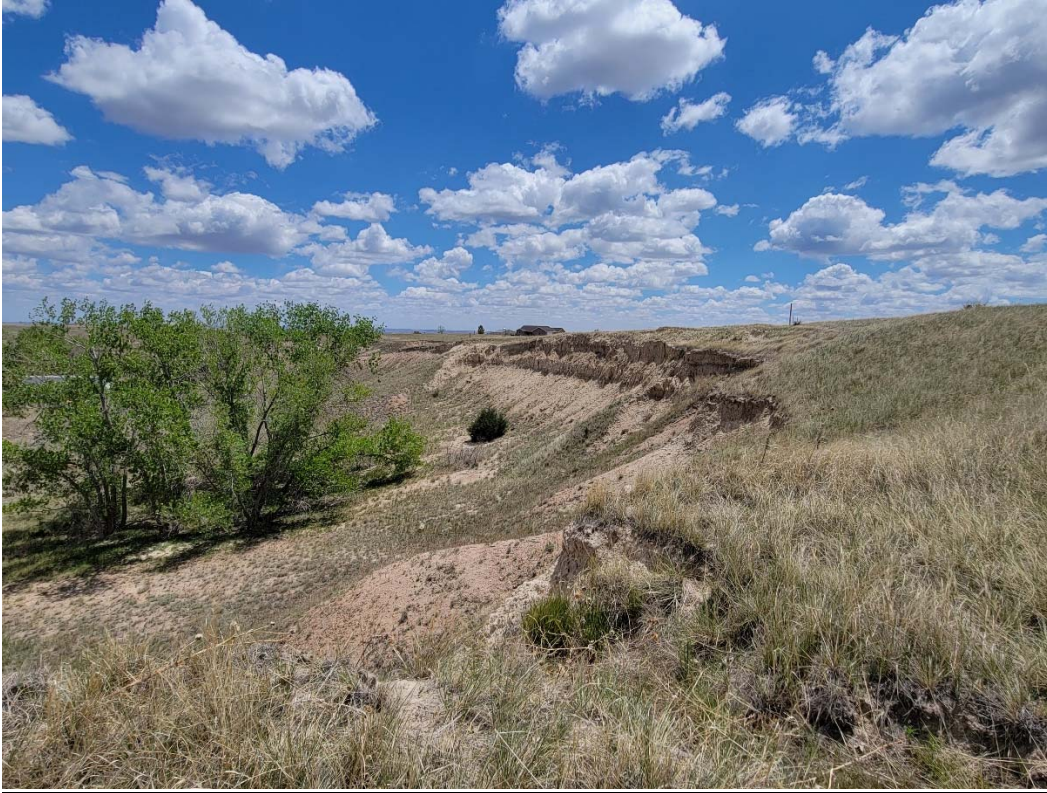
Looking east across area of older mining disturbance.

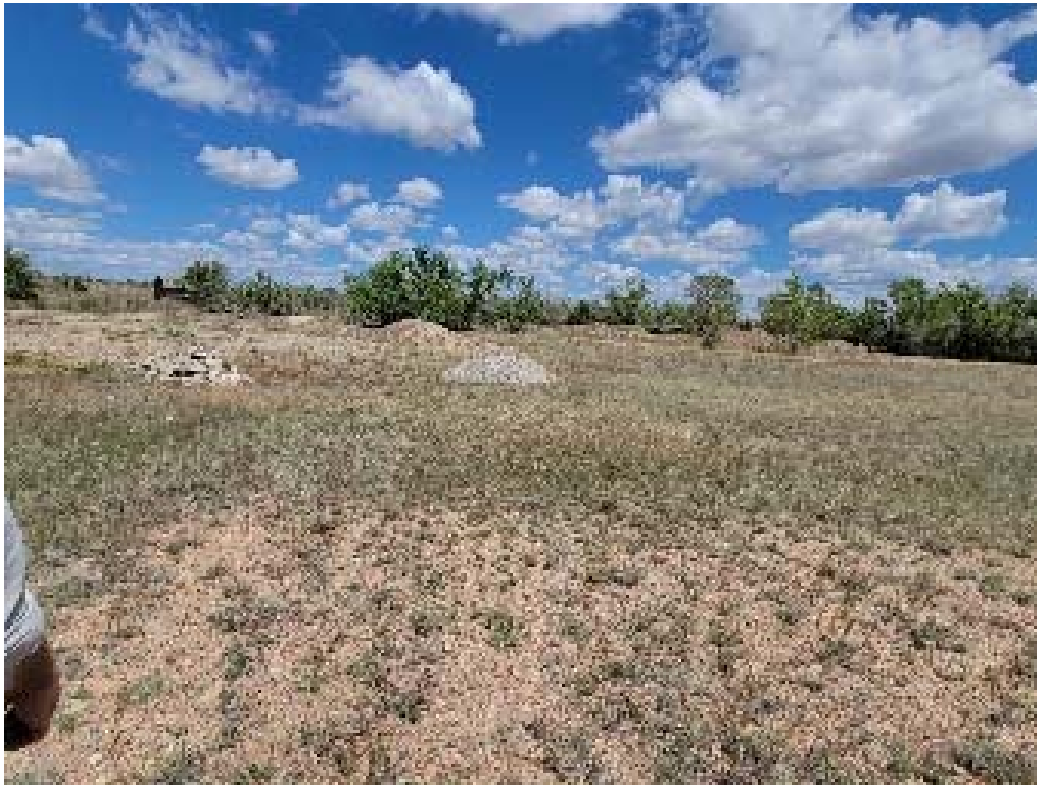
Stockpiles of mined material in front of old highwall in southeastern area of permit boundary.

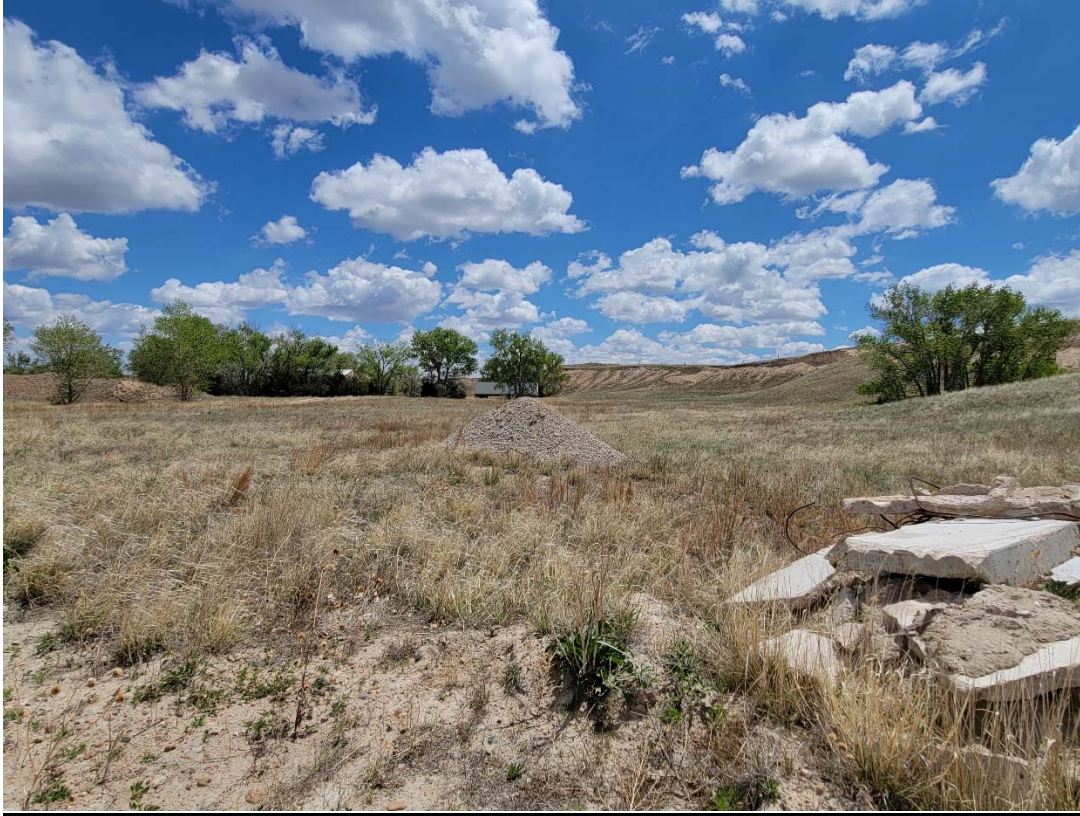
Stockpile of mined material in front of old highwall in southeastern area of permit boundary.
