Lorencito Canyon Mine, C-1996-084, May 26 2022 Inspection Report

COLORADO
Division of Reclamation,
Mining and Safety
Department of Natural Resources

Permit Number: C-1996-084 Mine Name: Lorencito Canyon Mine Operator: New Elk Coal Company, LLC Operator Address: Mr Mark Gray 12250 Highway 12 Weston, CO 81091	County: Las Animas Operation Type: Surface Permit Status: Permanent Cessation Ownership: Private
	Operator Representative Present: Mr. John Terry
Operator Representative Signature: (Field Issuance Only)

Inspection Start Date: May 26, 2022 Inspection Start Time: 09:30 Inspection End Date: May 26, 2022 Inspection End Time: 15:45		Inspection Type: Coal Complete Inspection Inspection Reason: Normal I&E Program Weather: Clear	
Joint Inspection Agency: None		Joint Inspection Contacts: 	
Post Inspection Agency: None		Post Inspection Contacts: 	
Inspector(s): Connor Drinkard Jared Ebert	Inspector's Signature:

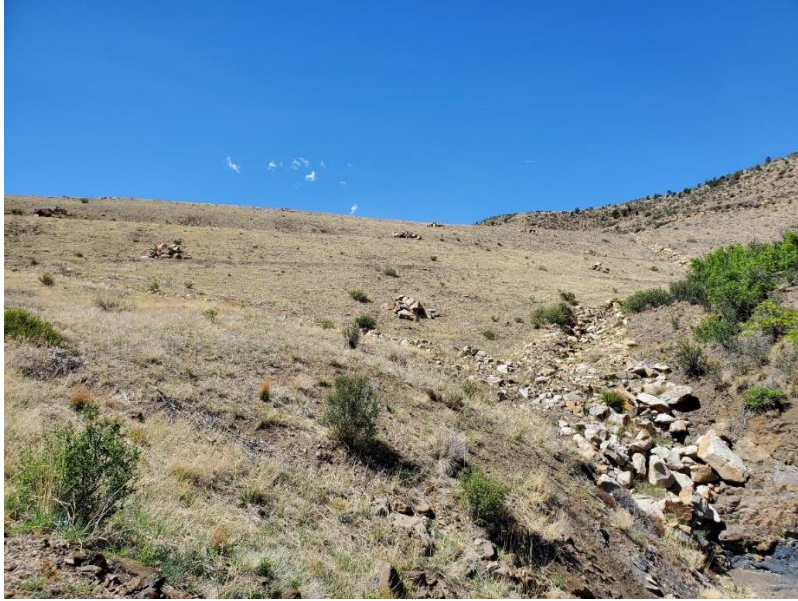
Fills 008, 007 and 009 were observed. No signs of instability were noted. The side drainage ways were clear and functional. The face of each fill was observed, overall the vegetation is well established.

Figure 1. Fill 007.

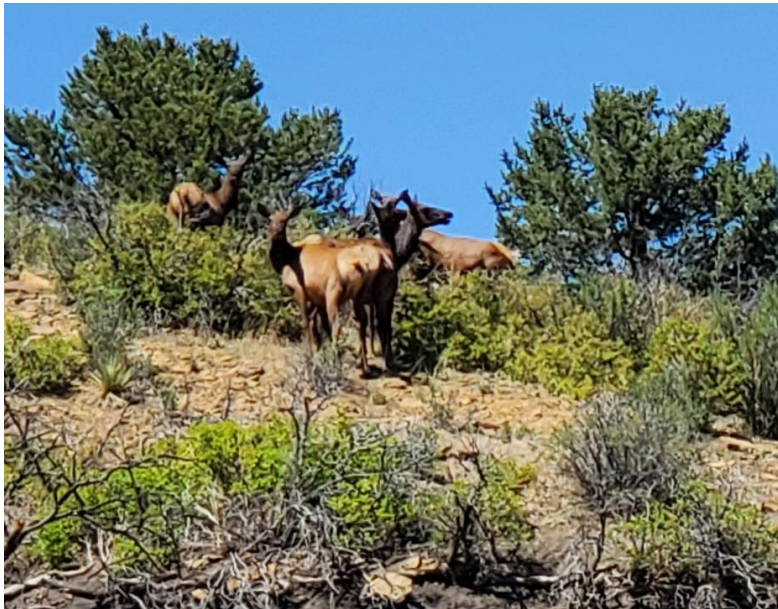
Elk were observed close to many of the ponds.

Figure 2. Elk near Pond 005.

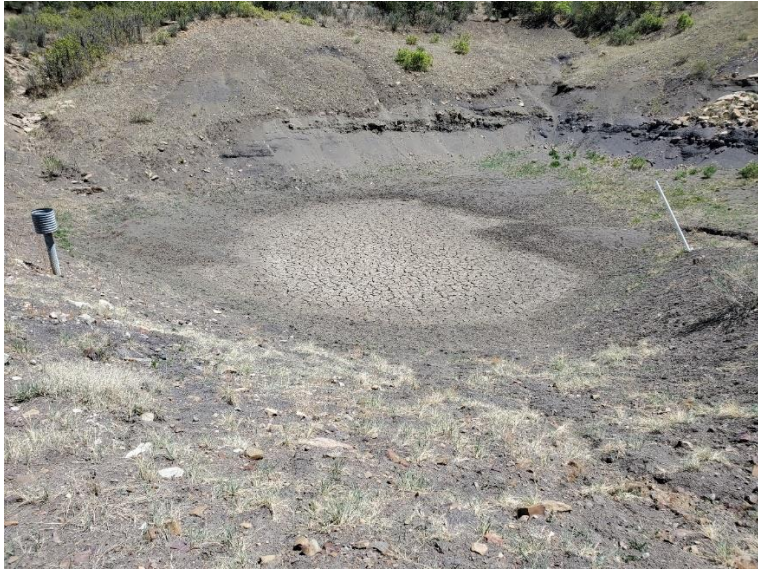
Figure 3. Pond 009.

Pond 009 was not holding water. The emergency spillway was clear and functional. The embankment was stable and vegetated. **Please clear the primary spillway outlet to ensure its functionality.**

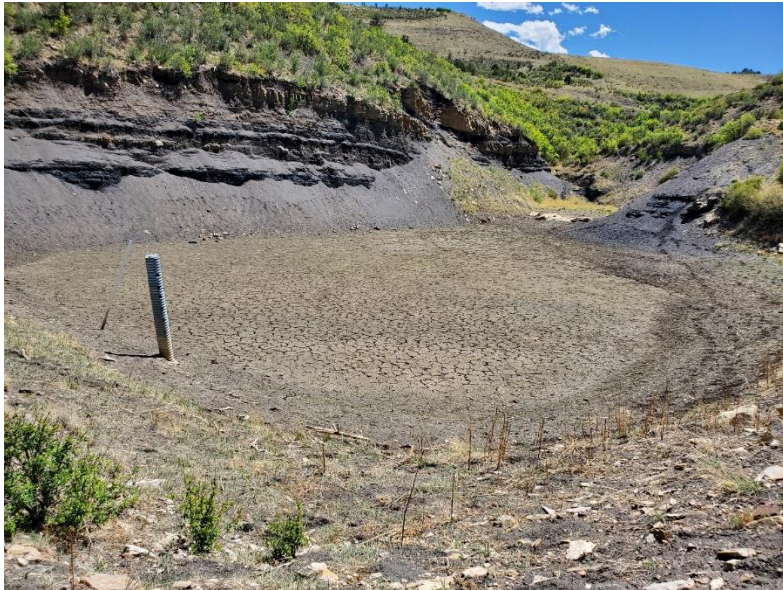
Figure 6. Pond 008.

Pond 008 was not holding water. The primary and emergency spillway was clear and functional. The embankment was stable and vegetated.

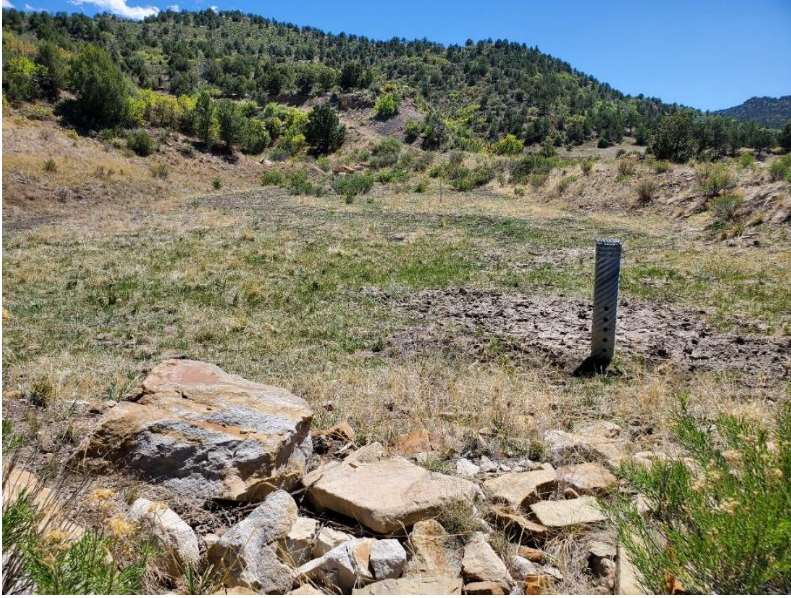
Figure 7. Pond 005.

Pond 005 was not holding water. The primary and emergency spillway was clear and functional. The embankment was stable and vegetated.

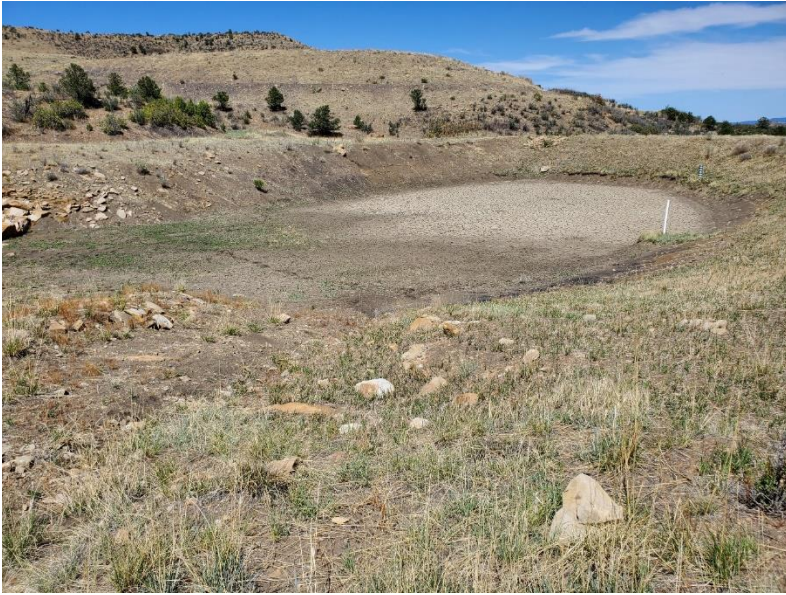
Figure 8. Pond 006a.

Pond 006a was not holding water. The primary and emergency spillway was clear and functional. The embankment was stable and vegetated.

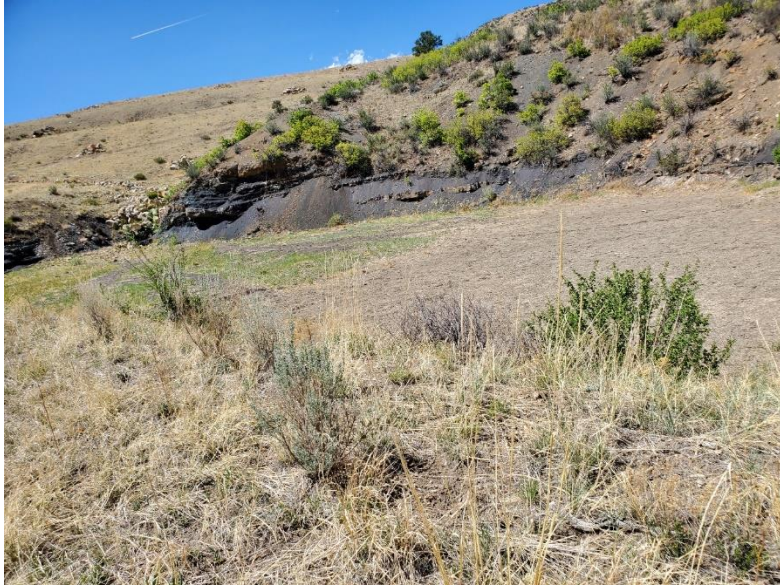
Figure 9. Pond 007a and Fill 007.

Pond 007a was not holding water. The primary and emergency spillway was clear and functional. The embankment was stable and vegetated.

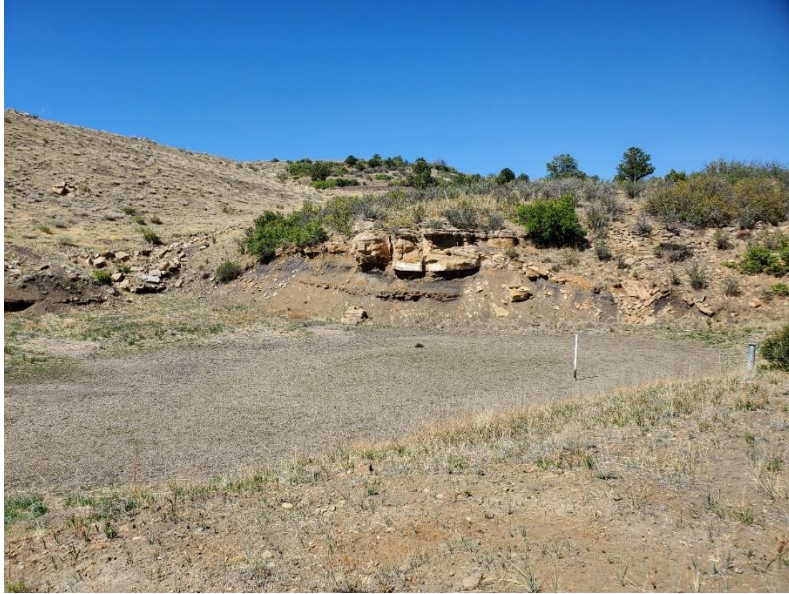
Figure 11. Pond 009a.

Pond 009a was not holding water. The primary and emergency spillway was clear and functional. The embankment was stable and vegetated.

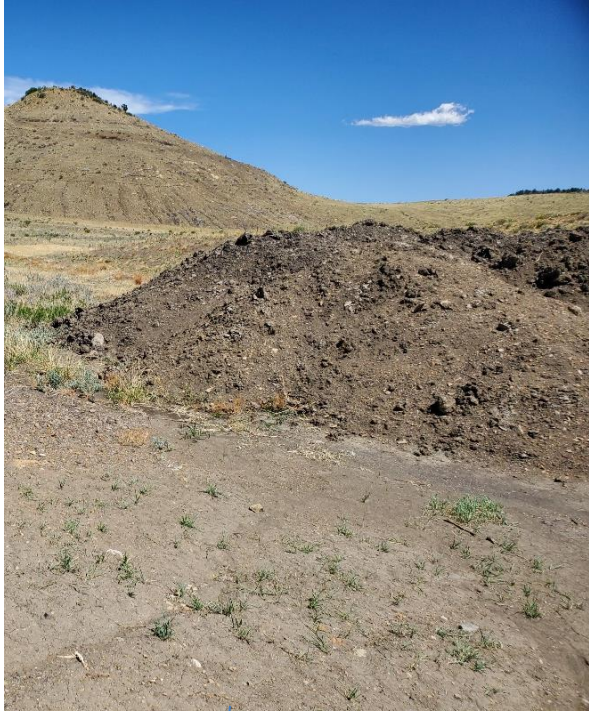
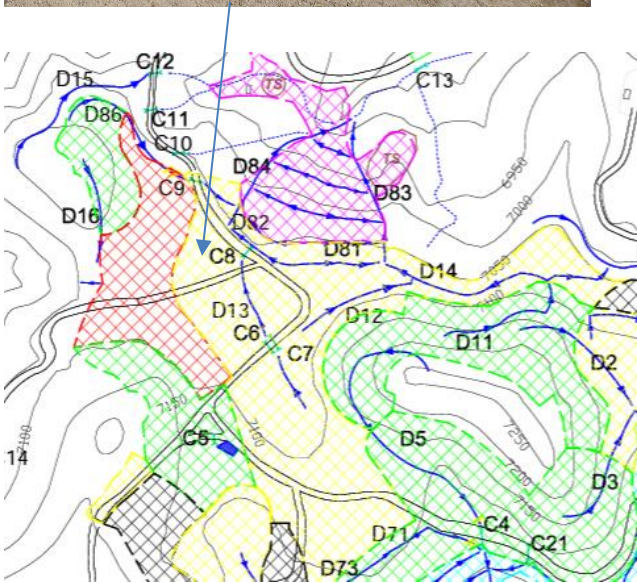
As discussed in the January 24, 2022 inspection report – NECC has placed the sediment they have cleaned from the various sumps and ditches in an area northwest of the “Knob” in an area previously reported to have been seeded in 2009 based on the 2020 annual reclamation report map. Page 2.05-30a of the Permit Application Package (PAP) provides a plan for the handling of sediment cleaned from Pond 009 to be placed in a “drying area” and then used for mine reclamation as determined by a soils analysis. PAP page 2.05-33 provides a general plan for handling sediment cleaning from ponds. **NECC should submit a Minor**

Revision to the permit that clarifies the plan for handling all material/sediment cleaned from all the sediment control structures as this is not clearly discussed in the PAP. NECC may also choose to address this issue through the permit renewal application currently under review. In addition, the stockpile area used for sediment drying has been re-affected by the stockpile activity and therefore cannot be considered to have been reclaimed in 2009 as portrayed in the annual report maps.

Figure 13. Sediment stockpile northwest of the “Knob.” Arrow pointing to location on 2021 Annual Report Map.

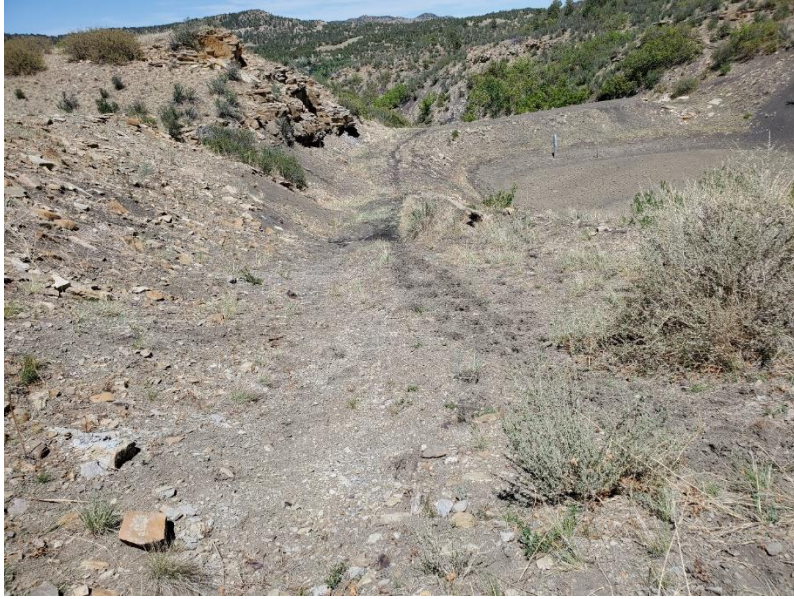
Figure 14. Access road to Pond 008.

The roads throughout the site were observed. Many of the access roads leading to the sediment control ponds are in need of maintenance and grading. **Please maintain and grade roads.**

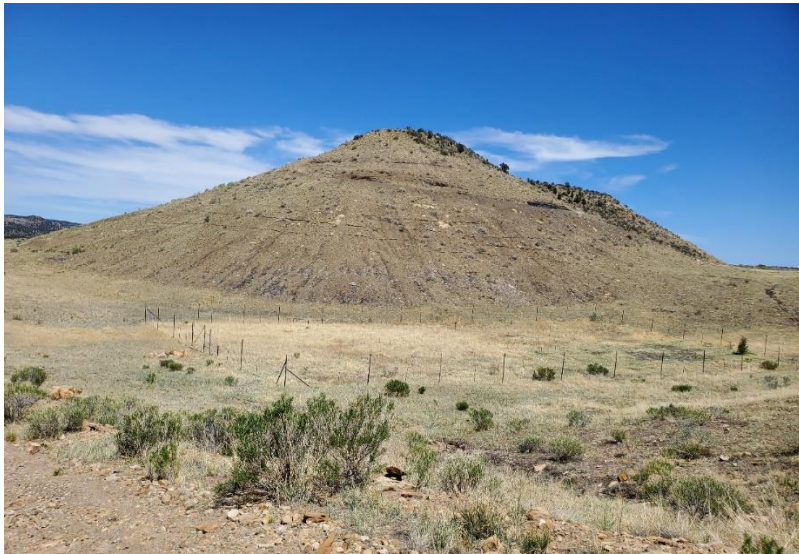
Figure 15. Western face of the “Knob.”

Several erosion features were observed on the western face of “The Knob.” **Please monitor and address.**

According to Mr. Terry with NECC, they are consulting with a contractor regarding various erosion repair and stabilization work that much occur on the site.

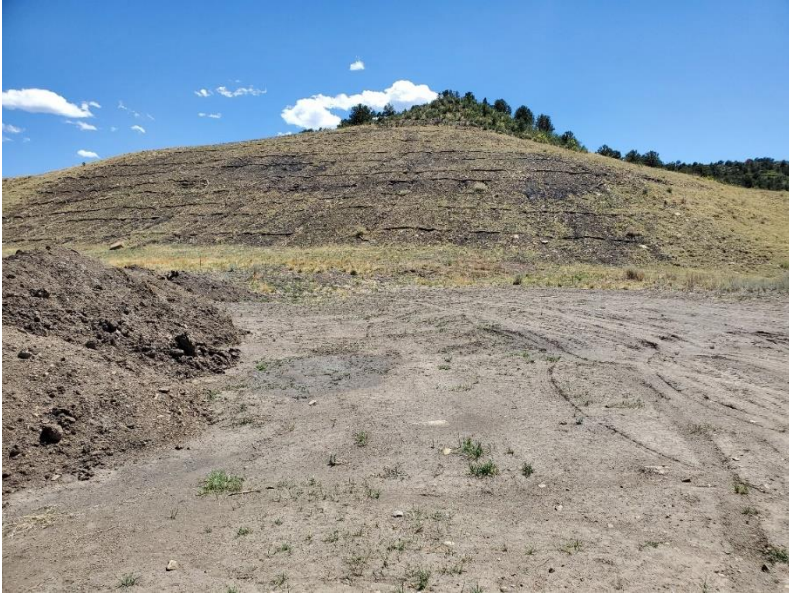
Several erosion features were observed on the eastern aspect of the slope west of the sediment stockpile. **Please monitor and address.**

Figure 16. Affected land west of the sediment stockpile. Eastern aspect of the slope is eroded.

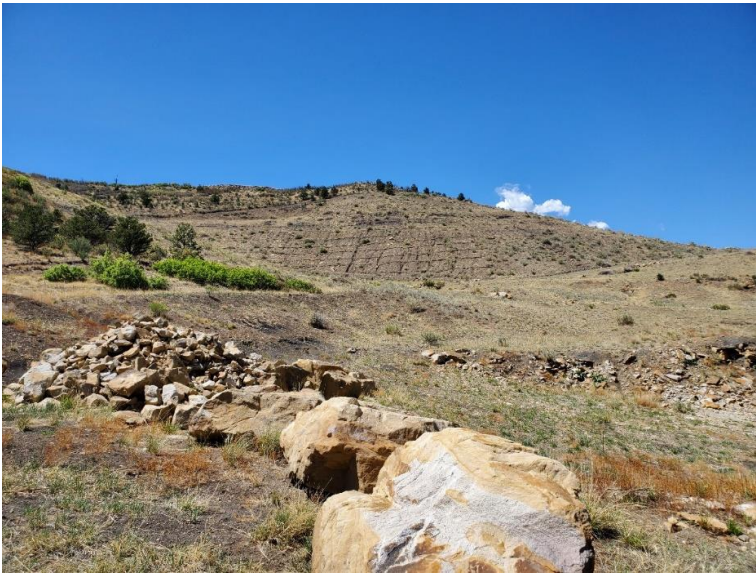
Figure 17. Standing west of Pond 006 looking north.

Several erosion features were observed on the southern face northwest of Pond 006a. **Please monitor and address.**
