MINERALS PROGRAM INSPECTION REPORT
PHONE: (303) 866-3567

MINE NAME: Mule Creek Pit	MINE/PROSPECTING ID#: M-2000-077	MINERAL: Gravel	COUNTY: Teller
INSPECTION TYPE: Monitoring	INSPECTOR(S): Elliott R. Russell	INSP. DATE: June 14, 2017	INSP. TIME: 10:00
OPERATOR: PK Enterprises, Inc.	OPERATOR REPRESENTATIVE: Bryan Johnson	TYPE OF OPERATION: 112c - Construction Regular Operation

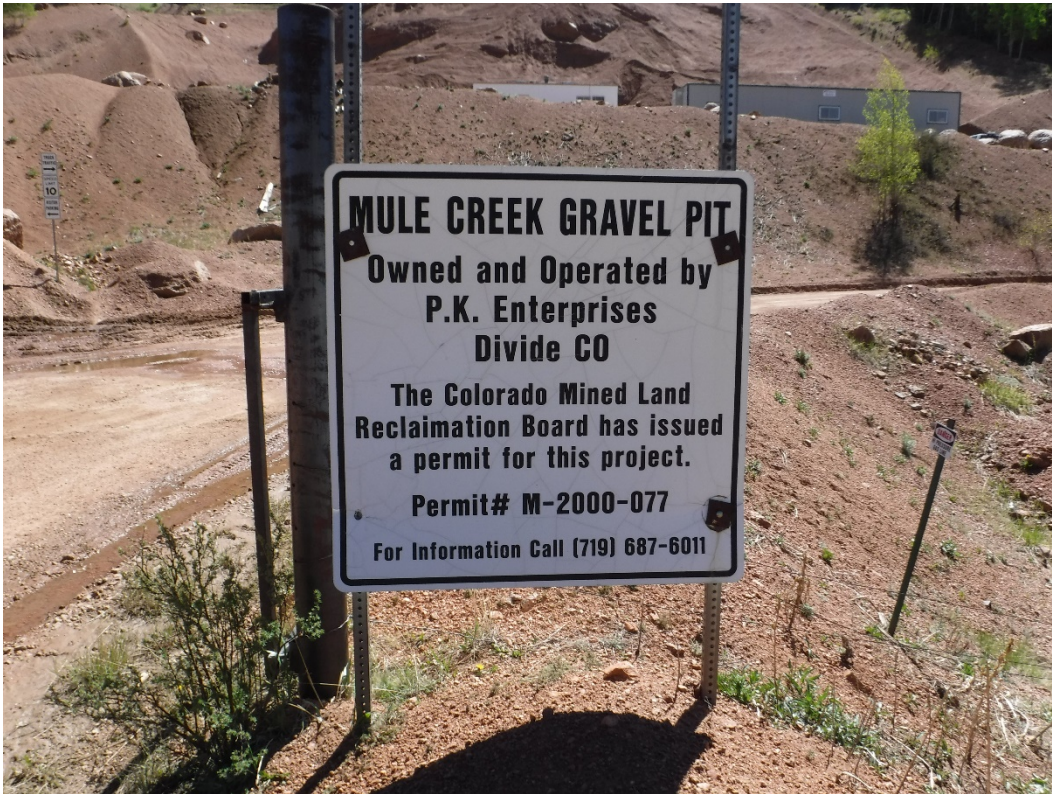
Signs and Markers: The permit sign was posted along the access road in accordance with Rule 3.1.12(1). The permit boundary was delineated by fence lines in accordance with Rule 3.1.12(2).

Photo 1. Permit Identification Sign; looking east.

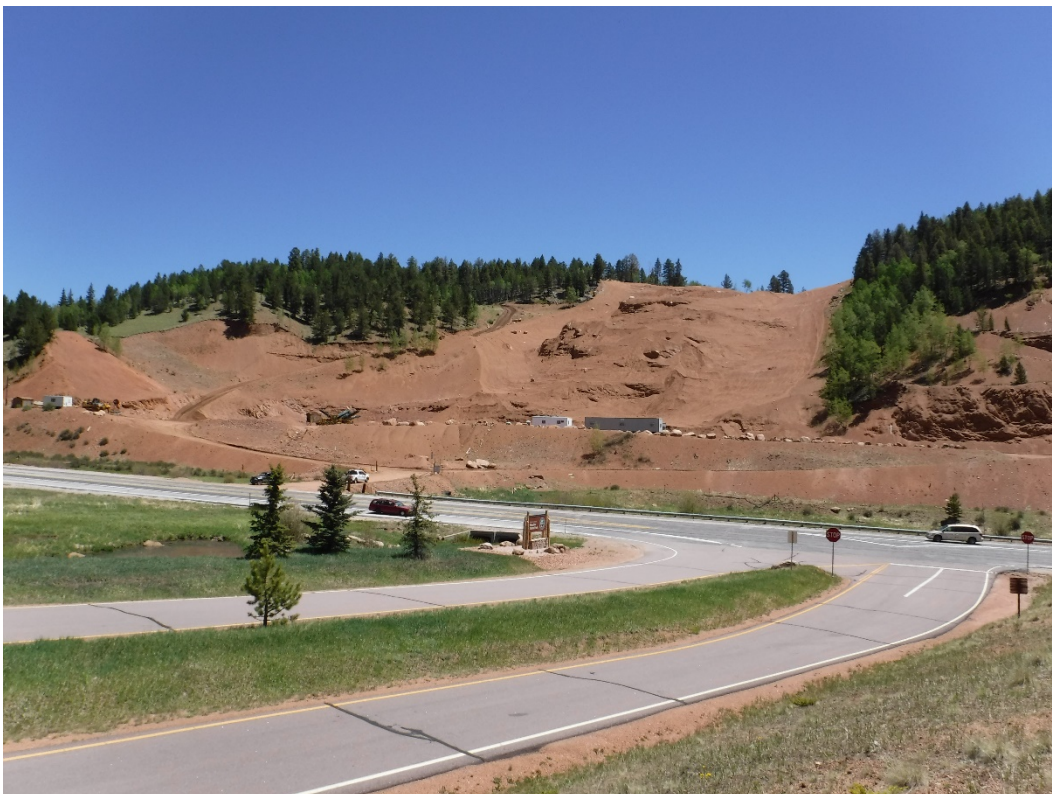
Photo 2. Site overview from the entrance to Mueller State Park; looking northeast.

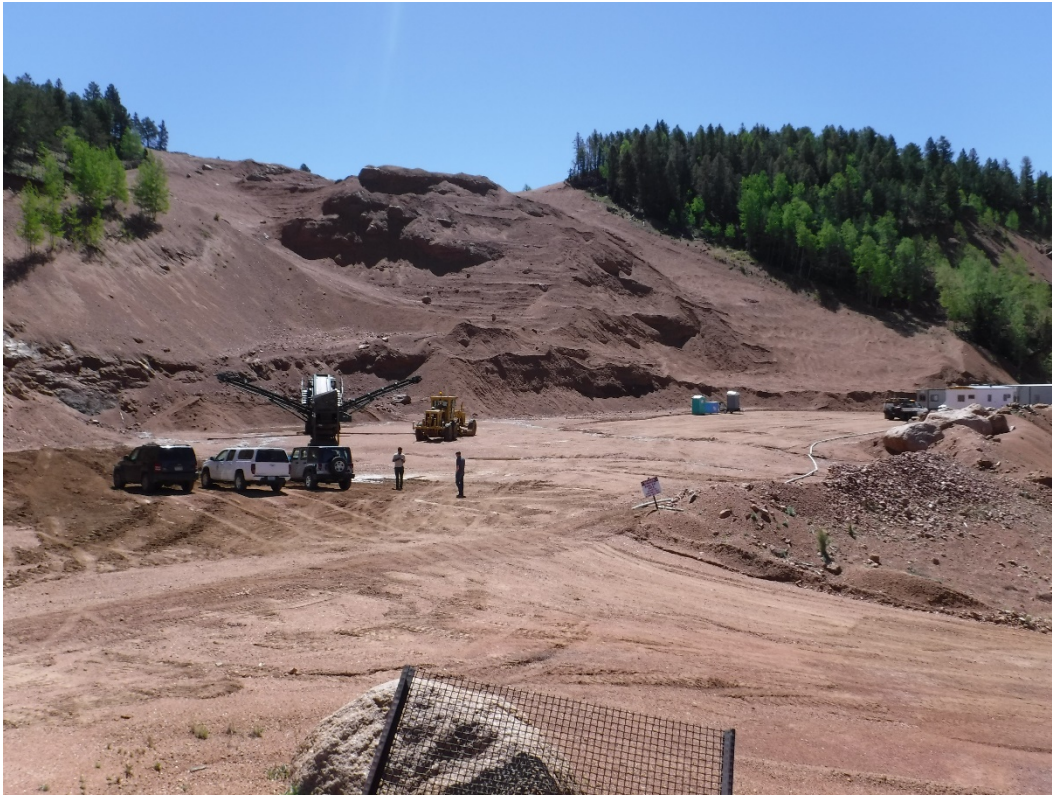
Photo 3. Lower area overview; looking southeast.

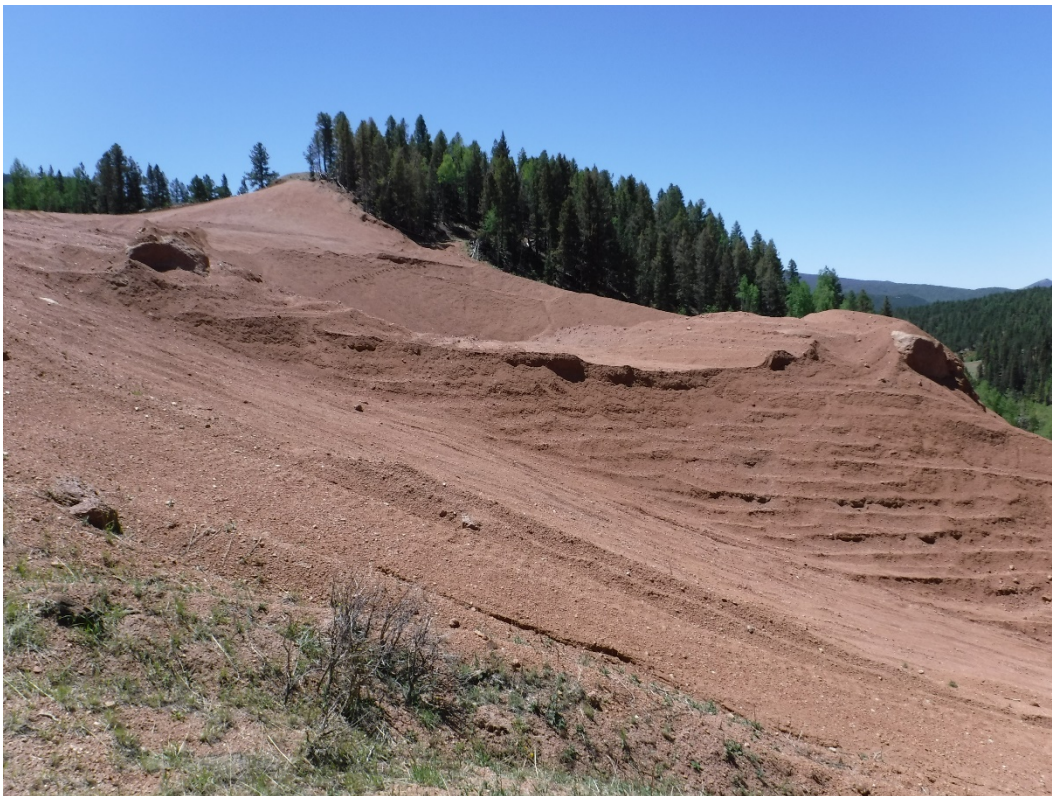
three areas (lower, middle, upper). The lower area involves the access roads into the permit, the processing area, and the Operator's office trailer and maintenance shed. The middle area is a large west-facing slope, approximately 200 hundred feet in elevation change, where material has been mined from and pushed down to the processing area. The Upper area consists of a flatter, bowl-shaped area above the main slope where additional material has been mined. Two of the Division's observations to note, which were discussed in the field with the Operator were: 1) some general housekeeping and cleanup was needed in and around the maintenance shed where a small quantity of used oil containers and other miscellaneous debris had accumulated; and 2) the middle mining area's slopes should be monitored closely to ensure they do not become too steep or over-mined, as substantial impacts to the reclamation cost estimate could occur if the slopes require costly backfilling rather than the cheaper cut/fill approach to achieve the final reclamation slopes. Please note, the approved permit states final slopes will vary from 2H:1V to 3H:1V, with the exception of rock outcrops.

Photo 4. Middle permit area with graded slope (foreground) and remaining material to be mined (background); looking south.

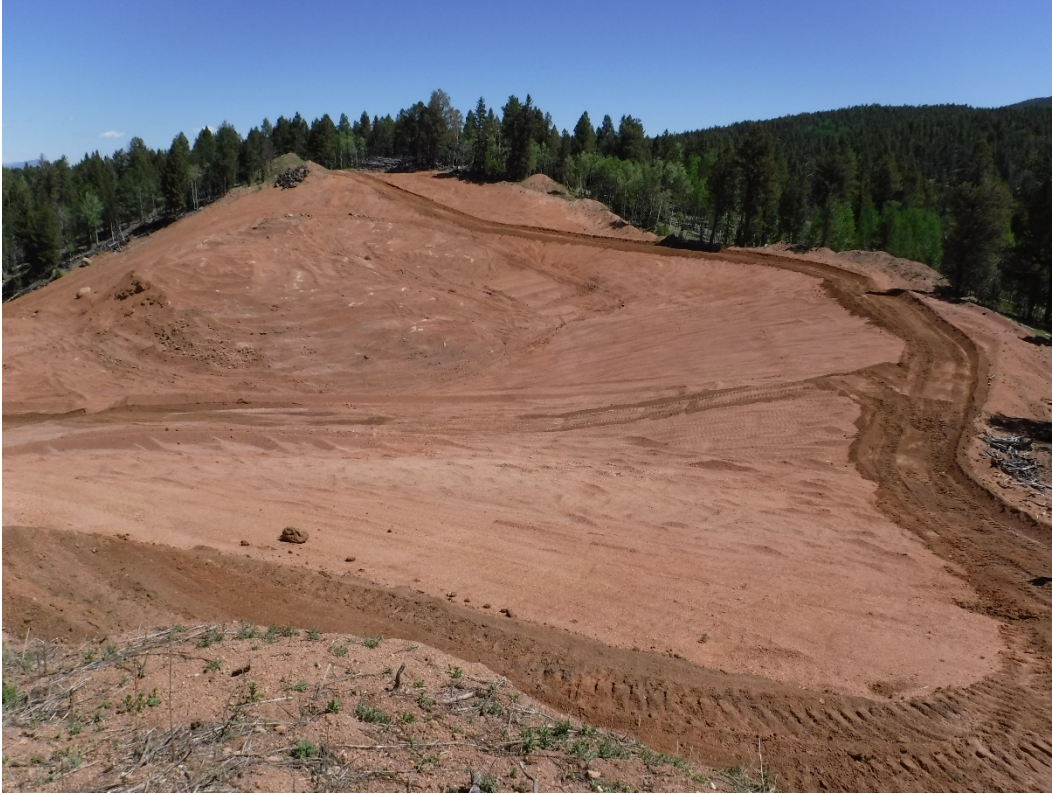
Various topsoil stockpiles were located in the upper permit area along the northeast, eastern, and southeastern permit boundaries. All stockpiles appeared to be stable, however additional seeding should be implemented to ensure there is no loss of topsoil due to erosion. The Division observed some Canada thistle growing on the southeast topsoil stockpile. This is a List B Noxious Weed and will need to be treated; please refer to the enclosed Fact Sheet from the Dept. of Agriculture regarding possible treatments. Due to the limited amount of thistles, the Division is not pursuing a compliance problem at this time.

Photo 5. Upper permit area; looking north.

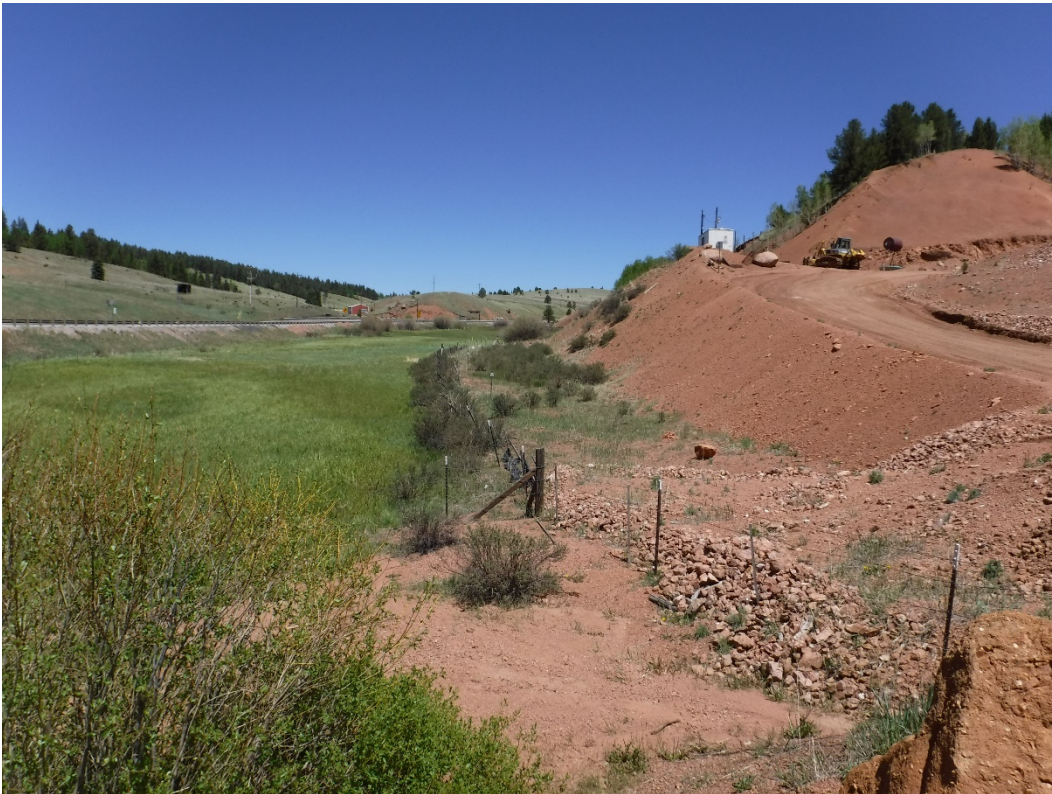
COMPLIANCE PROBLEM #1: Silt fencing is not in place along western permit boundary in accordance with the approved permit. This is a problem pursuant to the approved permit, Rule 3.1.5(3), and Rule 3.1.6(3).

Sediment Control: An old silt fence is located along the western permit boundary where the mine disturbance meets an adjacent creek/wetland. This silt fence has fallen down in several places and is missing in others. Pursuant to the approved permit, Rule 3.1.5(3), and Rule 3.1.6(3), the Operator will need to replace this silt fence to ensure there is no off-site sedimentation. This has been cited as Compliance Problem #1. No other erosion problems were observed and no other BMPs were needed at the time of the inspection.

Photo 6. Western permit boundary needing silt fence north of access road; looking north.

CORRECTIVE ACTIONS: The Operator shall provide photographic evidence showing the silt fencing has been re-established along the western permit boundary on or before the corrective action deadline.

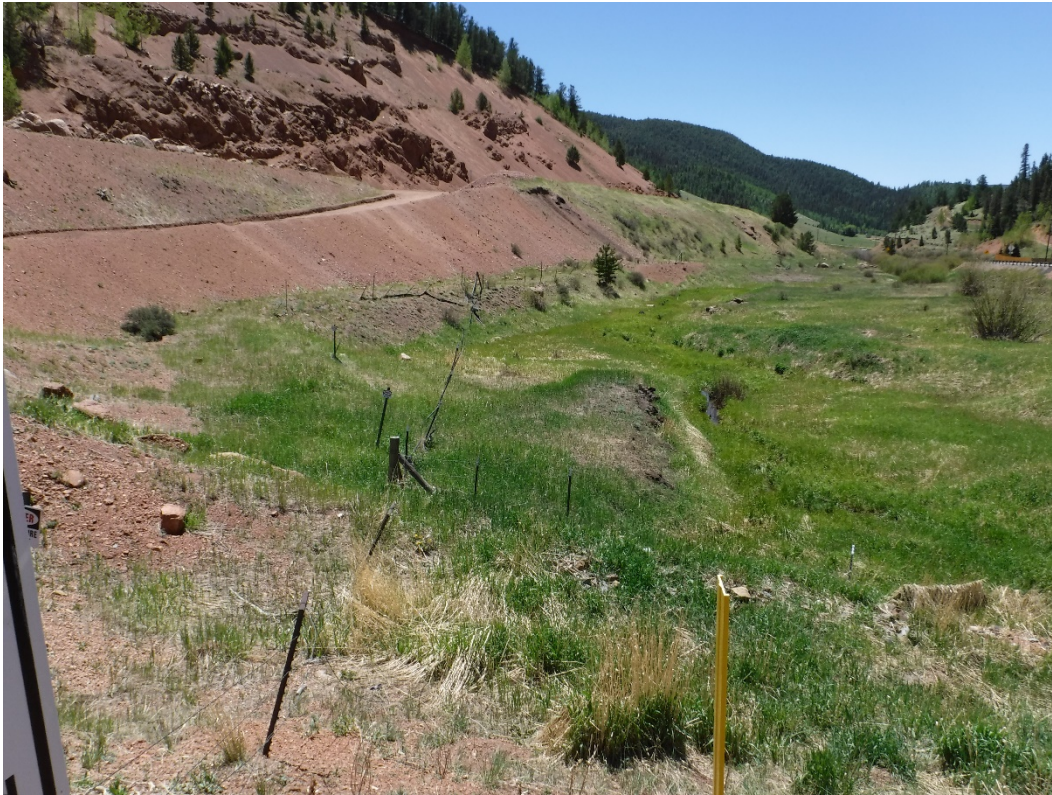
Photo 7. Western permit boundary needing silt fence south of access road; looking south.
