MINERALS PROGRAM INSPECTION REPORT

MINE NAME: Indian Springs Park Pit	MINE/PROSPECTING ID#: M-2001-087	MINERAL: Gravel	COUNTY: Fremont
INSPECTION TYPE: Monitoring	INSPECTOR(S): Timothy Cazier, P.E.	INSP. DATE: April 20, 2022	INSP. TIME: 12:50
OPERATOR: Fremont County	OPERATOR REPRESENTATIVE: Sterling Rife	TYPE OF OPERATION: 112c - Construction Regular Operation

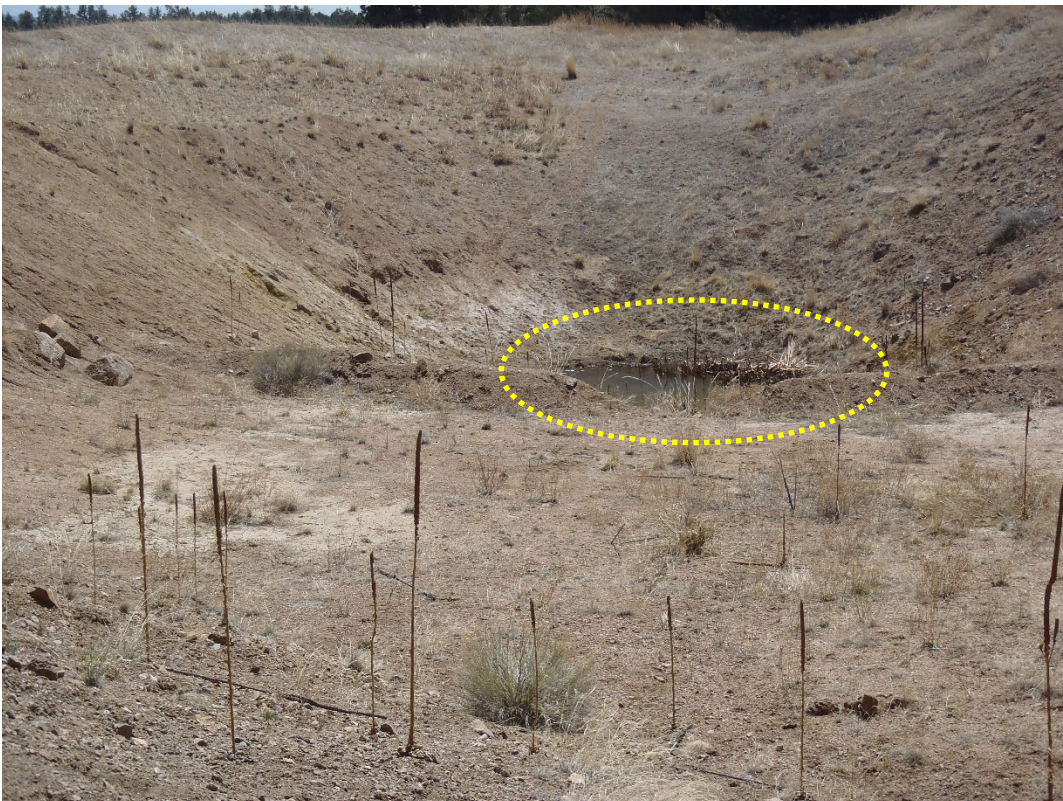
PROBLEM/POSSIBLE VIOLATION: Problem: The Division has no evidence that the operator has a valid well permit, substitute water supply plan, or approved water augmentation plan for the exposed groundwater at the site. This is a problem related to 34-32.5-116(4)(h) of the Colorado Revised Statutes and 3.1.6(1)(a) of the Construction Materials Rules and Regulations governing injury to existing water rights.

Hydrologic Balance: No standing water was observed on the pit floor. However, standing water was observed in the sediment pond (see **Photo 1**). The water surface area was estimated to be 30 feet in diameter. A subsequent review of Google Earth imagery revealed the pond was expanded between 2013 and 2016. The presence of the water also appears to be constant, suggesting that it is exposed groundwater. **The exposed groundwater is cited as a problem on page 1 of this report.**

Revegetation: Mr. Rife indicated a small area in the southeast corner had been seeded. Other than a small amount of common mullein (a List C species not requiring treatment – see **Photo 1**), no noxious weeds were observed.

Photo 1. Water (most likely groundwater) in sediment pond and a few mullein stalks.

CORRECTIVE ACTIONS: The operator shall demonstrate that the operation is in compliance with the Office of the State Engineer, show evidence that the operator is taking measures to bring the site into compliance with the SEO, or backfill the pits to at least two feet above the groundwater surface by the corrective action date specified.

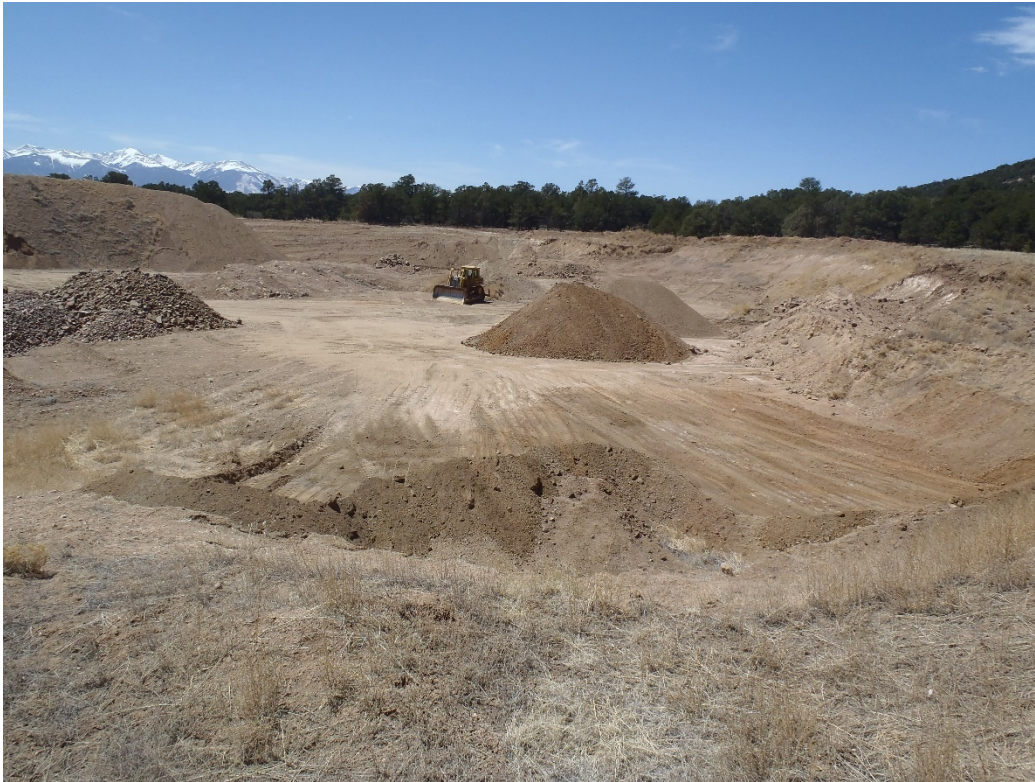
Gen. Compliance with Mine Plan: The operation appeared to be in compliance with the approved mine plan. The maximum allowed disturbed area is 20 acres. Google Earth was used to measure the disturbed area, which was approximately 6.2 acres (including the access road and topsoil stockpiles), based on older 2019 imagery. Highwalls were estimated to vary between 15 and 20 feet in height and appeared stable (see **Photo 2**).

Photo 2. Highwalls on advancing north end (looking west).

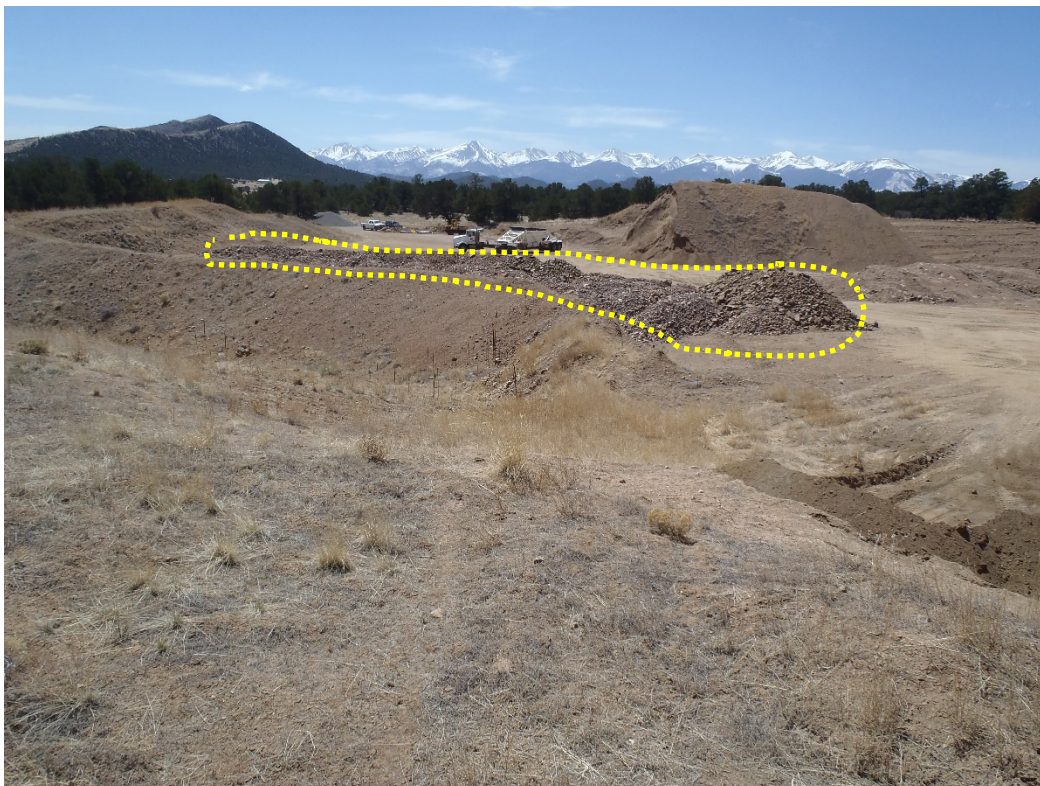
Processing Waste: Some oversize material piles were observed (see **Photo 3**). Mr. Rife indicated they would be used to backfill the sediment pond.

Photo 3. Oversize material stockpiles (just west of sediment pond, looking SW).

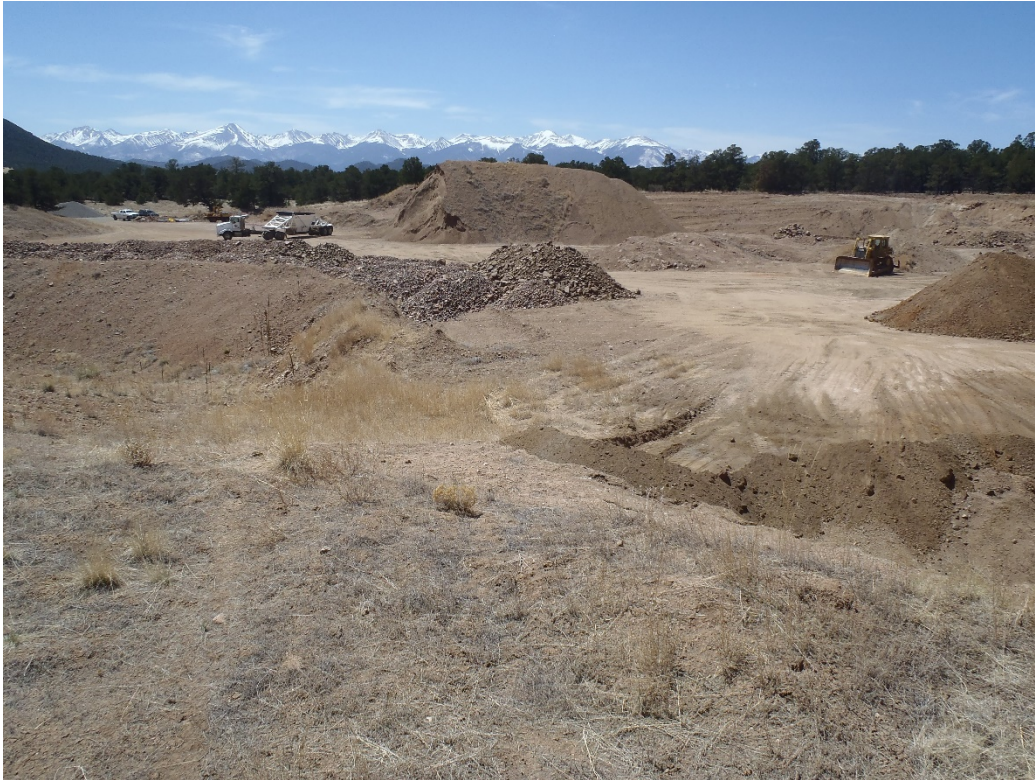
Support Facilities On-site: A dozer, and haul truck were observed on site (see **Photo 4**).

Photo 4. Dozer and haul truck, product stockpile in between (looking SW).

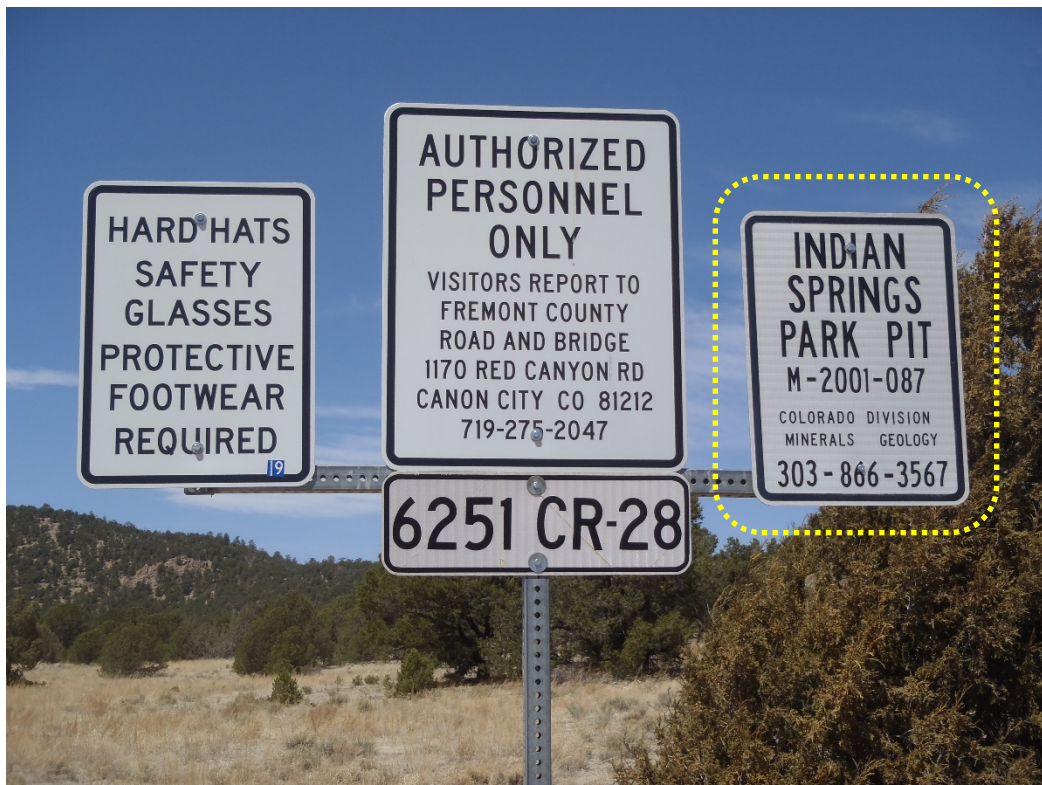
Photo 5. Permit sign at entrance off Copper Gulch Rd/CR28.

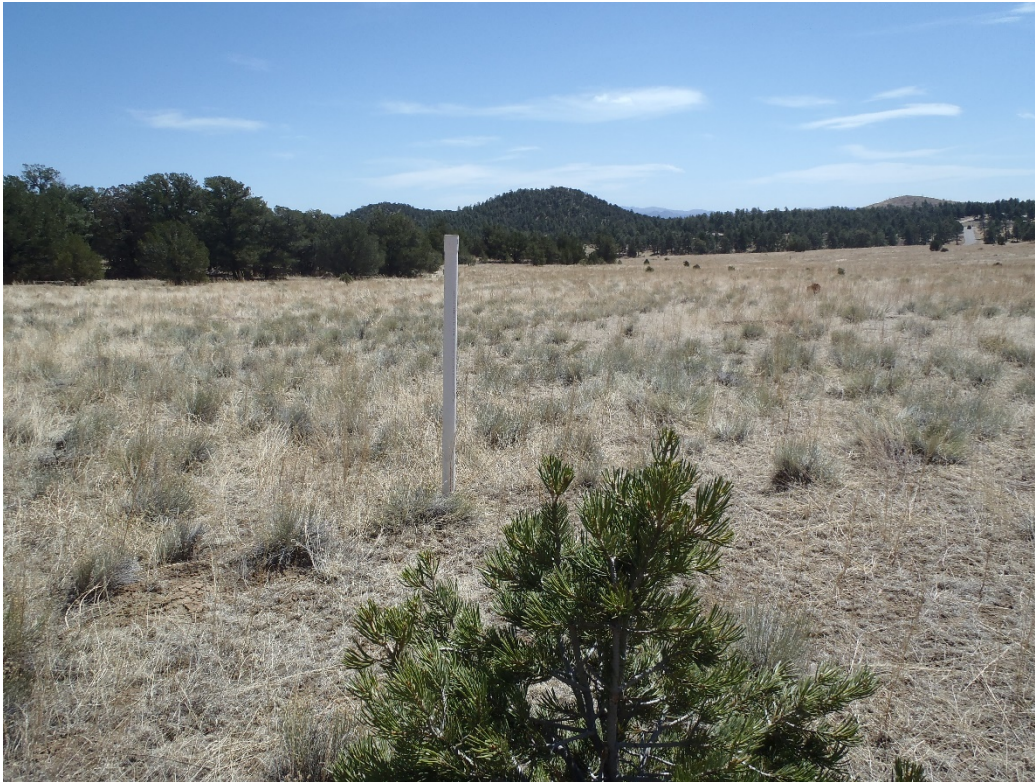
Photo 6. Typical boundary marker (east corner, looking SSE).

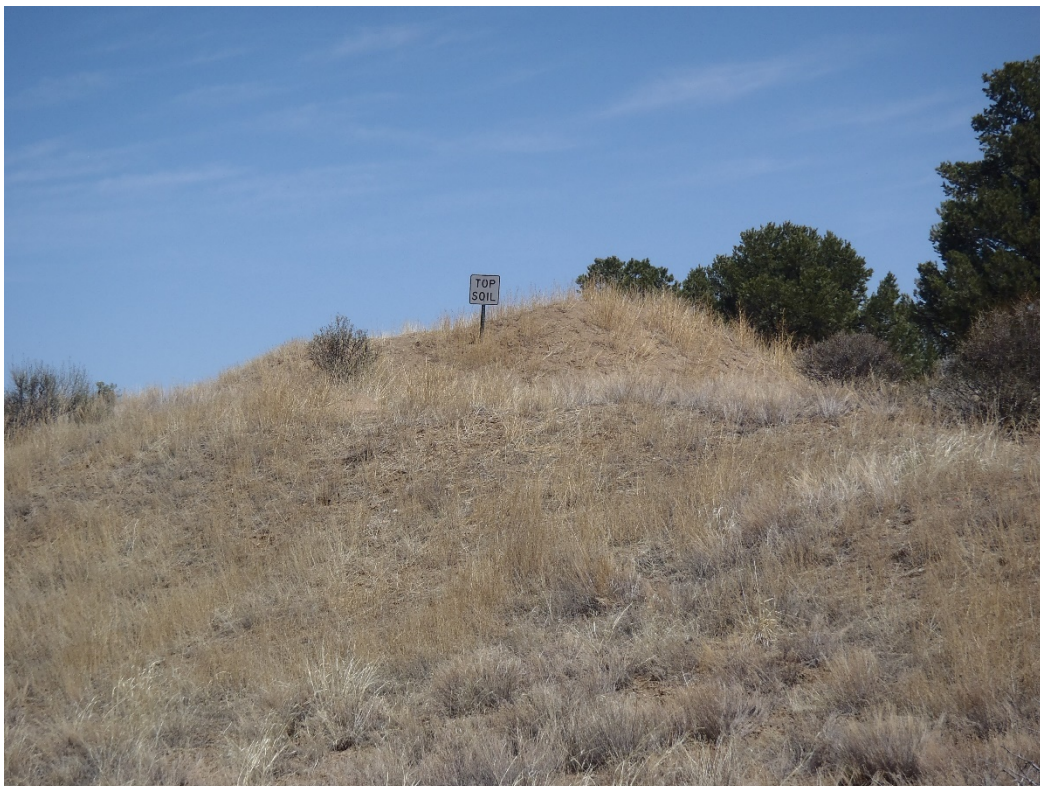
Topsoil: Topsoil has been stripped, stockpiled on the perimeter and is labeled as such (see **Photo 7**).

Photo 7. Labeled topsoil stockpile (looking NE).
