MINERALS PROGRAM INSPECTION REPORT
PHONE: (303) 866-3567

MINE NAME: Bumgarner Ranches Gravel Pit	MINE/PROSPECTING ID#: M-1980-027	MINERAL: Sand and gravel	COUNTY: Grand
INSPECTION TYPE: Monitoring	INSPECTOR(S): Peter Hays	INSP. DATE: March 31, 2022	INSP. TIME: 10:30
OPERATOR: Bumgarner Ranches, Inc	OPERATOR REPRESENTATIVE: Bud Carpenter	TYPE OF OPERATION: 112c - Construction Regular Operation	
REASON FOR INSPECTION: Normal I&E Program	BOND CALCULATION TYPE: Partial Bond	BOND AMOUNT: \$60,400.00	
DATE OF COMPLAINT: NA	POST INSP. CONTACTS: None	JOINT INSP. AGENCY: None	
WEATHER: Clear	INSPECTOR'S SIGNATURE:

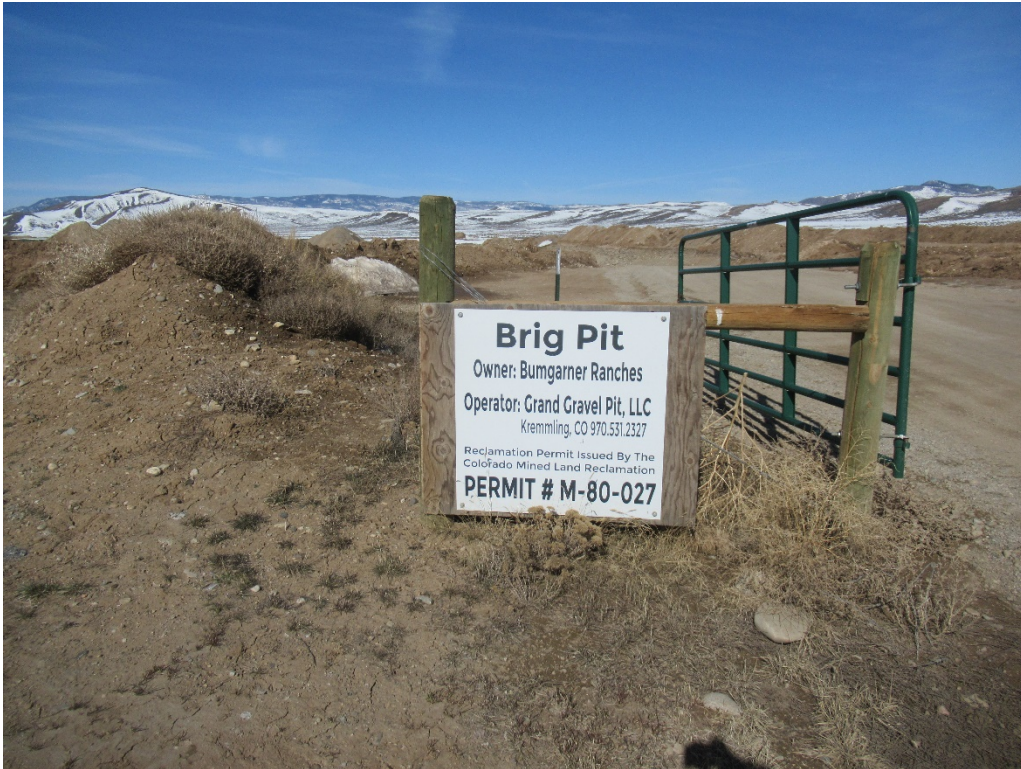
An entrance sign was posted and permit boundary markers were observed as required by Rule 3.1.12.

Bumgarner Ranches Gravel Pit mine sign

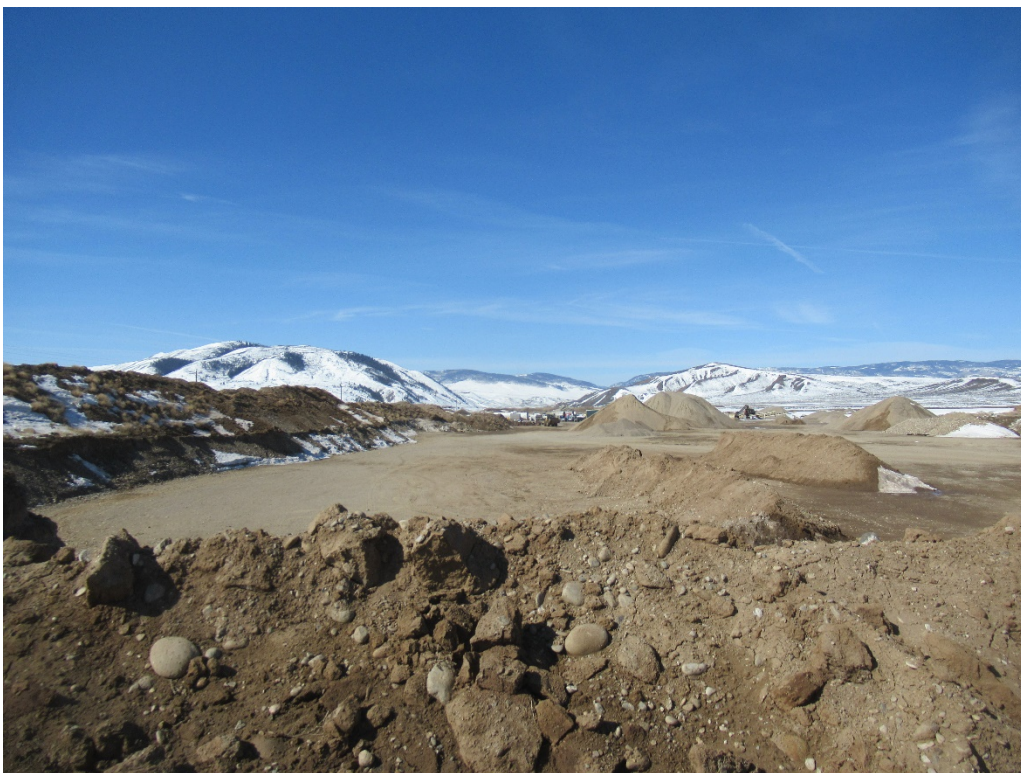
View of the site from the east highwall in Phase 4 looking west

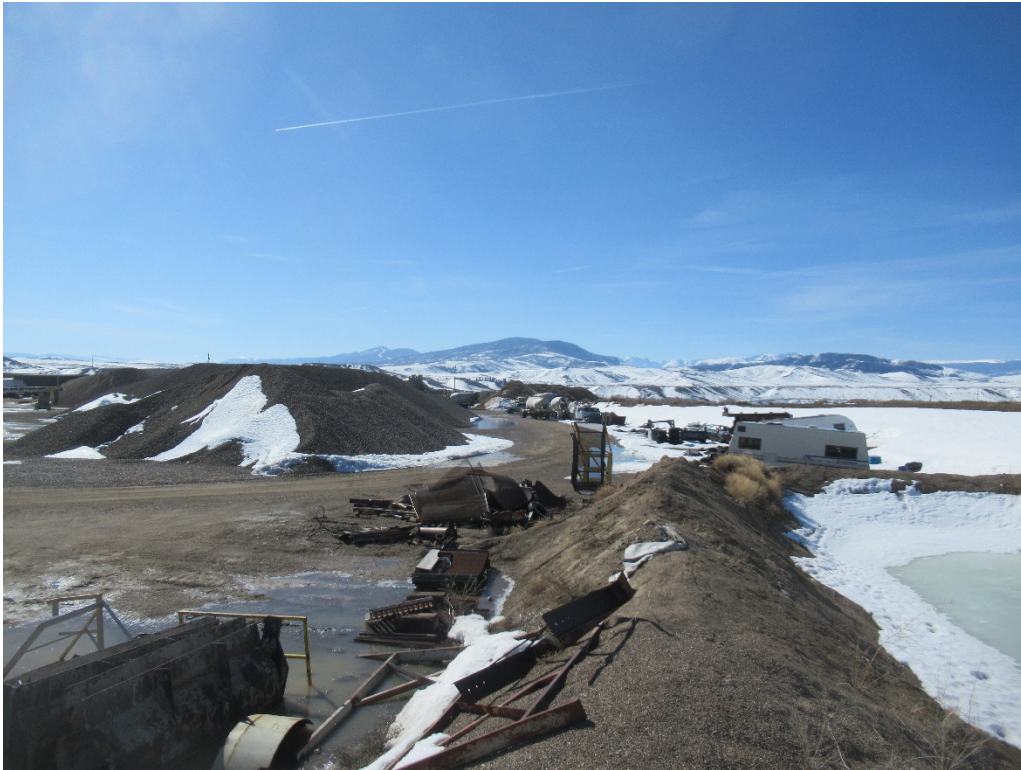
View of the site from the northwest corner of Phase 1 looking south

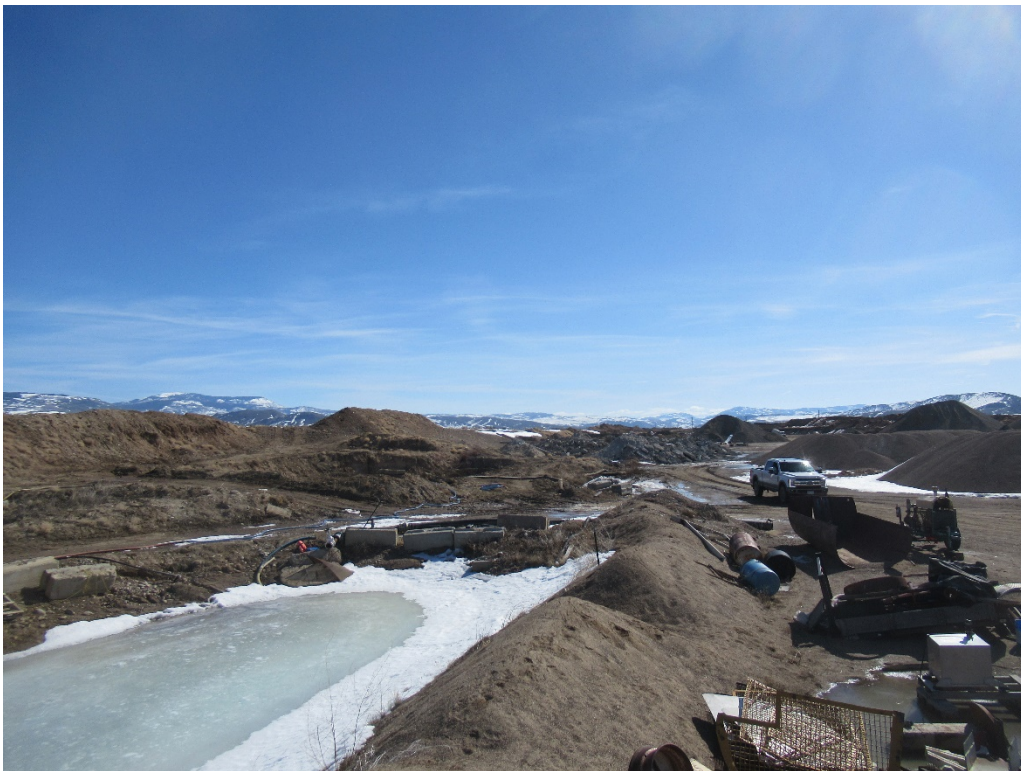
View of the site from the northwest corner of Phase 1 looking east

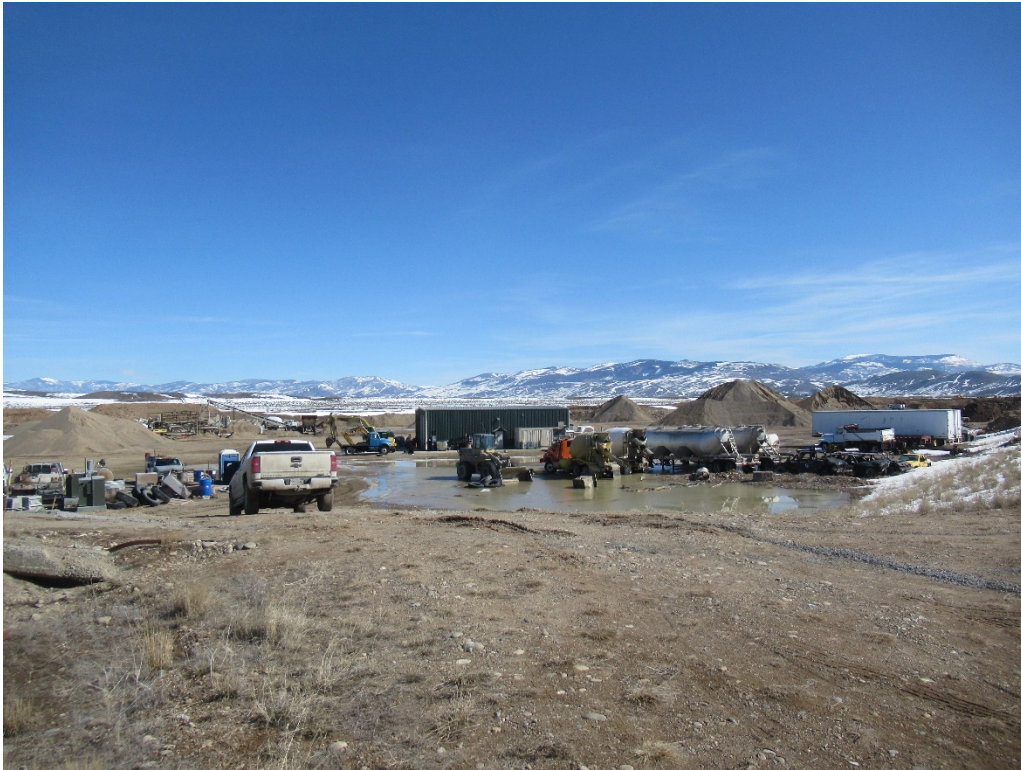
View of the site from the west side of Phase 1 looking east

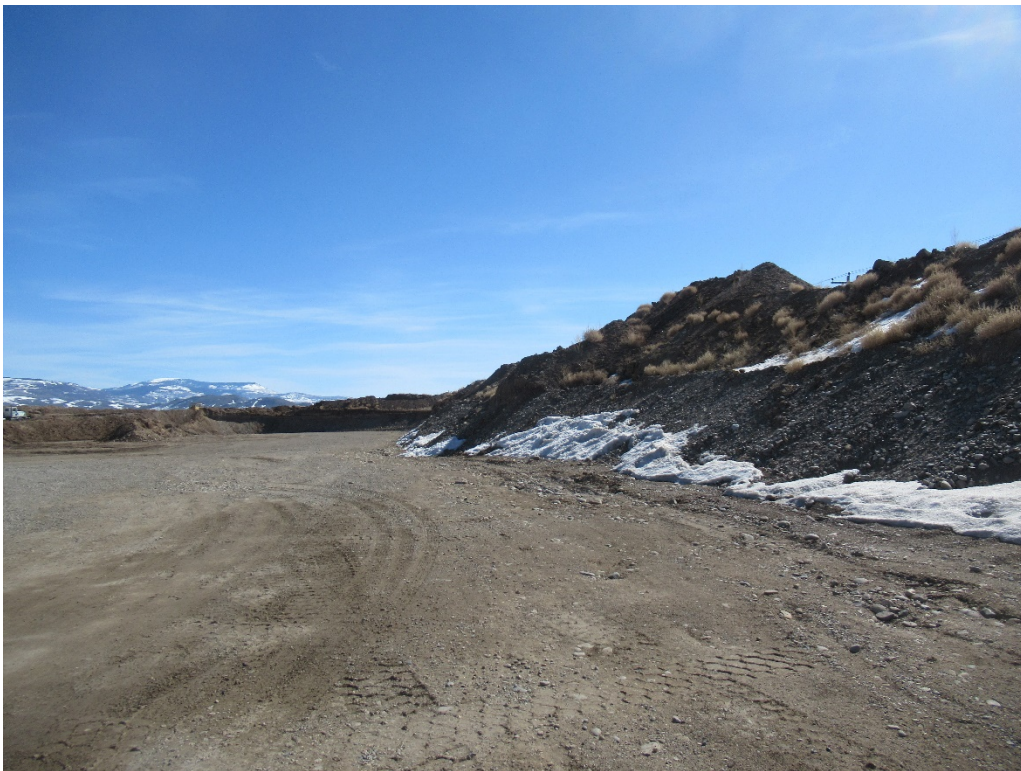
View of the pit floor and highwalls in Phase 3 and 4

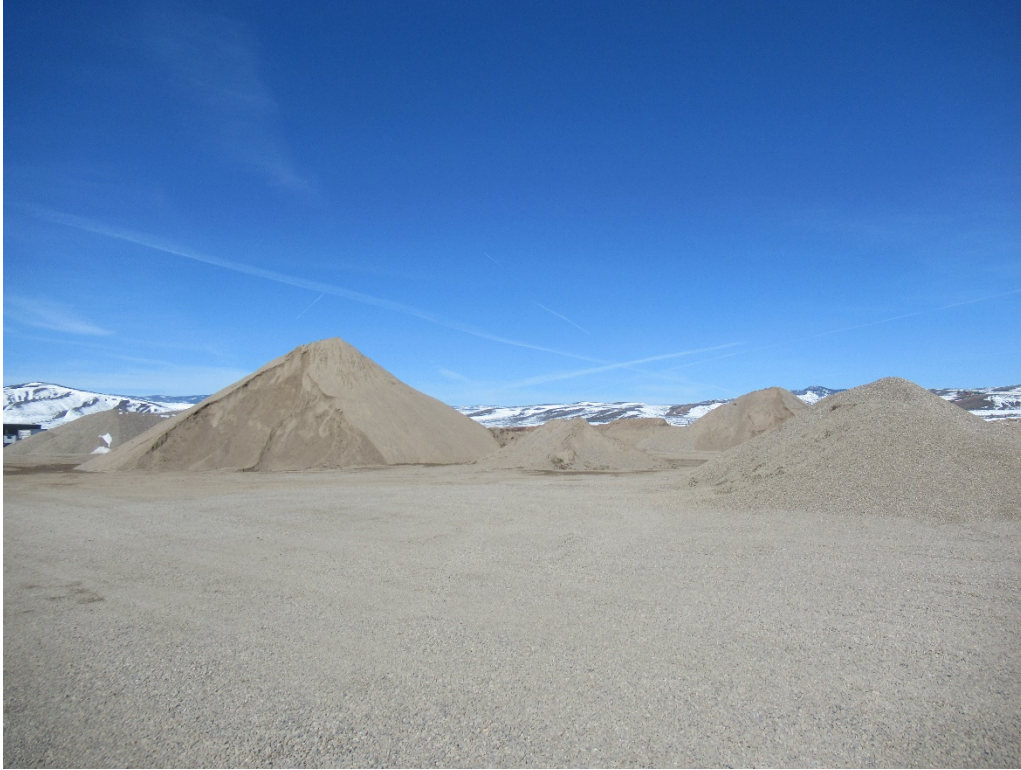
View of the stockpiled materials on the pit floor
