MINERALS PROGRAM INSPECTION REPORT

MINE NAME: Sunday Mine	MINE/PROSPECTING ID#: M-1977-285	MINERAL: Uranium and vanadium	COUNTY: San Miguel
INSPECTION TYPE: Multi Person Inspection	INSPECTOR(S): Lucas West	INSP. DATE: May 19, 2022	INSP. TIME: 09:45
OPERATOR: Pinon Ridge Mining LLC	OPERATOR REPRESENTATIVE: Michael Rutter	TYPE OF OPERATION: 112d-2 - Designated Mining Operation	
REASON FOR INSPECTION: Normal I&E Program	BOND CALCULATION TYPE: Complete Bond	BOND AMOUNT: \$330,242.00	
DATE OF COMPLAINT: NA	POST INSP. CONTACTS: None	JOINT INSP. AGENCY: None	
WEATHER: Clear	INSPECTOR'S SIGNATURE:

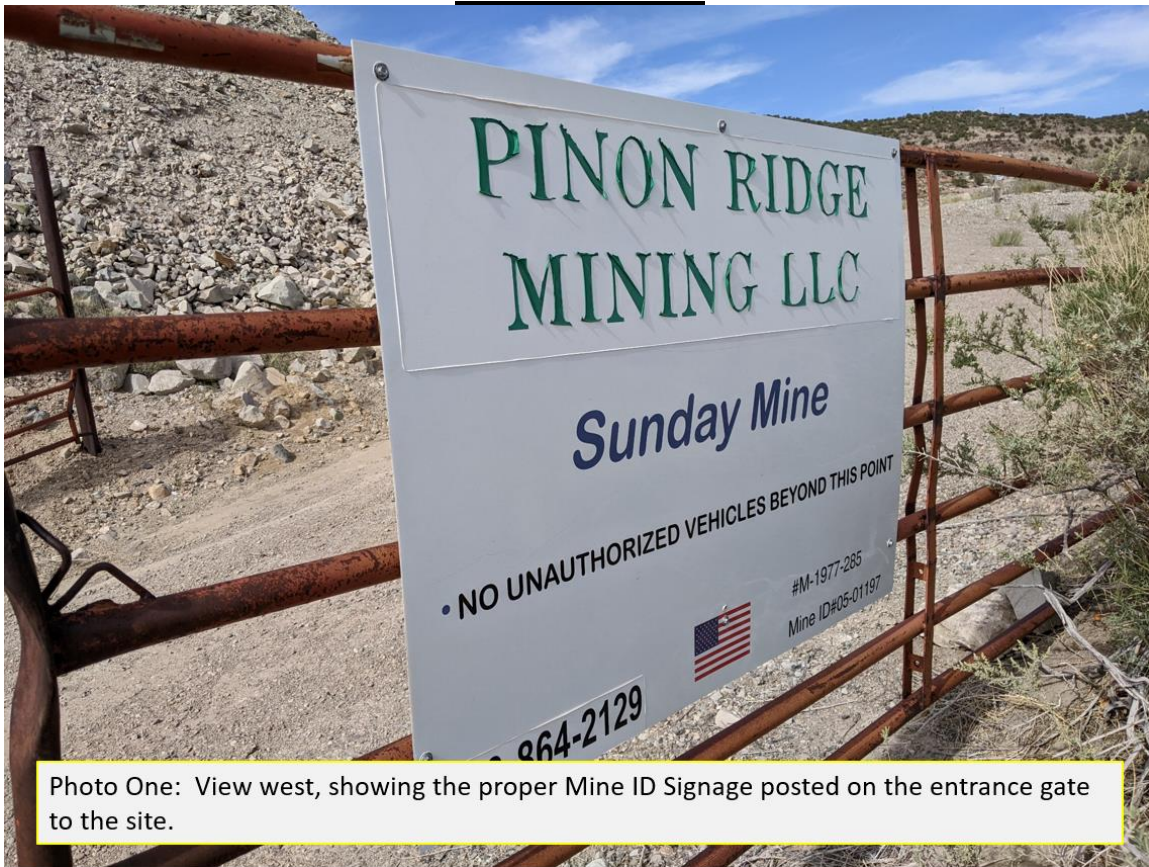
As seen in Photo One, the permit ID sign was observed at the entrance to the site. The permit boundary markers were also observed. Photos Two and Three shows an example of the sediment catchment basins that are located on site as part of the storm water management plan. All storm water control devices were in good condition and appear to be functioning as designed. All diversion ditches appear to be functioning as designed and no significant erosion was observed throughout of the site. Both waste rock dumps and out slopes of all constructed faces were observed and appear to be stable. The pads and road areas showed no signs of settling, slumping or erosion and appeared stable during the inspection.

Photo One: View west, showing the proper Mine ID Signage posted on the entrance gate to the site.

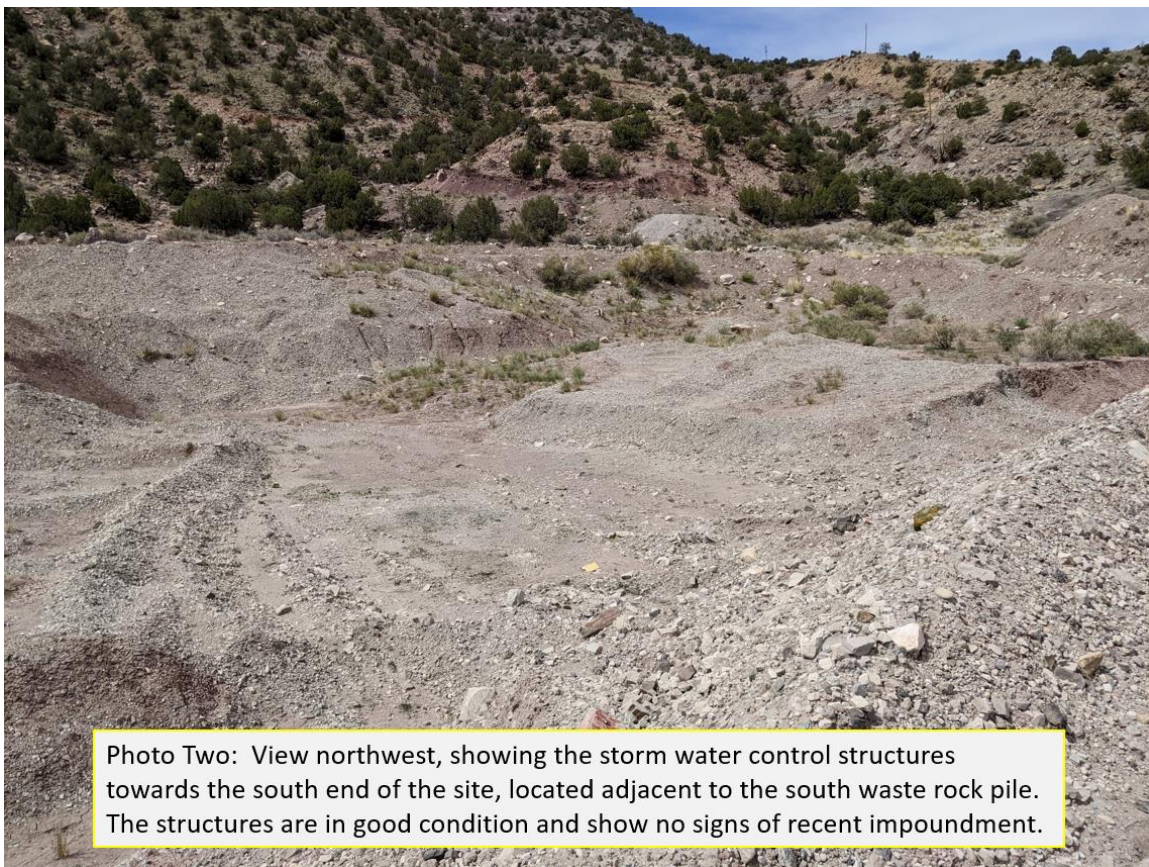
Photo Two: View northwest, showing the storm water control structures towards the south end of the site, located adjacent to the south waste rock pile. The structures are in good condition and show no signs of recent impoundment.

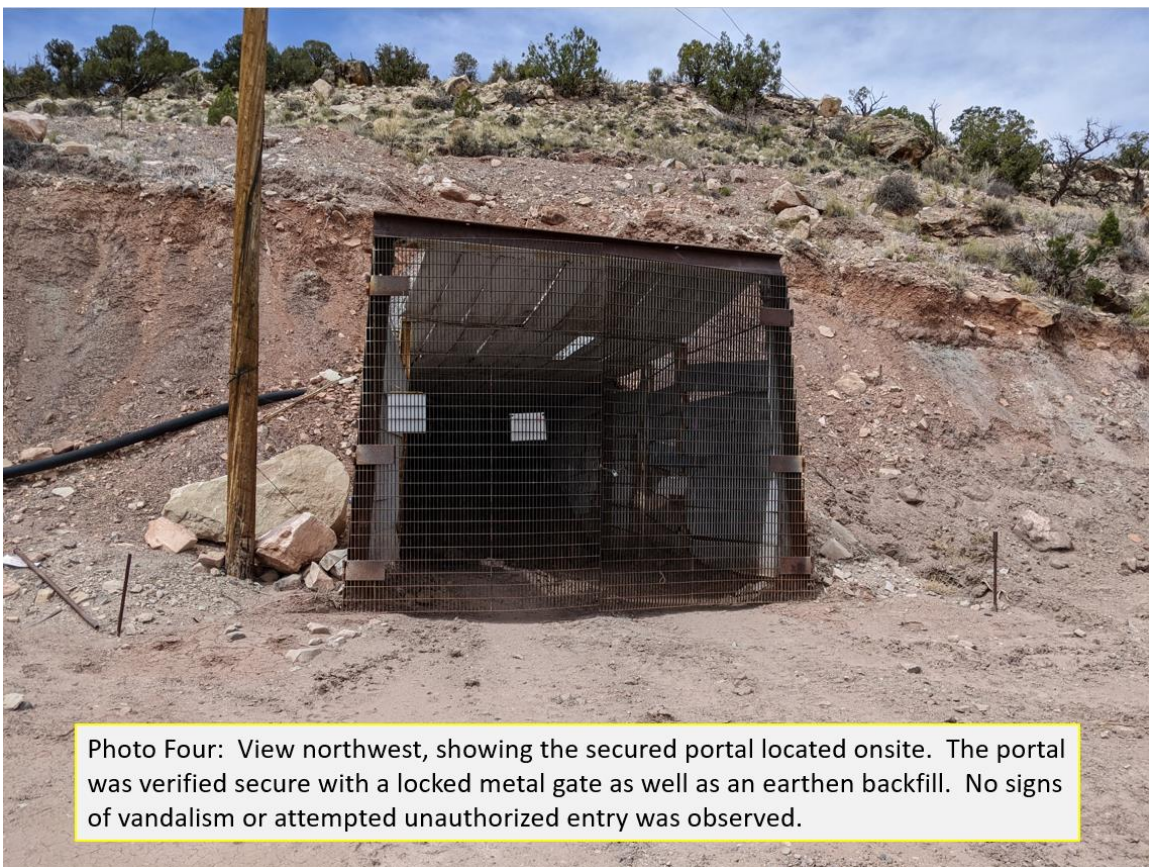
The portal on site remains secure and shows no signs of attempted unauthorized entry. The earthen backfill and locked steel gate are in good condition. The portal and its enclosure can be seen in Photo Four. All work facilities were secure and seemed to be in good condition during the time of the inspection. All other support infrastructure such as power lines and transformer stations were observed to be in good working order. Examples of the work facilities can be seen in Photo Five. Vent shaft S-2, located to the Northwest of the shop facilities is covered with a steel grate and has been secured as shown in Photo Six. All loadouts, roads and pad areas that exist on site were observed and in good condition.

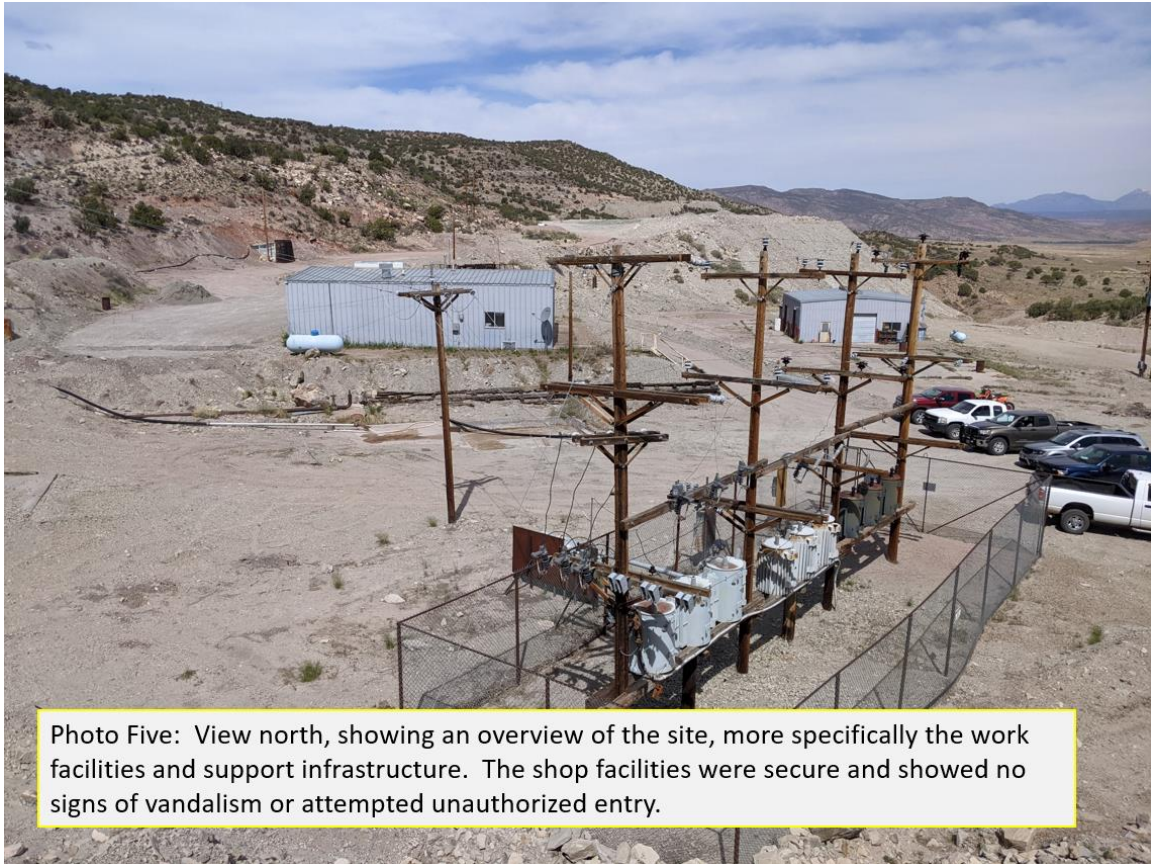
Photo Five: View north, showing an overview of the site, more specifically the work facilities and support infrastructure. The shop facilities were secure and showed no signs of vandalism or attempted unauthorized entry.

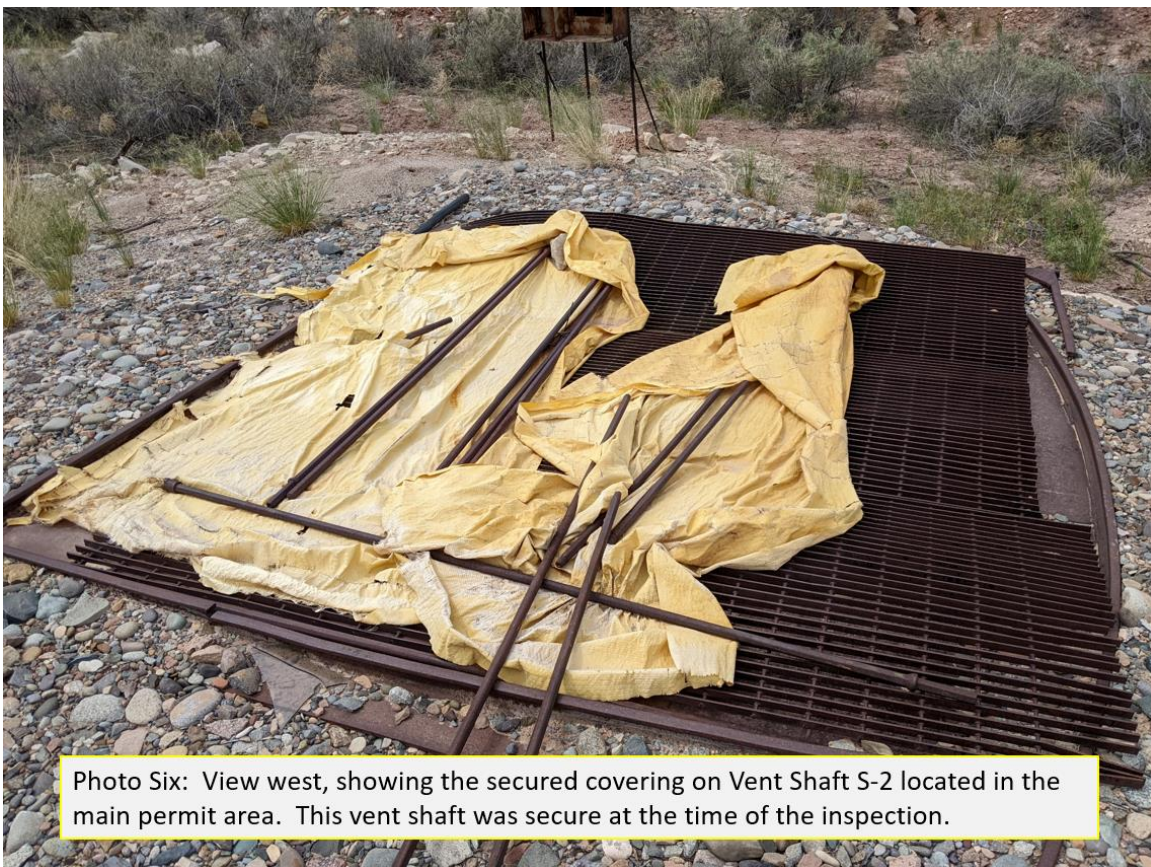
Photo Six: View west, showing the secured covering on Vent Shaft S-2 located in the main permit area. This vent shaft was secure at the time of the inspection.

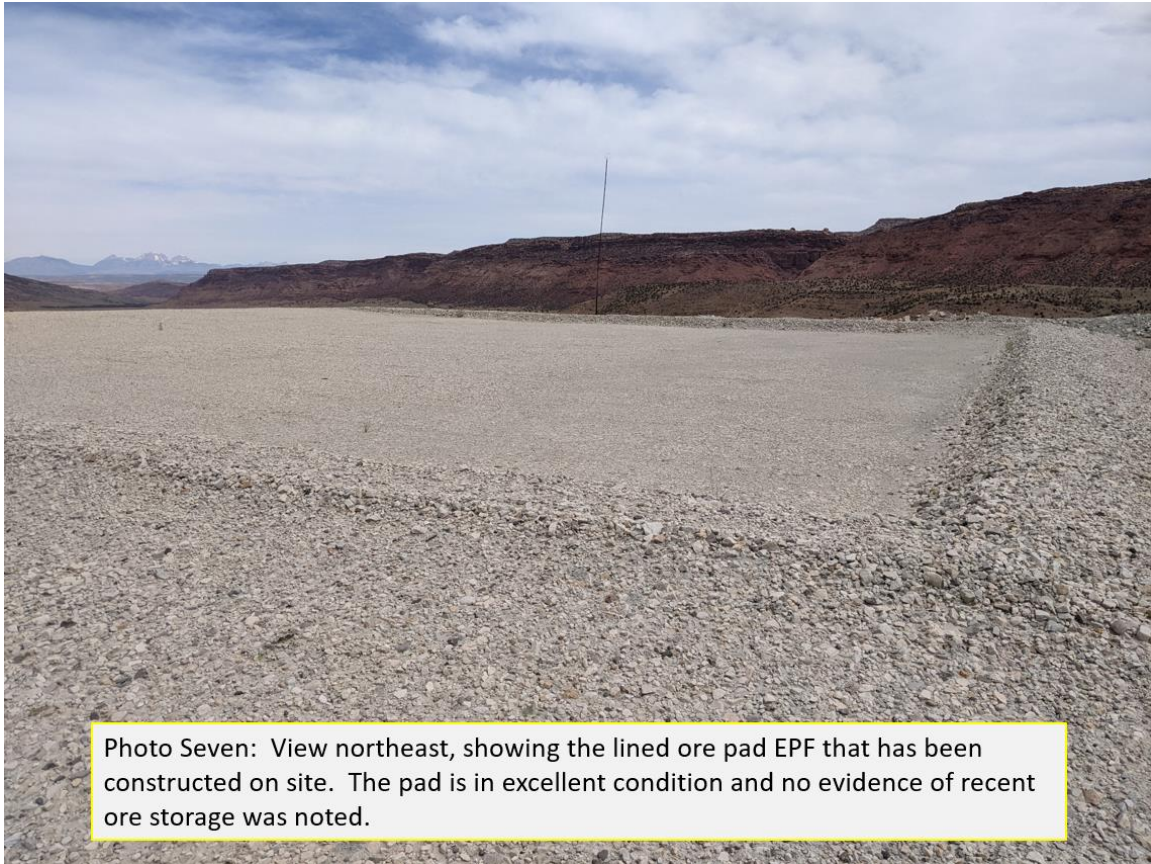
The lined Ore Pad was observed to be in good condition. The face of the pad shows no evidence of surface stockpiling and no observable impacts from precipitation was noted. The out slopes and berms of the pad appear stable. The pad can be seen in Photos Seven and Eight.

Photo Seven: View northeast, showing the lined ore pad EPF that has been constructed on site. The pad is in excellent condition and no evidence of recent ore storage was noted.

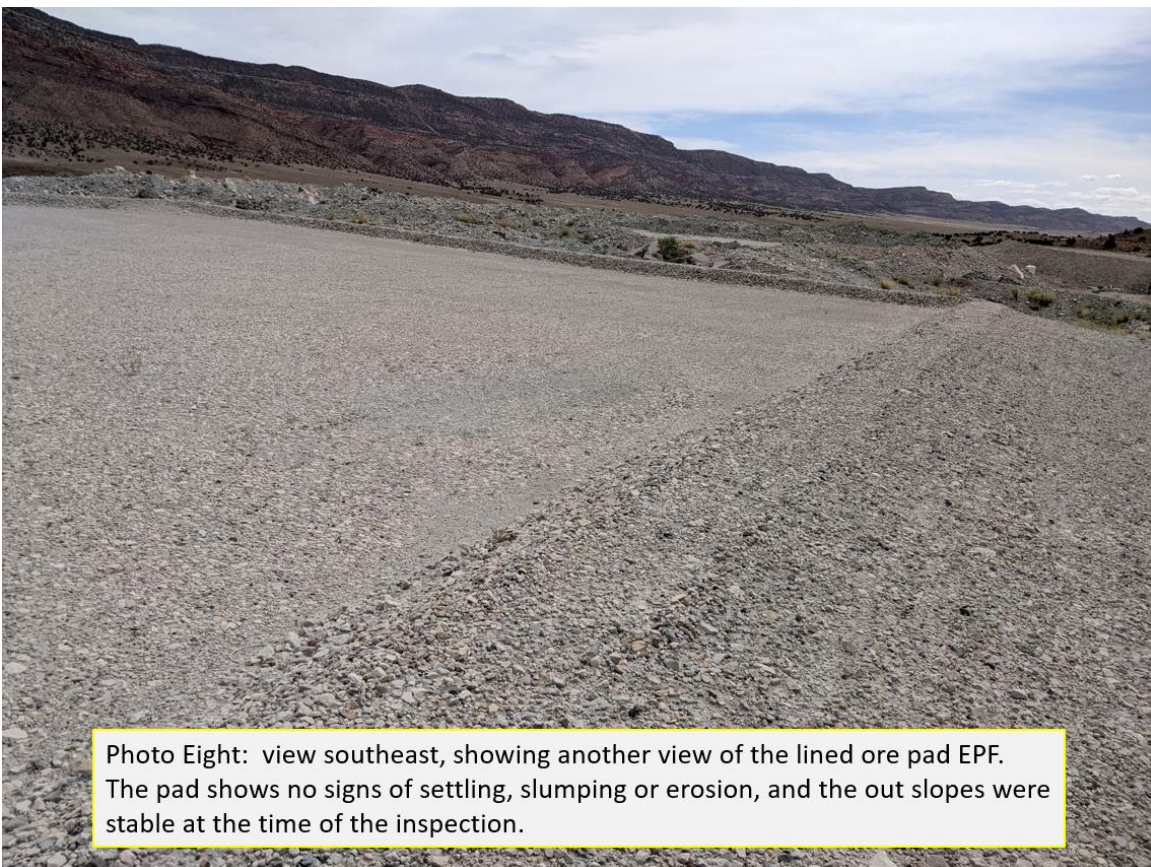
Photo Eight: view southeast, showing another view of the lined ore pad EPF. The pad shows no signs of settling, slumping or erosion, and the out slopes were stable at the time of the inspection.
