MINERALS PROGRAM INSPECTION REPORT
PHONE: (303) 866-3567

MINE NAME: GIR Surface Exploration Drilling	MINE/PROSPECTING ID#: P-2021-013	MINERAL: Gold and silver	COUNTY: Boulder
INSPECTION TYPE: Monitoring	INSPECTOR(S): Patrick Lennberg	INSP. DATE: June 3, 2022	INSP. TIME: 09:30
OPERATOR: Grand Island Resources LLC	OPERATOR REPRESENTATIVE: Sean Muller, Richard Mittasch	TYPE OF OPERATION: MP - Mineral Prospecting

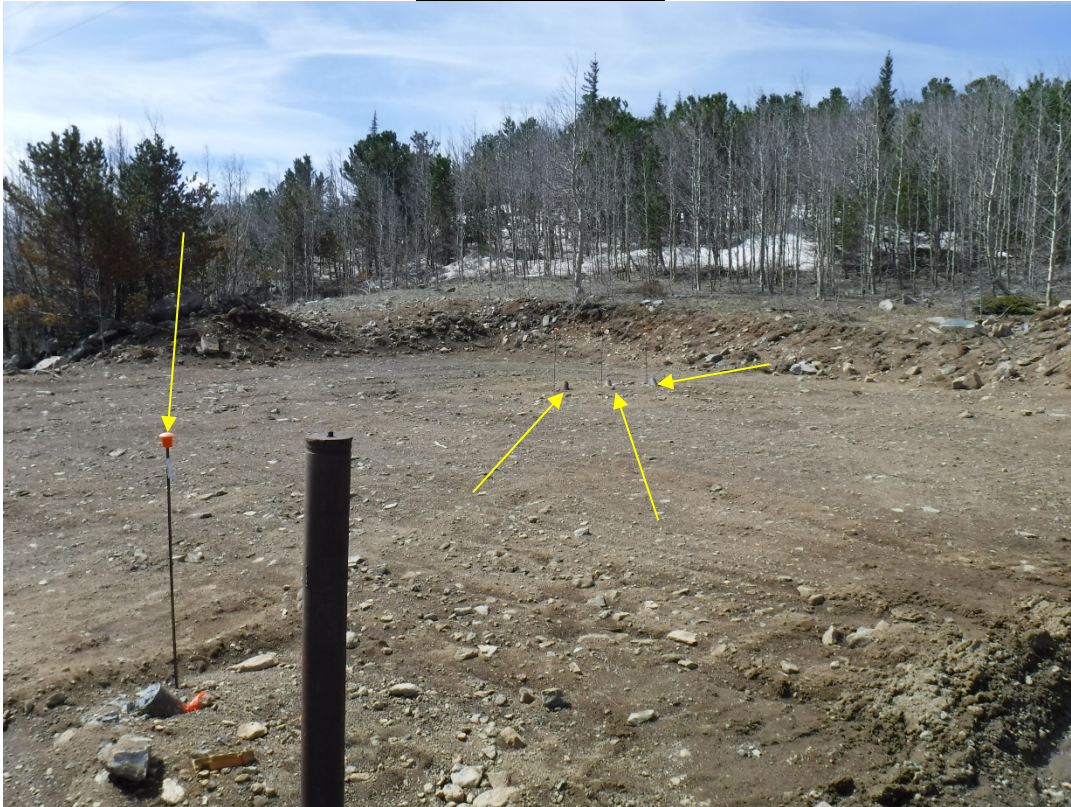
The drill pad of the Western Extension was approximately 80 feet by 80 feet. On the pad were six conductor casings sticking up from the ground. The casings were cemented at the surface. According to the abandonment logs the boreholes were plugged with HolePlug from the bottom depth to the base of the conductor casing which varied from hole to hole but was typically 30 feet deep. The conductor casing was then cemented from the bottom to the surface. Currently, there is a 6-12 inch stick-up at each borehole. The pad has been reclaimed to the approved parking lot conditions. During the inspection the operator inquired if they could cut the stick-ups off so the area could be used for storage and equipment laydown area. The Division is ok with the operator cutting the off the stick-ups and using the area as described.

Photo 1: Looking south across the drill pad, boreholes indicated with yellow arrow, the other steel pole is a survey marker

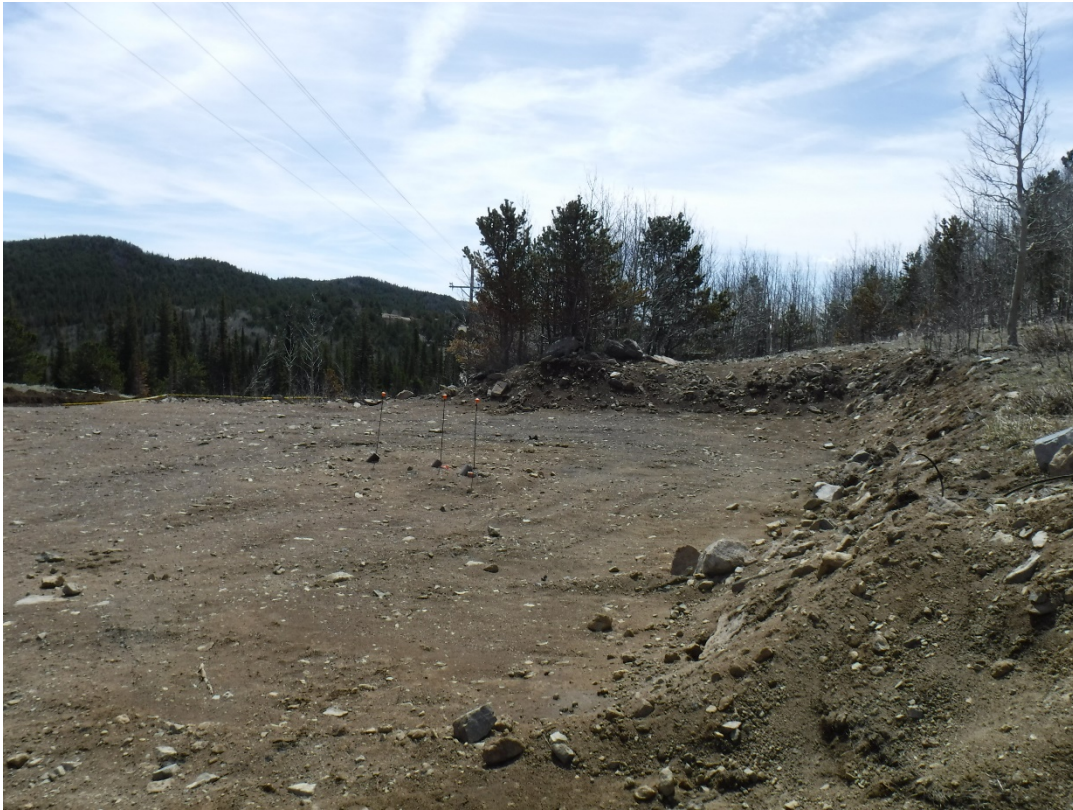
Photo 5: Looking southeast across the drill pad

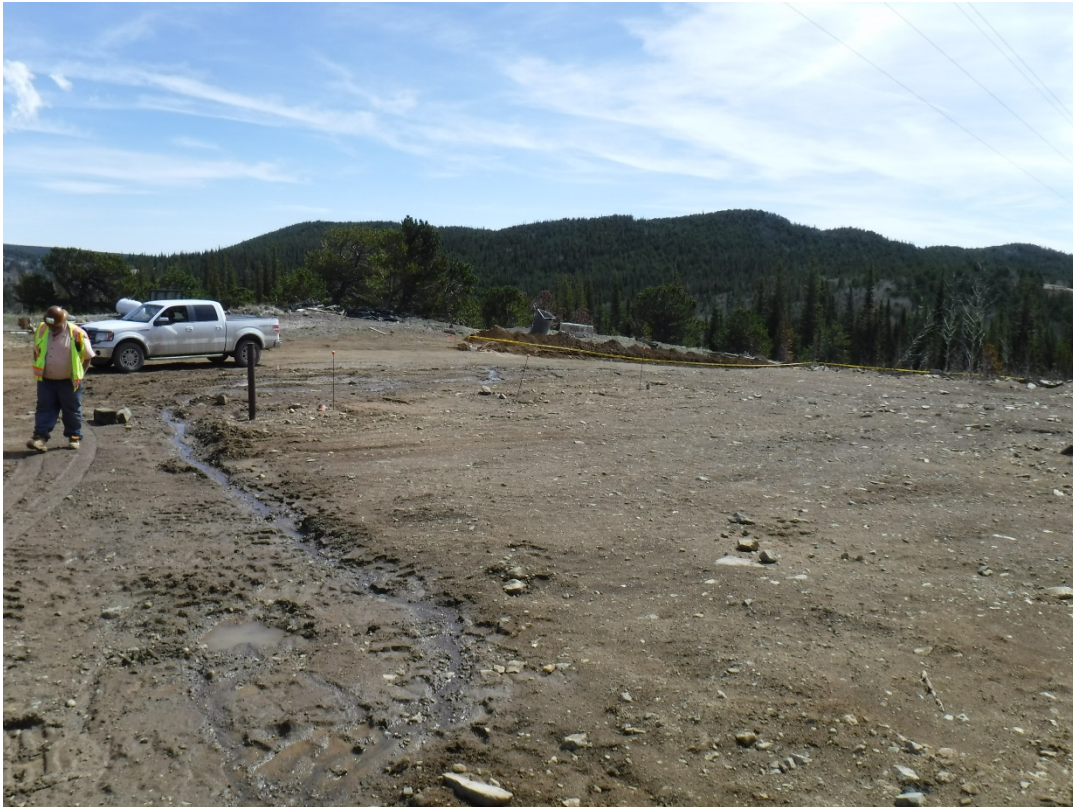
Photo 5: Looking east across the drill pad
