MINERALS PROGRAM INSPECTION REPORT
PHONE: (303) 866-3567

MINE NAME: Sooner Lucky Strike Mine and Mill	MINE/PROSPECTING ID#: M-1982-020	MINERAL: Gold and silver	COUNTY: Gunnison
INSPECTION TYPE: Monitoring	INSPECTOR(S): Dustin Czaplá	INSP. DATE: May 17, 2022	INSP. TIME: 09:00
OPERATOR: ALSH, LLC	OPERATOR REPRESENTATIVE: Jake Wilkinson	TYPE OF OPERATION: 110d - Designated Limited Impact	
REASON FOR INSPECTION: Normal I&E Program	BOND CALCULATION TYPE: Complete Bond	BOND AMOUNT: \$49,992.54	
DATE OF COMPLAINT: NA	POST INSP. CONTACTS: None	JOINT INSP. AGENCY: None	
WEATHER: Clear	INSPECTOR'S SIGNATURE:

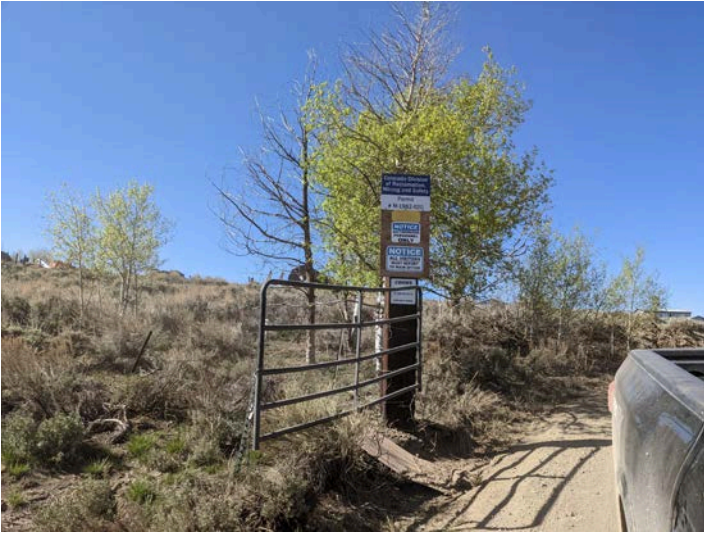
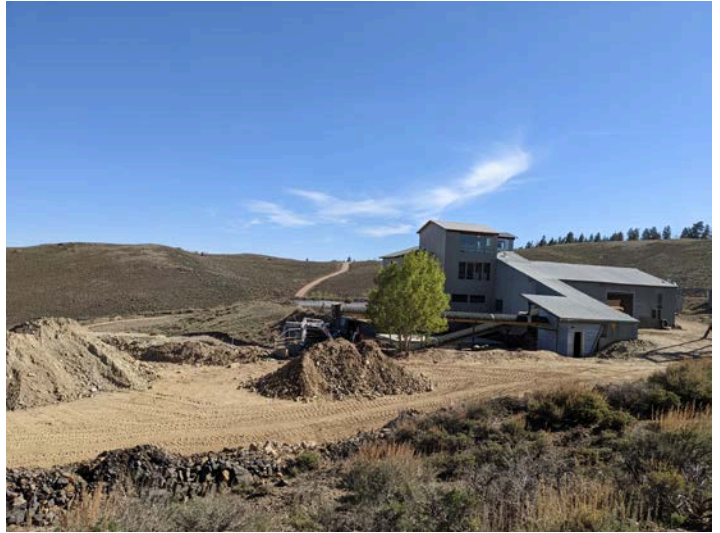
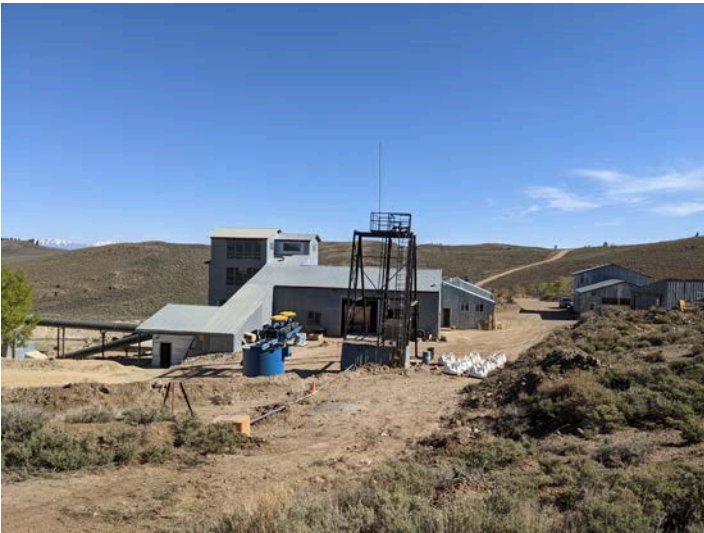
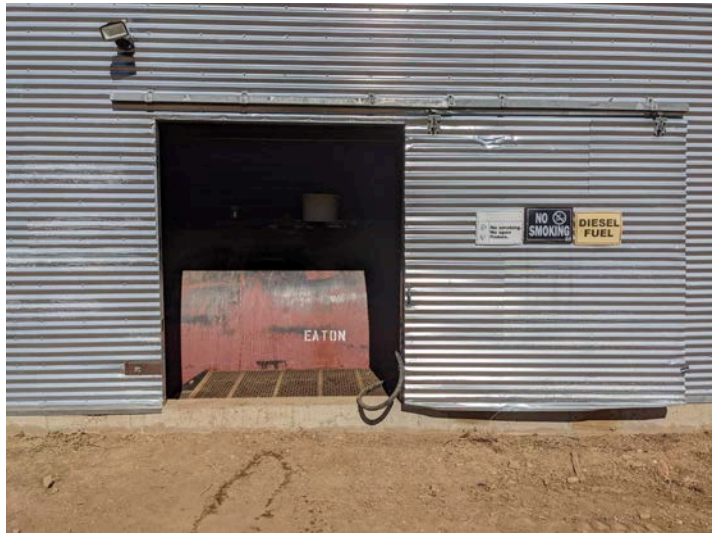
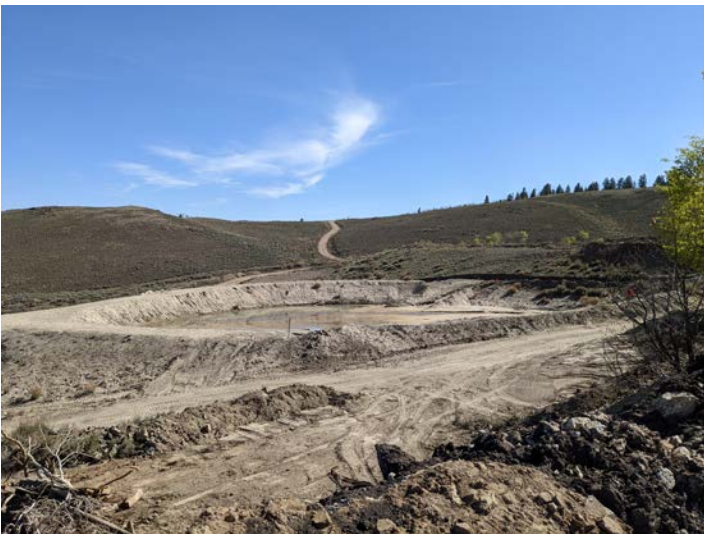
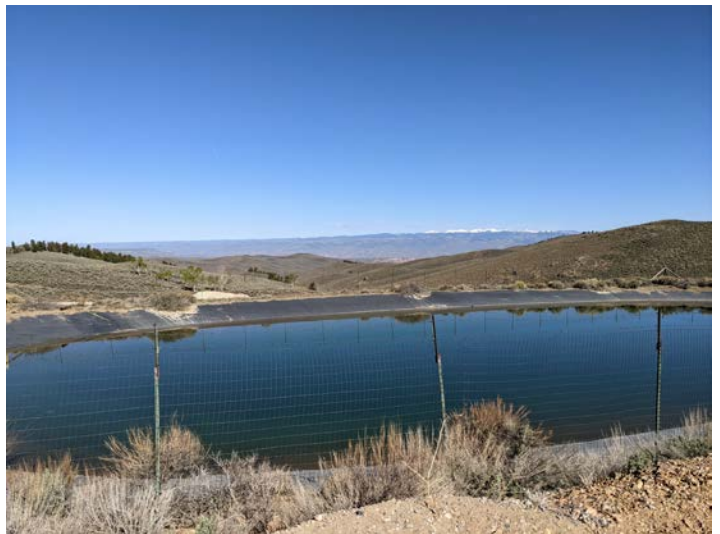
Adequate mine identification signage was noted at the entrance to the site.

The affected area was marked by posts adequate to delineate the affected area boundary.

The mill is in an active state. The mill processes ore from the CRG Gold Links mines in the Gold Creek area. The mill was operational during this inspection. Recirculation water for the mill is contained in the lined pond on the north side of the mill building. The pond had several feet of freeboard during this inspection. A primary settling pond is located downslope on the west side of the mill building. The pond banks appeared stable and no signs of seepage were noted.

Topsoil remains stockpiled in a berm at the west end of the site.

The mill facility appeared well kept and chemicals are stored with proper secondary containment.
