**MINERALS PROGRAM INSPECTION REPORT**  
**PHONE: (303) 866-3567**

<b>MINE NAME:</b> Tamarcaz Pit	<b>MINE/PROSPECTING ID#:</b> M-1985-072	<b>MINERAL:</b> Sand and gravel	<b>COUNTY:</b> Gunnison
<b>INSPECTION TYPE:</b> Monitoring	<b>INSPECTOR(S):</b> Dustin Czapl	<b>INSP. DATE:</b> May 20, 2022	<b>INSP. TIME:</b> 19:30
<b>OPERATOR:</b> Gunnison County	<b>OPERATOR REPRESENTATIVE:</b>	<b>TYPE OF OPERATION:</b> 110c - Construction Limited Impact	
<b>REASON FOR INSPECTION:</b> Normal I&E Program	<b>BOND CALCULATION TYPE:</b> Complete Bond	<b>BOND AMOUNT:</b> No Bond Held	
<b>DATE OF COMPLAINT:</b> NA	<b>POST INSP. CONTACTS:</b> None	<b>JOINT INSP. AGENCY:</b> None	
<b>WEATHER:</b> Clear	<b>INSPECTOR'S SIGNATURE:</b>

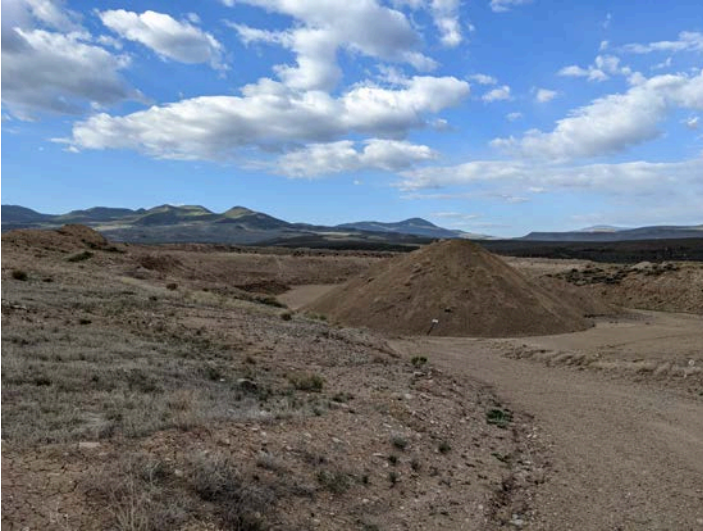
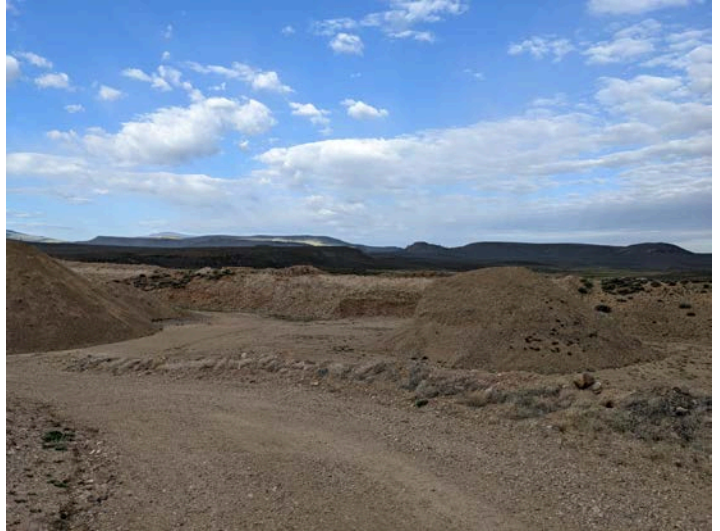
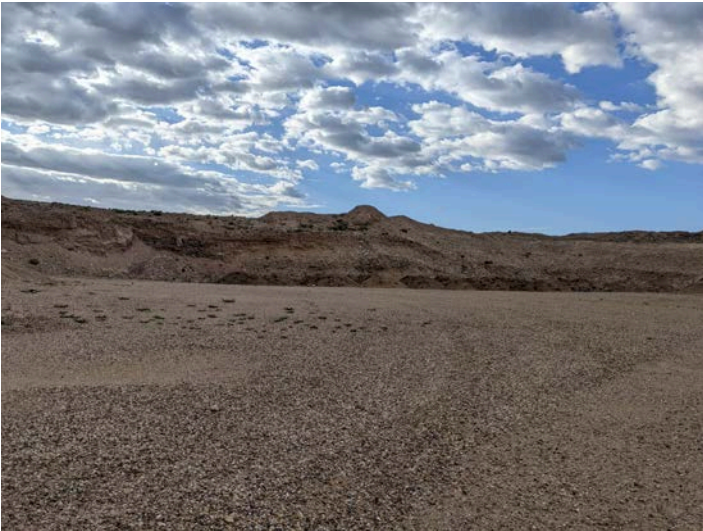
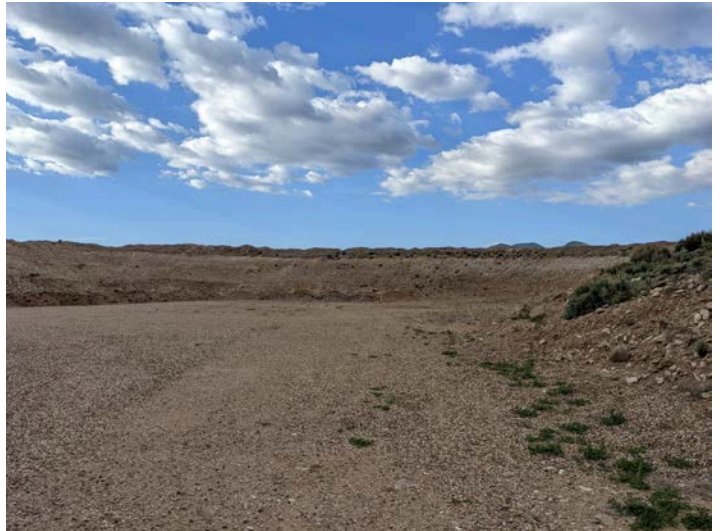
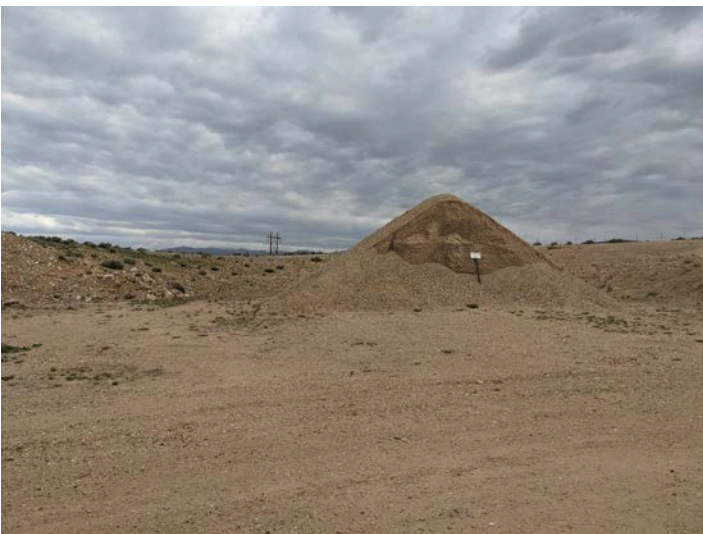
The affected area was marked by fencing that was clearly visible and adequate to delineate the affected area boundary.

The county typically mines and crushes enough material to last for approximately three years, so active mining/processing is infrequent at this site. Most of the slopes around the pit have been graded to 2H:1V or less. A portion of the east highwall is near vertical and 10-15 feet high. The slopes that have been reseeded show minimal growth at this time.

Gravel stockpiles were located on the pit floor. Topsoil stockpiles were located at the northeast rim of the pit.
