MINERALS PROGRAM INSPECTION REPORT
PHONE: (303) 866-3567

| MINE NAME: White River S & G Pit | MINE/PROSPECTING ID#: M-1991-009 | MINERAL: Gravel | COUNTY: Rio Blanco |
| INSPECTION TYPE: Monitoring | INSPECTOR(S): Amy Yeldell | INSP. DATE: May 24, 2022 | INSP. TIME: 14:30 |

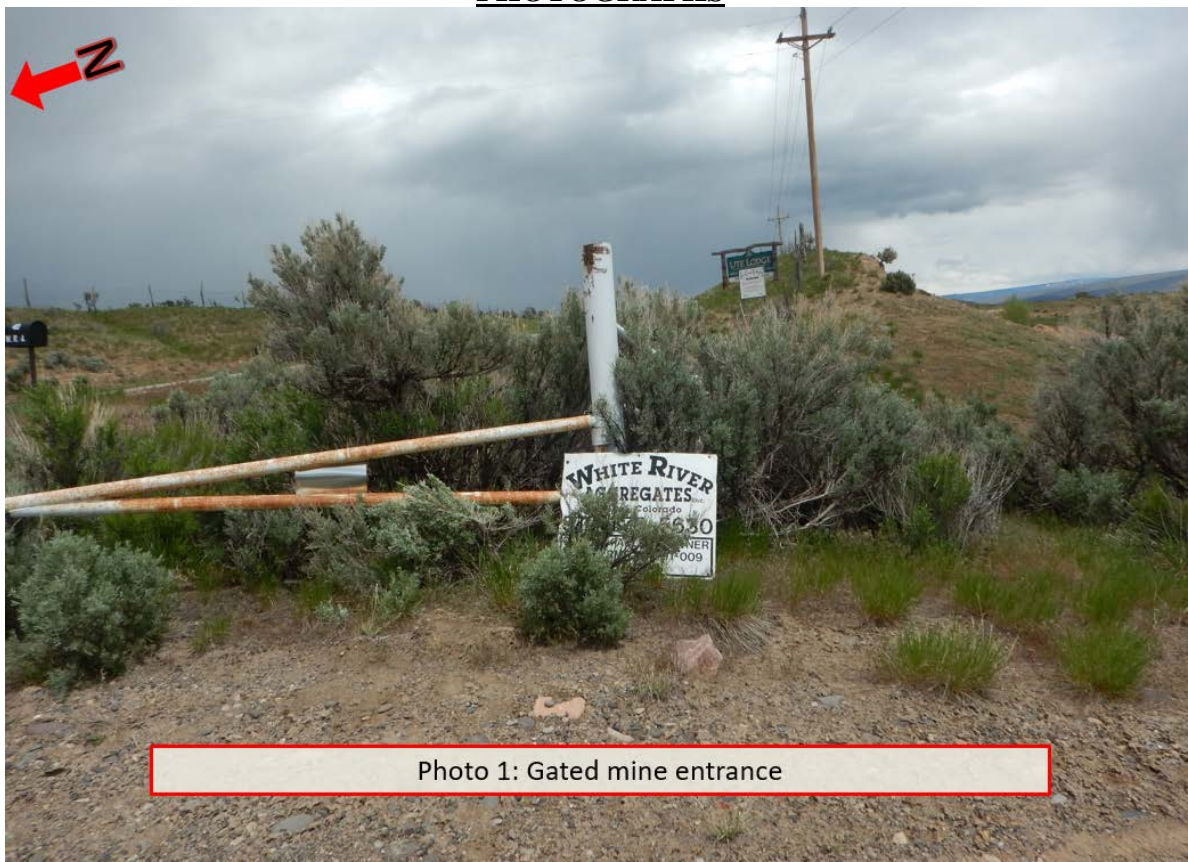
Photo 1: Gated mine entrance
