MINERALS PROGRAM INSPECTION REPORT
PHONE: (303) 866-3567

MINE NAME: Brown Derby Mine	MINE/PROSPECTING ID#: M-1999-074	MINERAL: Gemstones, lithium, unknown commodity	COUNTY: Gunnison
INSPECTION TYPE: Monitoring	INSPECTOR(S): Dustin Czapla	INSP. DATE: May 17, 2022	INSP. TIME: 10:30
OPERATOR: Precious Offerings Mineral Exchange, Inc.	OPERATOR REPRESENTATIVE: Jake Wilkinson	TYPE OF OPERATION: 110(2) - Hard Rock Limited Impact	
REASON FOR INSPECTION: Normal I&E Program	BOND CALCULATION TYPE: Complete Bond	BOND AMOUNT: \$2,500.00	
DATE OF COMPLAINT: NA	POST INSP. CONTACTS: None	JOINT INSP. AGENCY: None	
WEATHER: Clear	INSPECTOR'S SIGNATURE:

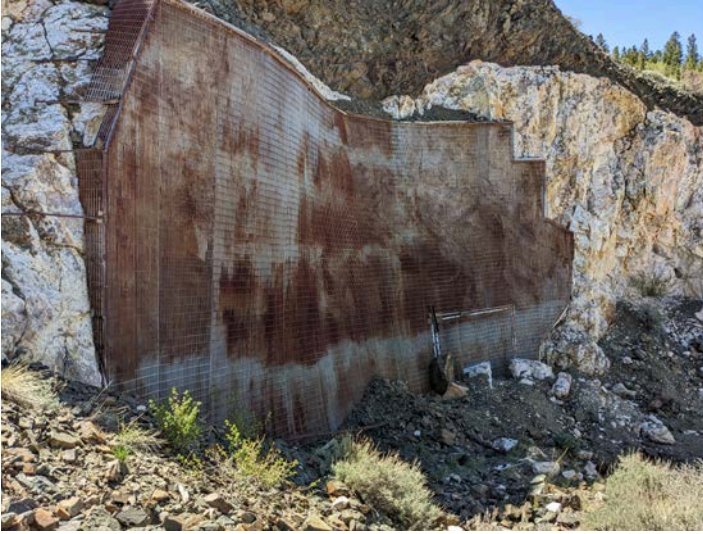
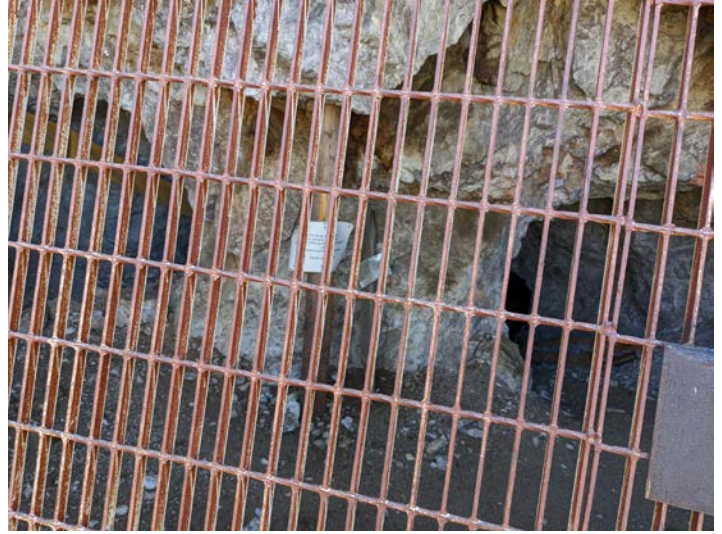
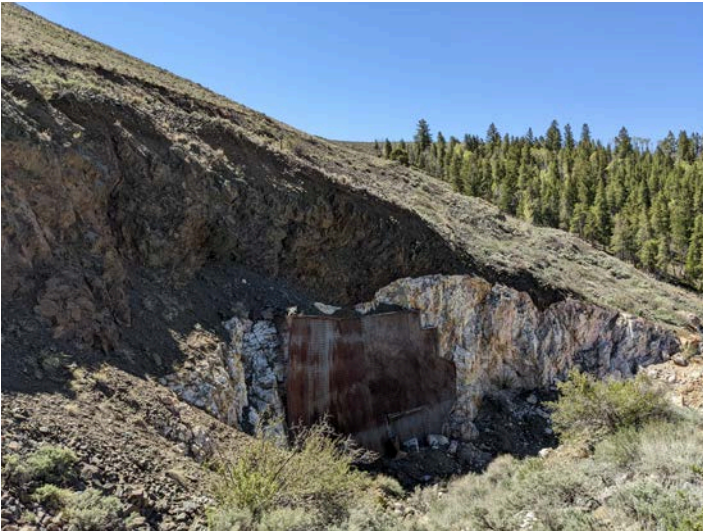
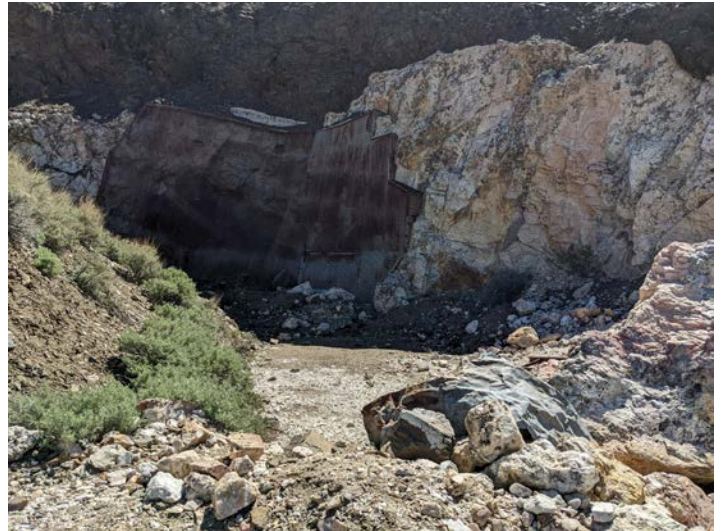
The site consists of a headwall cut into the west facing slope of the hill, where a grated portal is located. The portal was locked and appeared secure. A flat bench and stockpile area is located just outside the portal.

The site experiences problems with trespassers and vandals. Large boulders have been placed by the operator across the access road in order to prevent unauthorized vehicles from entering the site. Boulders and soil have also been placed in front of the mine entrance to prevent unauthorized access.
