MINERALS PROGRAM INSPECTION REPORT

MINE NAME: Sea Horse Ranch West Gravel Pit	MINE/PROSPECTING ID#: M-2001-113	MINERAL: Sand and aggregate	COUNTY: Gunnison
INSPECTION TYPE: Monitoring	INSPECTOR(S): Dustin Czapla	INSP. DATE: May 18, 2022	INSP. TIME: 10:00
OPERATOR: Oldcastle SW Group, Inc. dba United Compas County	OPERATOR REPRESENTATIVE:	TYPE OF OPERATION: 112c - Construction Regular Operation

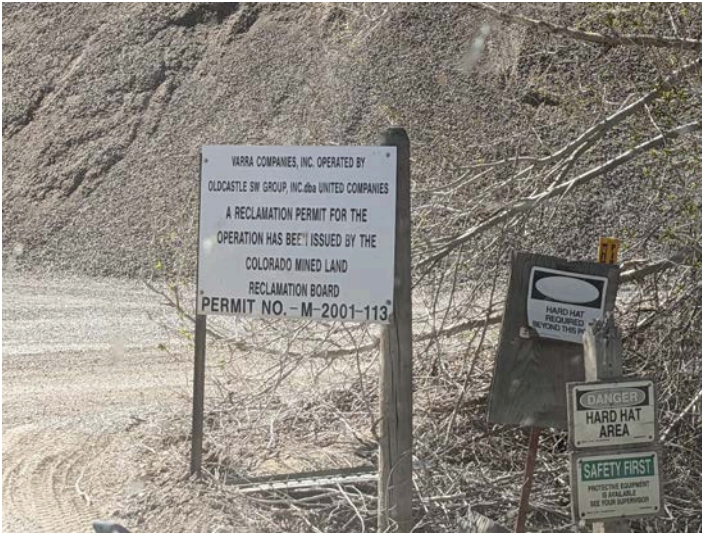
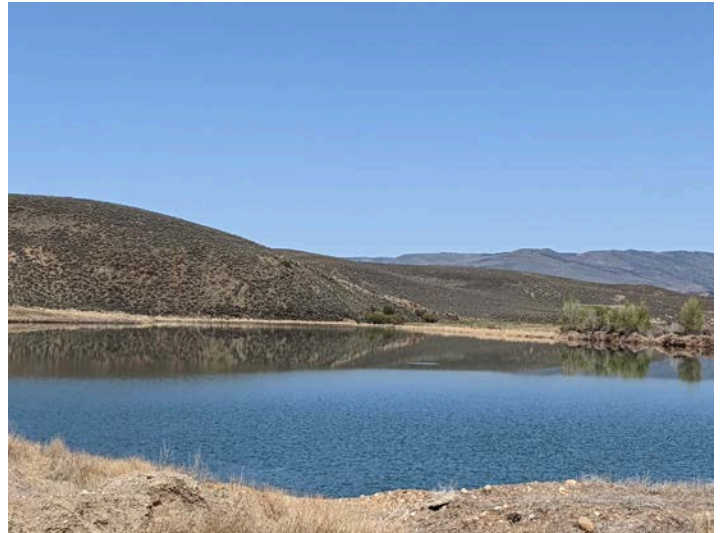
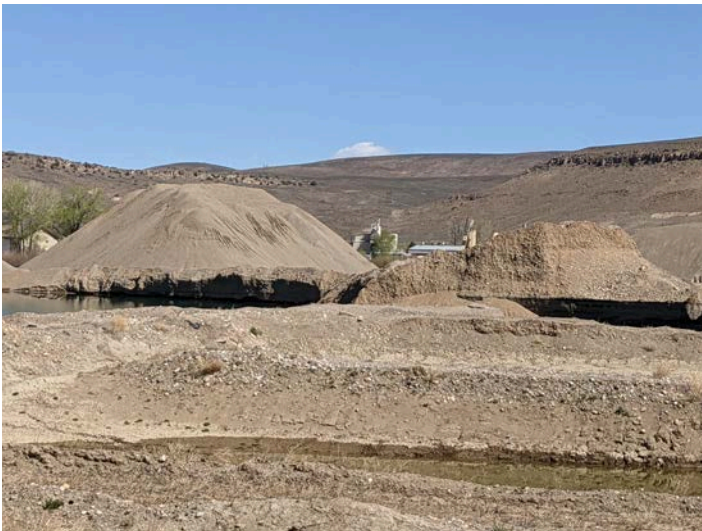
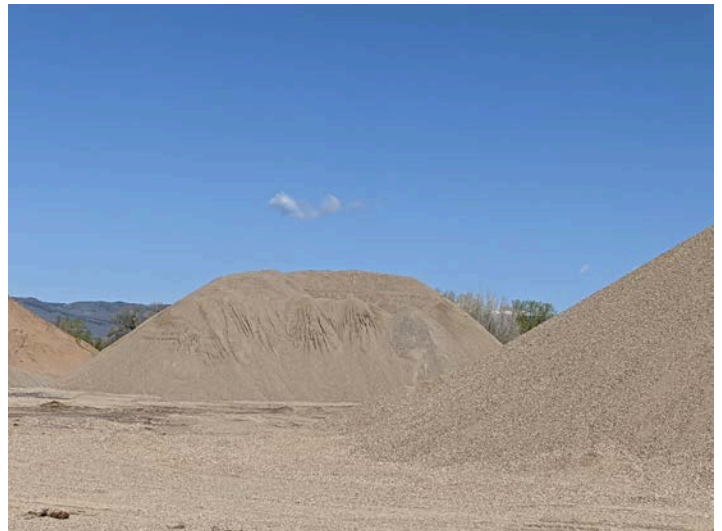
The pit was not dewatered during this inspection. Equipment was operating on site, working from existing materials stockpiles located on the northeast side of the pit. The pit highwalls had been mined to approximately 1.5H:1V. The slopes will require backfilling to 3H:1V during reclamation. Nearly the entire 40 acre permit area is currently disturbed by the operation.
