MINERALS PROGRAM INSPECTION REPORT PHONE: (303) 866-3567

MINE NAME:	MINE/PROSPECTING ID#:	MINERAL:	COUNTY:
Hollenbeck Pit	M-1985-023	Sand and gravel	Gunnison
INSPECTION TYPE:	INSPECTOR(S):	INSP. DATE:	INSP. TIME:
Monitoring	Dustin Czapla	May 17, 2022	08:00
OPERATOR:	OPERATOR REPRESENTATIVE:	TYPE OF OPERATION:	
Duane E. Hollenbeck		110c - Construction Limited Impact

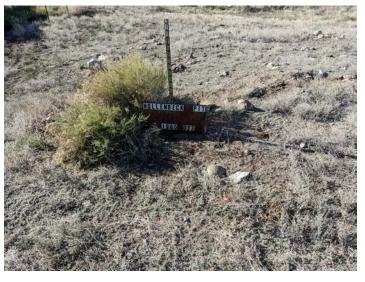
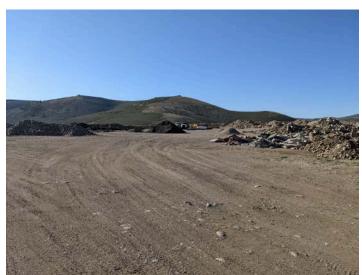
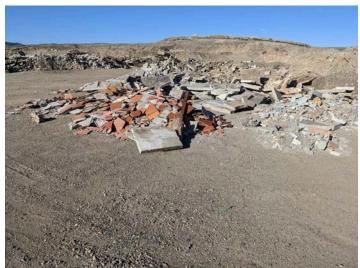
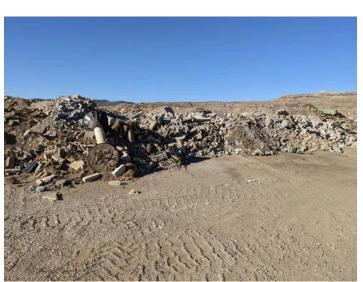
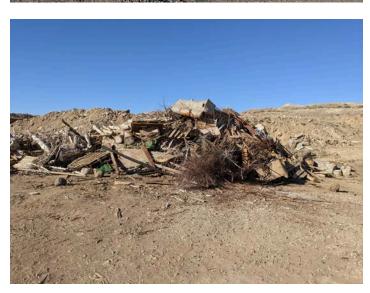
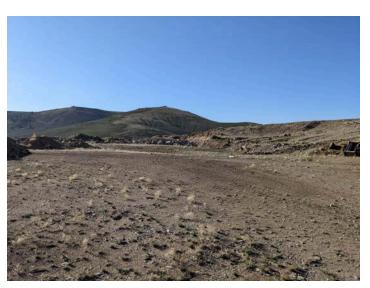
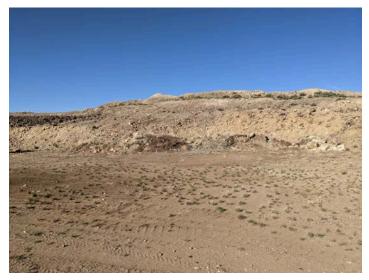
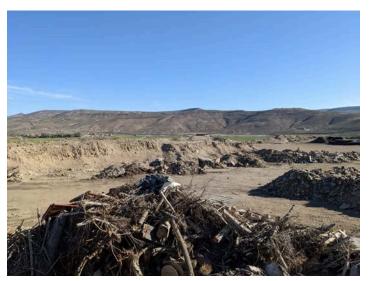
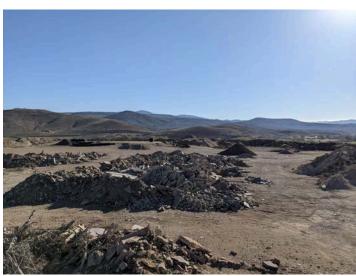
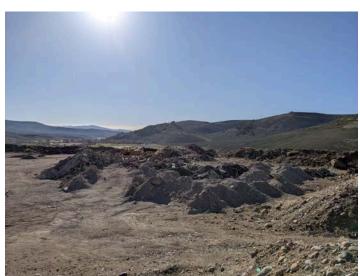
PROBLEM/POSSIBLE VIOLATION: Problem: Trash and refuse was noticed on the site. This is a problem at this time for failure to dispose of refuse in a manner that controls unsightliness or deleterious effects of such refuse pursuant to C.R.S. 34-32.5-116(4)(e).

Various construction waste material and refuse has been brought to the site, including ceramic tile, used asphalt and concrete, lumber, wood and furniture. The Division considers these items to be a reclamation liability and a problem for Operator's failure to dispose of refuse in a manner compliant with C.R.S. 34-32.5-116 (4)(e). This material must be removed from the site by the corrective action deadline noted on page one of this report.

CORRECTIVE ACTIONS: The operator shall submit a written notice to the Division with photo documentation, that the trash has been removed from the site by the corrective action date.
