## MINERALS PROGRAM INSPECTION REPORT

| <b>MINE NAME:</b><br>Lucille Lode Mine | <b>MINE/PROSPECTING ID#:</b><br>P-2015-002 | <b>MINERAL:</b><br>Gold and silver | <b>COUNTY:</b><br>Gunnison |
| <b>INSPECTION TYPE:</b><br>Monitoring | <b>INSPECTOR(S):</b><br>Dustin Czapla | <b>INSP. DATE:</b><br>May 17, 2022 | <b>INSP. TIME:</b><br>11:50 |

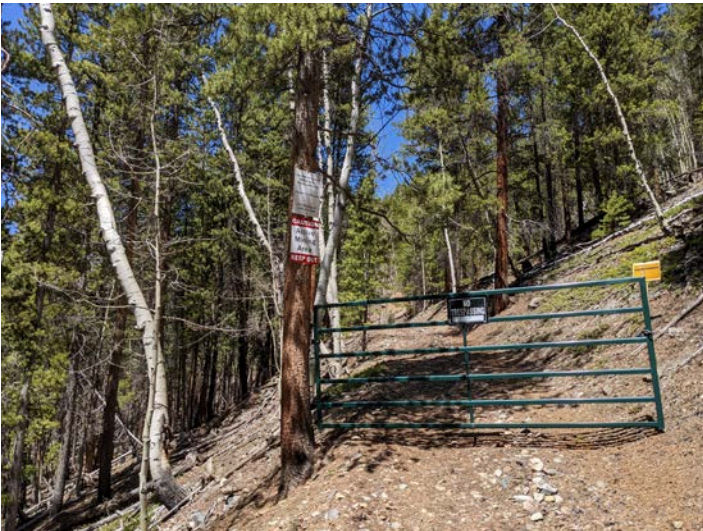
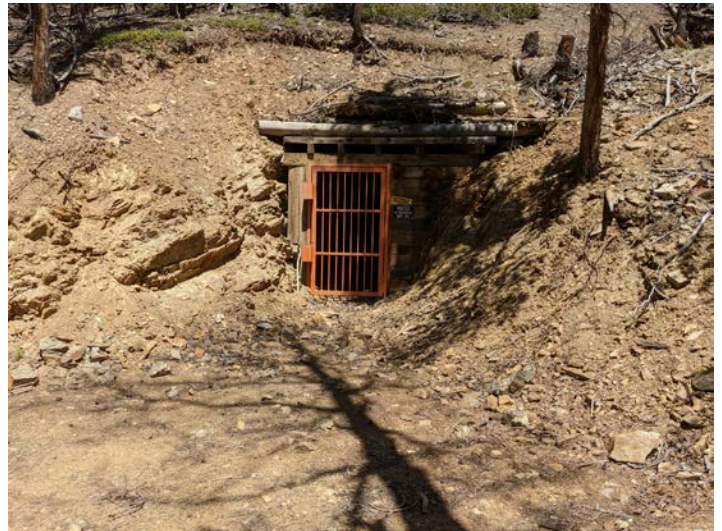
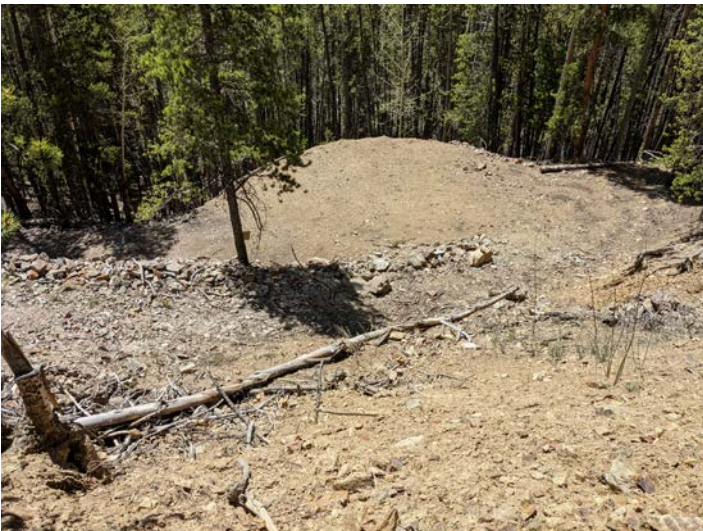
The Lucille Lode Mine is located approximately 3.5 miles north of Ohio City, at 38.612072°, -106.581704°, and accessed from Road 771, up Jones Gulch. The NOI authorized sampling from an historic portal. The disturbance area consists of the portal, waste rock area and access road. The previously unsecured portal is now secured with a locking door. The site appeared well kept. No problems or violations were noted during this inspection.
