MINERALS PROGRAM INSPECTION REPORT

MINE NAME: C8 Drilling NOI	MINE/PROSPECTING ID#: P-2016-025	MINERAL: Gold and silver	COUNTY: Gunnison
INSPECTION TYPE: Monitoring	INSPECTOR(S): Dustin Czapla	INSP. DATE: May 17, 2022	INSP. TIME: 12:50
OPERATOR: CRG Mining, LLC	OPERATOR REPRESENTATIVE: Jake Wilkinson	TYPE OF OPERATION: MP - Mineral Prospecting

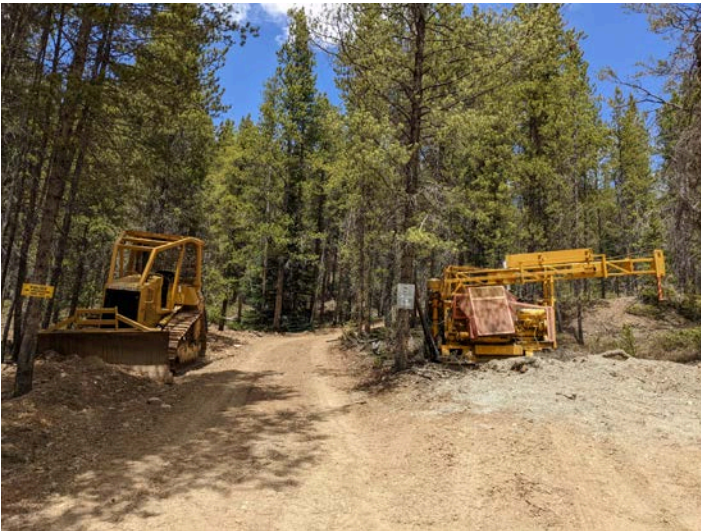
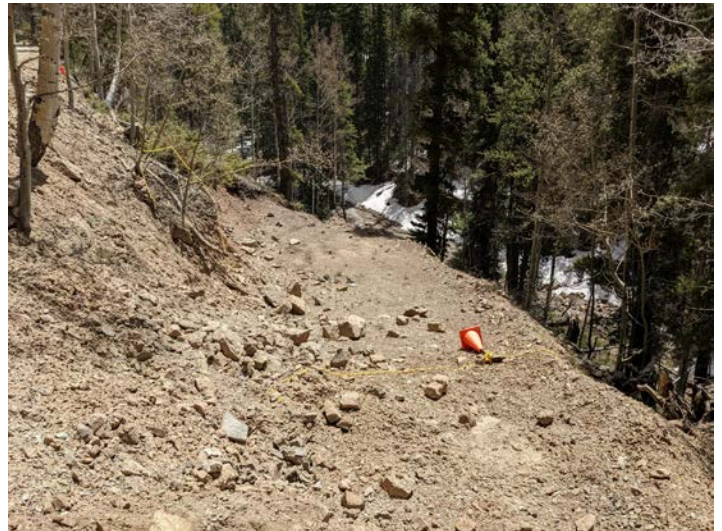
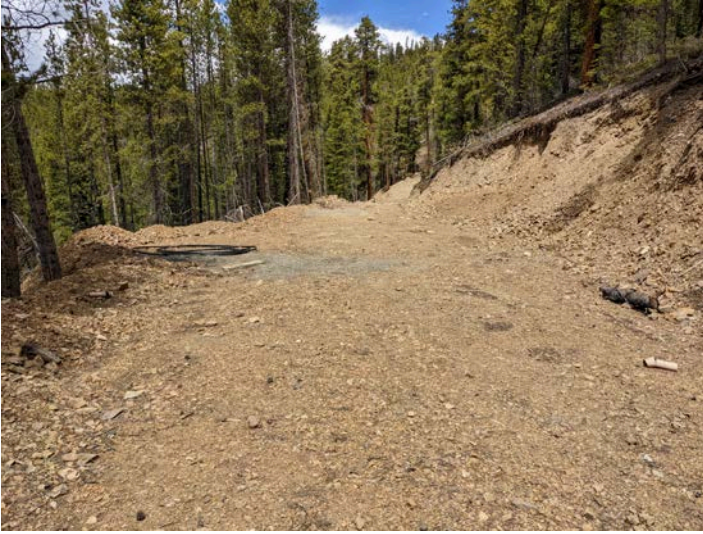
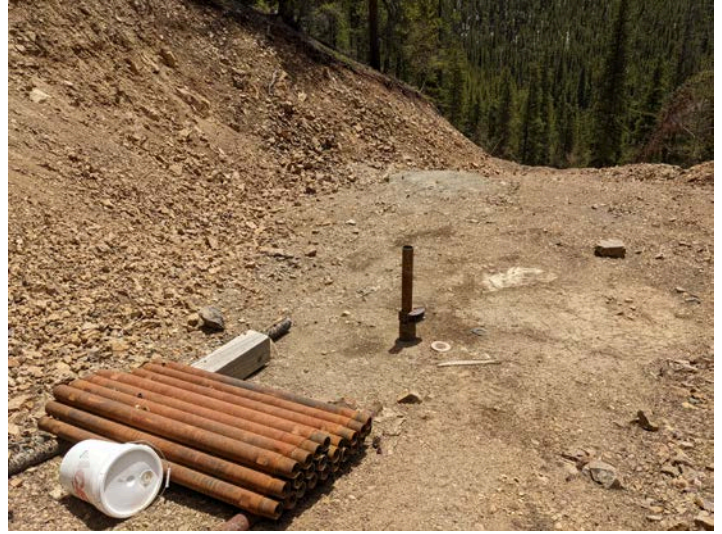
The site is located on private land within the Gold Links Mine complex (M-1987-143, M-2016-083, M-2016-084). 53 holes are authorized to be drilled by the NOI. The holes are to be backfilled after drilling. Except for one hole, the drilled holes observed had been backfilled with no sign of subsidence. The one open hole had drill pipe stuck in it that had not yet been removed by the drill operator.
