MINERALS PROGRAM INSPECTION REPORT

MINE NAME: Cross Gold Mine	MINE/PROSPECTING ID#: M-1977-410	MINERAL: Gold, copper, silver,	COUNTY: Boulder
INSPECTION TYPE: Monitoring	INSPECTOR(S): Patrick Lennberg	INSP. DATE: June 3, 2022	INSP. TIME: 09:30
OPERATOR: Grand Island Resources LLC	OPERATOR REPRESENTATIVE: Richard Mittasch, Sergio Rivera	TYPE OF OPERATION: 110(2) - Hard Rock Limited Impact

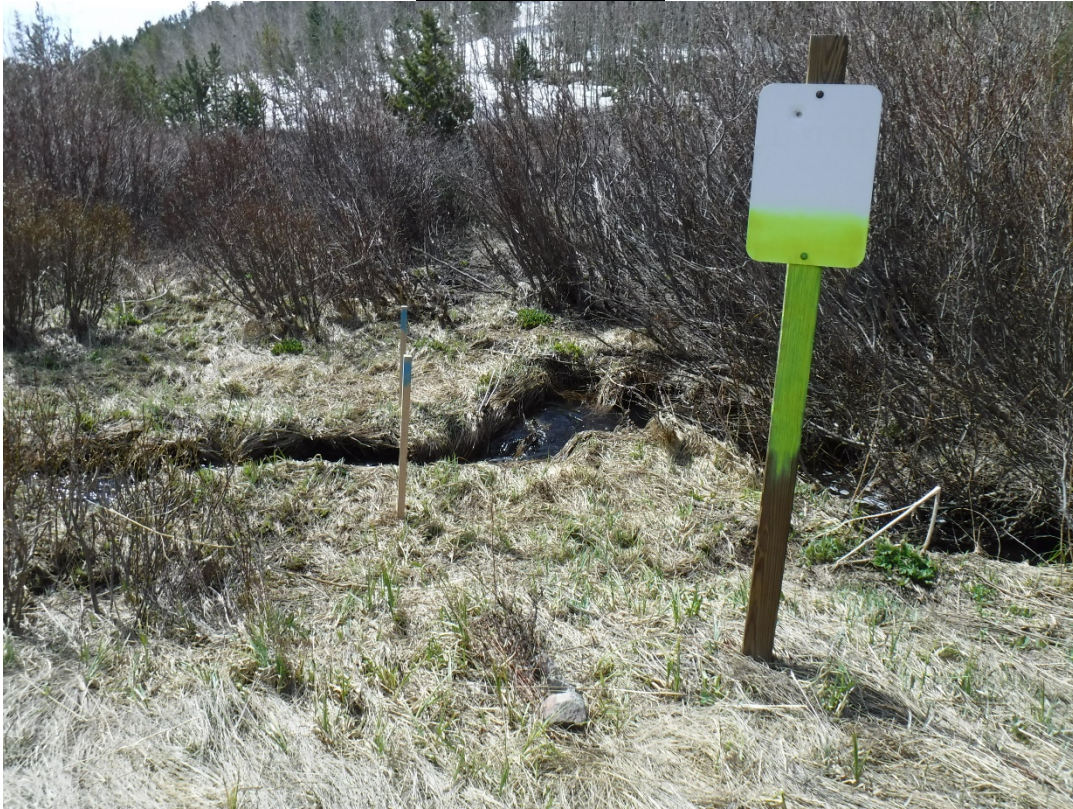
Photo 1: Upgradient surface water sampling location, adjacent to Caribou Road

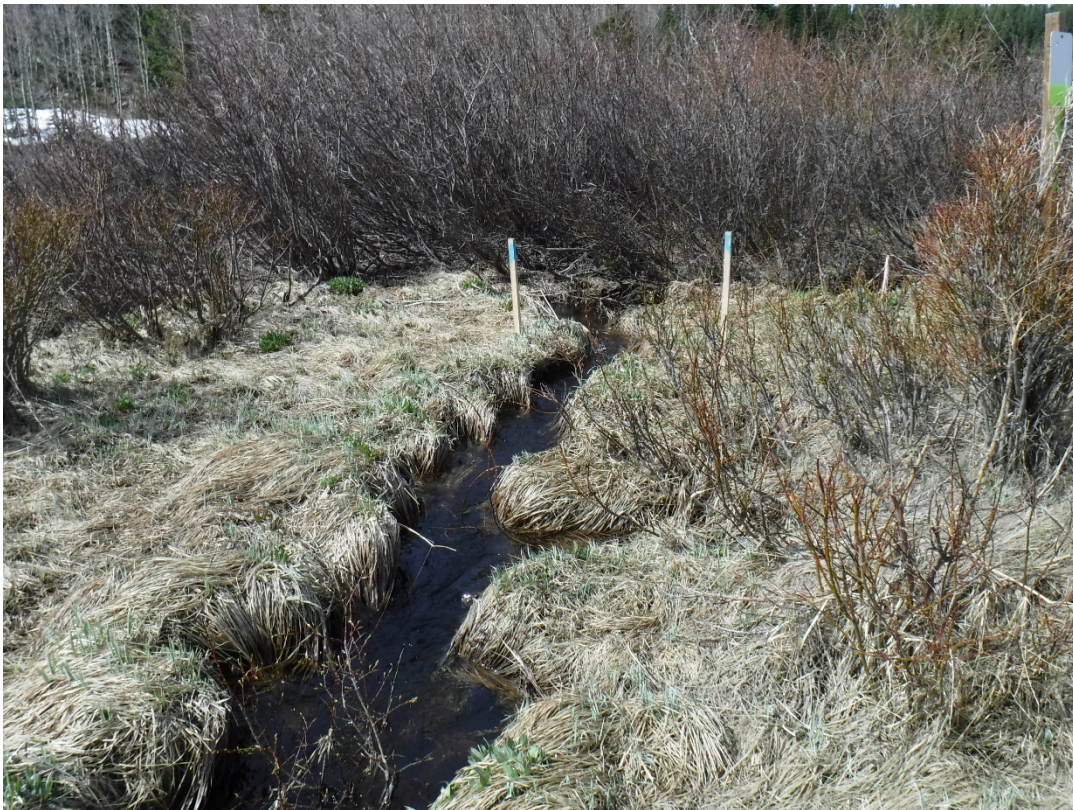
Photo 2: Looking upstream at the upgradient surface water sampling location

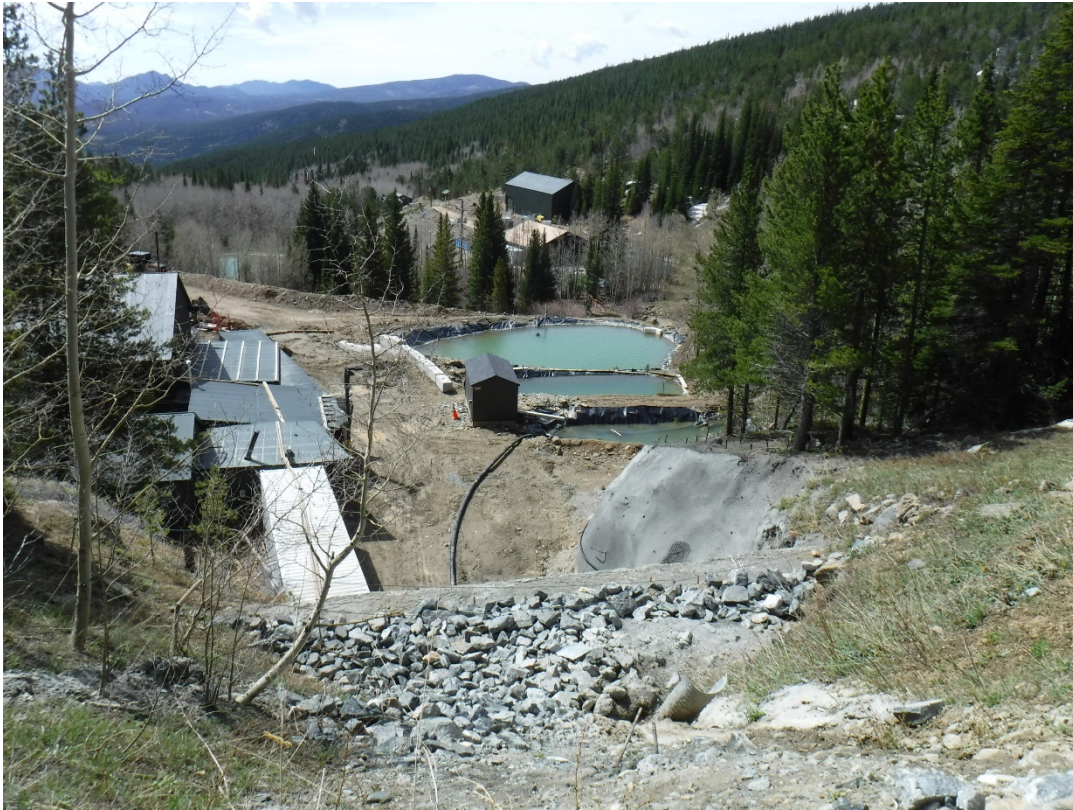
Photo 3: Looking down to the Caribou Mine (Idaho Tunnel) entrance from Caribou Road. Ponds 3a, b and c center of picture

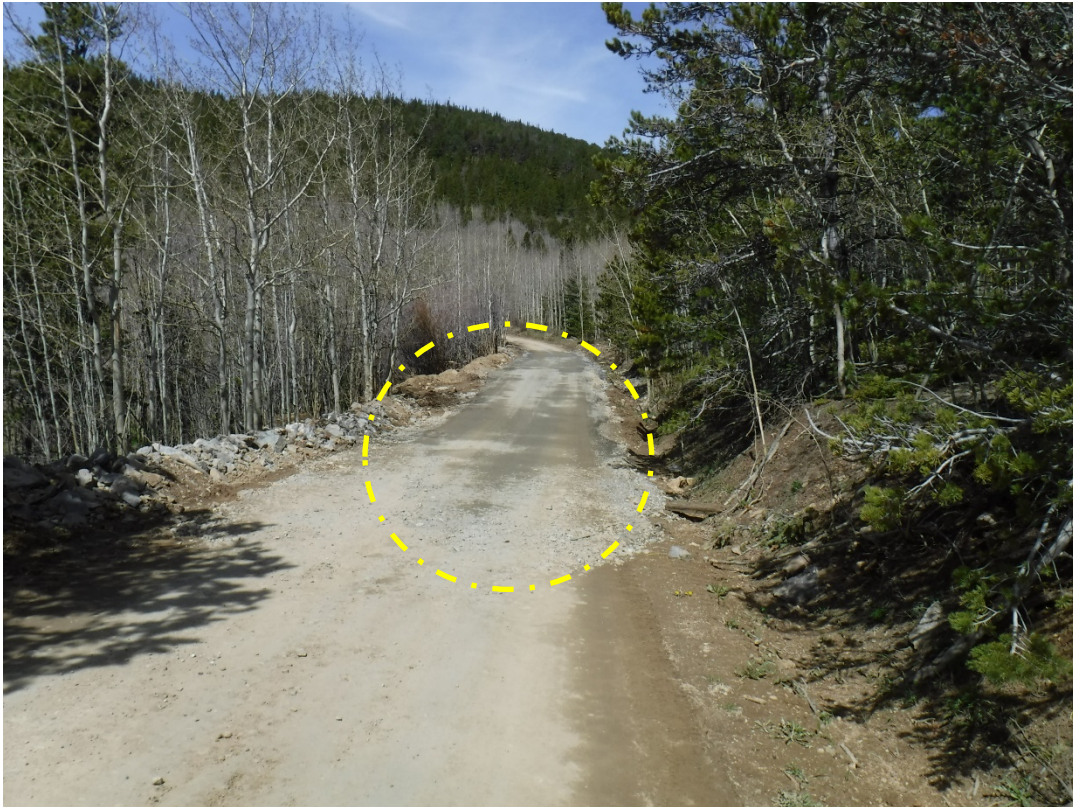
Also observed were some road maintenance areas where imported material was placed. The imported material was hauled to the site via dump trucks and the increased in truck traffic was the subject of a brief public inquiry with the Division. One particular road maintenance item was a stretch of road along the southern access road that was usually submerged during periods of runoff. The road was upgraded to get rid of the submerge area, promote proper drainage and enable traffic to pass without getting stuck in the mud.

Photo 4: Road repair, yellow outline, along the southern access road

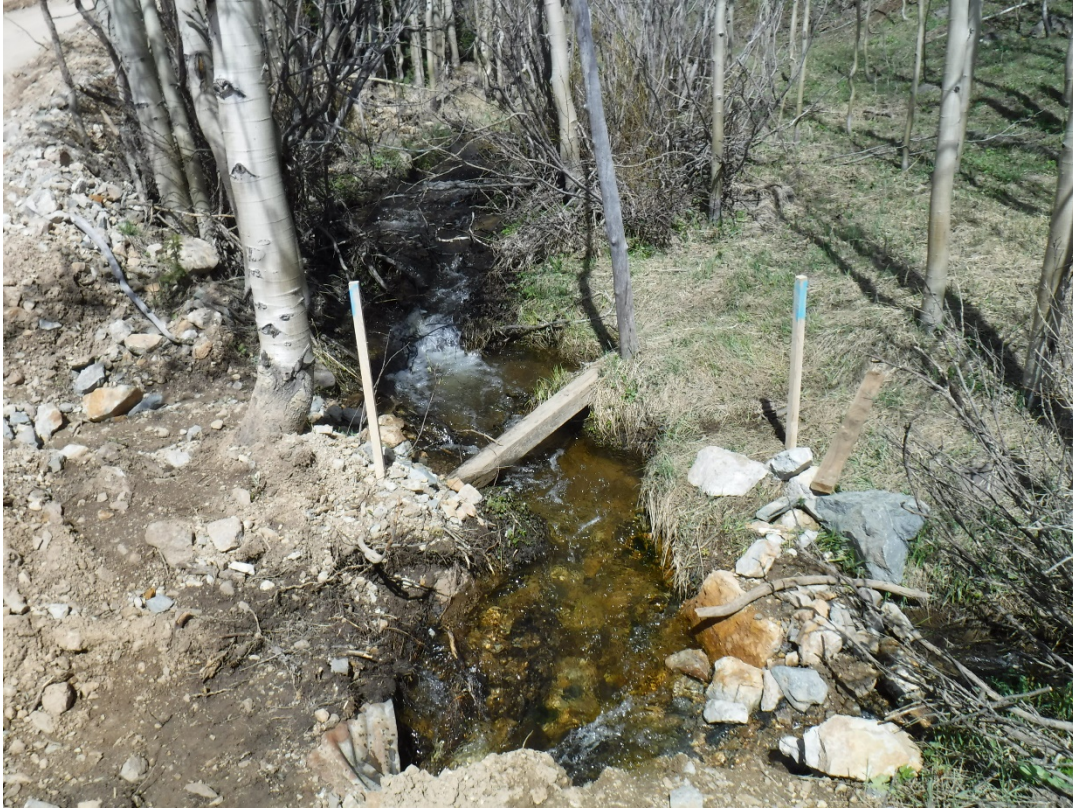
Photo 5: Downgradient surface water sampling location

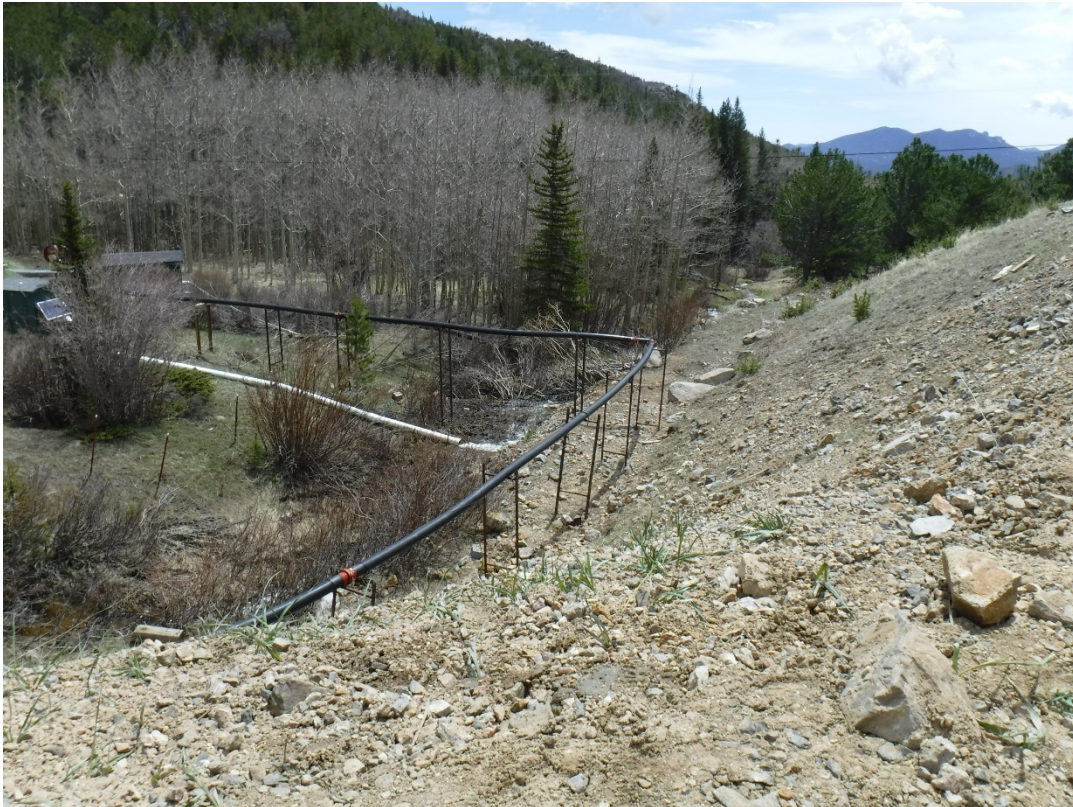
Photo 6: Elevated pipeline that goes from the water treatment to the discharge shed then to the WQCD discharge point to Coon Track Creek

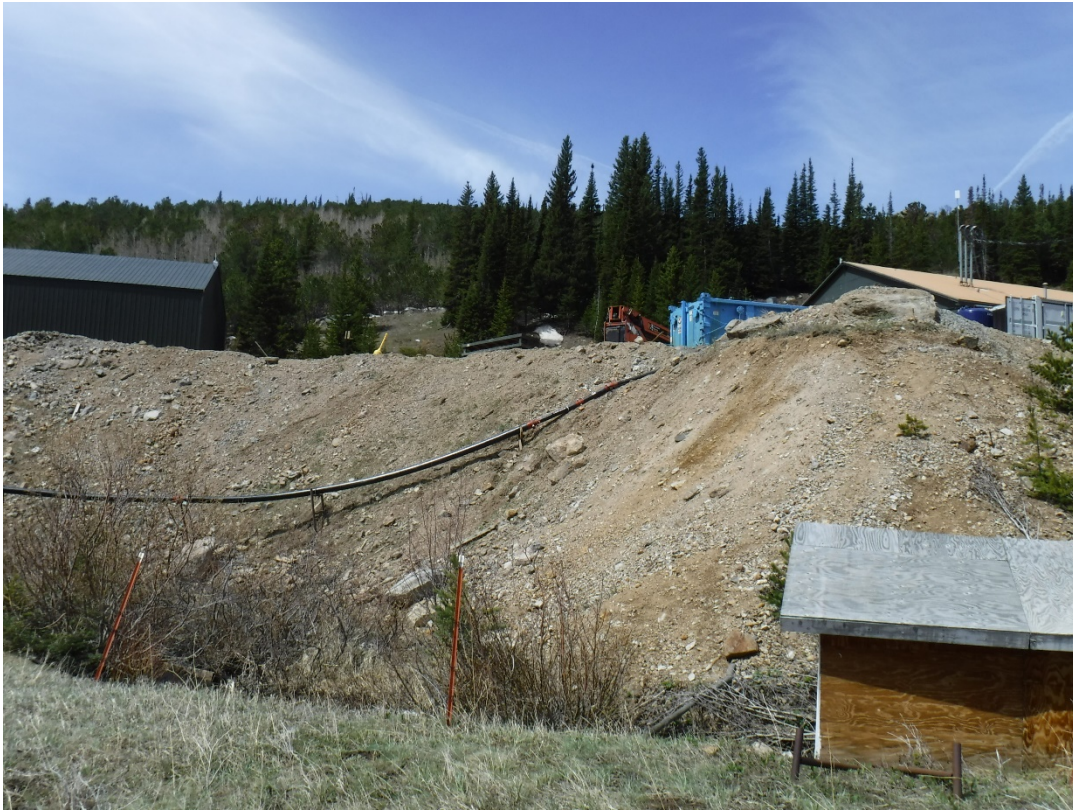
1. Where the water treatment conex box is located the operator would like to expand the parking lot to alleviate a congested area and make the area safer for equipment and personnel. Additionally, expanding the parking area would allow for better stabilization of the elevated discharge pipeline and prevent snow sloughing into the pipeline foundations resulting in damage of the pipeline.

Photo 7: Elevated pipeline, water treatment conex to the right of photo

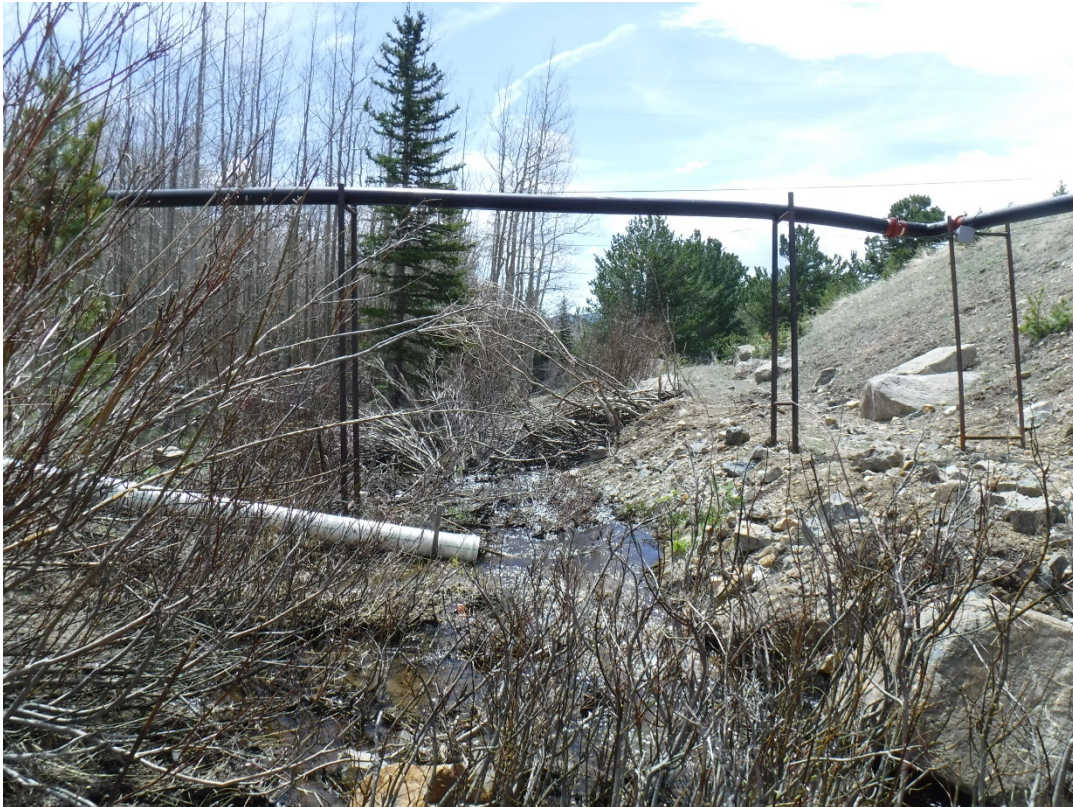
Photo 8: Permitted discharge point to Coon Track is at the outfall from the white PVC pipe

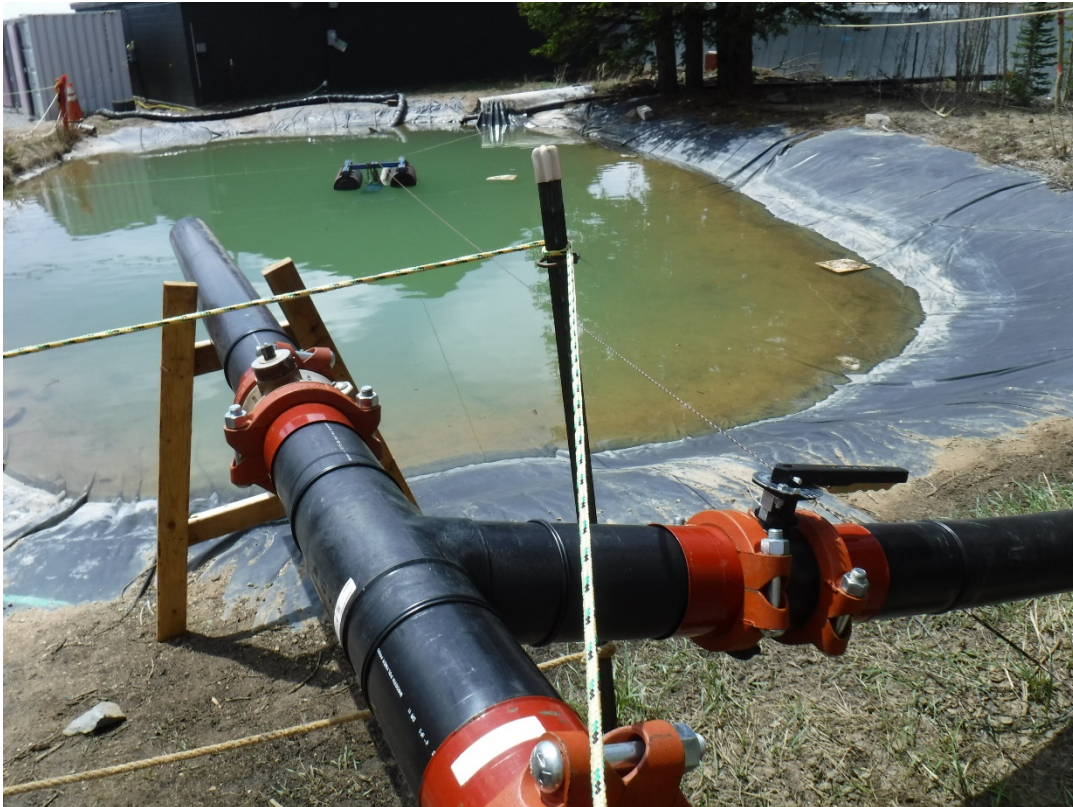
Photo 10: Pond 1 showing the outfall from Pond 3c, the T-fitting directs flow to Juliet Raise during high runoff

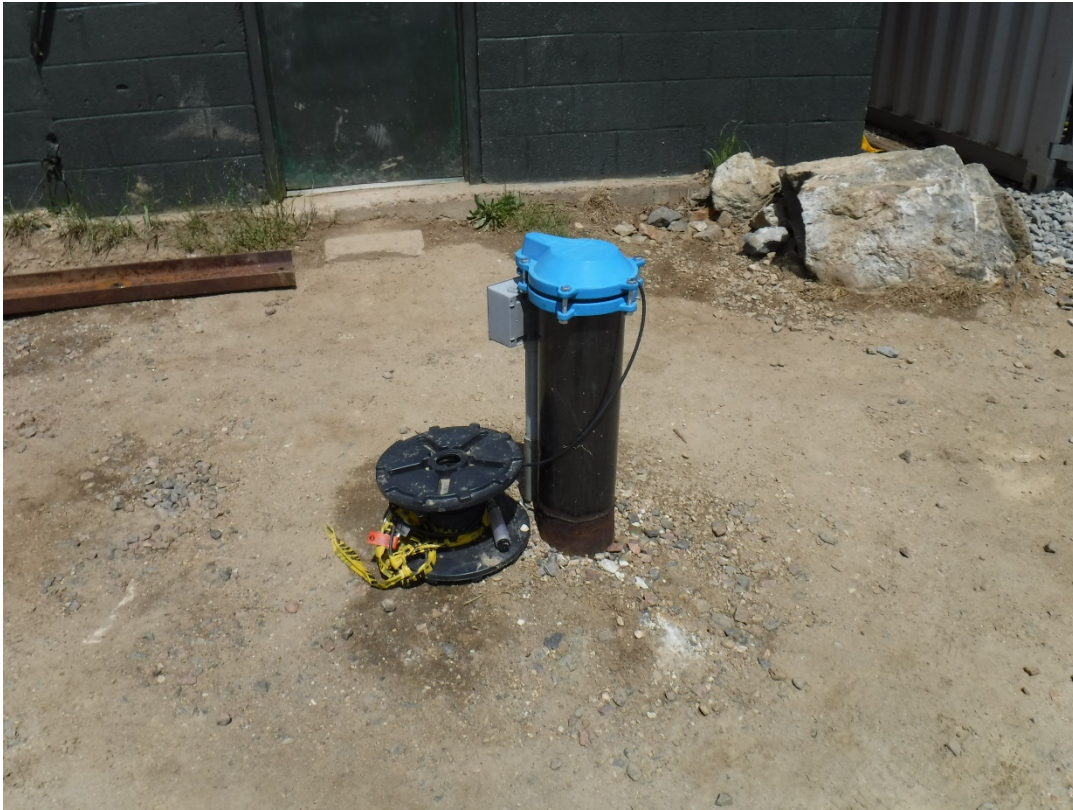
Photo 11: Cross Well, groundwater sampling location, near the water treatment conex

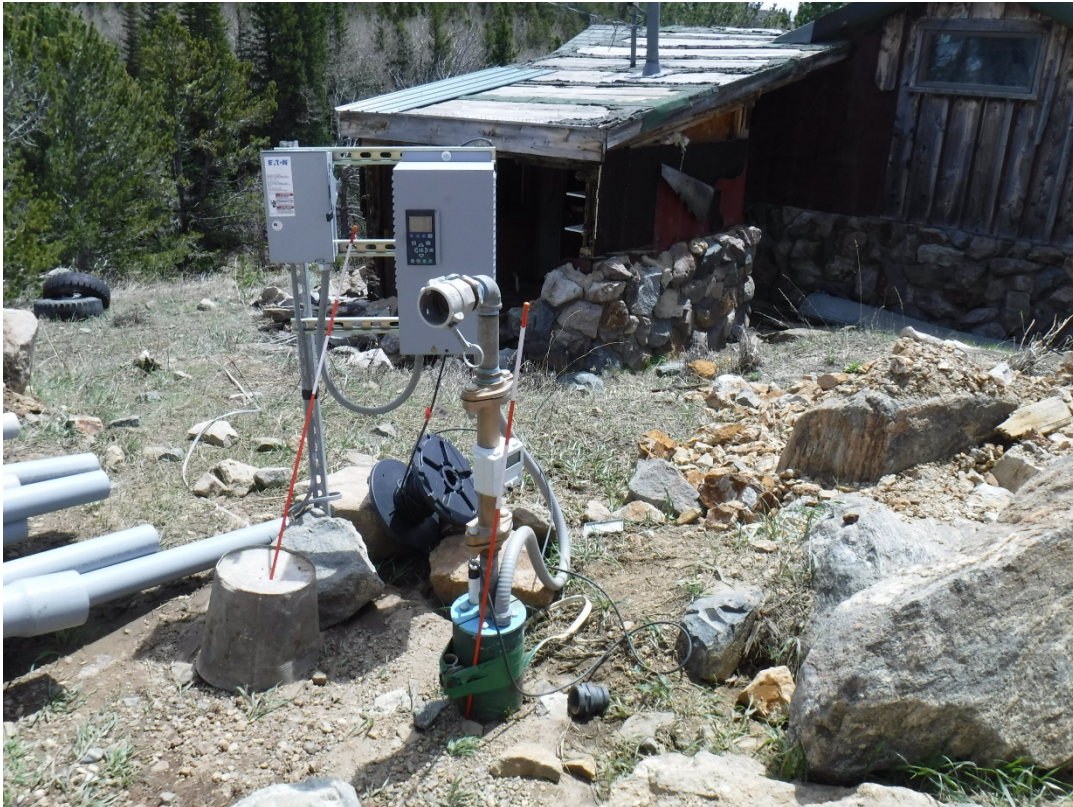
Photo 12: Cabin Well, groundwater sampling location, near the southern permit boundary

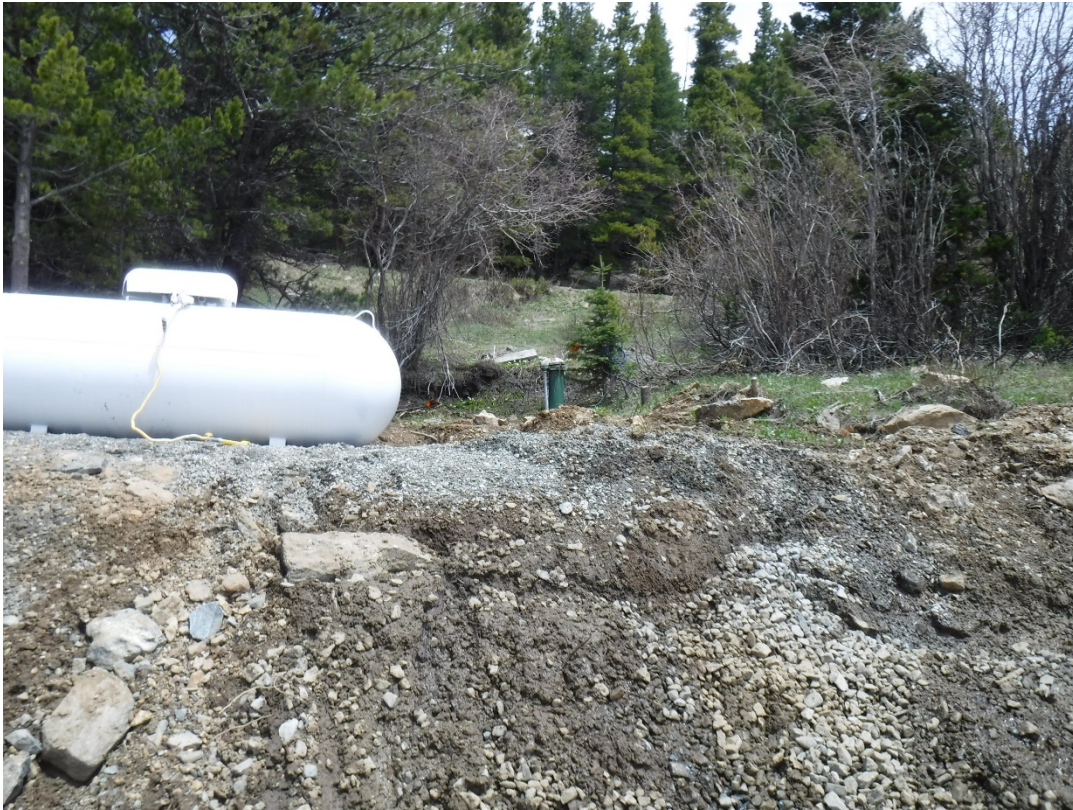
Photo 13: Caribou Well, groundwater sampling location, near the main mine offices

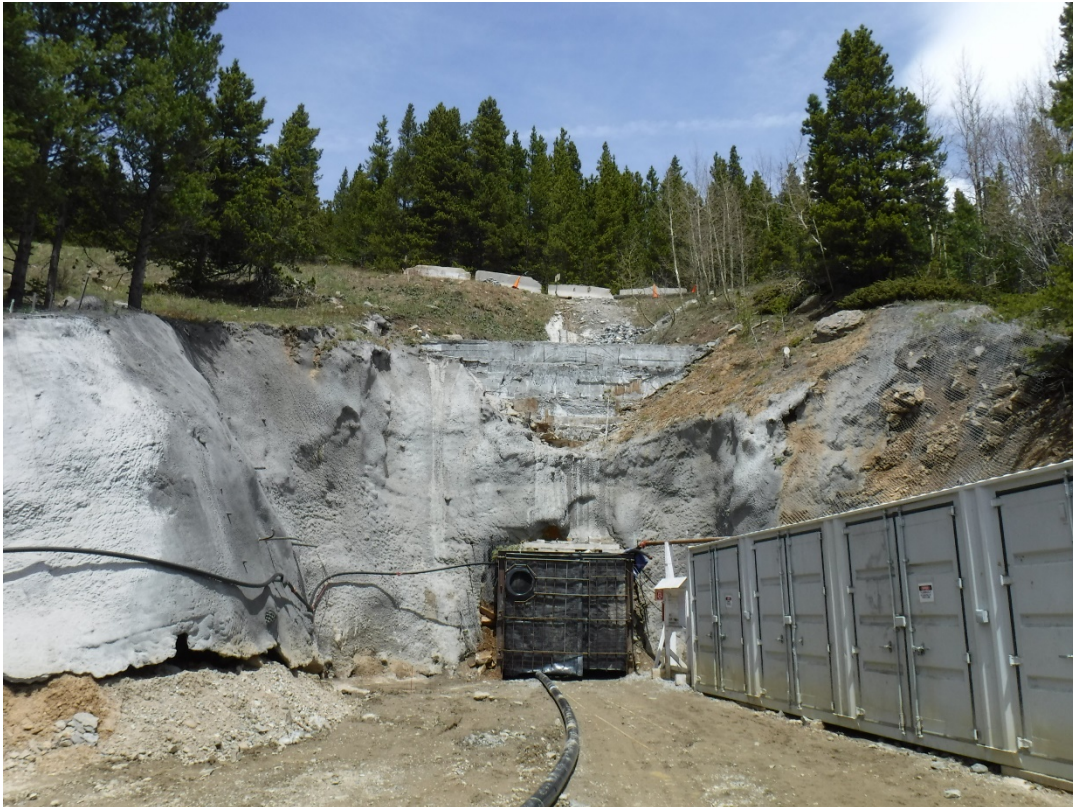
4. Begin work at the Caribou Mine (Idaho Tunnel) entrance to reclaim the hillside to 2H:1V or match the existing slope contours by installing a shed over the portal entry that would also allow for the ability to control air-flow in and out of the mine entrance. Being able to control air flow into the mine will help eliminate ice build-up in the mine making it a safer work environment. Work in the area would ensure long-term stability and water management of the mine effluent to be routed to a discharge shed before entering Pond 3a where parameters would be continually monitored. The shed will also reclaim the area to a more aesthetically pleasing condition for the public passing along the adjacent Caribou Road.

Photo 14: Caribou Mine (Idaho Tunnel) entrance

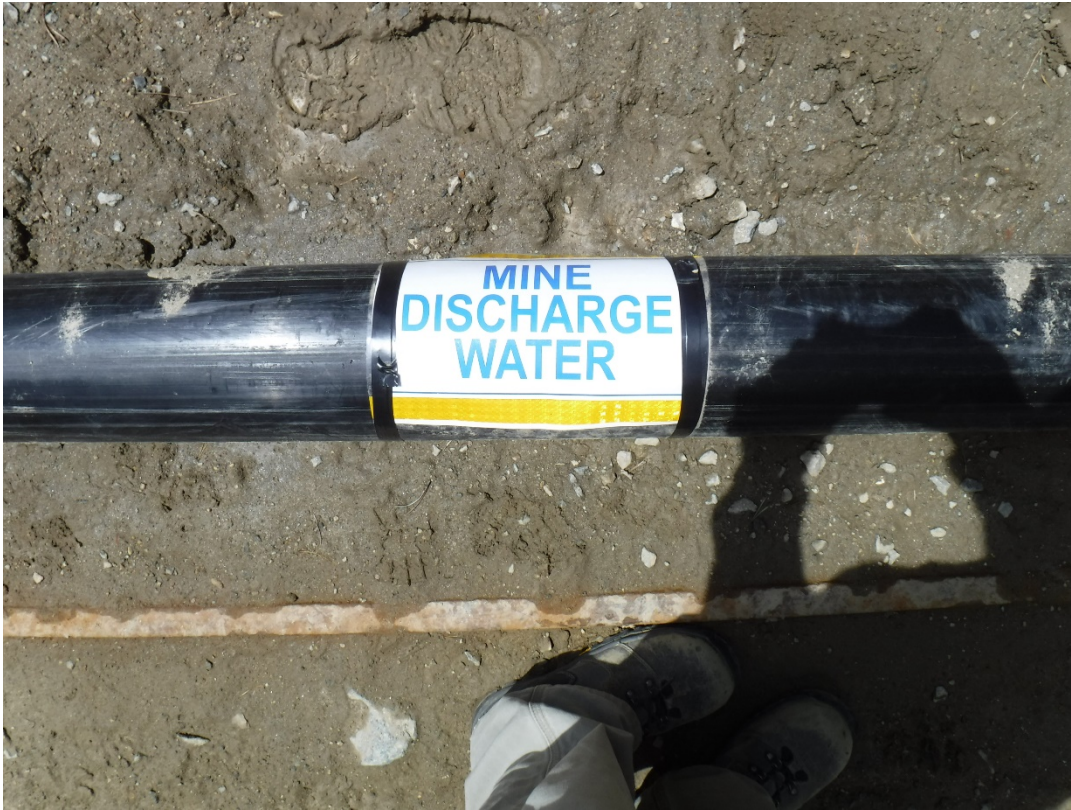
Photo 15: Mine effluent coming from the Caribou Mine

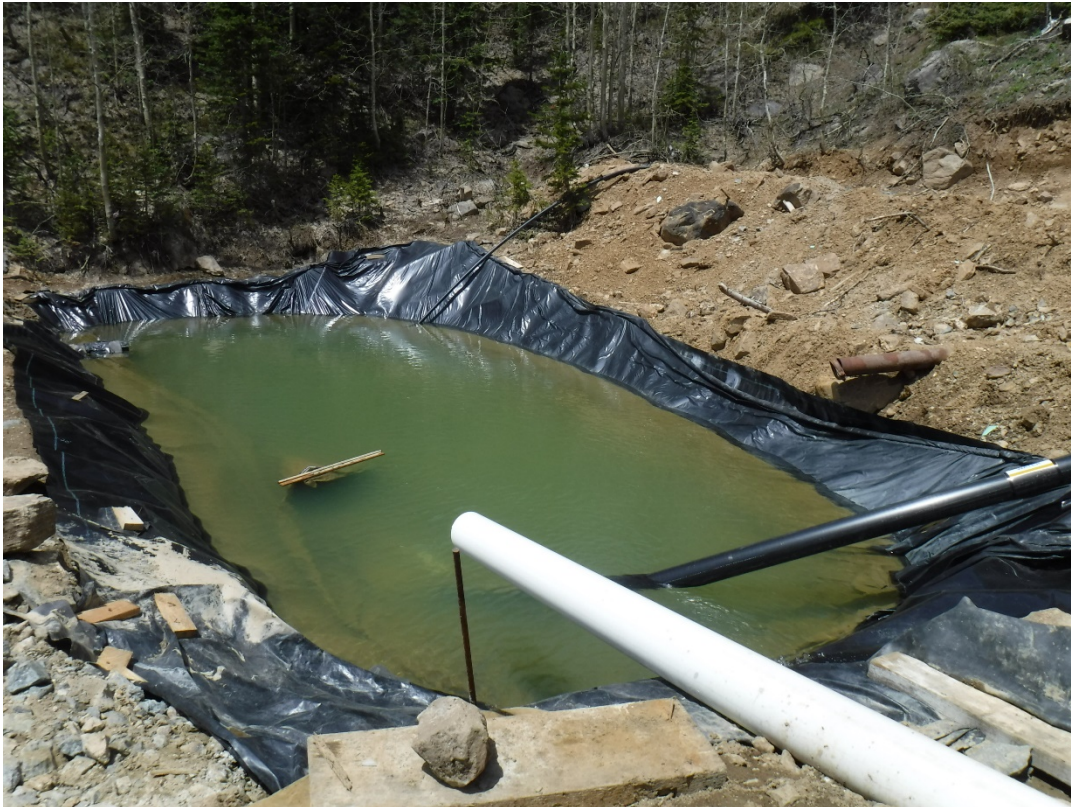
Photo 16: Pond 3a, first settling pond receiving effluent from the Caribou Mine

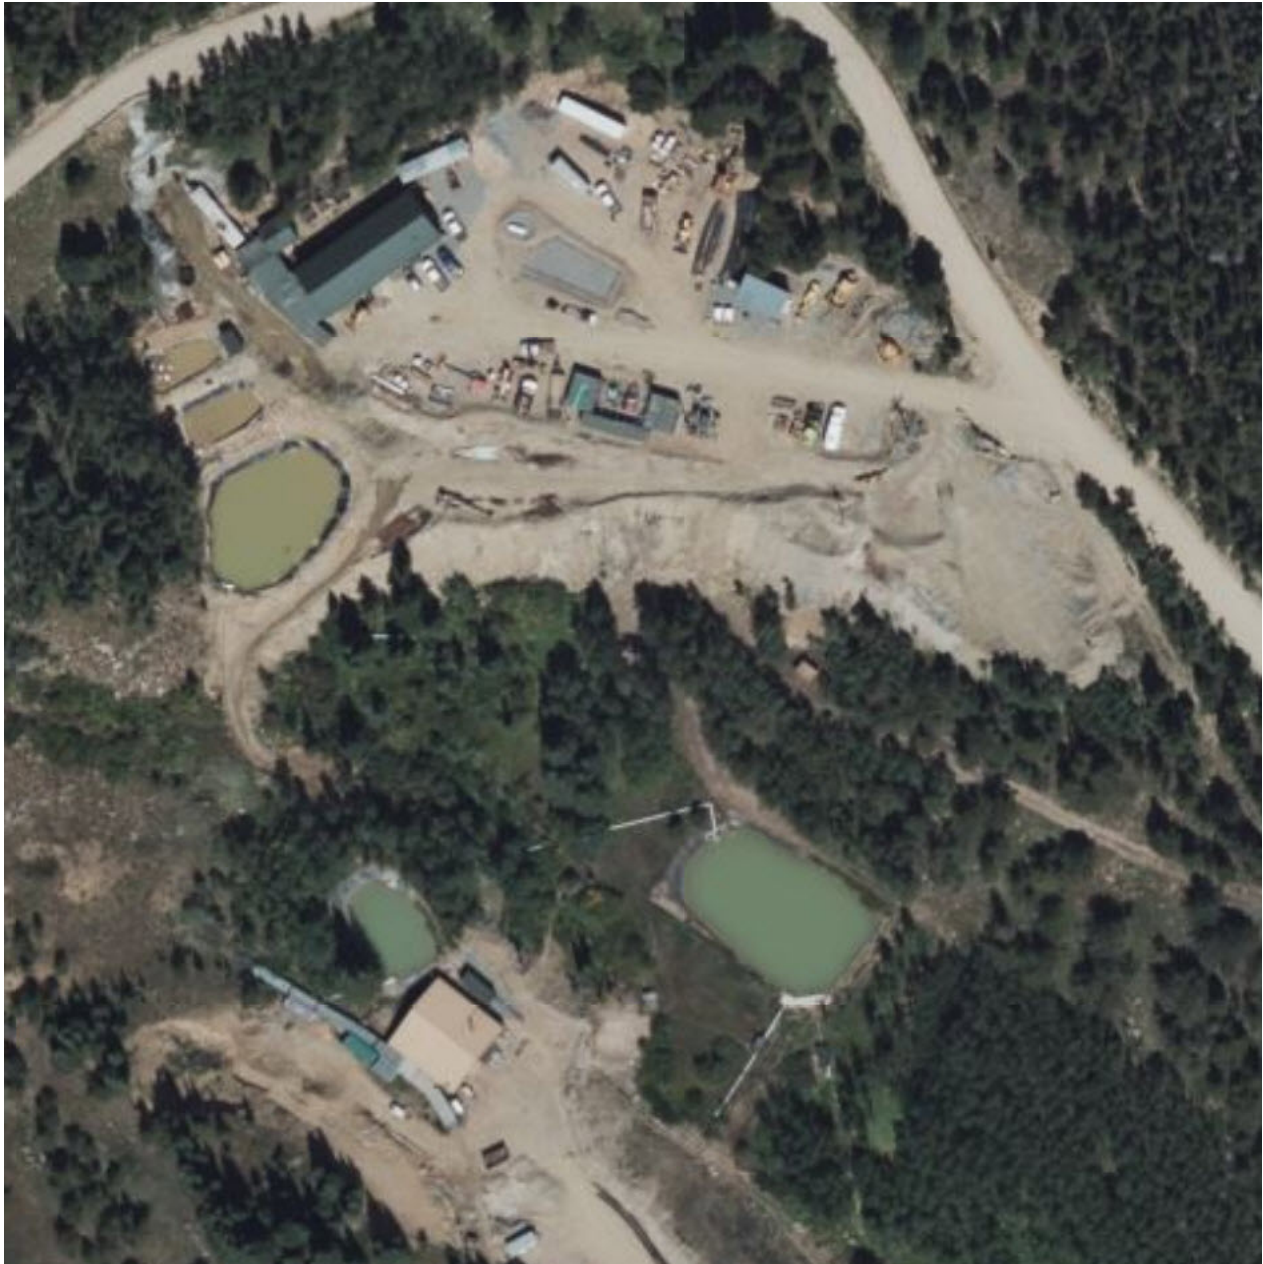
Photo 17: Aerial image of the main mine area showing the ponds and other features.
