PERMIT INFORMATION

Permit Number: C-1981-038 Mine Name: Bowie No. 1 Mine Operator: Bowie Resources, LLC Operator Address: Mr. Basil R Bear P.O. Box 1488 Paonia, CO 81428	County: Delta Operation Type: Underground Permit Status: Active Ownership: Private
	Operator Representative Present: None
Operator Representative Signature: (Field Issuance Only)

INSPECTION INFORMATION

Inspection Start Date: June 8, 2022 Inspection Start Time: 12:35 Inspection End Date: June 8, 2022 Inspection End Time: 13:25		Inspection Type: Coal Partial Inspection Inspection Reason: Normal I&E Program Weather: Clear	
Joint Inspection Agency: None		Joint Inspection Contacts: 	
Post Inspection Agency: None		Post Inspection Contacts: 	
Inspector(s): Robert Zuber, P.E.	Inspector's Signature: <i>Robert D. Zuber</i>		Signature Date: 6/9/2022

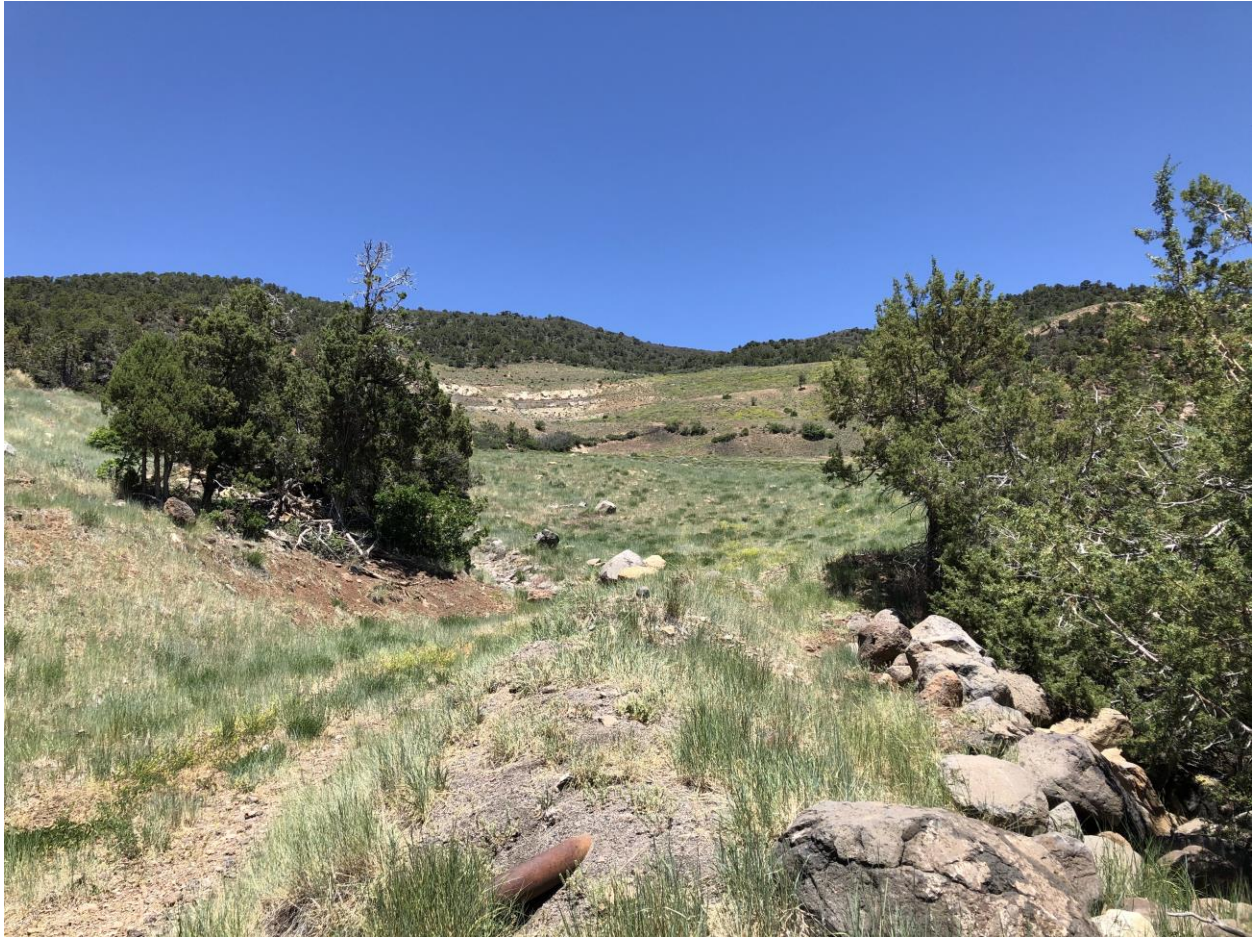
East Mine, taken from location next to the RDA

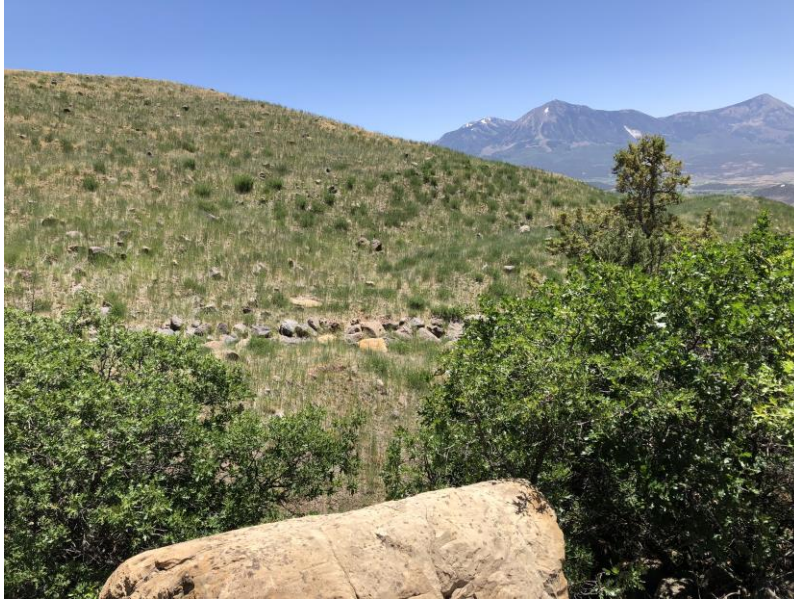
West side of the RDA, with good vegetation cover

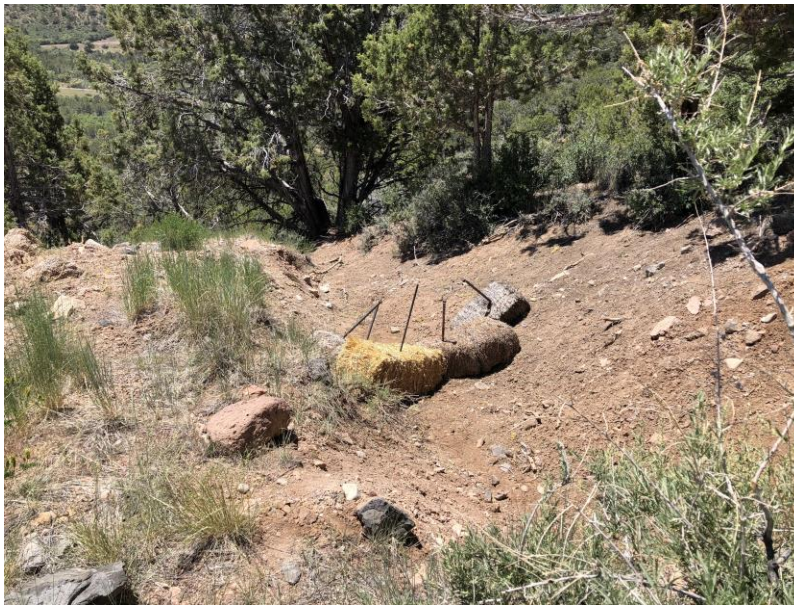
Near the first bend in the haul road west of the RDA, straw bales in the ditch have been replaced.

Straw bales in ditch next to road to portals
