Permit Number: C-1996-083 Mine Name: Bowie No. 2 Mine Operator: Bowie Resources, LLC Operator Address: Mr. Basil Bear P.O. Box 1488 Paonia, CO 81428	County: Delta Operation Type: Underground Permit Status: Active Ownership: Private
	Operator Representative Present: Basil Bear
Operator Representative Signature: (Field Issuance Only)

Inspection Start Date: June 8, 2022 Inspection Start Time: 11:00 Inspection End Date: June 8, 2022 Inspection End Time: 12:30		Inspection Type: Coal Partial Inspection Inspection Reason: Normal I&E Program Weather: Clear	
Joint Inspection Agency: None		Joint Inspection Contacts: 	
Post Inspection Agency: None		Post Inspection Contacts: 	
Inspector(s): Robert Zuber, P.E.	Inspector's Signature: <i>Robert D. Zuber</i>		Signature Date: 6/9/2022

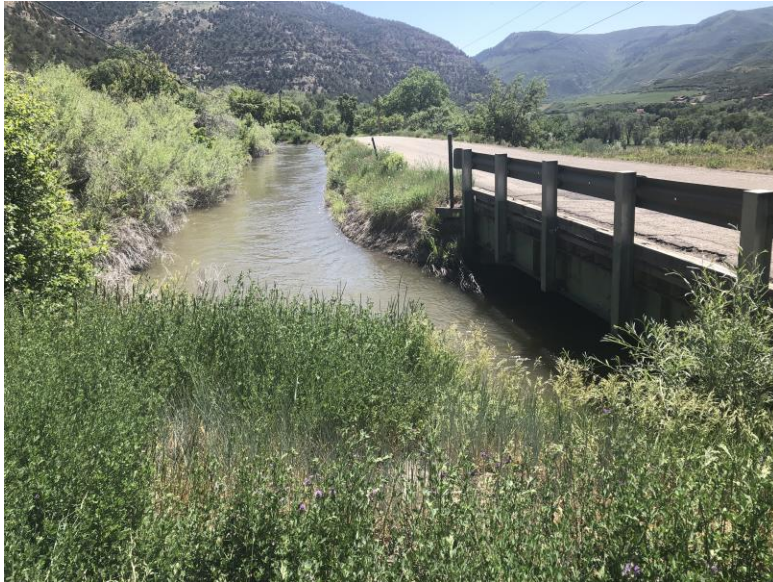
Fire Mountain Canal below Pond F

The Fire Mountain Canal was flowing full.

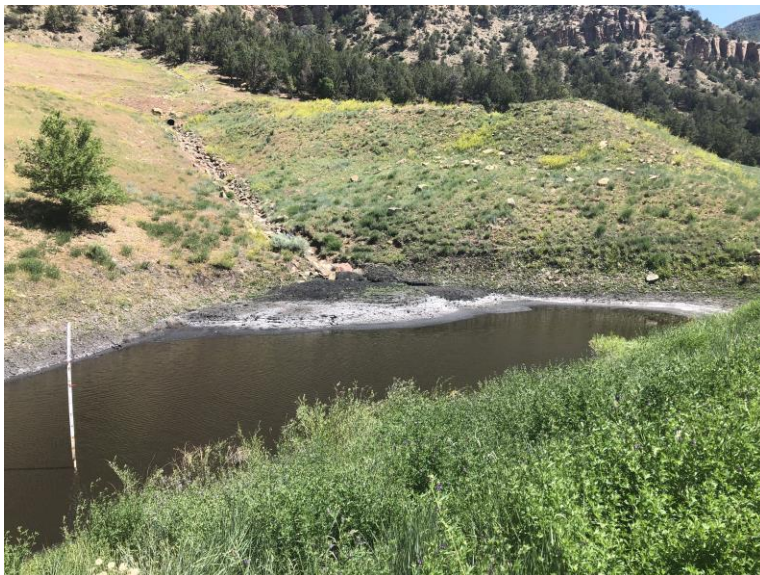
Two sediment ponds were inspected: Pond C and Pond F. They were not discharging. Pond C was dry, and Pond F was not close to full. No significant problems were identified with embankments, spillways, inlet channels, or other features of the ponds.

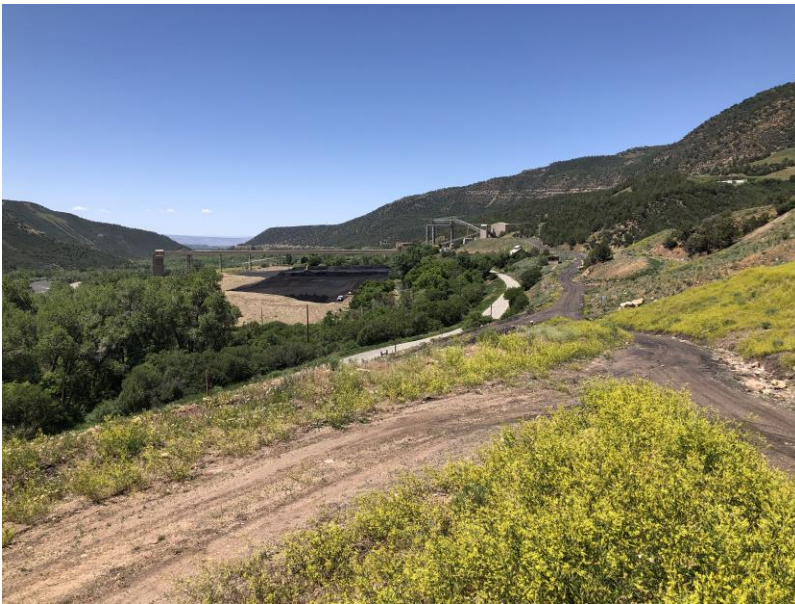
Looking west at Gob Pile #3 and facilities area

Gob Piles 1, 3, and 4 were observed from afar. Gob piles 1 and 4 appeared stable. No problems were identified with Gob Pile #3.

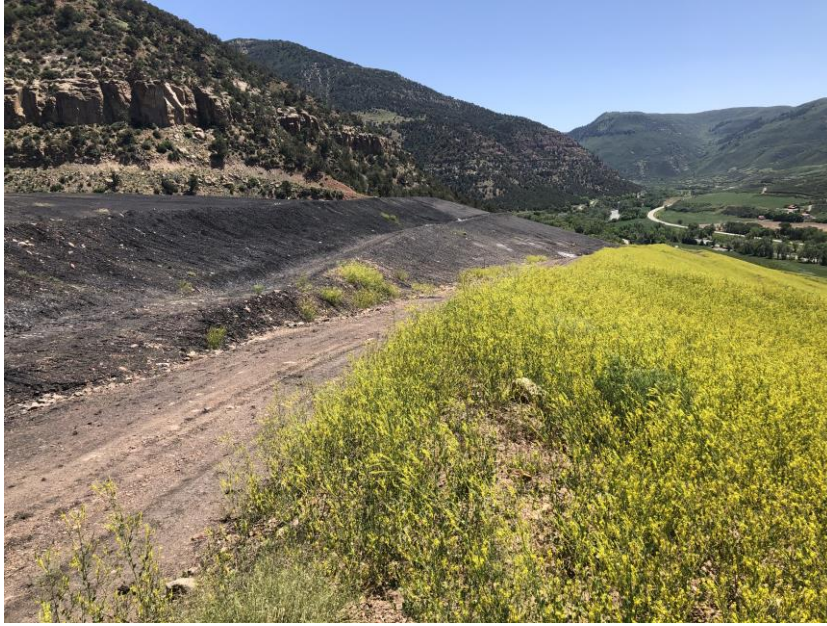
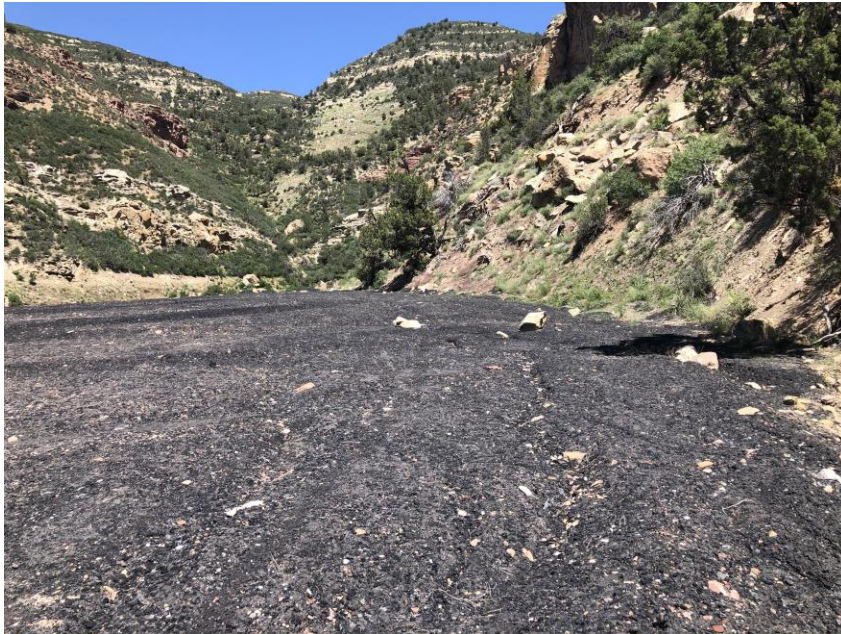
Rills were visible on the upper (bare) slopes of Gob Pile #2, but they are small. No puddles or other problems were observed on the upper, flat portion of this pile. The hill above this pile appears stable. The lower slopes of this pile were mostly covered with yellow sweet clover.

Gob Pile #2, looking east at upper slopes

Gob Pile #2, east side of unreclaimed upper area, with hillside above in the background

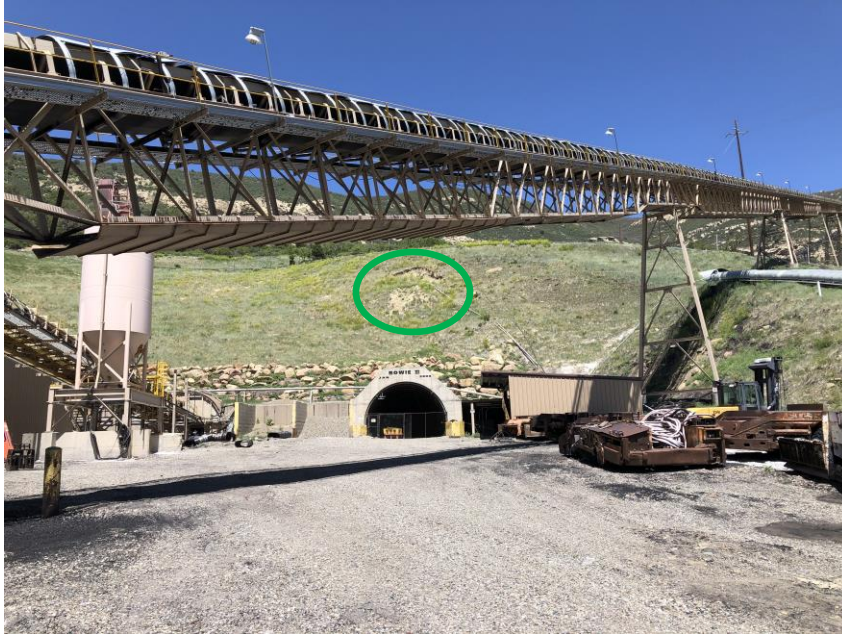
It appears that slumps have not moved significantly in the recent past. These include slumps by the B Portal and by Curve Number 11 along the Haul Road. The Division recommends that these continue to be monitored closely by BRL.

B Portal bench (slump circled)

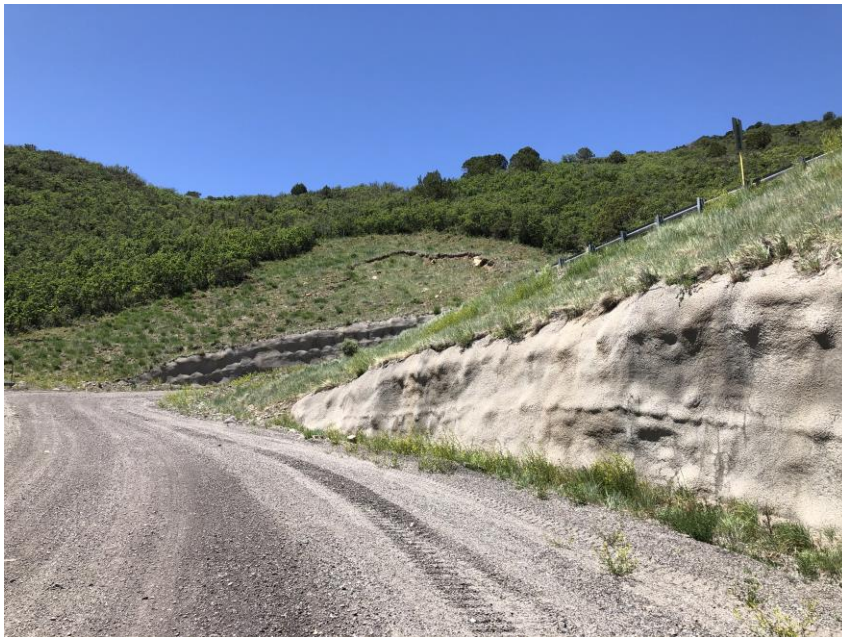
Slump at Curve 11

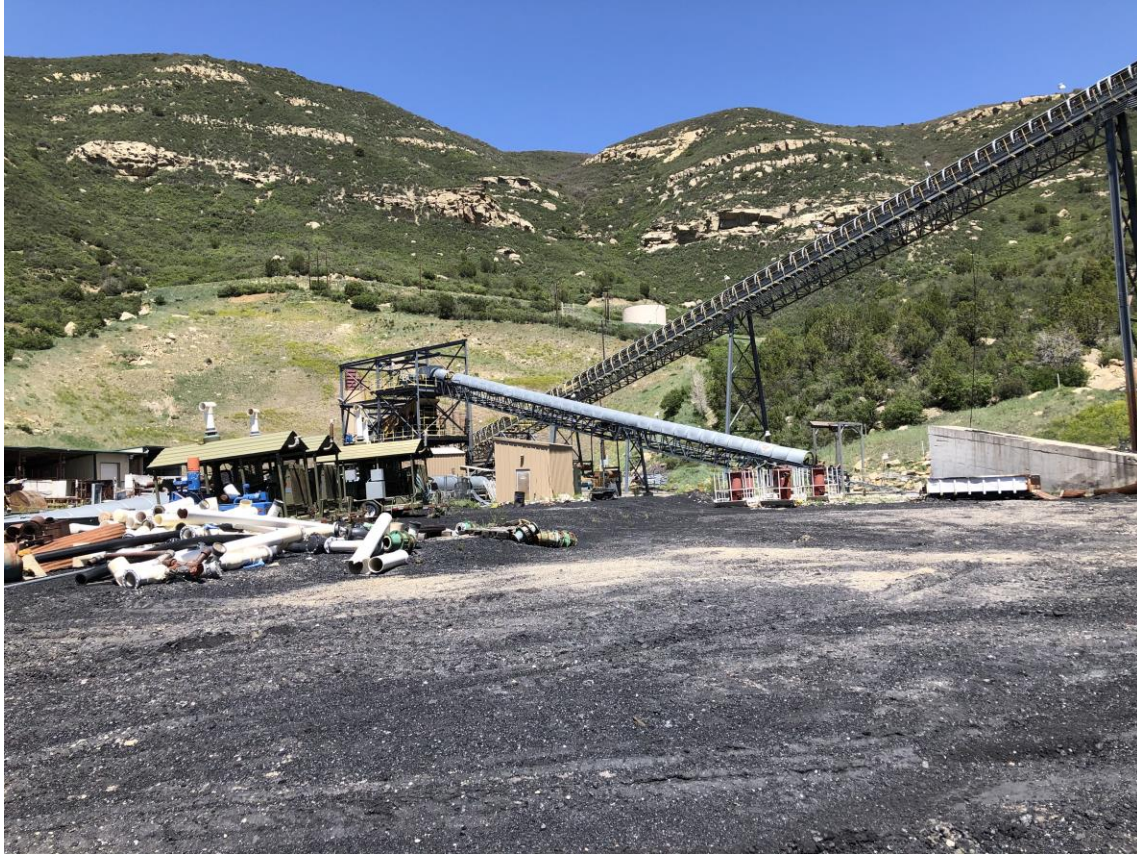
D Portal bench and hillside below Utility Bench

All benches appeared stable with no signs of erosion. These include the pads for the Utility Bench, B Portal bench and the D Portal bench. Other comments on facilities:
