**MINERALS PROGRAM INSPECTION REPORT**  
**PHONE: (303) 866-3567**

<b>MINE NAME:</b> Mesa Gravel Pit	<b>MINE/PROSPECTING ID#:</b> M-1982-036	<b>MINERAL:</b> Sand and gravel	<b>COUNTY:</b> Routt
<b>INSPECTION TYPE:</b> Monitoring	<b>INSPECTOR(S):</b> Tabetha Lynch	<b>INSP. DATE:</b> May 25, 2022	<b>INSP. TIME:</b> 12:00
<b>OPERATOR:</b> Peabody Sage Creek Mining, LLC	<b>OPERATOR REPRESENTATIVE:</b> Kevin Copeland	<b>TYPE OF OPERATION:</b> 112c - Construction Regular Operation	
<b>REASON FOR INSPECTION:</b> Normal I&E Program	<b>BOND CALCULATION TYPE:</b> Complete Bond	<b>BOND AMOUNT:</b> \$132,273.00	
<b>DATE OF COMPLAINT:</b> NA	<b>POST INSP. CONTACTS:</b> None	<b>JOINT INSP. AGENCY:</b> None	
<b>WEATHER:</b> Clear	<b>INSPECTOR'S SIGNATURE:</b>

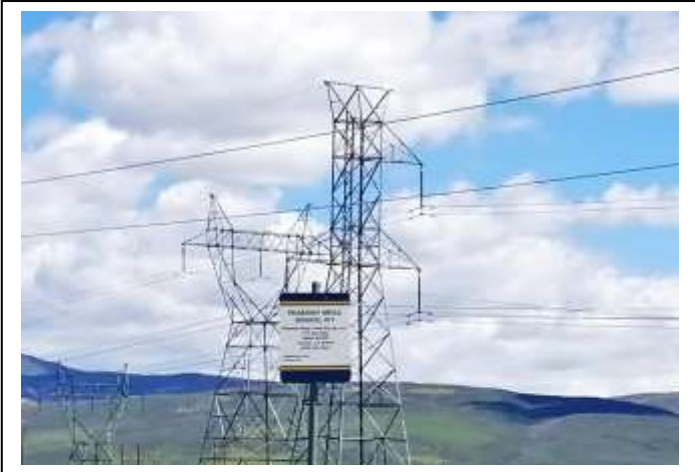
Mine ID sign

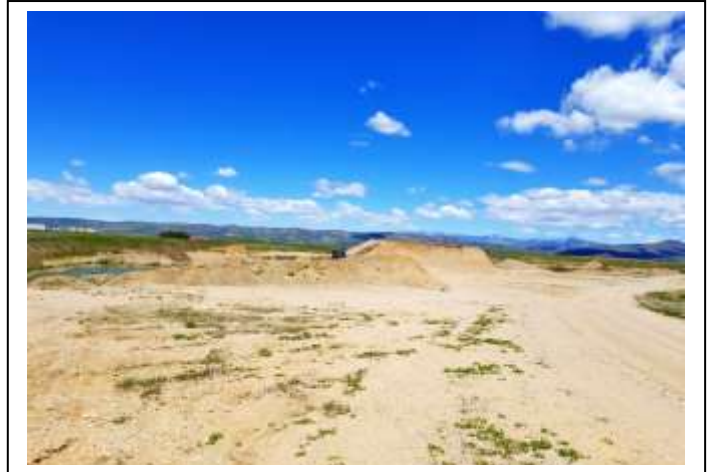
Pit overview, looking north

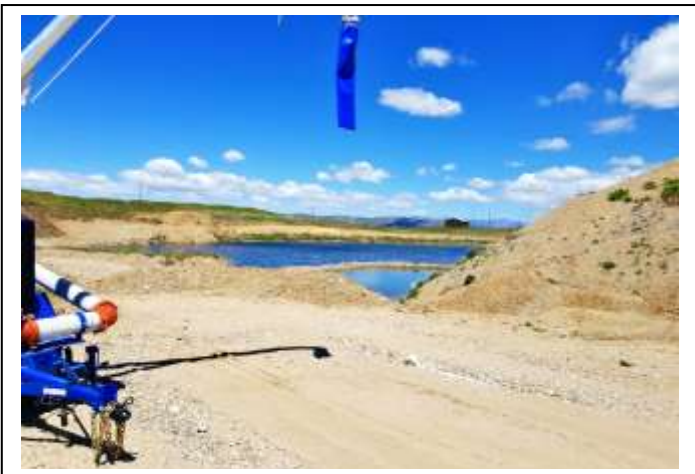
North excavated pit looking north

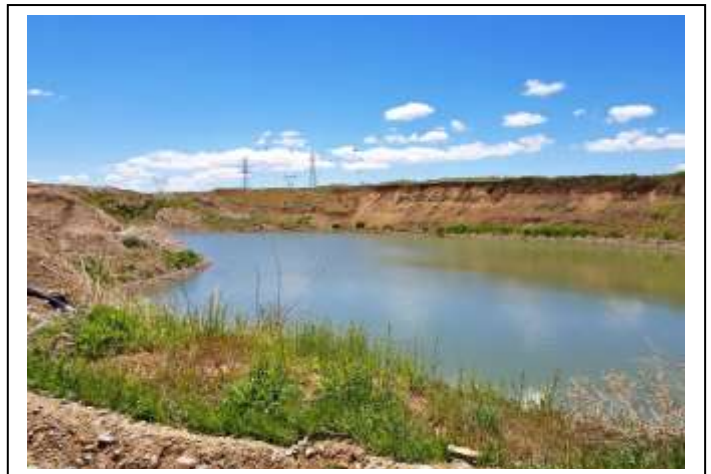
South excavated pit looking south

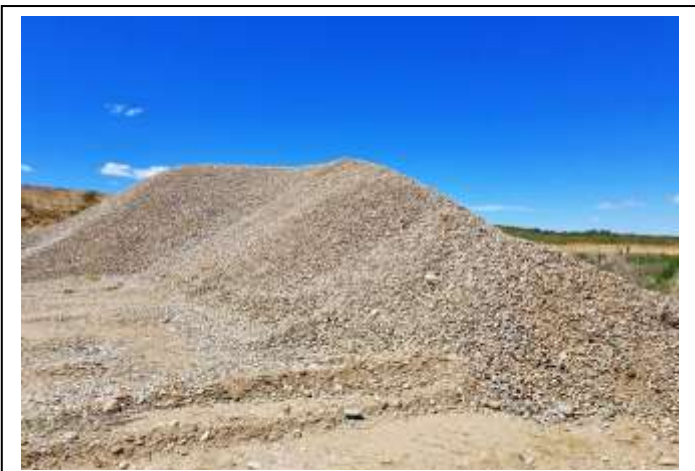
Stockpile of processed material, approximately 15 ft high

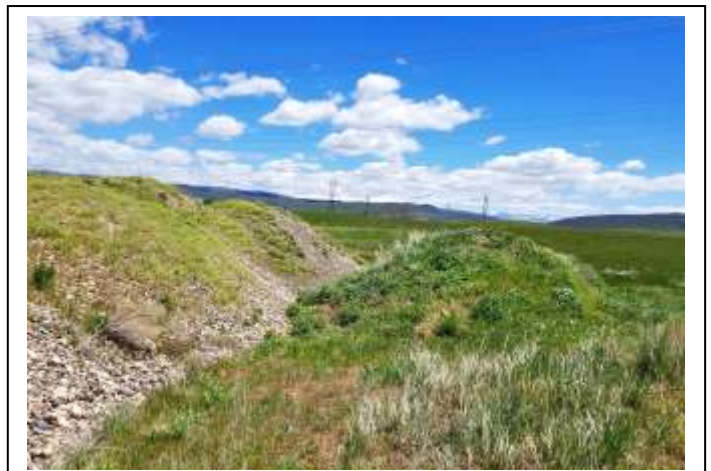
Stockpile at east side of pit. Mostly covered in cheatgrass

The Division recommends that the operator start weed treatments a weather allows. Weed treatments should occur periodically throughout the active growing season since timing and effectiveness vary by species.
