Division of Reclamation,
Mining and Safety

PERMIT INFORMATION

Permit Number: C-1981-041 Mine Name: Roadside Portals Operator: Snowcap Coal Company, Inc. Operator Address: MS Tonya Hammond P.O. Box 1430 Palisade, CO 81526	County: Mesa Operation Type: Underground Permit Status: Active Ownership: Private
	Operator Representative Present: Tonya Hammond
Operator Representative Signature: (Field Issuance Only)

Inspection Start Date: May 25, 2022 Inspection Start Time: 08:30 Inspection End Date: May 27, 2022 Inspection End Time: 10:50		Inspection Type: Coal Partial Inspection Inspection Reason: Normal I&E Program Weather: Clear	
Joint Inspection Agency: Colorado Division of Water Resources		Joint Inspection Contacts: Ben Krause	
Post Inspection Agency: None		Post Inspection Contacts: None	
Inspector(s): Clayton Wein	Inspector's Signature: <i>Clayton Wein</i>		Signature Date: 6/10/2022

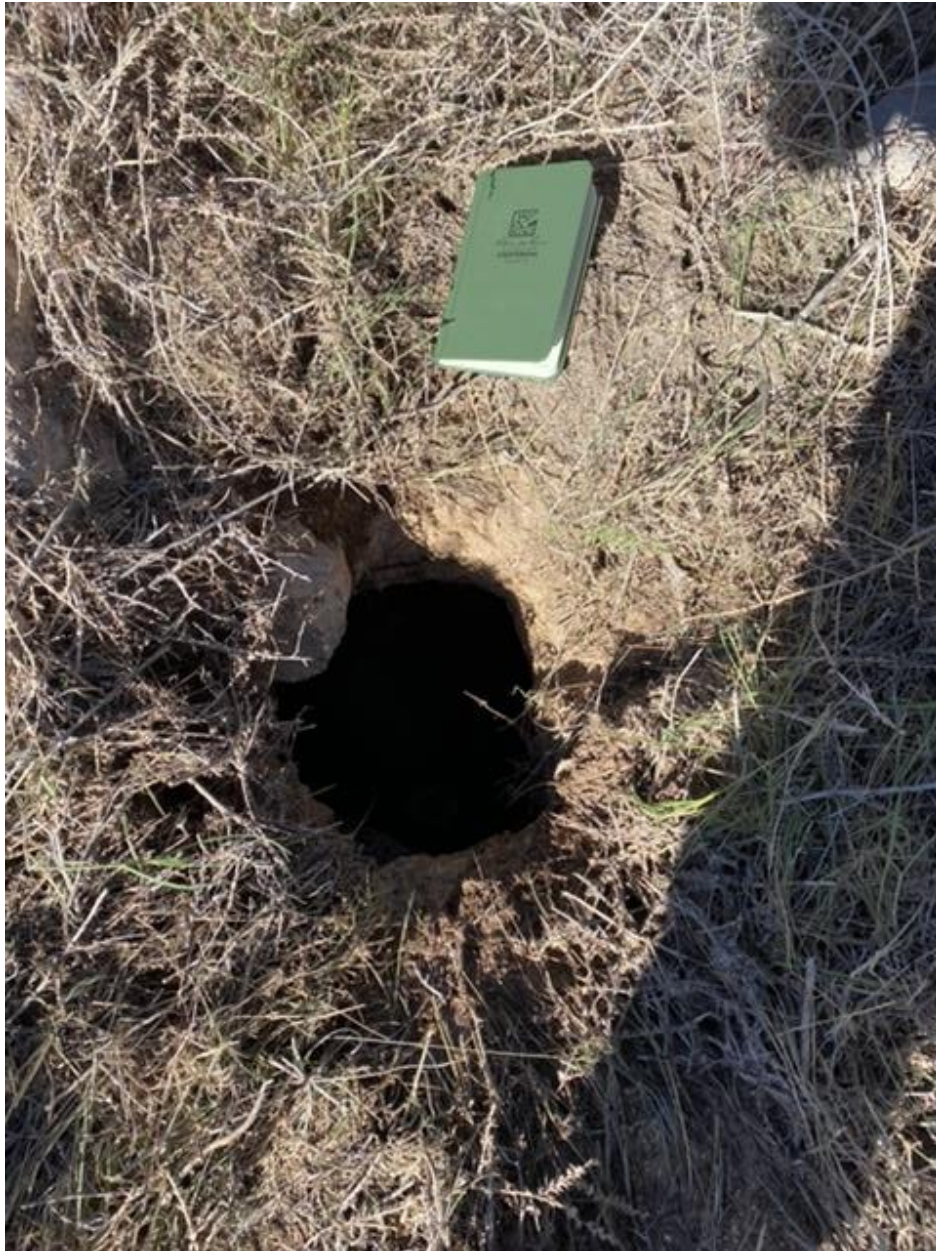
This hole was completely draining water by the end of the inspection. At the start of the inspection the hole was barely accepting any water from the ditch. This hole is the furthest west in the ditch.

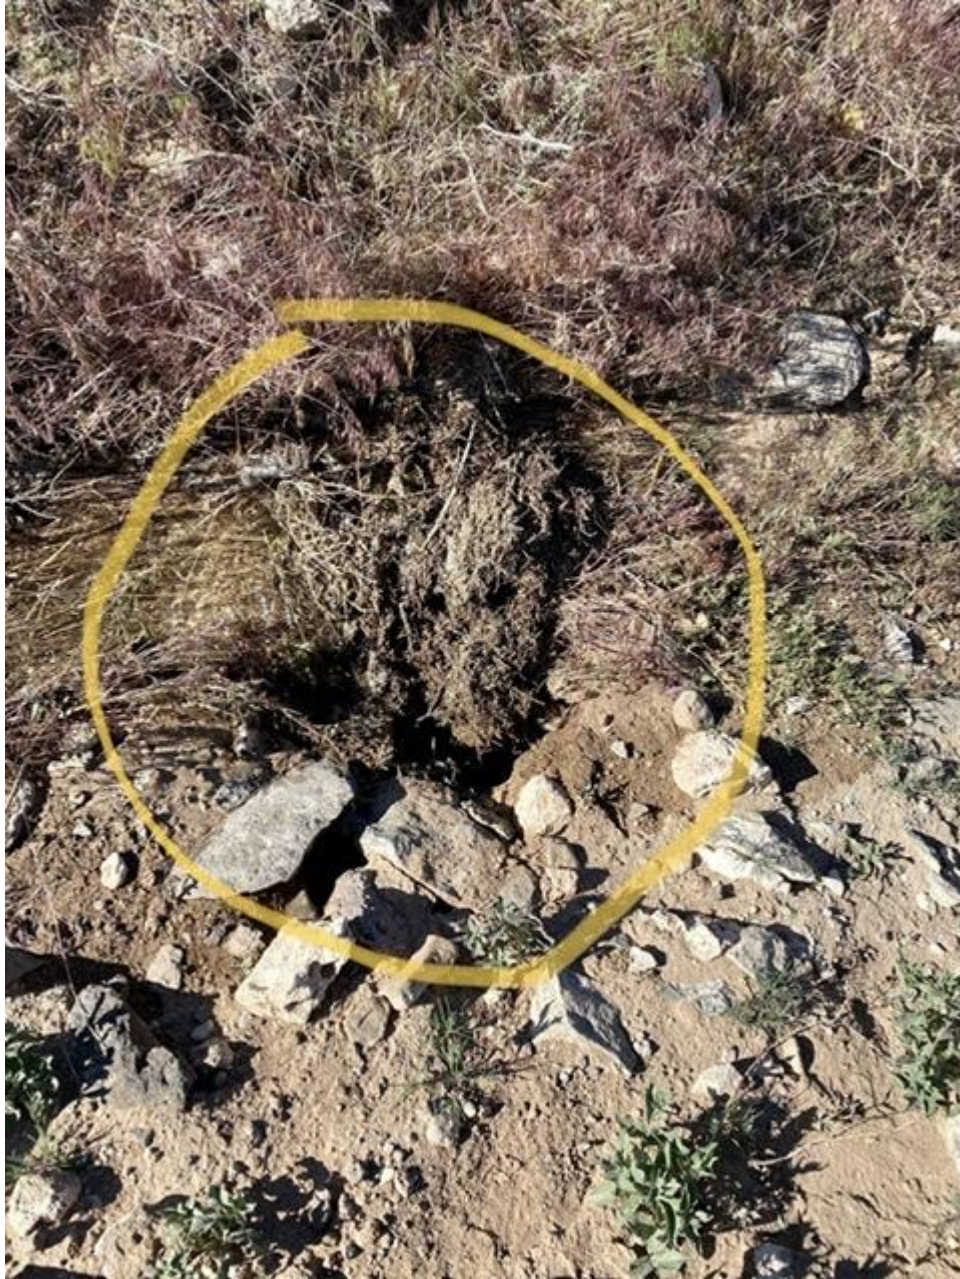
This was the second hole in the ditch the Division observed receiving water from the ditch. This hole is located approximately 10 yards to the east of the western hole. The sound of water flowing into the hole could easily be heard. Some debris was over the hole's opening but not impeding flow into the hole.

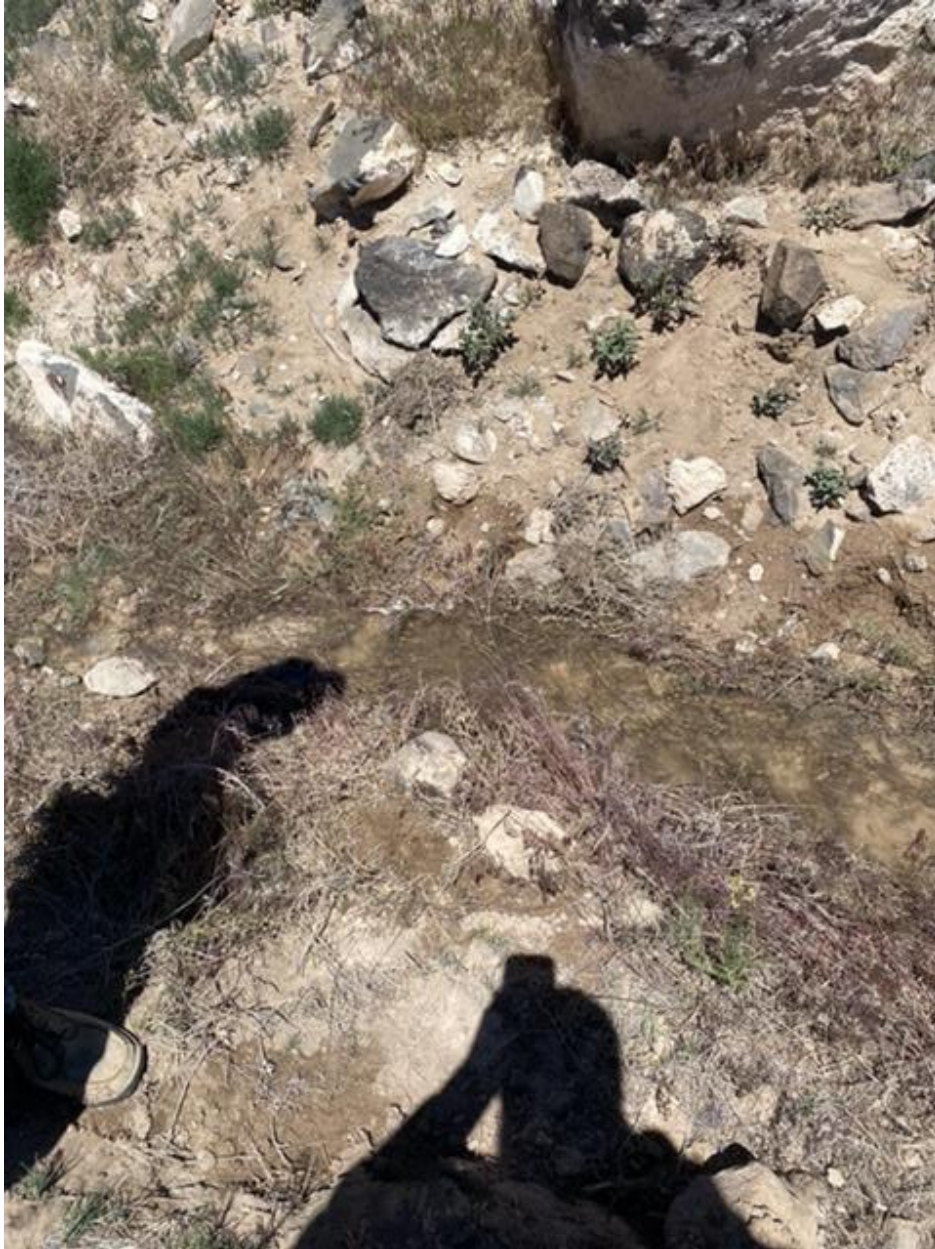
This photo was of the third hole, or the one furthest east. In the bottom of the ditch. Water was flowing into the hole and past, continuing down gradient to the other holes and towards the Ute easement.

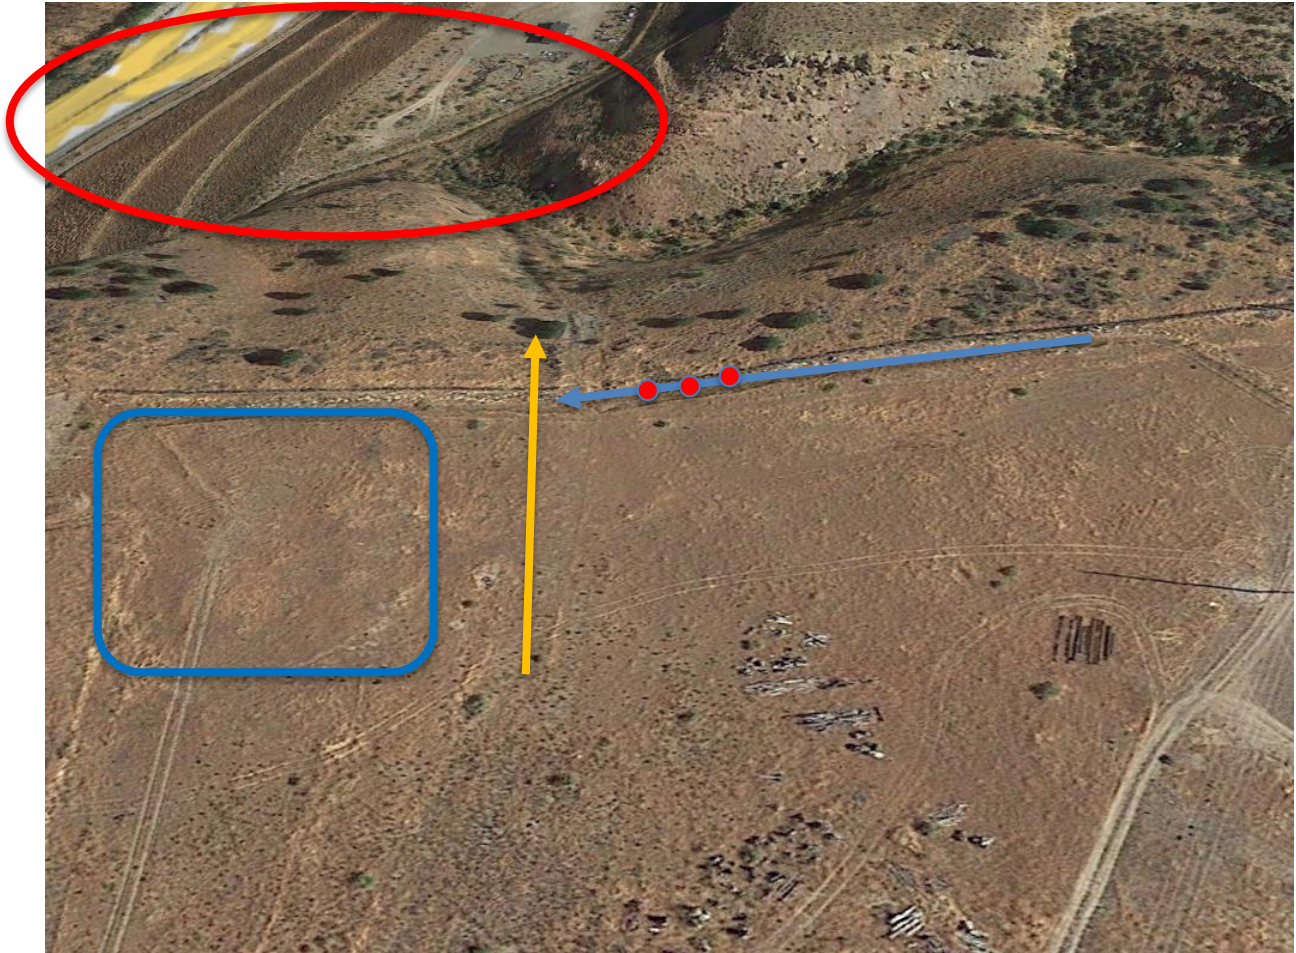
The image above shows the approximate location of the ditch observed with water flowing in it on May 25th. The Ditch and water flow are indicated by the blue arrow. The red dots on the blue line indicate the rough locations of the holes in the ditch observed during the inspection. The Orange arrow indicates the location of the Ute easement. The dark blue box shows the rough location of the TR-69 Repair Area. The reclaimed refuse pile can be identified in the red circle. Interstate 70 is located in the top left corner of the image in yellow.

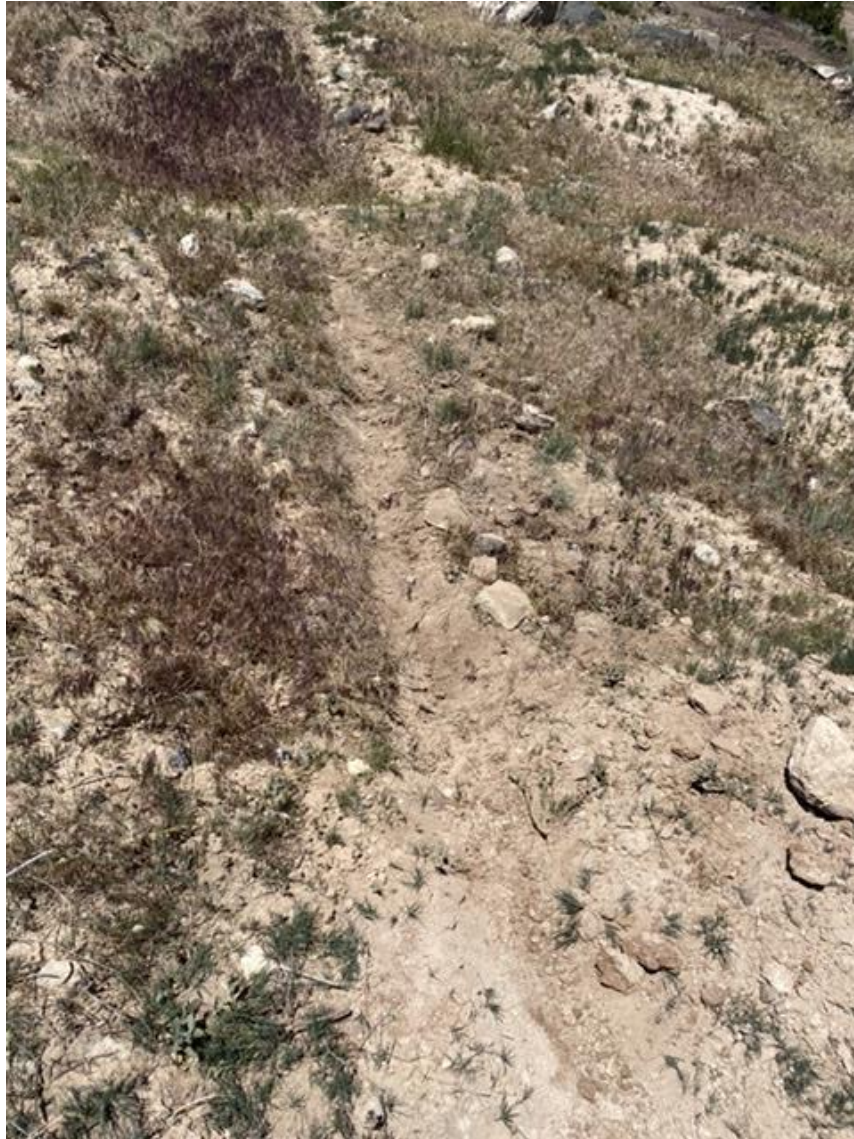
The trench in the photo above was created by one of Fontanari's workers during the inspection. This trench goes directly across the Ute Water pipeline. The trench connects the two sections of the ditch.

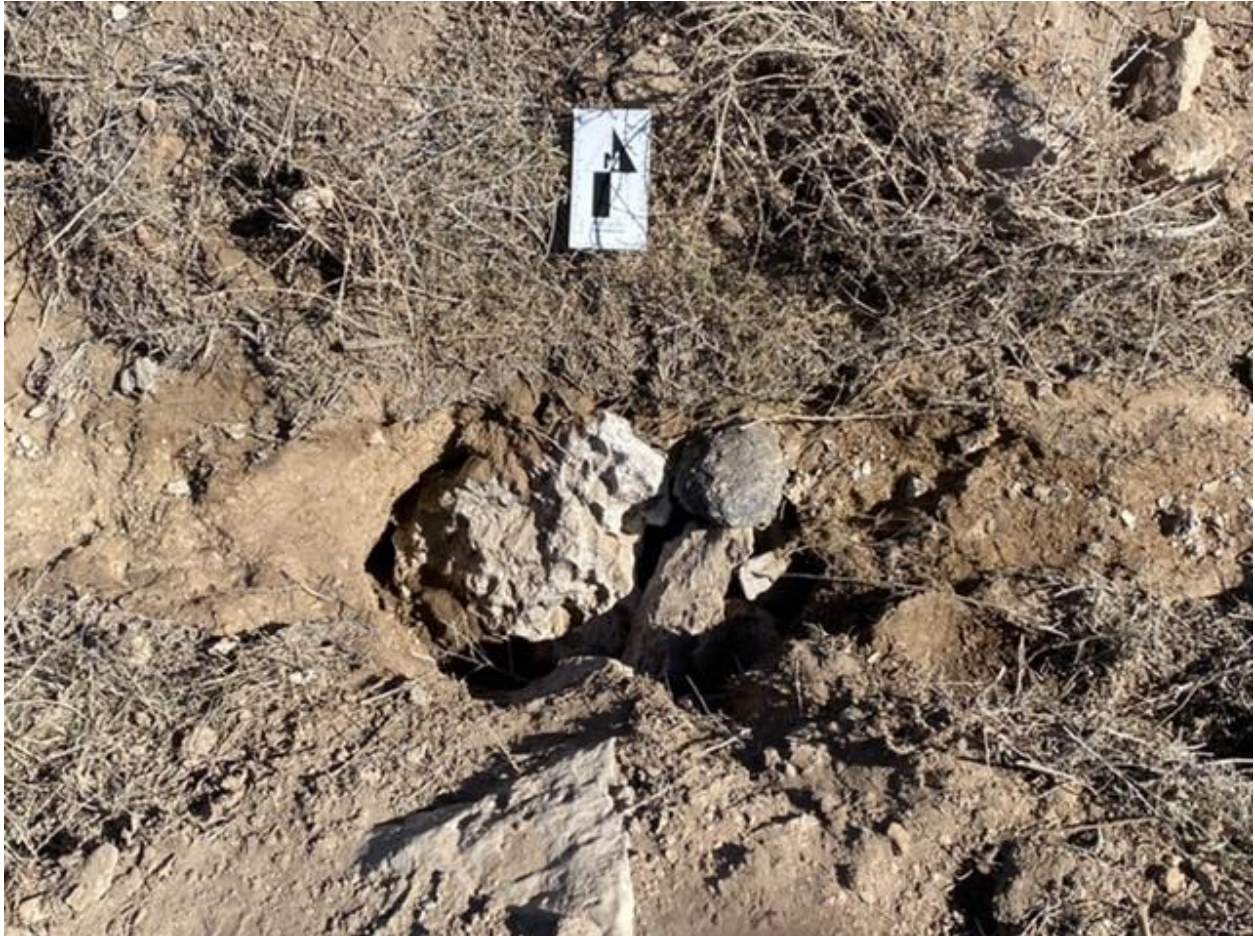
The photo above is the west hole. The card in the photo is the same scale as my field notebook. The hole extends further the west and south under the surface.

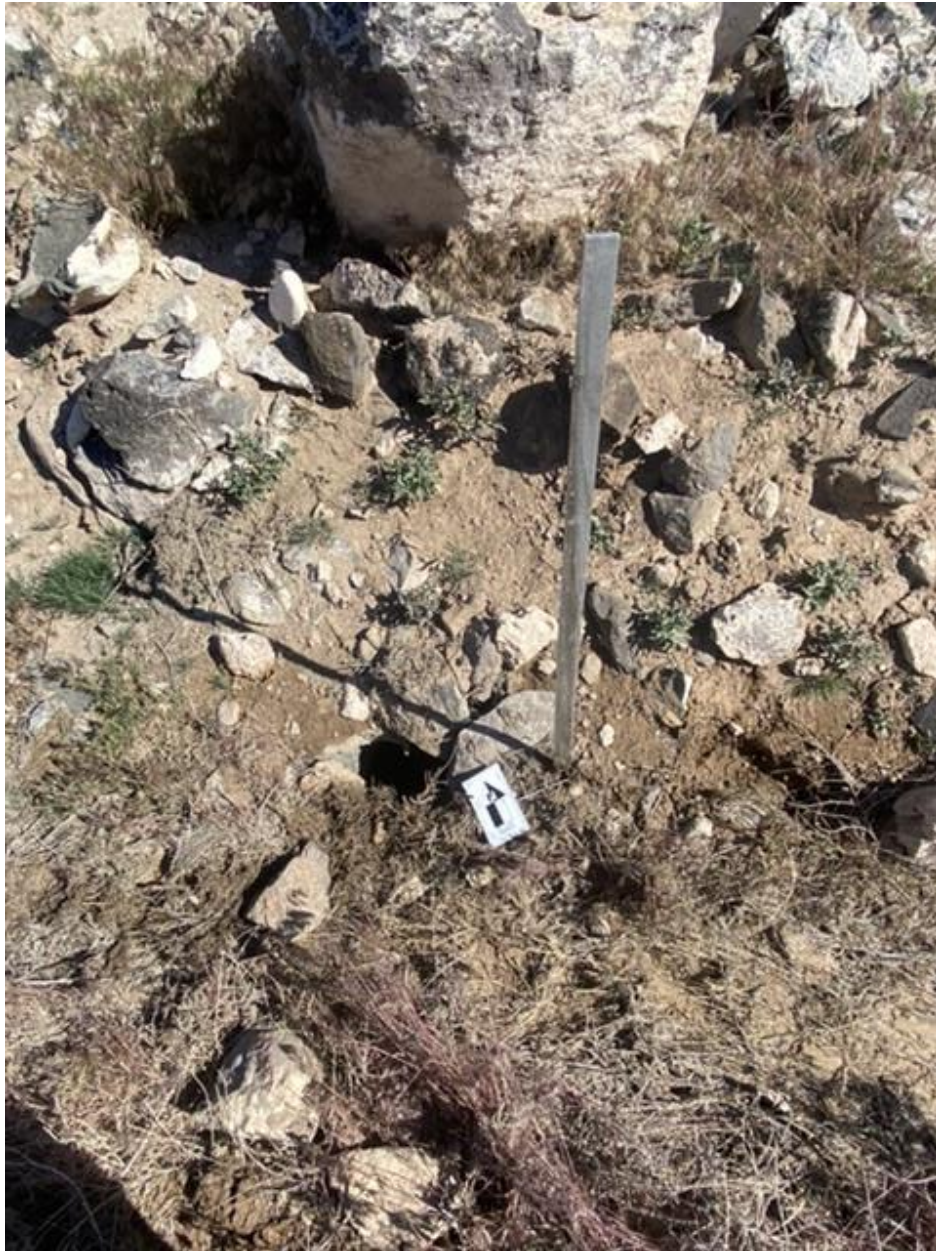
The photo above was taken of the middle hole. The hole did not appear to widen on the surface but definitely was deeper. The wooden stake in the photo is about 3 feet in length.

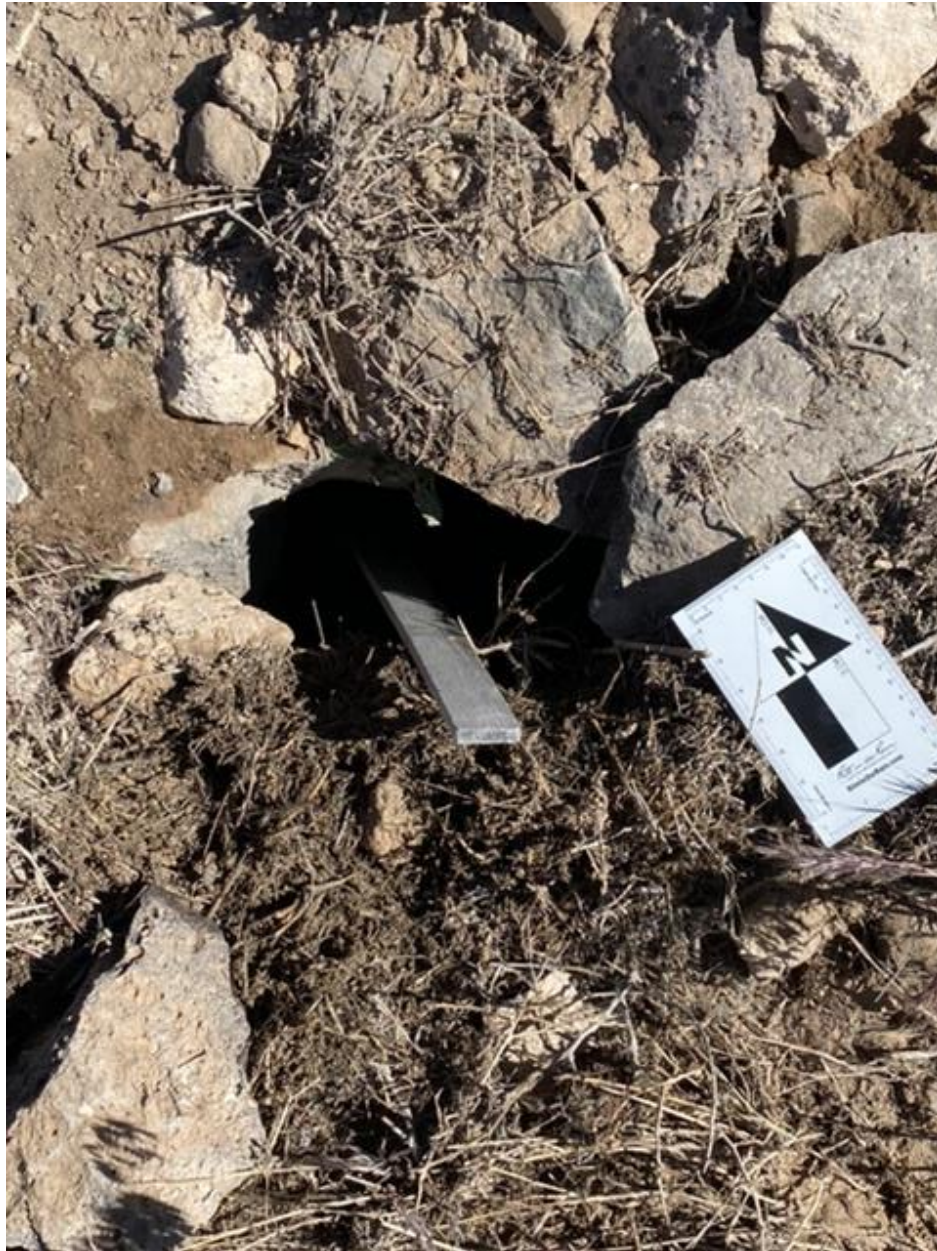
The photo above is also of the middle hole. The 3 foot wooden stake fit easily in the hole and could have kept going further underground.

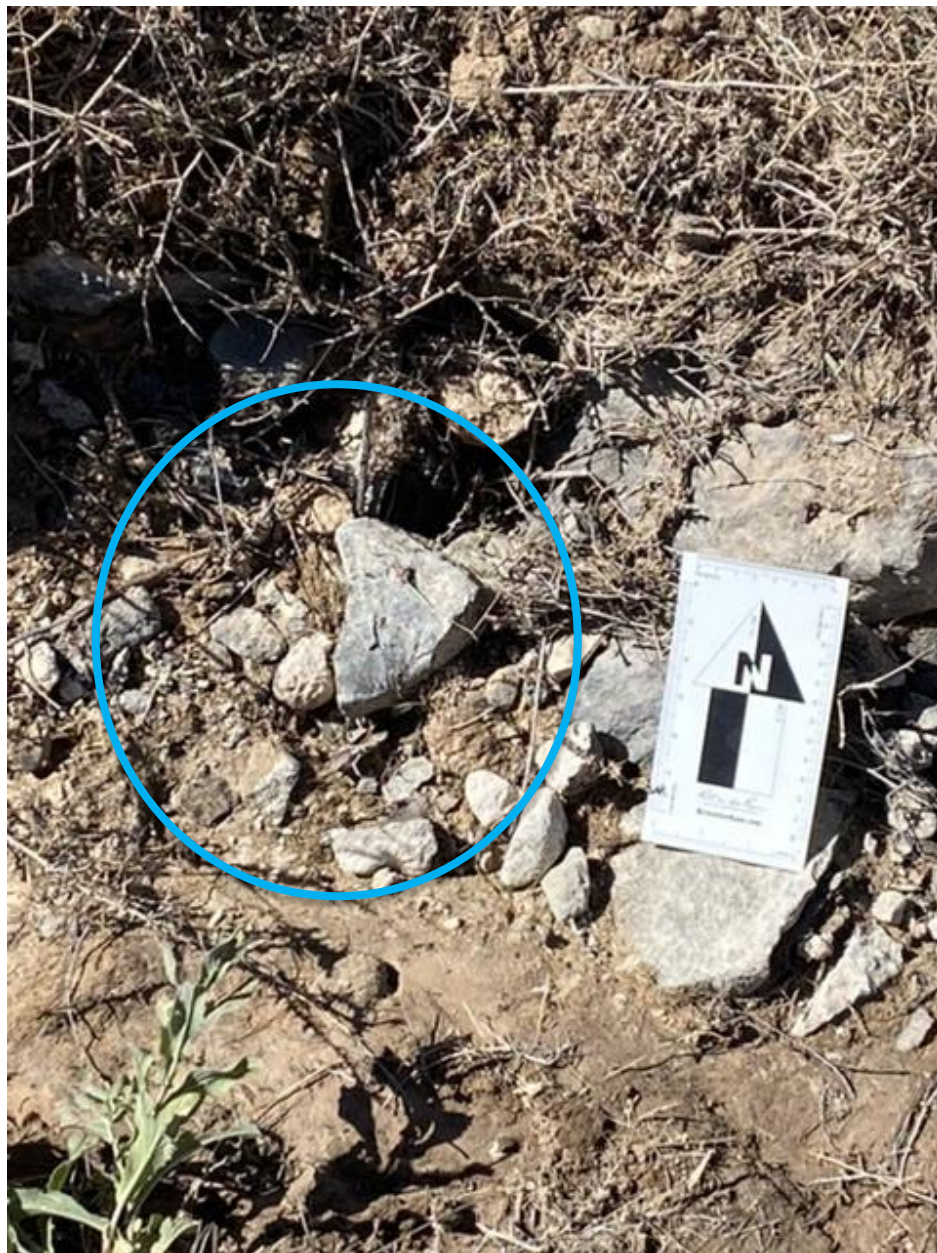
This photo is of the east hole. The hole has rocks covering much of its surface. The hole does extend downwards. The water running on May 25th could be heard flowing into the subsurface at this location.

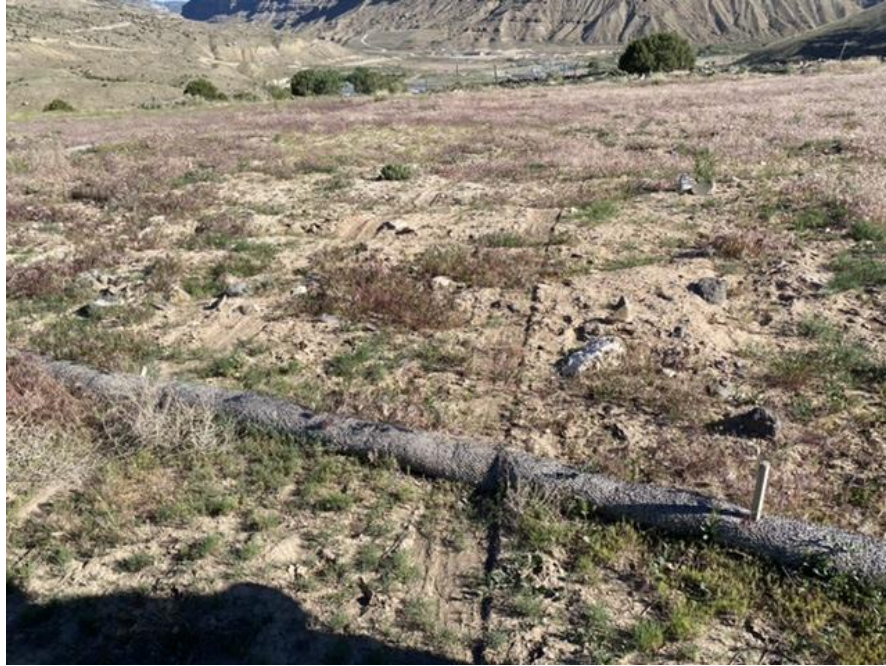
Tire tracks observed on May 25th. The tracks go over the straw waddle to the left of the posted mine id sign.

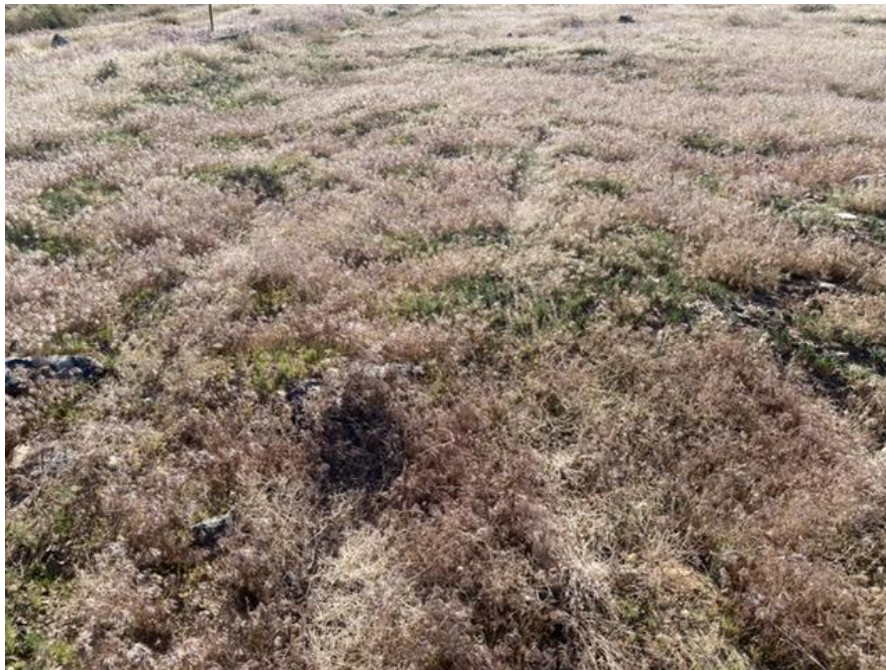
More tire tracks observed on May 25th. The tracks were in the northern portion of the Repair Area. The tracks trended east-west.

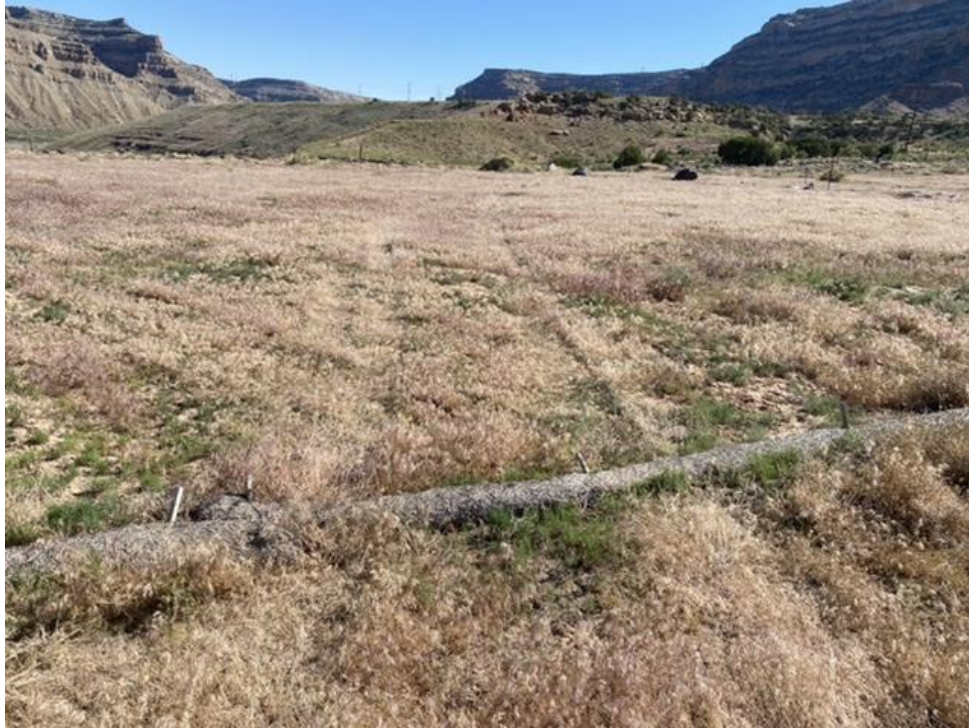
The tire tracks in the photo above were new and identified on May 26th. The tracks go over the straw waddle into the Repair area. The tracks were identified just to the right of the mine identification sign.

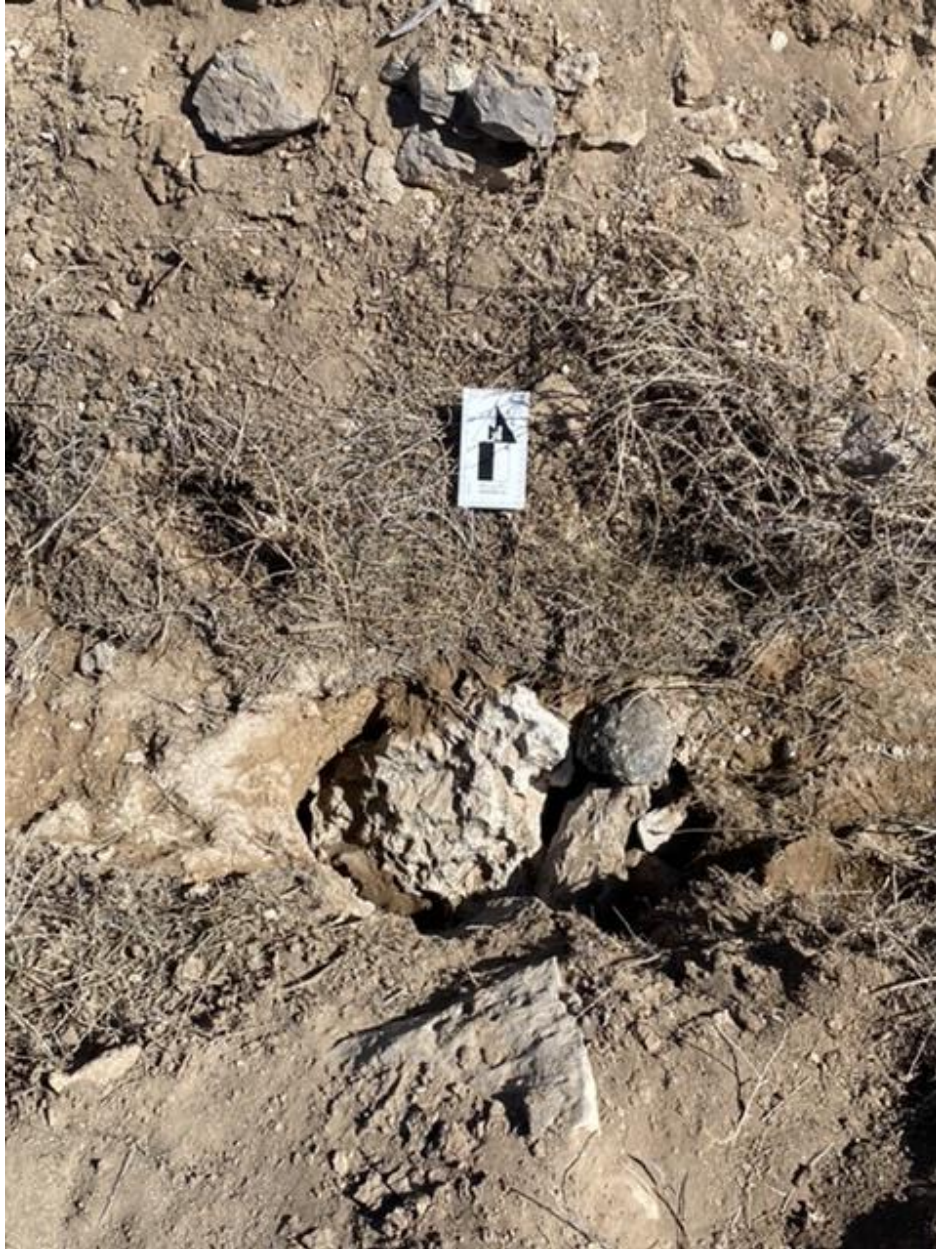
The photo above was taken of the west hole. There was no water infiltrating the hole during the inspection. The size of the hole on the surface is similar to the May 26th inspection.

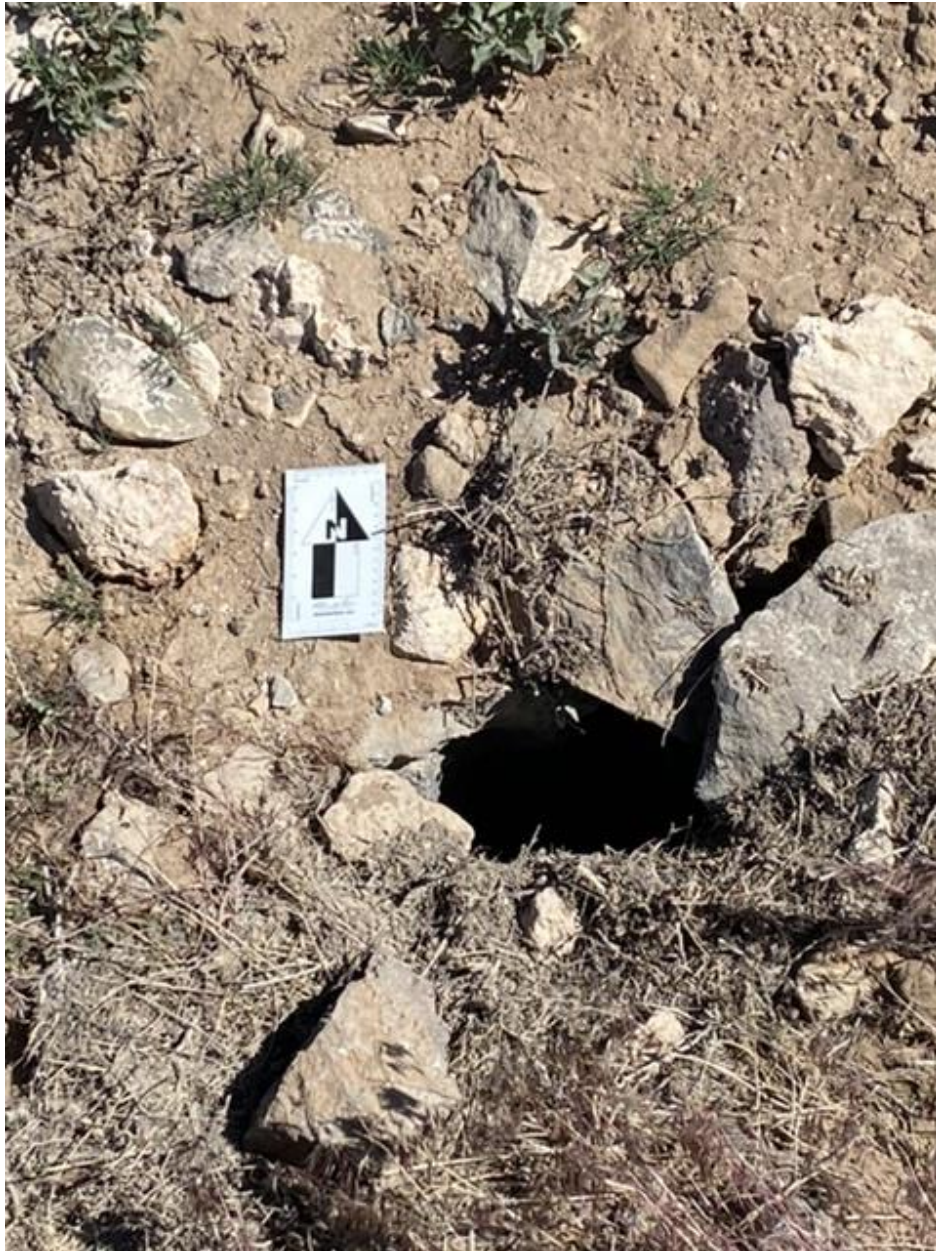
The middle hole was approximately the same size on the surface during this inspection. No water was entering the hole.

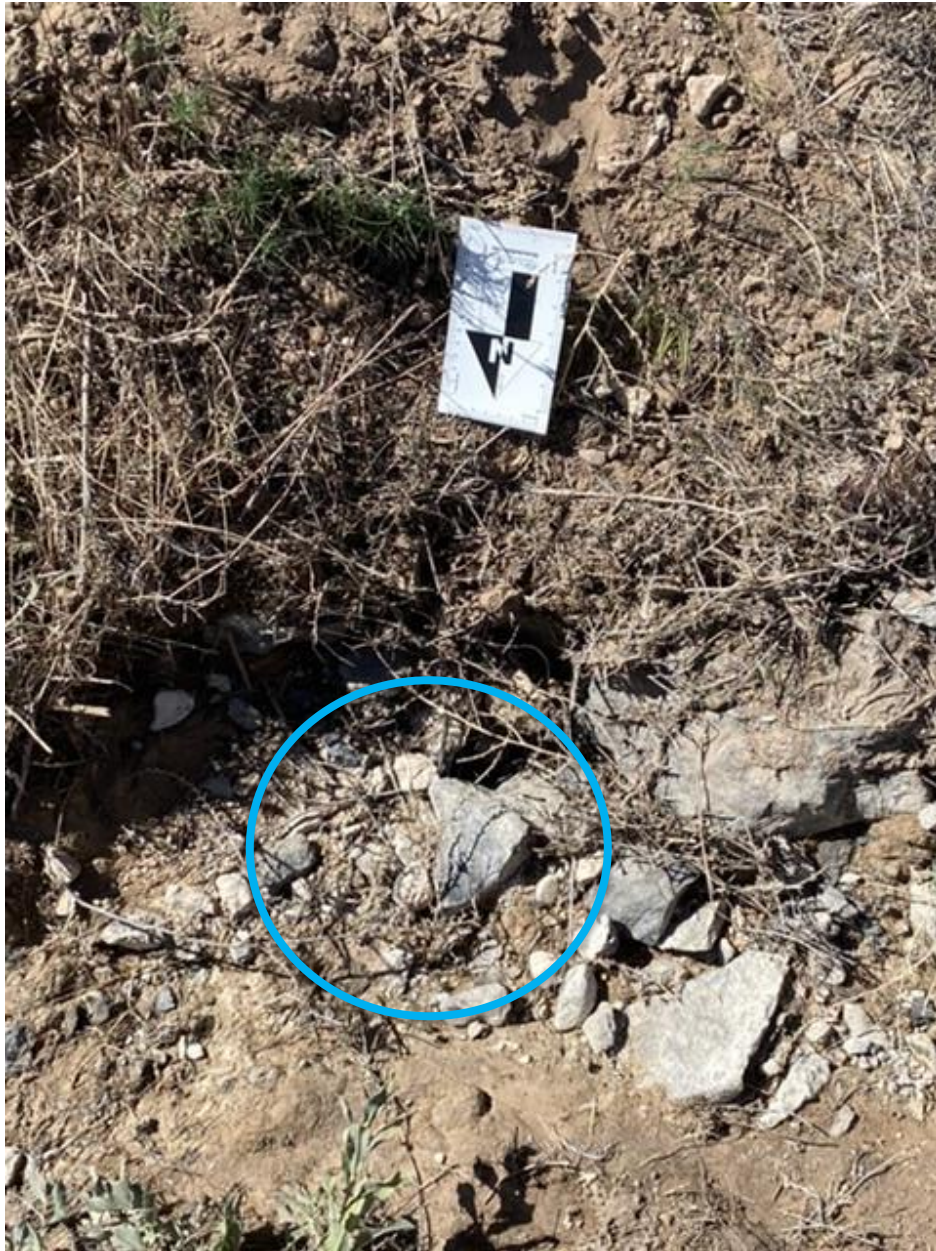
The east hole was also approximately the same size as on May 26th. The size of the hole is difficult to determine due to the rocks on the surface.

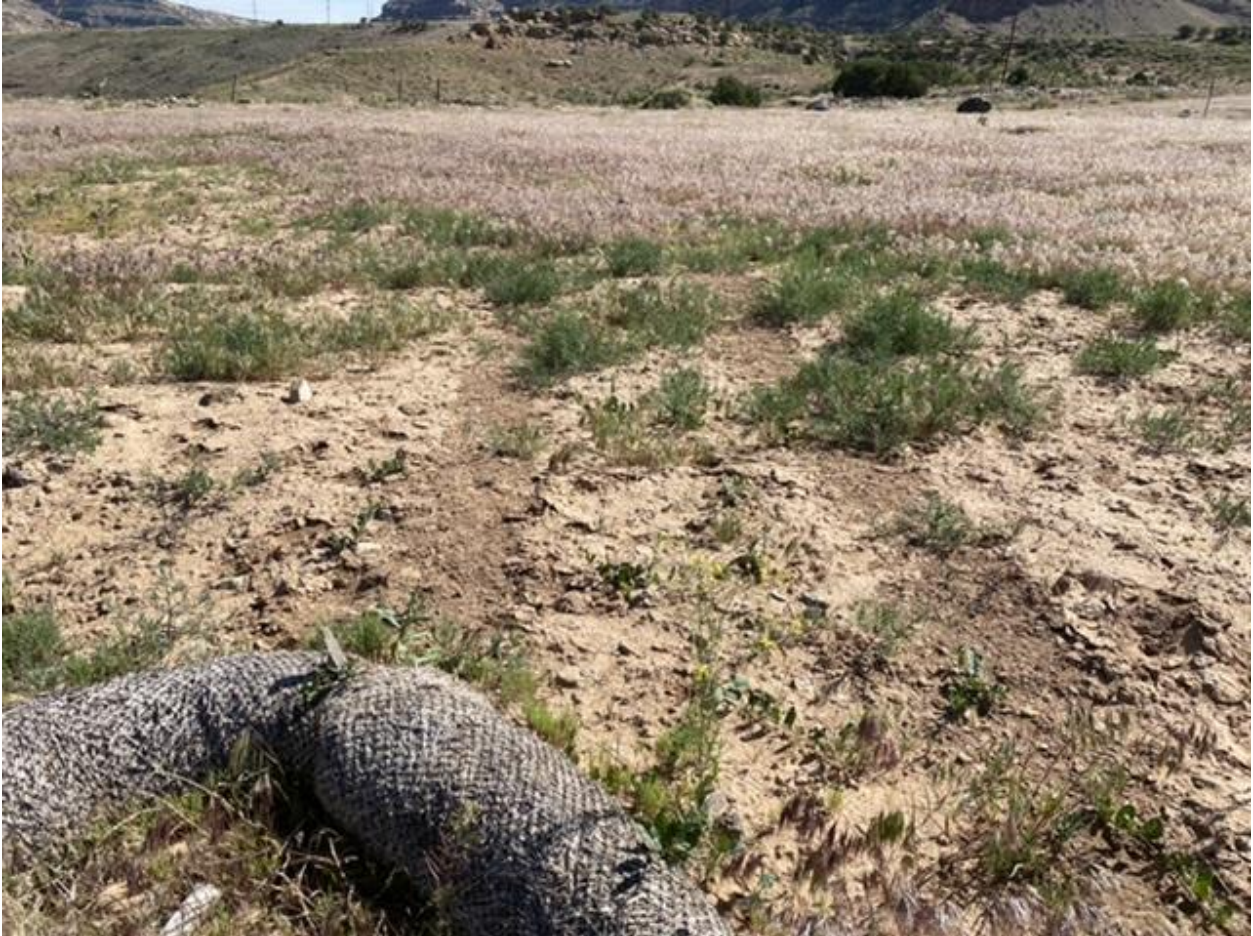
The photo above was taken of the ATV tracks observed going over the straw waddle into the TR-69 Repair Area.
The tracks were just to the left of the mine identification sign.
