**MINERALS PROGRAM INSPECTION REPORT**  
**PHONE: (303) 866-3567**

<b>MINE NAME:</b> Topaz Mine	<b>MINE/PROSPECTING ID#:</b> M-1980-055-HR	<b>MINERAL:</b> Uranium and vanadium	<b>COUNTY:</b> San Miguel
<b>INSPECTION TYPE:</b> Multi Person Inspection	<b>INSPECTOR(S):</b> Lucas West	<b>INSP. DATE:</b> May 19, 2022	<b>INSP. TIME:</b> 11:50
<b>OPERATOR:</b> Pinon Ridge Mining LLC	<b>OPERATOR REPRESENTATIVE:</b> Michael Rutter	<b>TYPE OF OPERATION:</b> 112d-3 - Designated Mining Operation	
<b>REASON FOR INSPECTION:</b> Normal I&E Program	<b>BOND CALCULATION TYPE:</b> Complete Bond	<b>BOND AMOUNT:</b> \$99,893.00	
<b>DATE OF COMPLAINT:</b> NA	<b>POST INSP. CONTACTS:</b> None	<b>JOINT INSP. AGENCY:</b> None	
<b>WEATHER:</b> Clear	<b>INSPECTOR'S SIGNATURE:</b>

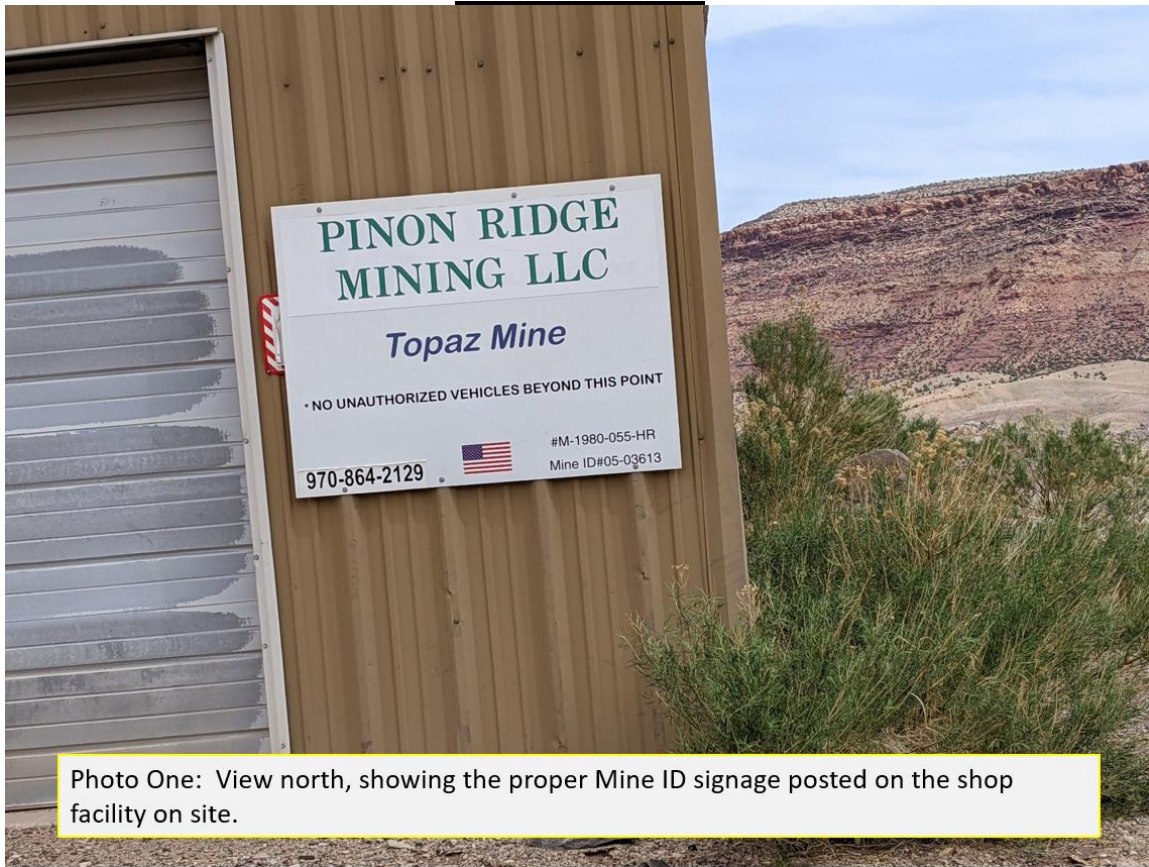
As seen in Photo One, the permit ID sign was observed near the entrance to the site. The permit boundary markers were also observed. Evidence that the diversion ditches and storm water control devices are functioning as designed was noted and no significant erosion was observed throughout the site. Maintenance of the storm water control structures has not been needed and all structures were in good condition at the time of the inspection.

Photo One: View north, showing the proper Mine ID signage posted on the shop facility on site.

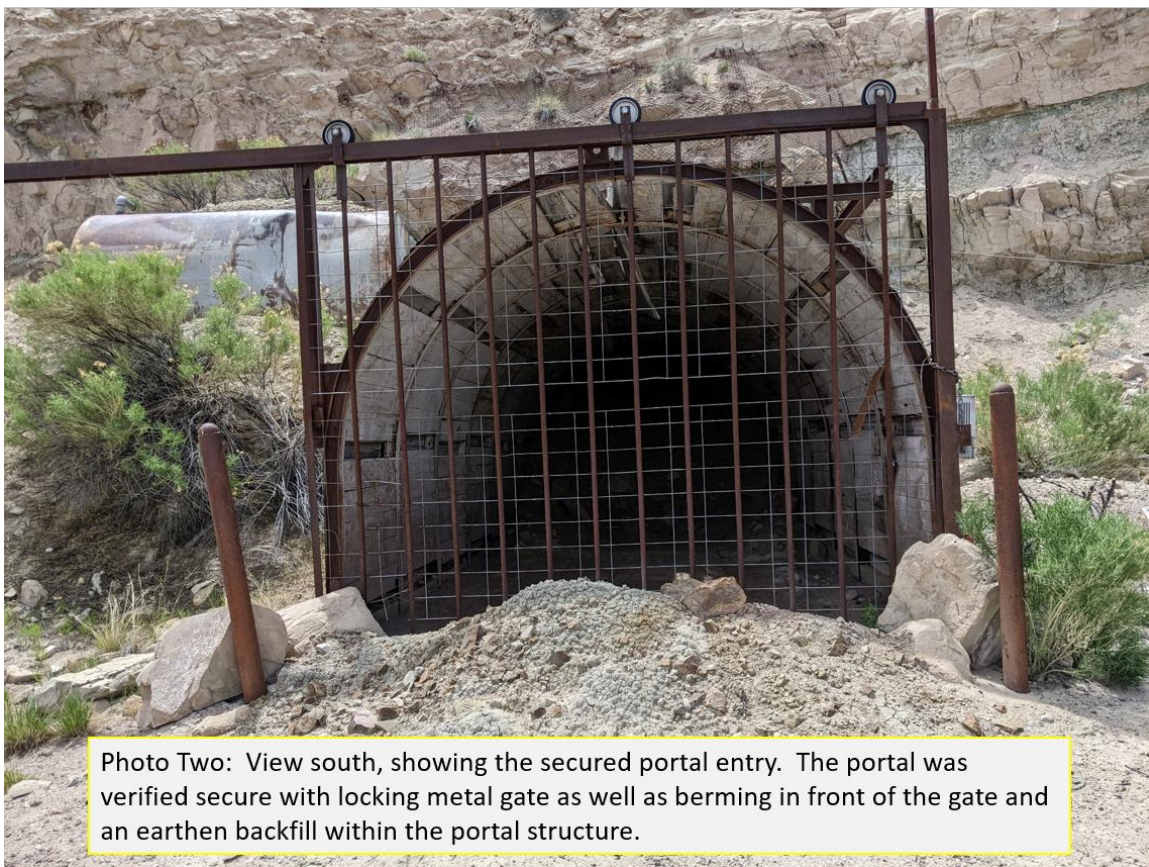
The shop facility located on site was observed to be secure and is in good working order. No damage or signs of vandalism was noted during the inspection. The portal located on site was also secured, it has been closed off with steel grates as well as encompassed by a small berm as seen in Photo Two. Some mining related equipment including vent tubing and steel scaffolding is being stored on site. The items that are stored are in a neat and orderly fashion and not considered a problem at this time. No fuel storage containers were observed on site. Various other debris was observed on site however it was stored in an orderly fashion and was not a concern at this time.

Photo Two: View south, showing the secured portal entry. The portal was verified secure with locking metal gate as well as berming in front of the gate and an earthen backfill within the portal structure.

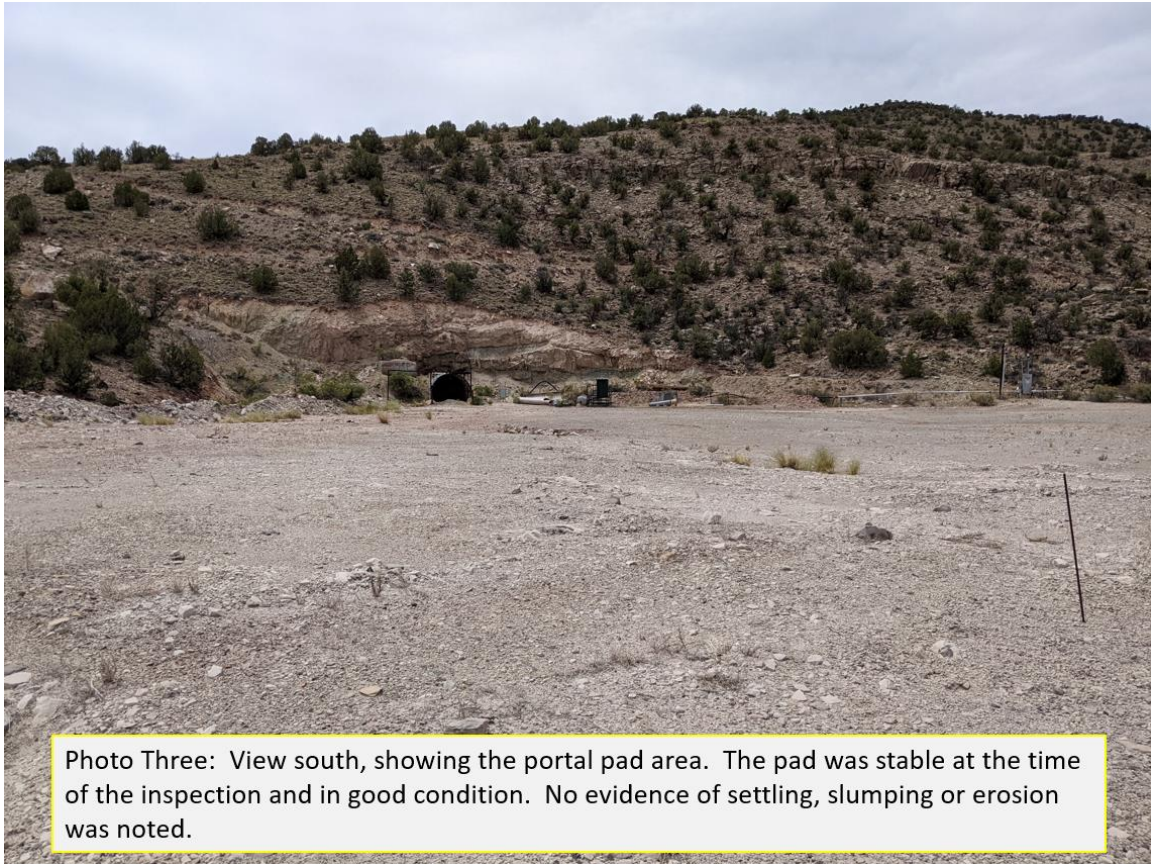
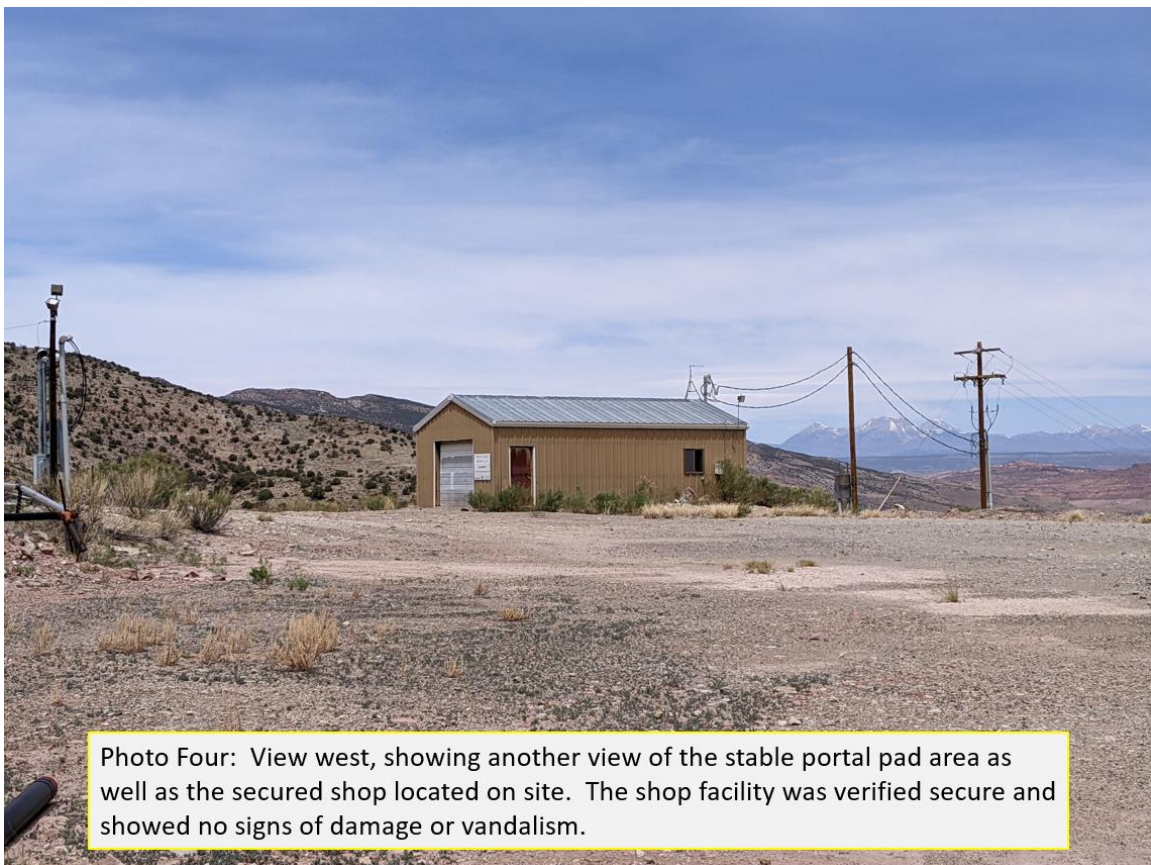
The main pad and work area was in good condition as seen in Photos Three and Four, evidence of weed management during the growing season was observed. Some areas around the perimeter of the pad area have begun to revegetate themselves with volunteer species. The whole site exhibits positive drainage and no erosional issues were observed at this time.
