MINERALS PROGRAM INSPECTION REPORT
PHONE: (303) 866-3567

MINE NAME: West Sunday	MINE/PROSPECTING ID#: M-1981-021	MINERAL: Uranium and vanadium	COUNTY: San Miguel
INSPECTION TYPE: Multi Person Inspection	INSPECTOR(S): Lucas West	INSP. DATE: May 19, 2022	INSP. TIME: 12:39
OPERATOR: Pinon Ridge Mining LLC	OPERATOR REPRESENTATIVE: Michael Rutter	TYPE OF OPERATION: 112d-3 - Designated Mining Operation	
REASON FOR INSPECTION: Normal I&E Program	BOND CALCULATION TYPE: Complete Bond	BOND AMOUNT: \$85,036.00	
DATE OF COMPLAINT: NA	POST INSP. CONTACTS: None	JOINT INSP. AGENCY: None	
WEATHER: Clear	INSPECTOR'S SIGNATURE:

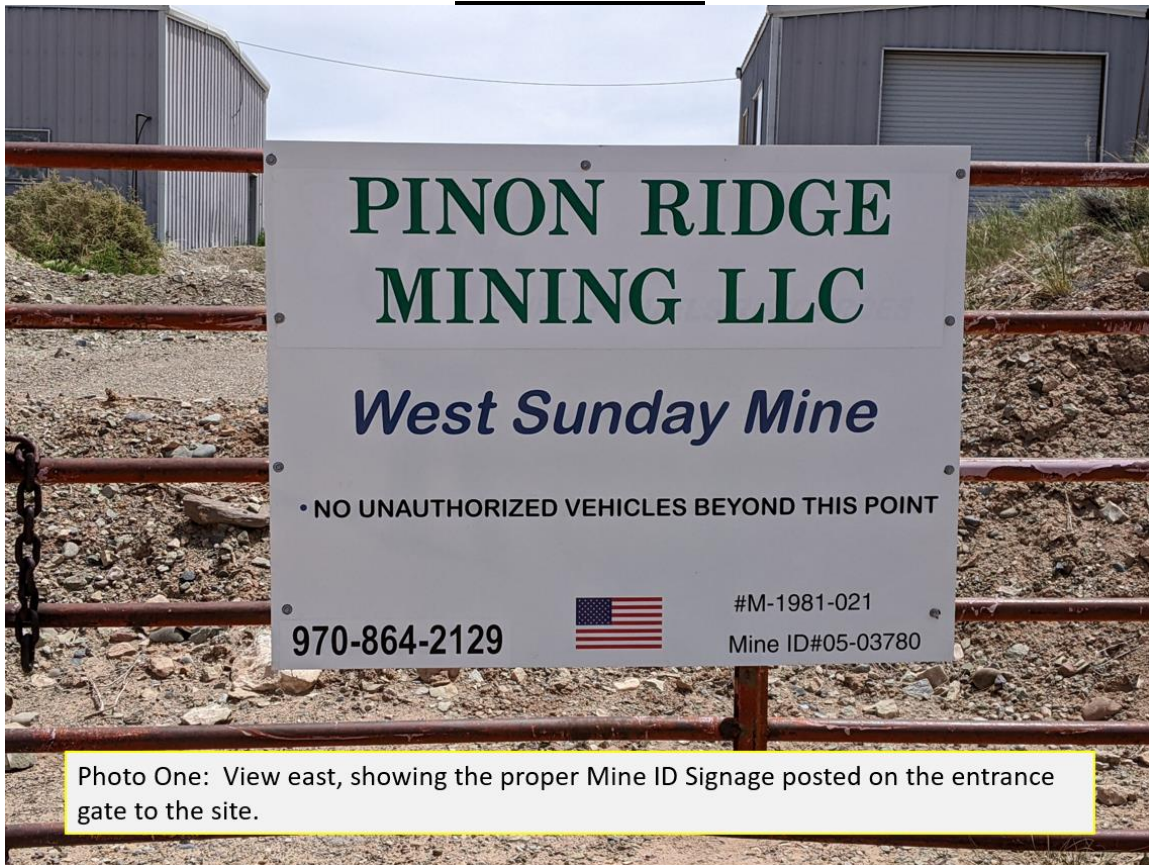
As seen in Photo One, the permit ID sign was observed at the entrance to the site. The permit boundary markers were also observed. The remote vent shaft sites were not inspected at this time. Evidence that the diversion ditches and storm water control devices are functioning as designed was observed and no significant erosion was observed throughout the site.

Photo One: View east, showing the proper Mine ID Signage posted on the entrance gate to the site.

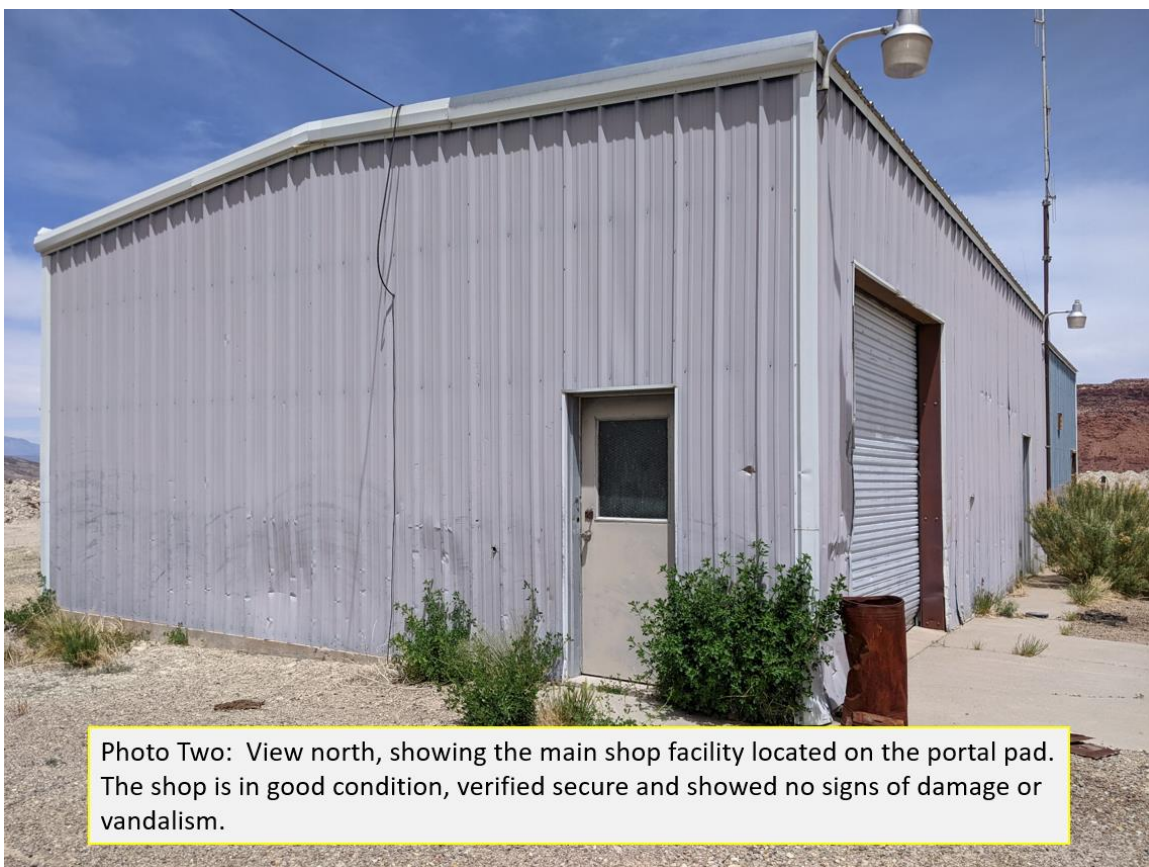
All work and shop appeared to be in good condition as seen in Photos Two and Three. The shop and storage facility in Photo Two was discovered to be unsecure, with the bay door opened. According to the operator there appeared to be no signs of theft or damage to the structure. The office facility was secured, and no signs of attempted unauthorized entry were noted on that facility. The portal located on site has been opened to be used as ventilation for the underground workings of the entire Sunday Complex. The earthen backfill material has been removed but the gates remain locked to prevent unauthorized entry. The portal with its locked gates can be seen in Photo Four. Various other debris was observed on site however it was stored in an orderly fashion and was not a concern at this time. The main pad and work area was in good condition, evidence of weed management during the growing season was observed. The whole site exhibits positive drainage and no erosional issues were observed at this time. Some areas around the perimeter of the pad area have begun to revegetate themselves with volunteer species.

Photo Two: View north, showing the main shop facility located on the portal pad. The shop is in good condition, verified secure and showed no signs of damage or vandalism.

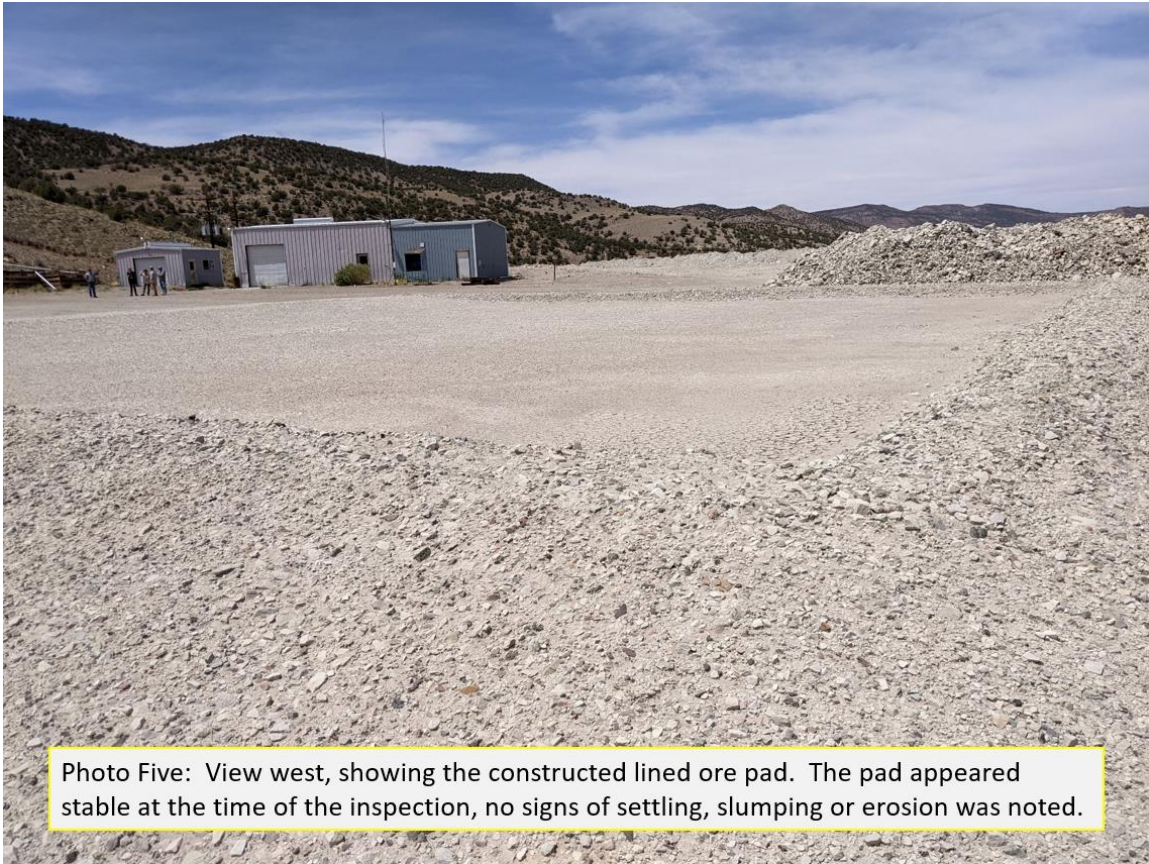
The lined Ore Pad was observed to be in good condition. The face of the pad shows no evidence of surface stockpiling and no observable impacts from precipitation was noted. The out slopes and berms of the pad appear stable. The pad can be seen in Photos Five and Six.

Photo Five: View west, showing the constructed lined ore pad. The pad appeared stable at the time of the inspection, no signs of settling, slumping or erosion was noted.

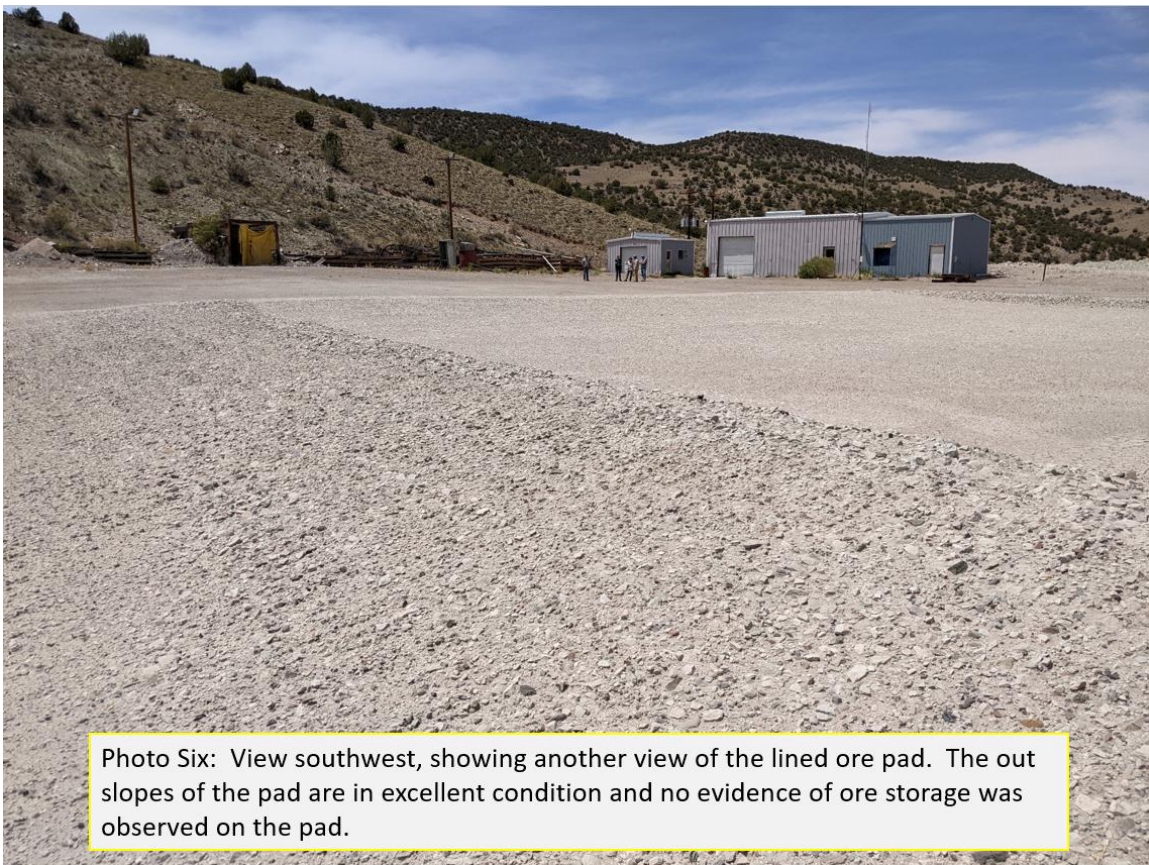
Photo Six: View southwest, showing another view of the lined ore pad. The out slopes of the pad are in excellent condition and no evidence of ore storage was observed on the pad.
