MINERALS PROGRAM INSPECTION REPORT

MINE NAME: Carnation Mine	MINE/PROSPECTING ID#: M-1977-416	MINERAL: Uranium and vanadium	COUNTY: San Miguel
INSPECTION TYPE: Multi Person Inspection	INSPECTOR(S): Lucas West	INSP. DATE: May 19, 2022	INSP. TIME: 13:50
OPERATOR: Pinon Ridge Mining LLC	OPERATOR REPRESENTATIVE: Michael Rutter	TYPE OF OPERATION: 110d - Designated Limited Impact	
REASON FOR INSPECTION: Normal I&E Program	BOND CALCULATION TYPE: Complete Bond	BOND AMOUNT: \$40,245.00	
DATE OF COMPLAINT: NA	POST INSP. CONTACTS: None	JOINT INSP. AGENCY: None	
WEATHER: Clear	INSPECTOR'S SIGNATURE:

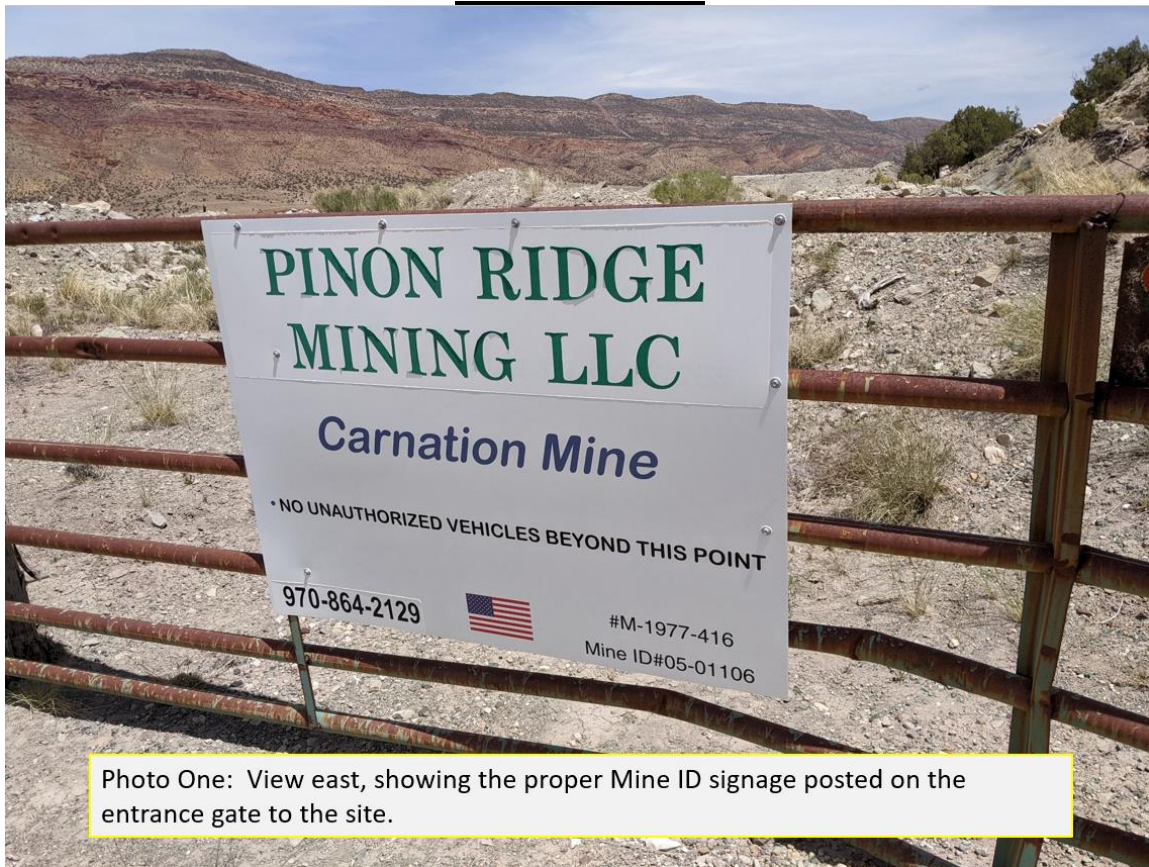
As seen in Photo One, the permit ID sign was observed at the entrance to the site. The permit boundary markers were also observed and all disturbances were confined within the permitted area. Evidence that the diversion ditches and storm water control devices are functioning as designed and no significant erosion was observed throughout the site. The lower permit area was also in good condition with no signs of significant erosion. The lower area has begun to revegetate itself and appears to be in good condition.

Photo One: View east, showing the proper Mine ID signage posted on the entrance gate to the site.

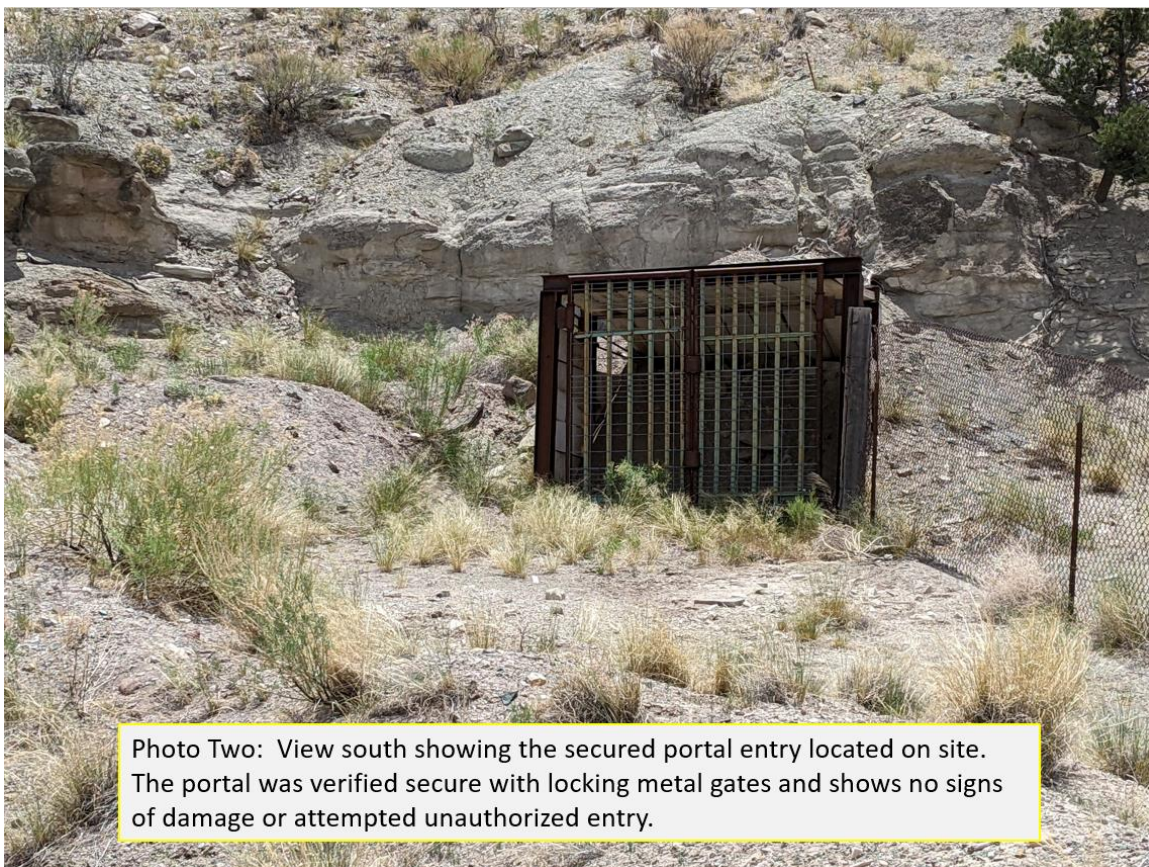
The portal located on site was also secured, it has been backfilled, closed off with steel grates as well as encompassed by a small berm as seen in Photo Two. No fuel storage containers were observed on site.

Photo Two: View south showing the secured portal entry located on site. The portal was verified secure with locking metal gates and shows no signs of damage or attempted unauthorized entry.

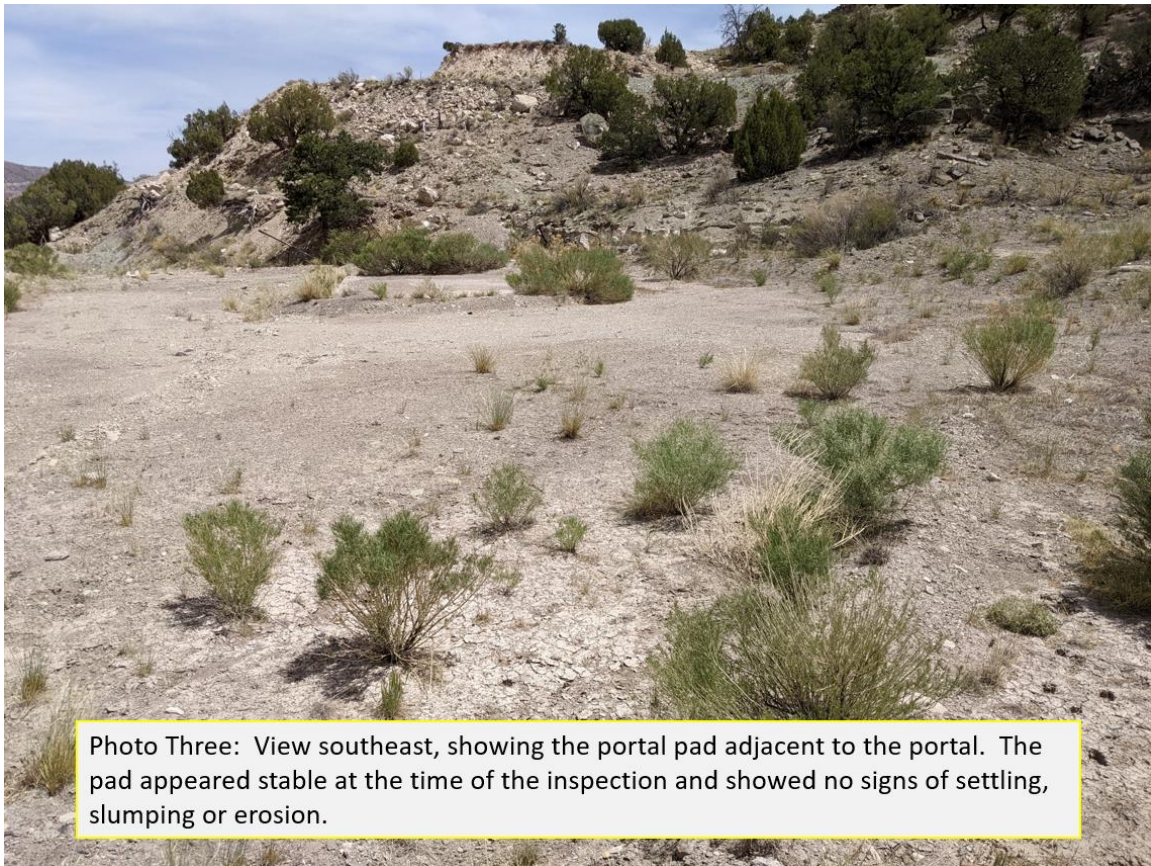
The main pad and work area was in good condition as seen in Photos Three and Four, evidence of weed management during the growing season was observed. The whole site exhibits positive drainage and no erosional issues were observed at this time. A concrete slab foundation is located on the portal pad measuring approximately 20 x 30 ft. with an adjacent utility pole and line. The foundation, utility pole and wire are slated to be removed during final reclamation. The portal pad area has begun to revegetate itself with volunteer species.

Photo Three: View southeast, showing the portal pad adjacent to the portal. The pad appeared stable at the time of the inspection and showed no signs of settling, slumping or erosion.

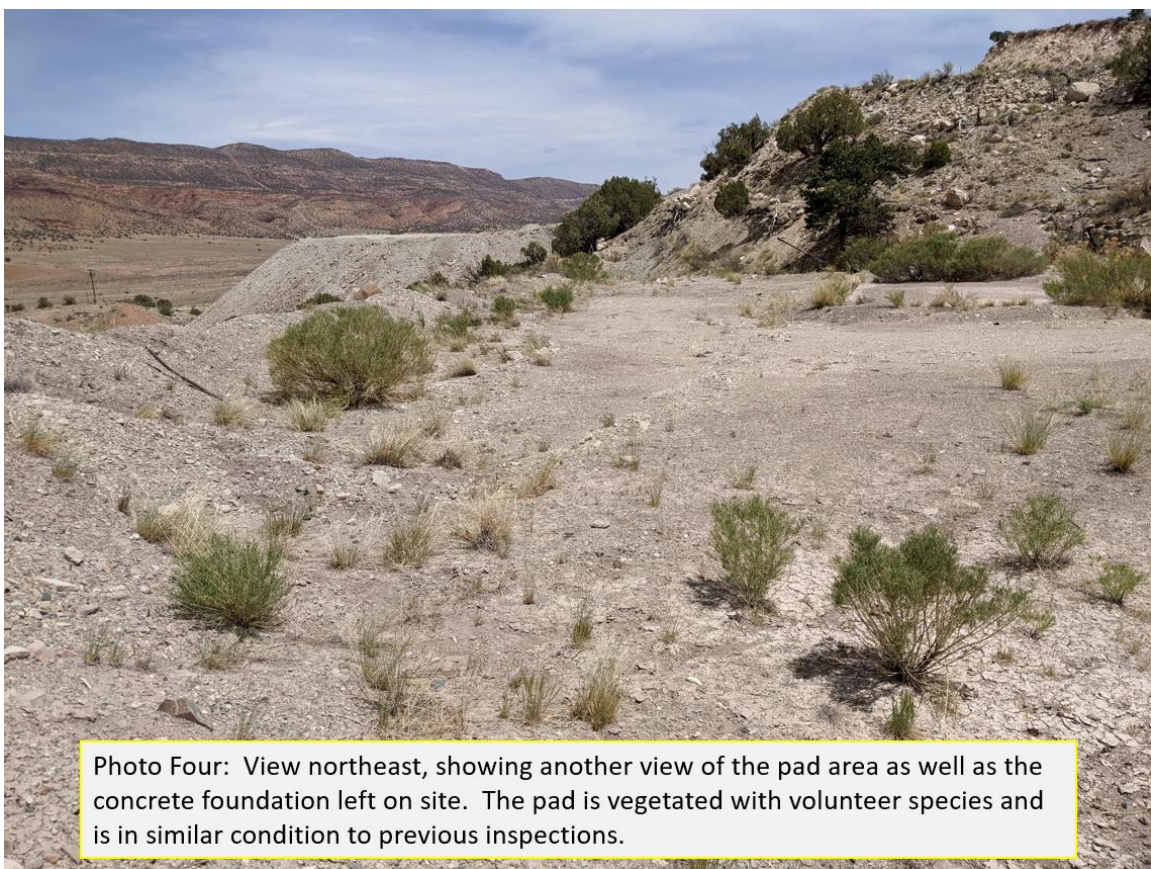
Photo Four: View northeast, showing another view of the pad area as well as the concrete foundation left on site. The pad is vegetated with volunteer species and is in similar condition to previous inspections.
