Leone Gardner, M-1985-008, Inspection Report and Reclamation Cost Estimate

MINERALS PROGRAM INSPECTION REPORT

MINE NAME: Leone Gardner	MINE/PROSPECTING ID#: M-1985-008	MINERAL: Sand and gravel	COUNTY: Huerfano
INSPECTION TYPE: Monitoring	INSPECTOR(S): Connor Drinkard and Jared Ebert	INSP. DATE: April 13, 2022	INSP. TIME: 12:00
OPERATOR: Hard Rock Paving and Redi-Mix, Inc.	OPERATOR REPRESENTATIVE: Mr. John Paul Ary and Ms. Jodi Schreiber	TYPE OF OPERATION: 112c - Construction Regular Operation	
REASON FOR INSPECTION: Normal I&E Program	BOND CALCULATION TYPE: Complete Bond	BOND AMOUNT: \$162,970.00	
DATE OF COMPLAINT: NA	POST INSP. CONTACTS: None	JOINT INSP. AGENCY: None	
WEATHER: Clear	INSPECTOR'S SIGNATURE:

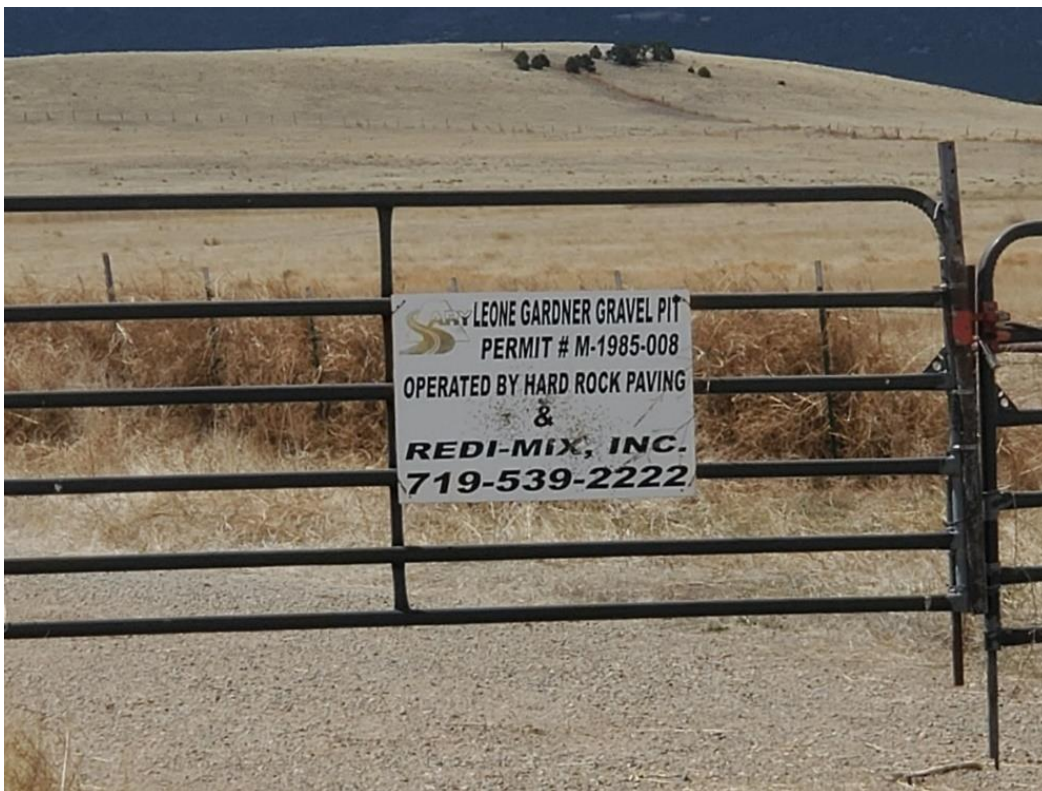
The mine identification sign and permit boundary markers were observed.

Figure 1. Permit sign at entrance.

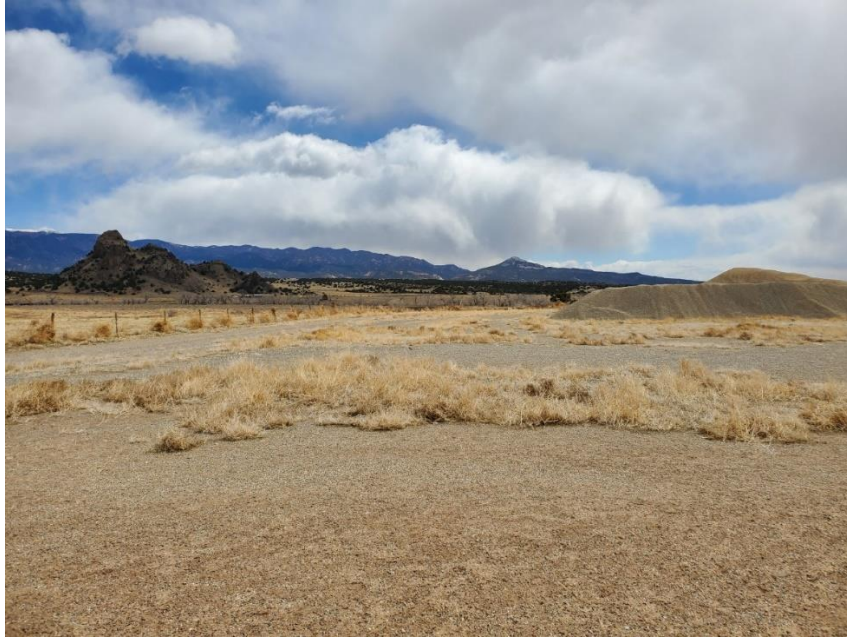
Figure 2. Looking northeast from northwest corner of affected area.

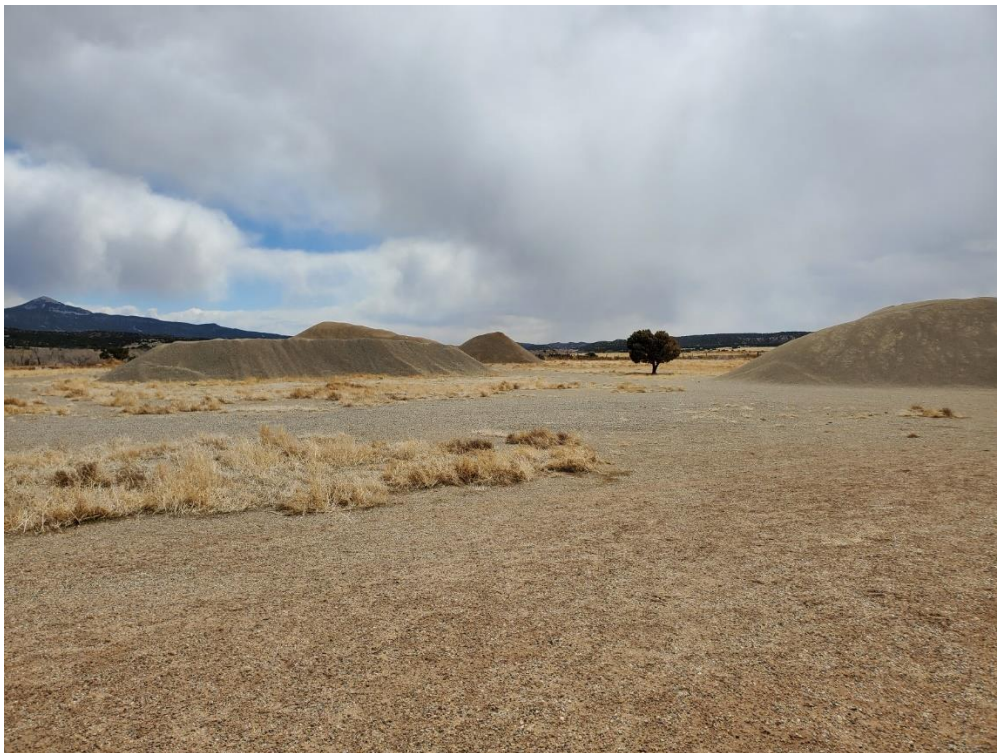
Figure 3. Looking east from northwest corner of affected area.

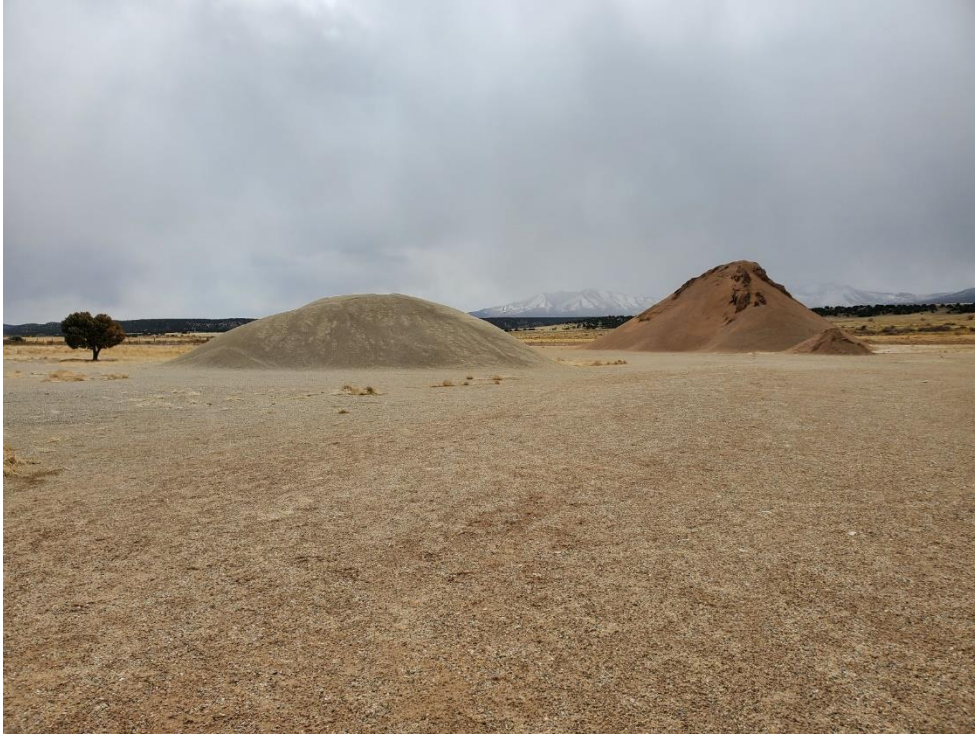
Figure 4. Looking southeast from northwest corner of affected area.

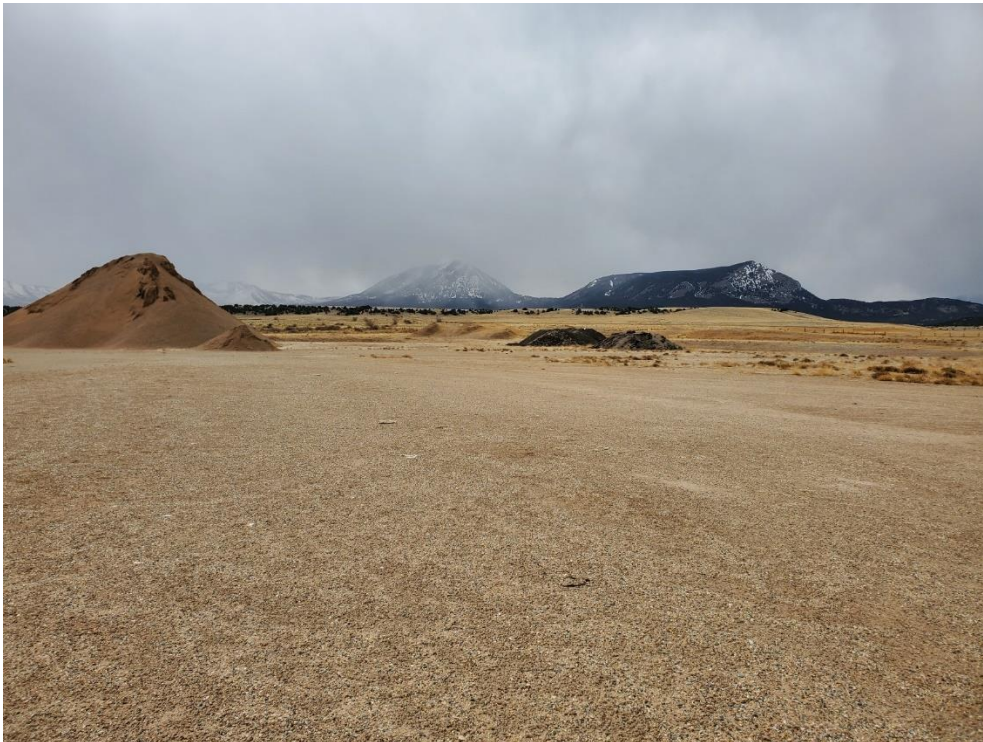
Figure 5. Looking south from northwest corner of affected area.

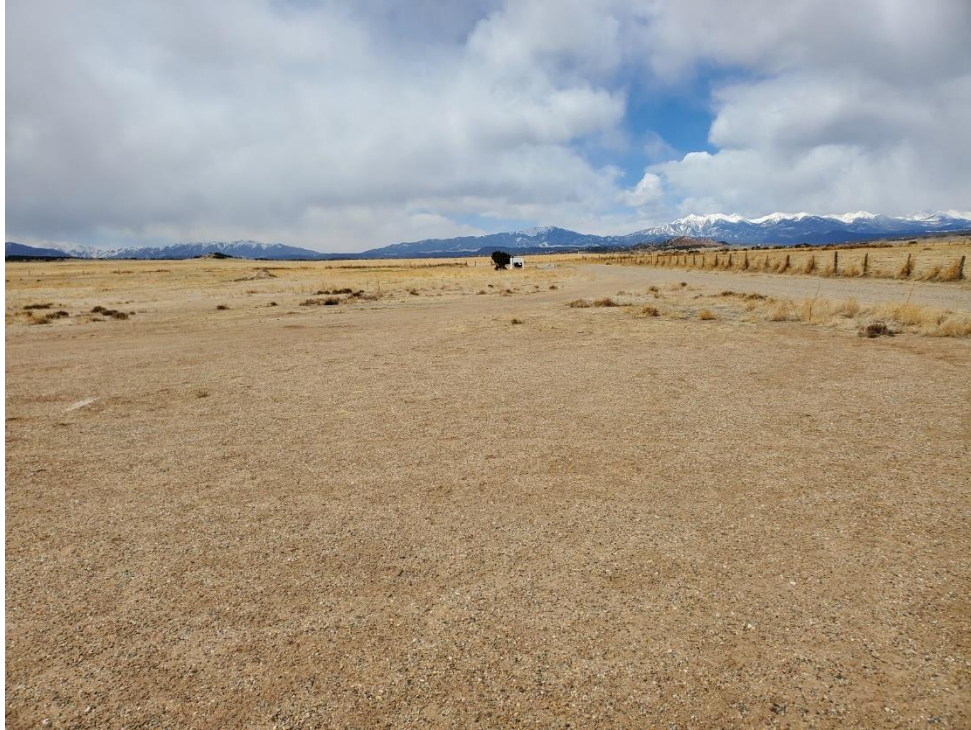
Figure 6. Looking west from northwest corner of affected area.

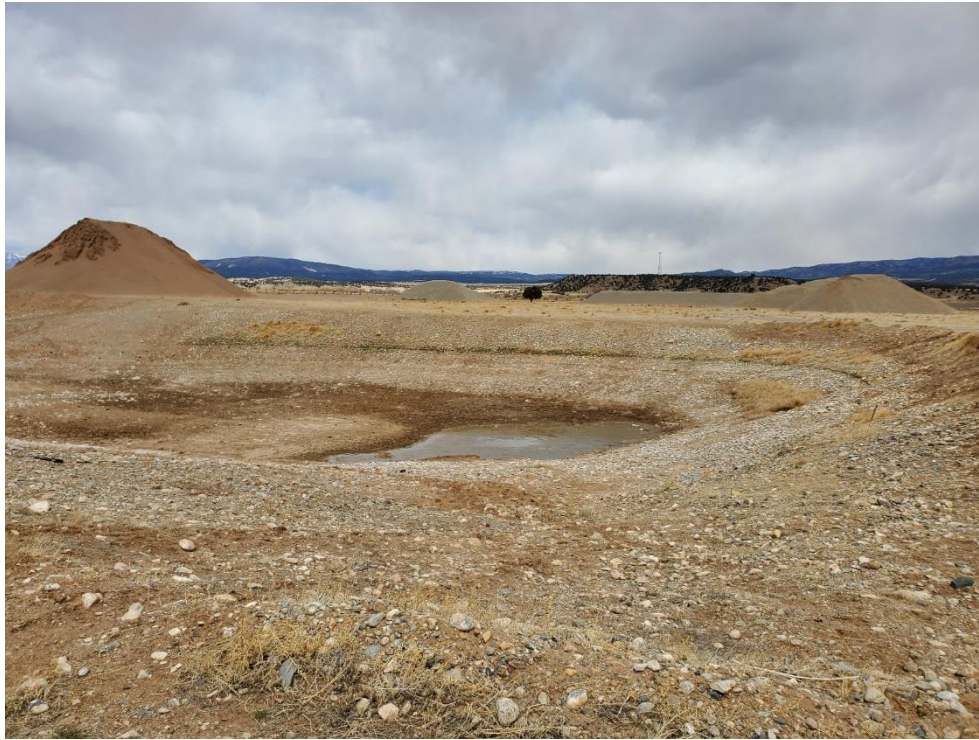
Some water was observed in the southeast pit but it is likely snowmelt. No other water was observed. Exposure of groundwater must not occur during or after mining operations.

Figure 8. Looking northwest from southeast corner of affected area. Water in pit likely snowmelt.

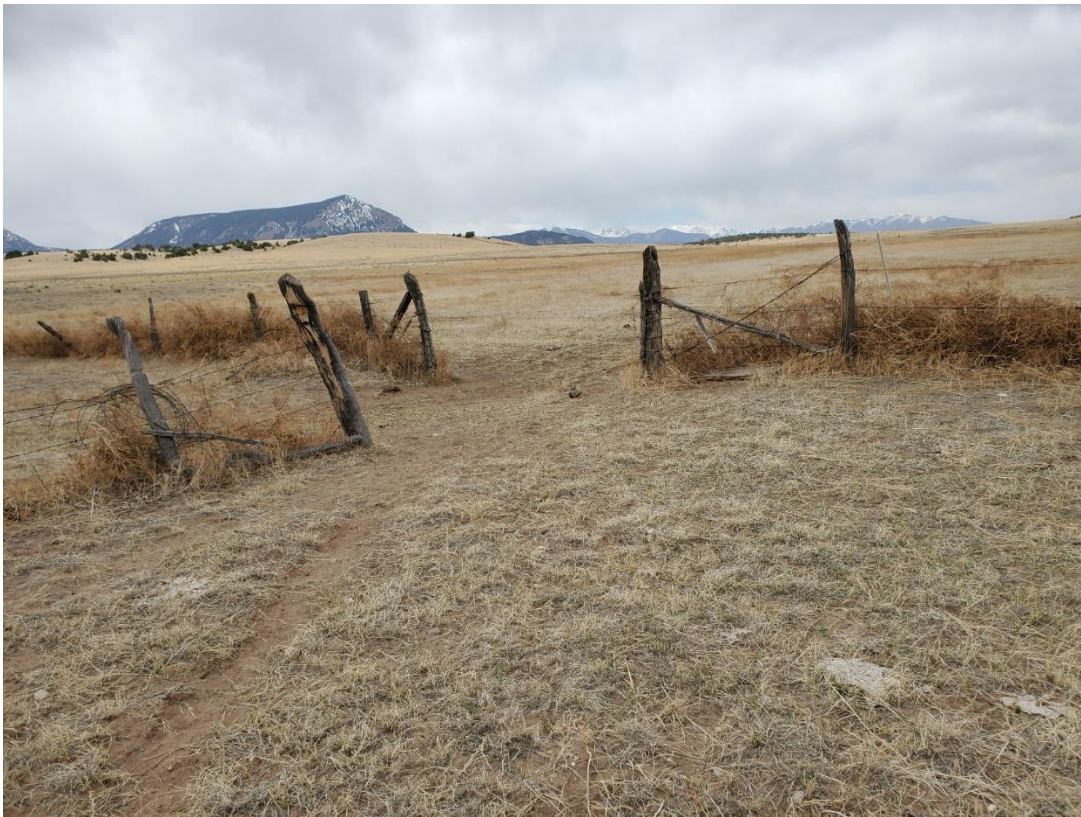
Figure 9. Looking west from southwest corner of affected area. White pipe permit boundary marker.

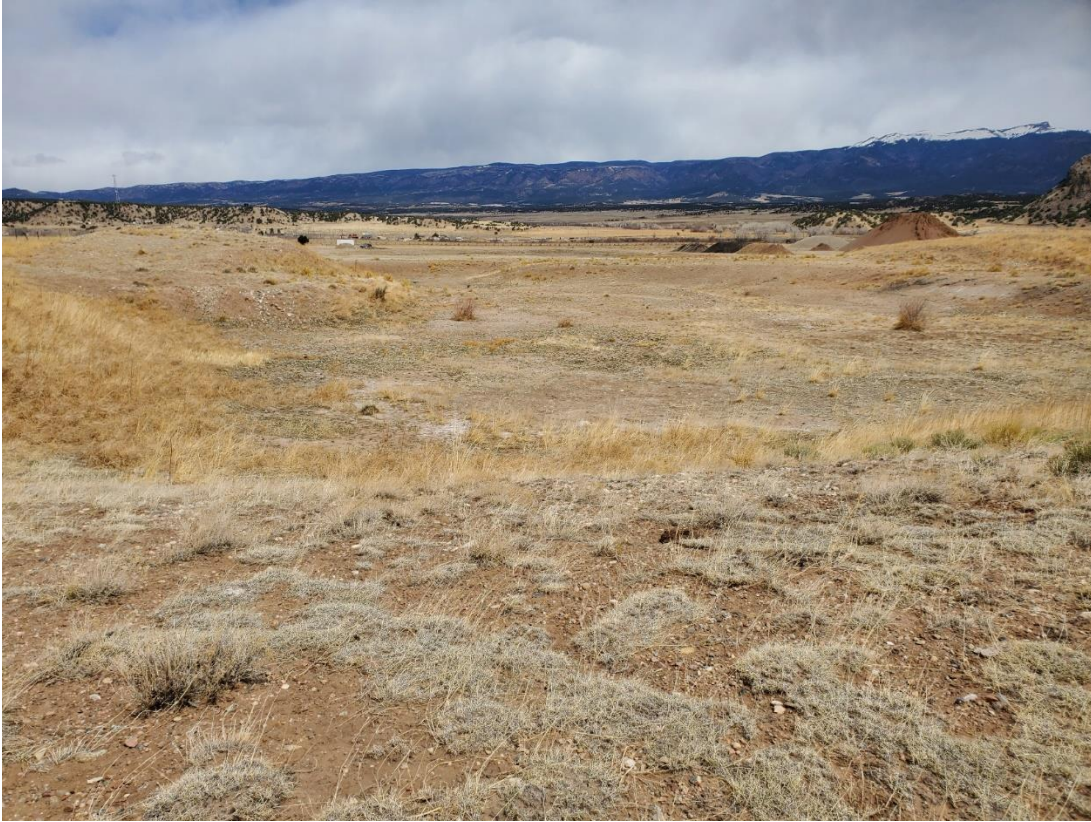
Figure 10. Looking north from southwest corner of affected area.

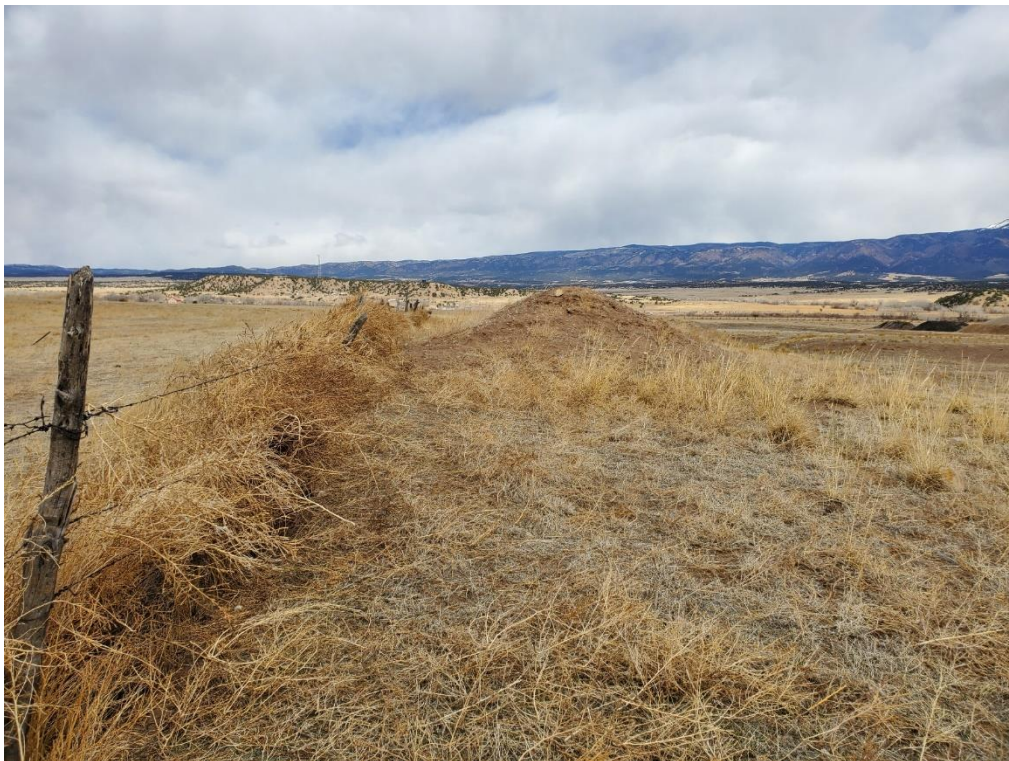
Figure 11. Looking north from southwest corner of affected area.

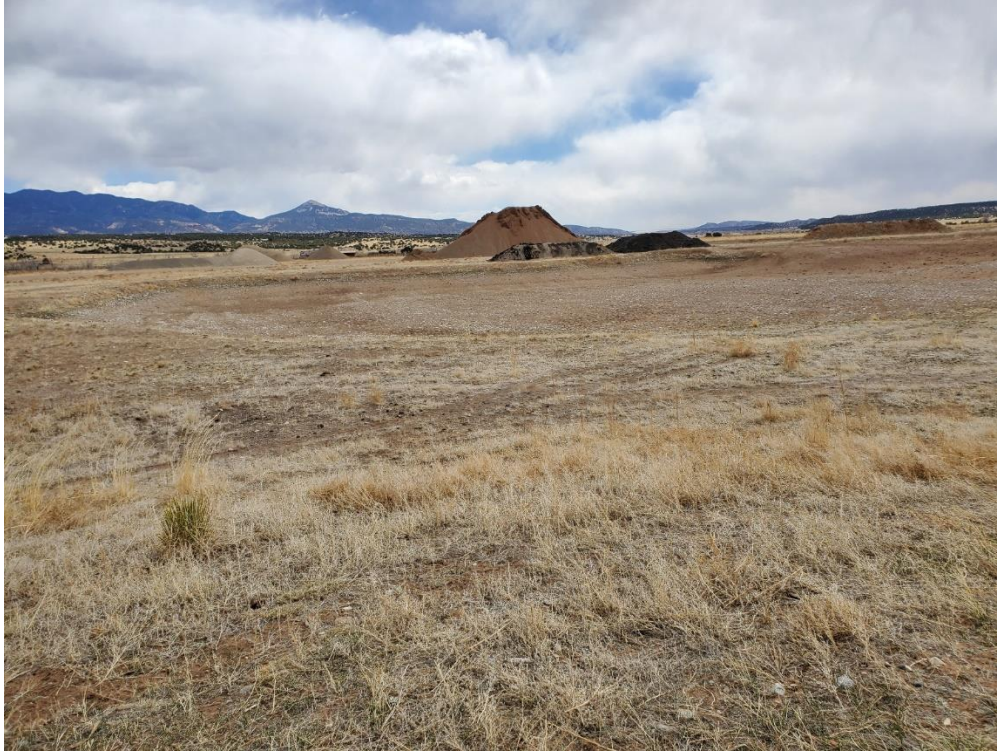
Figure 12. Looking east from western side of affected area.

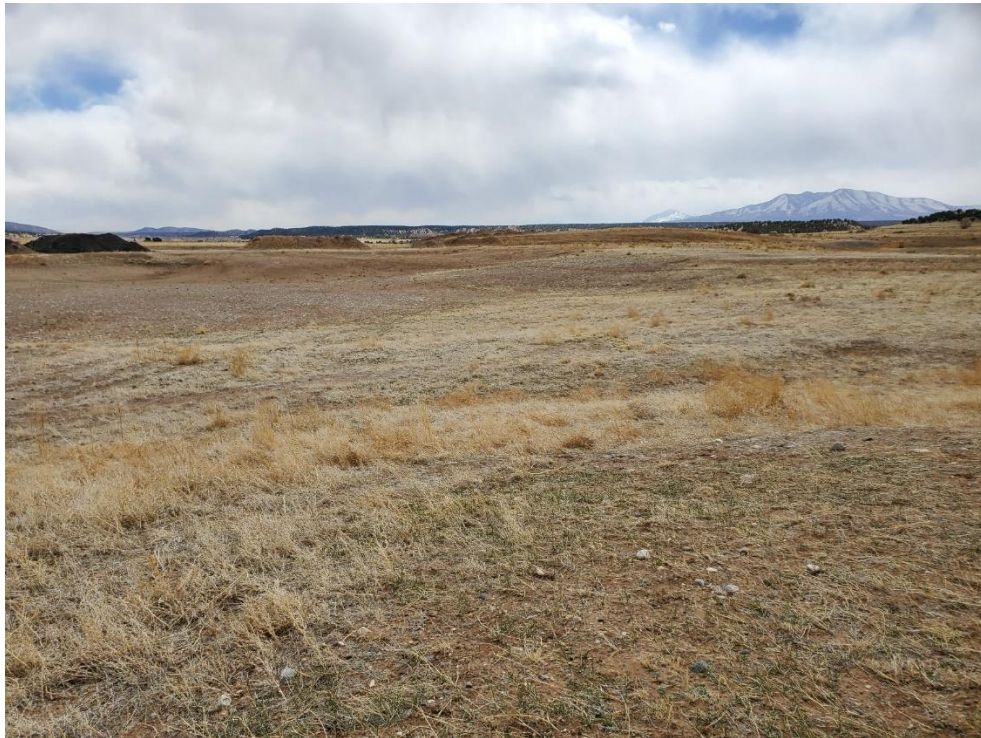
Figure 13. Looking southeast from western side of affected area.

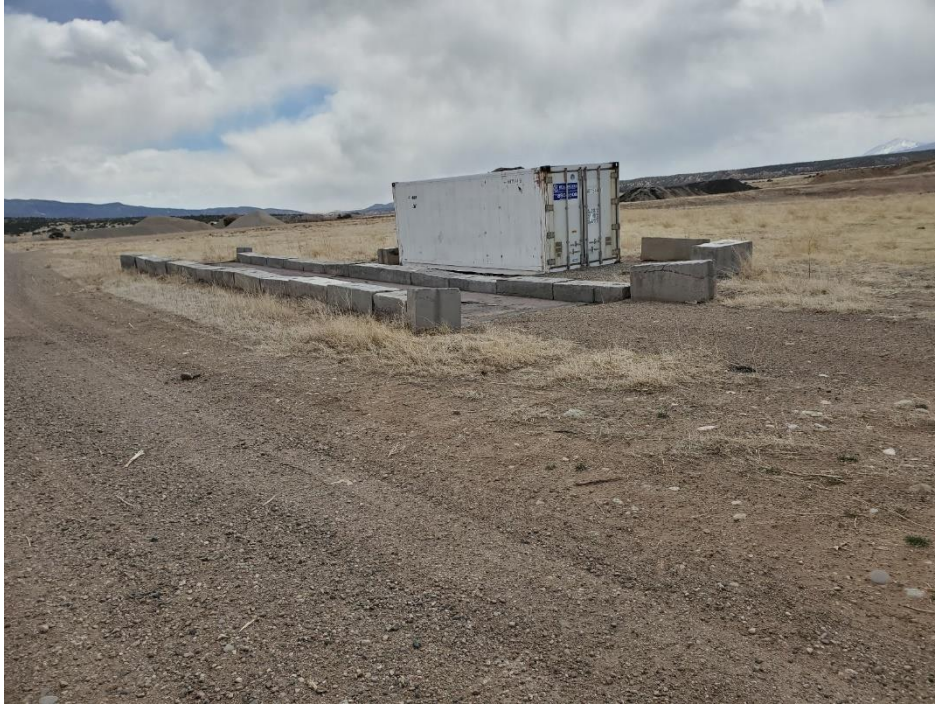
Figure 14. Looking southeast at scale in the northwest corner of affected area.

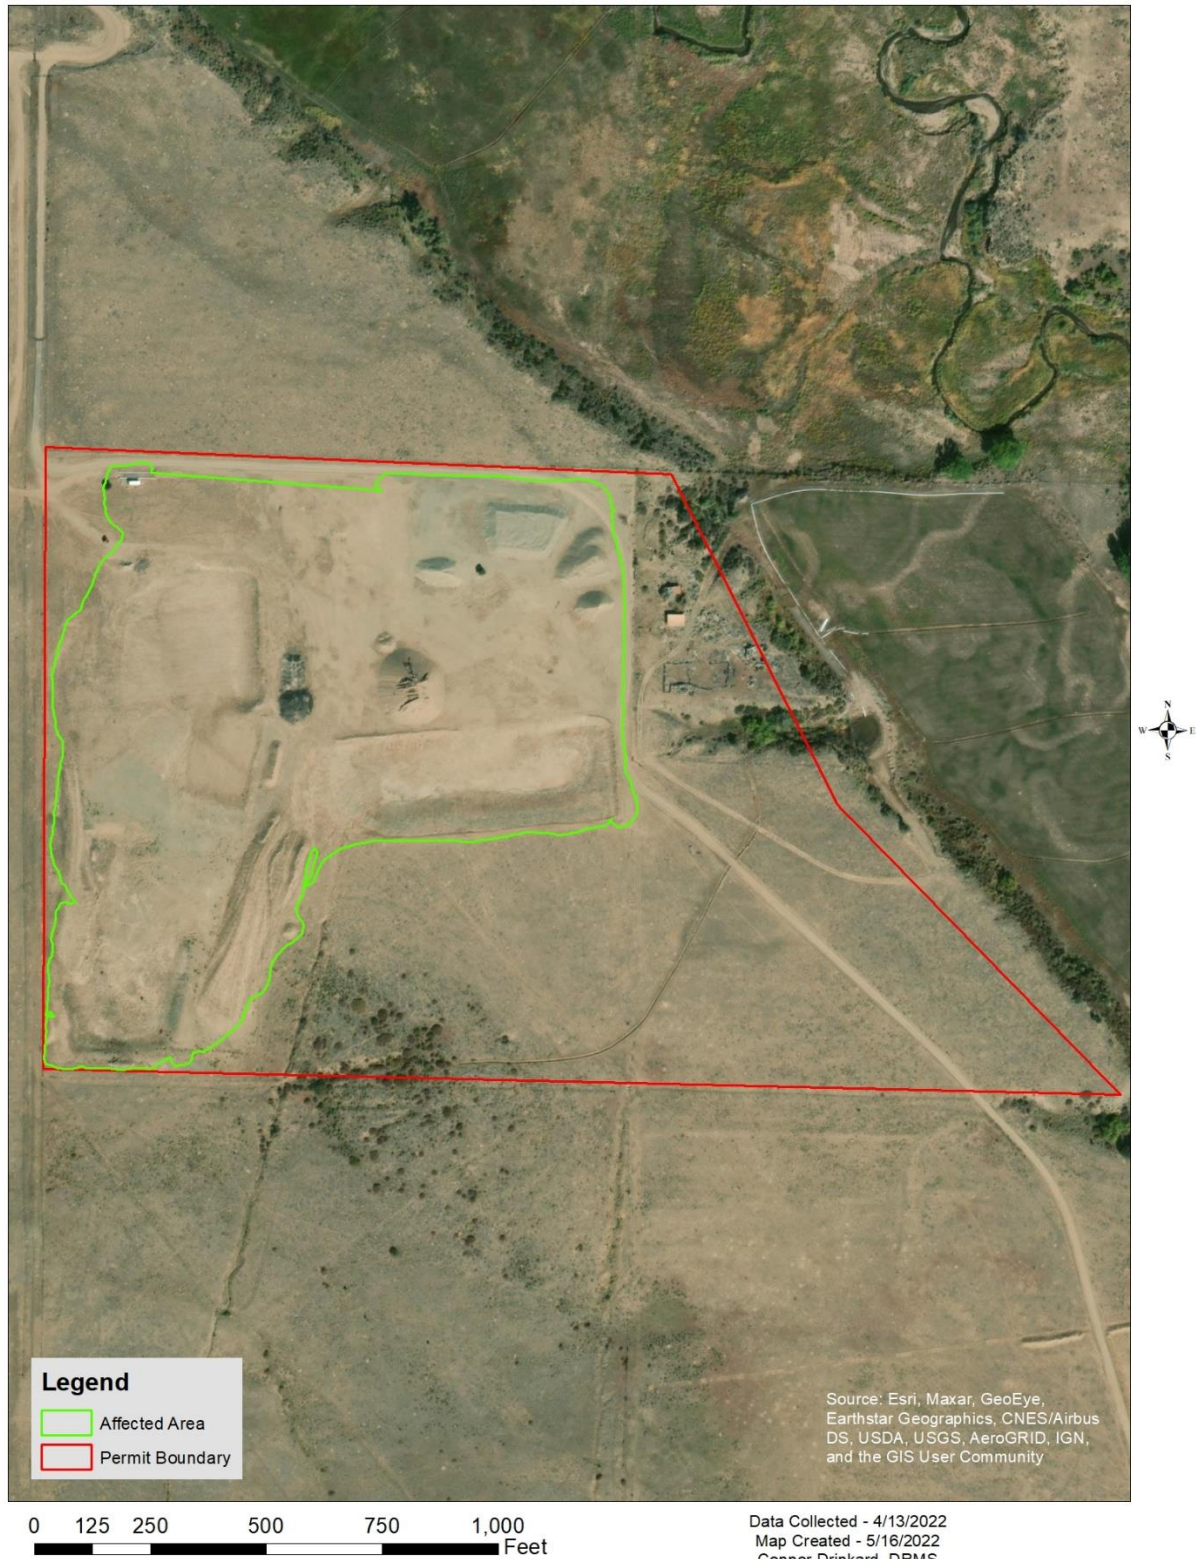
The current affected area was plotted and shown to be approximately 26.49 acres which is within the maximum allowed 54.43 acres. According to the 02/21/2022 annual reclamation report the last activity at the site occurred on 11/15/21 with 30 acres reported affected. In accordance with Rule 1.13.5(1), if the Operator plans to, or does temporarily cease production of the mining operation for one hundred and eighty (180) days or more, the Operator must file a Notice of Temporary Cessation.

Figure 15. Map of Leone Gardner. Affected Area approx. 26.49 acres.
