PERMIT INFORMATION

Permit Number: C-1981-041 Mine Name: Roadside Portals Operator: Snowcap Coal Company, Inc. Operator Address: MS Tonya Hammond P.O. Box 1430 Palisade, CO 81526	County: Mesa Operation Type: Underground Permit Status: Active Ownership: Private
	Operator Representative Present: Tonya Hammond
Operator Representative Signature: (Field Issuance Only)

Inspection Start Date: May 31, 2022 Inspection Start Time: 10:00 Inspection End Date: June 3, 2022 Inspection End Time: 09:24	Inspection Type: Coal Partial Inspection Inspection Reason: Normal I&E Program Weather: Clear	
Joint Inspection Agency: None	Joint Inspection Contacts: None	
Post Inspection Agency: None	Post Inspection Contacts: None	
Inspector(s): Clayton Wein Travis Marshall	Inspector's Signature: <i>Clayton Wein</i>	Signature Date: 6/13/2022

This report covers two inspections of the Roadside Portals Mine conducted on May 31, 2022 and June 3, 2022. The inspections were conducted by Travis Marshall (DRMS) and Clayton Wein (DRMS) respectively. Tonya Hammond of Snowcap Coal Company, Inc. was present for both of the inspections. The inspections were conducted as follow-up inspections after the observations made dur

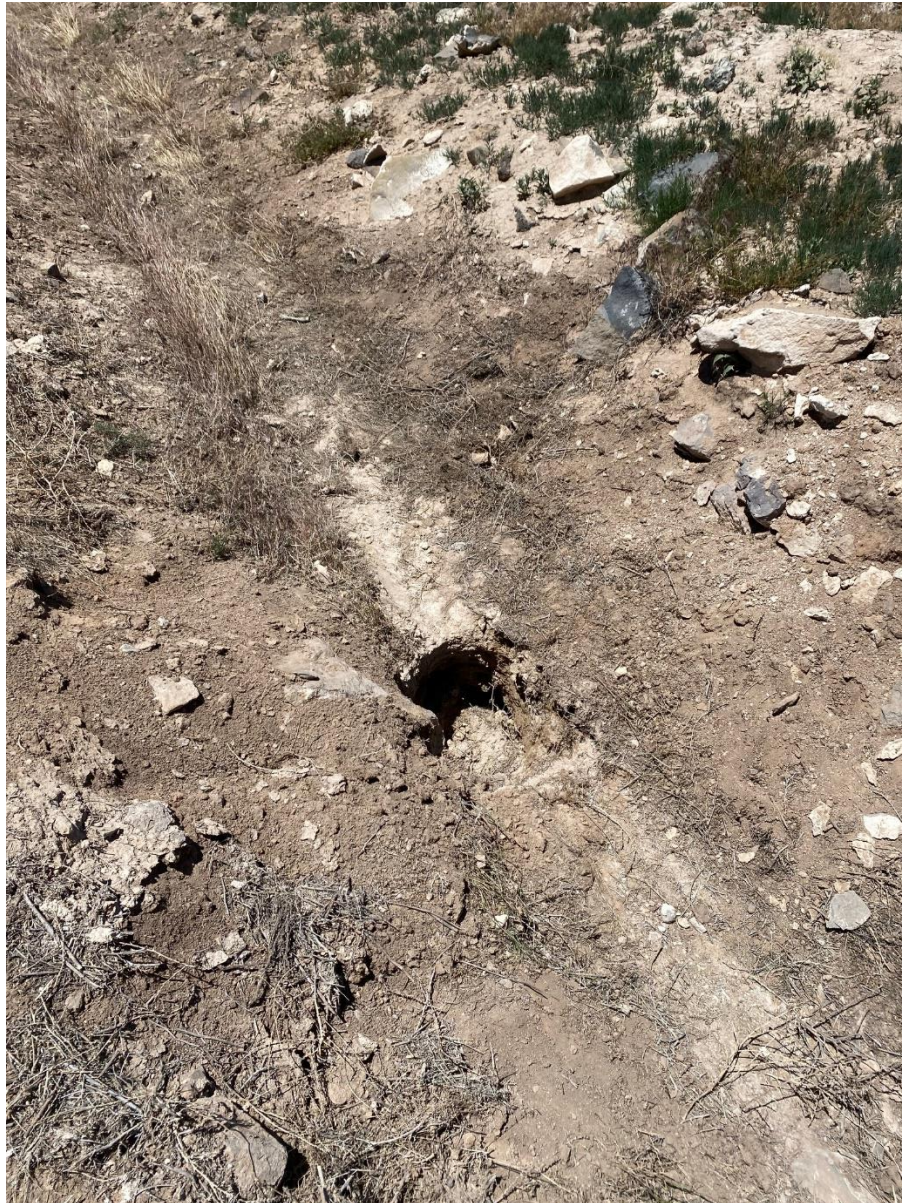
The west hole was approximately the same size as observed on May 27, 2022.

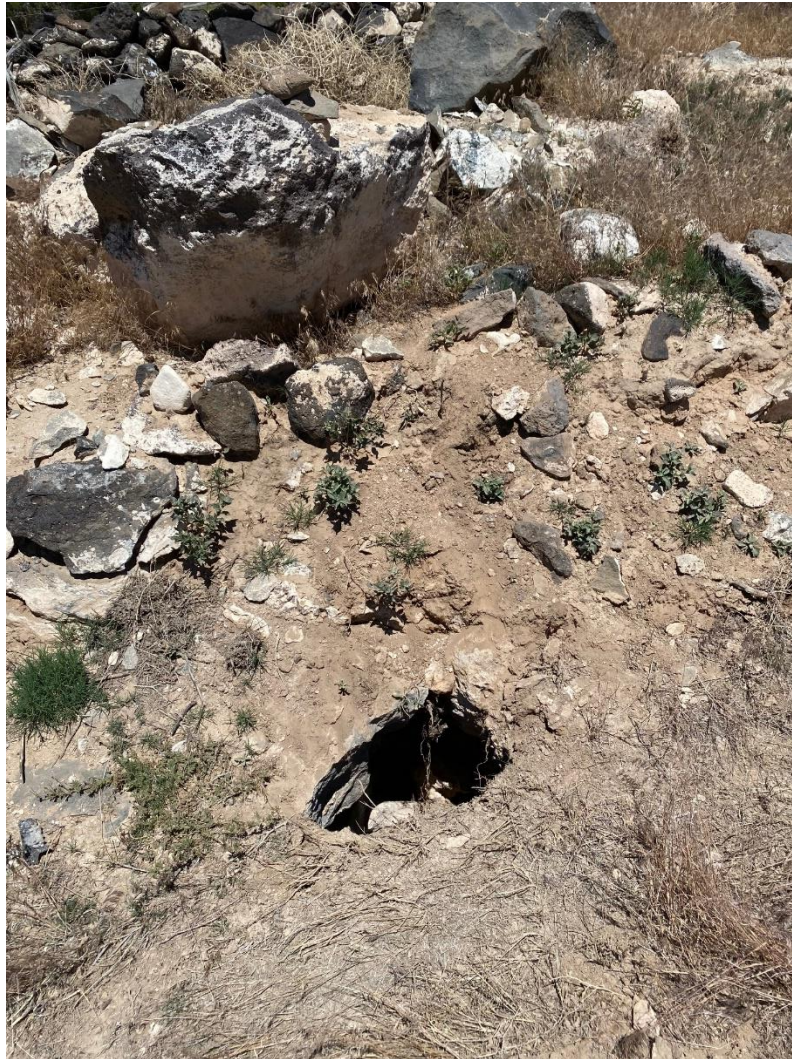
The middle hole was in similar condition as on May 27, 2022.

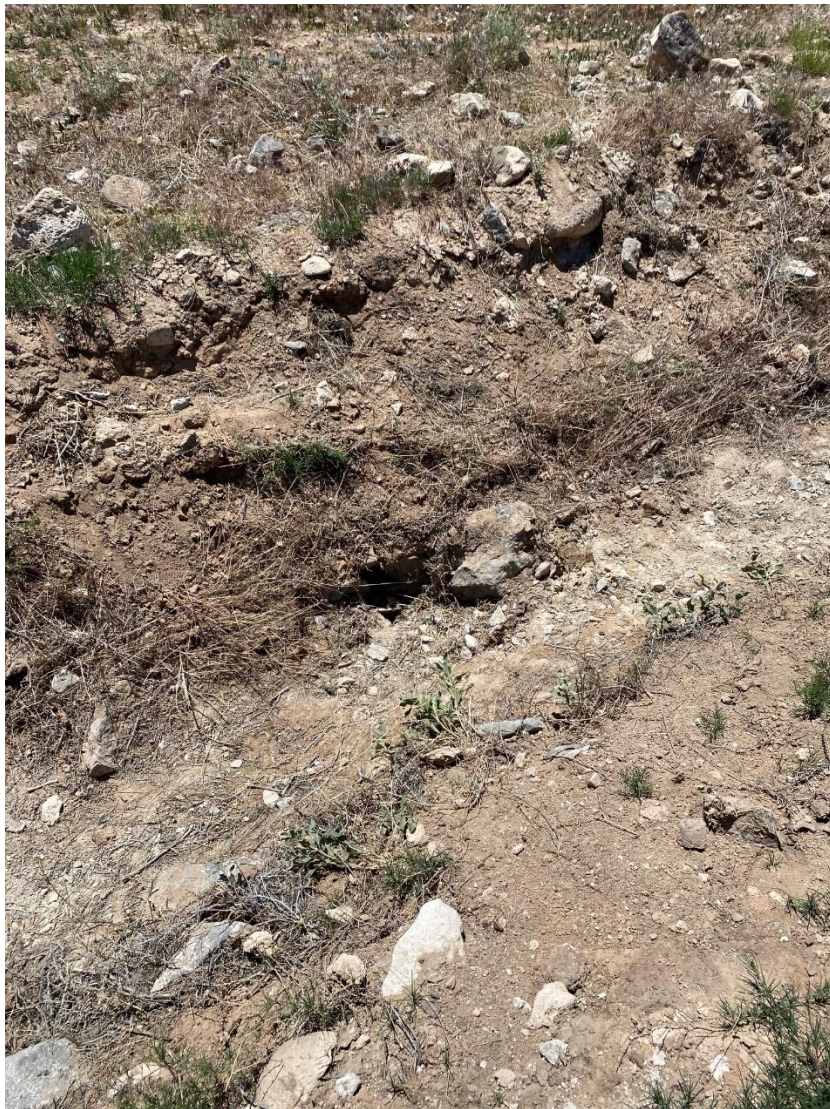
The east hole was observed to be in similar condition as it was on May 27, 2022.

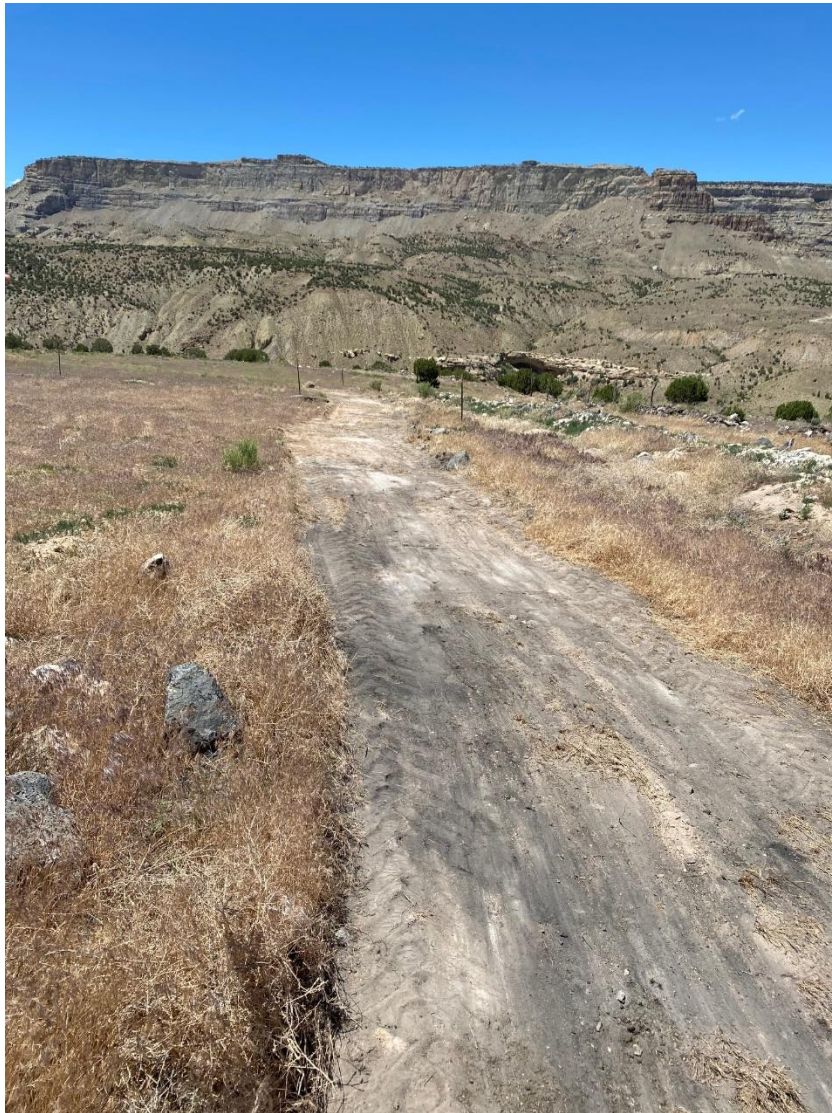
below for more details. The Division did identify a section in the northern part of the TR-69 Repair Area that had been bladed. The disturbance was not created by Snowcap Coal Company. The Disturbance had bladed the vegetation of the site included grasses and shrubs. The Disturbance trended east/west. The straw waddles at the northwest corner of the TR-69 Repair Area had been destroyed by the disturbance created by blading.

The photo above was taken of the bladed disturbance crossing through the TR-69 Repair Area.

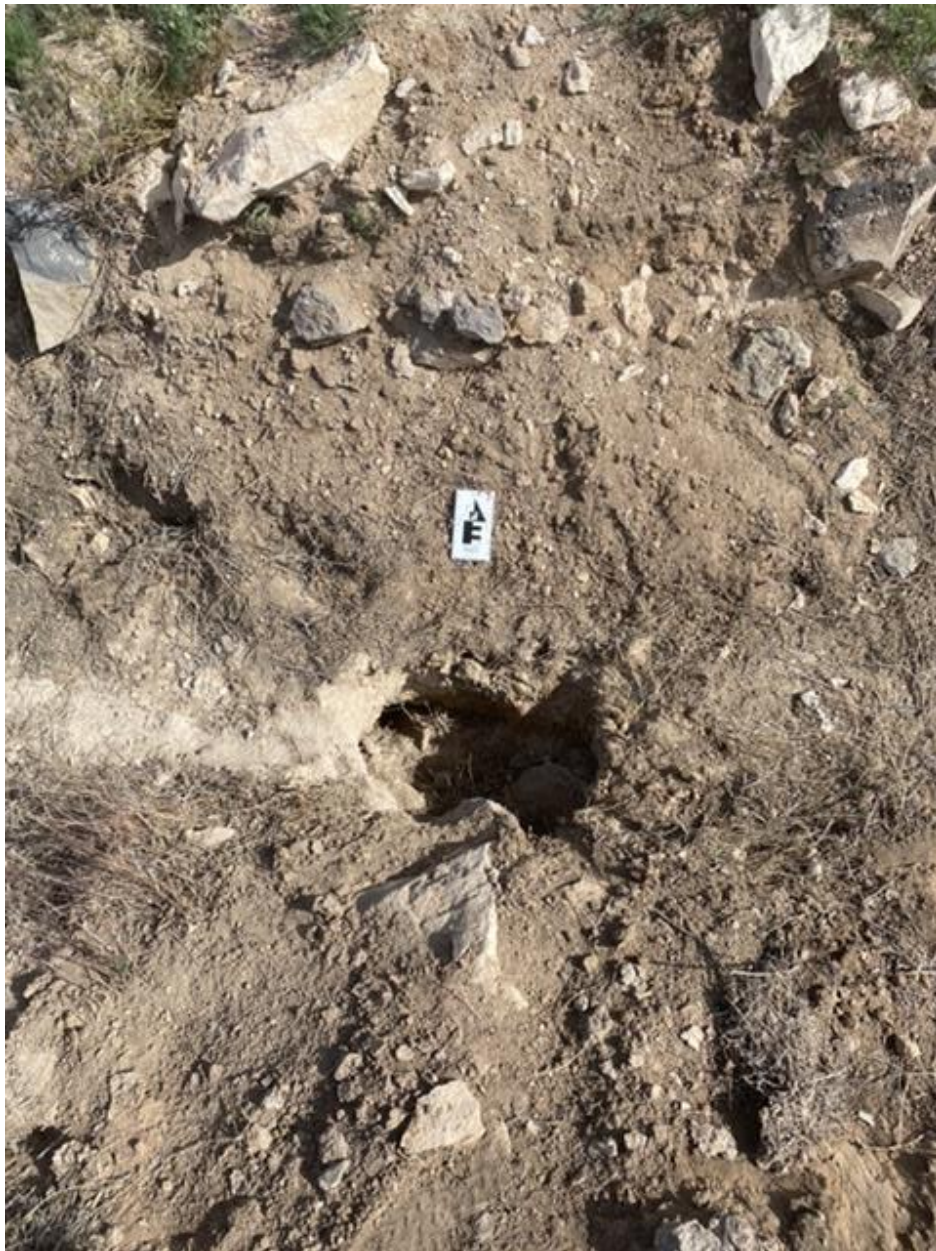
The photo above was taken of the west hole. There was no water infiltrating the hole during the inspection. The size of the hole on the surface is slightly larger than previous inspections.

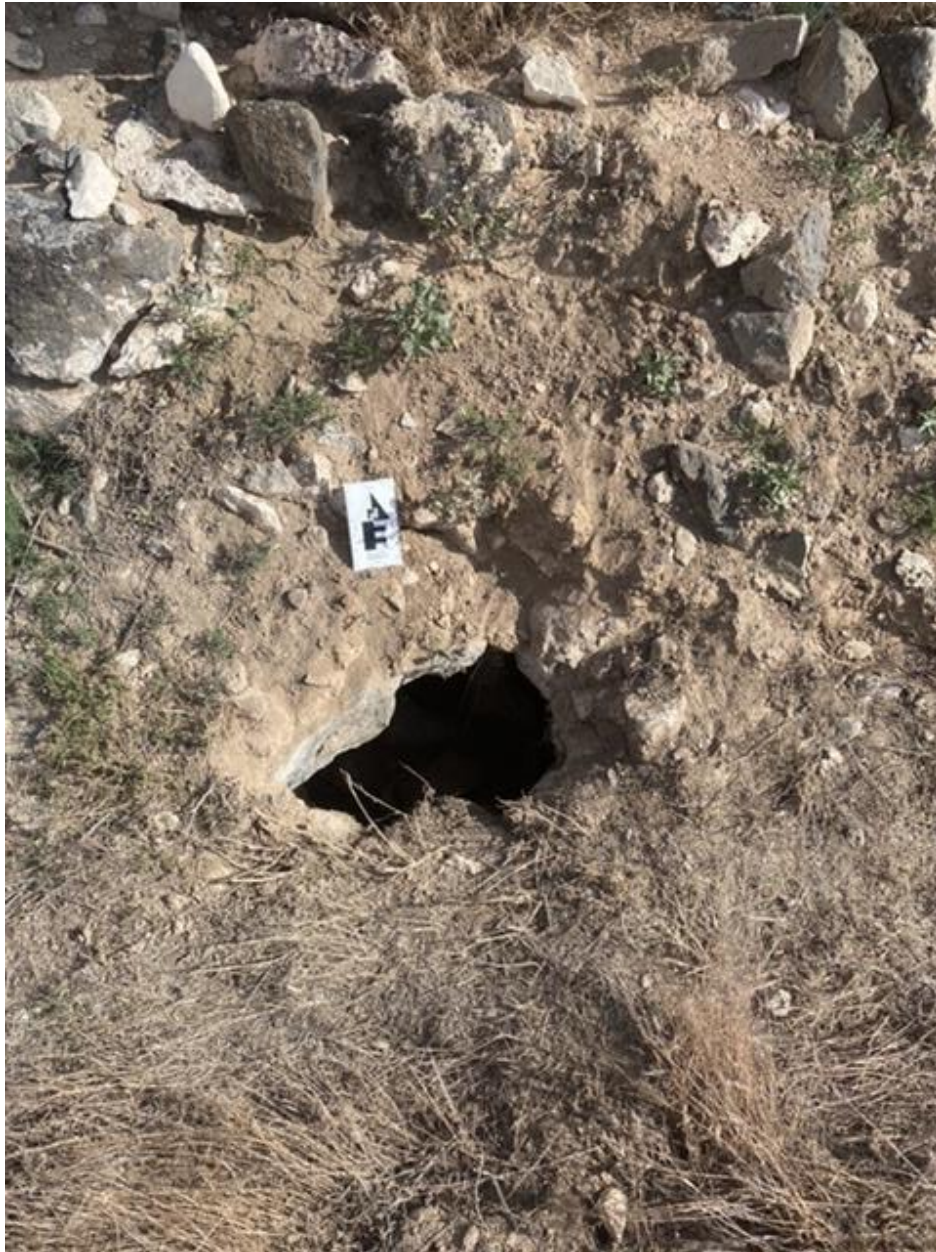
The middle hole was larger on the surface during this inspection. No water was entering the hole.

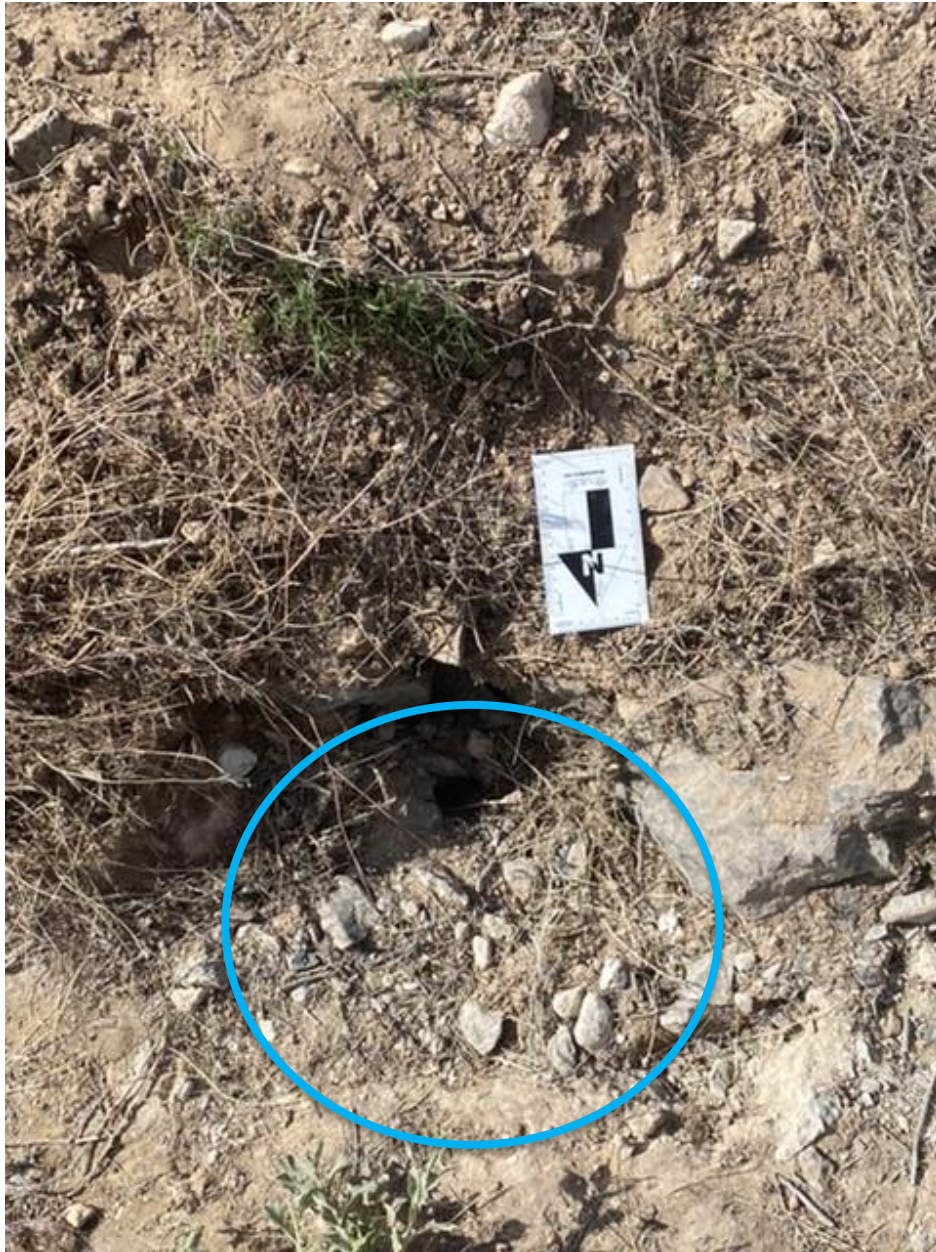
The east hole was also approximately the same size as previous inspections. The size of the hole is still difficult to determine due to the rocks on the surface.

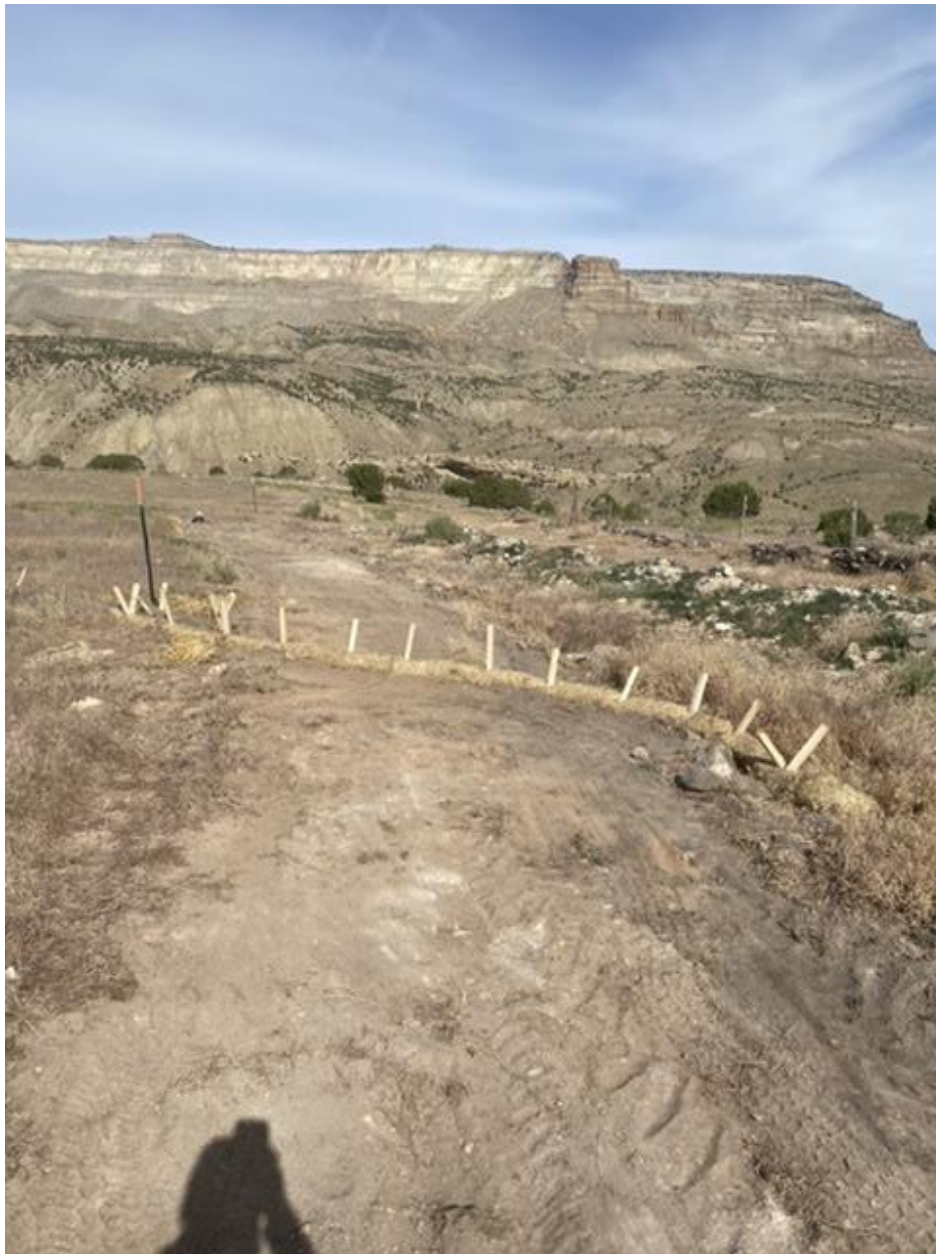
The straw wattle in the photo above was replaced during the inspection. The straw wattle in this location was damaged when the landowner scraped the surface through the TR-69 repair area. The scrapped path was similar to the inspections conducted earlier in the week.

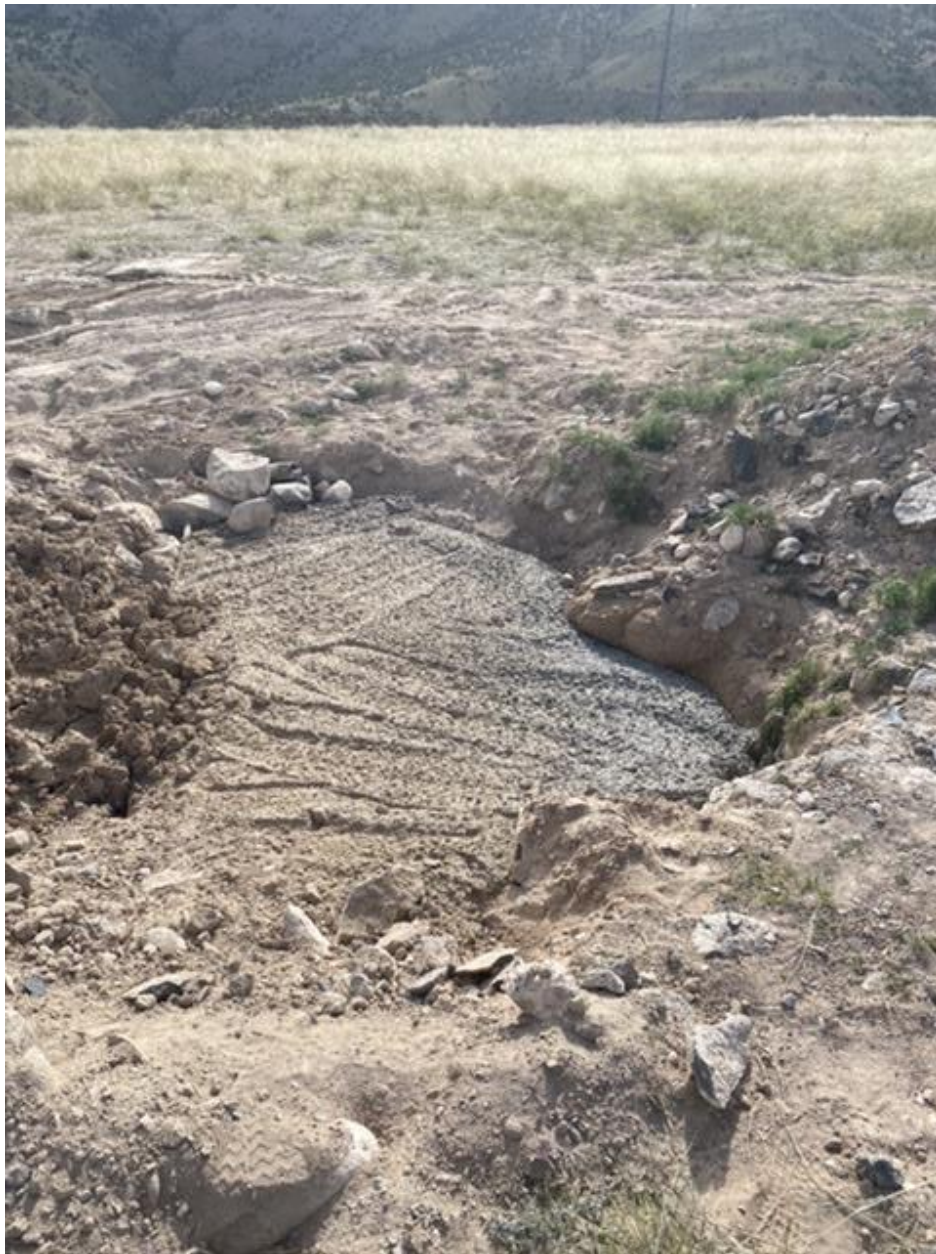
The photo above was taken of the cement cap located on top of the Tract 70 Mesa. The hole with the cement in it was approximately 3 feet by 4 feet.
