MINERALS PROGRAM INSPECTION REPORT PHONE: (303) 866-3567

MINE NAME:	MINE/PROSPECTING ID#:	MINERAL:	COUNTY:
Mahogany Research Project - Public Land	P-2003-018	Oil shale	Rio Blanco
Prospecting			
INSPECTION TYPE:	INSPECTOR(S):	INSP. DATE:	INSP. TIME:
Monitoring	Amy Yeldell	May 31, 2022	09:00
OPERATOR:	OPERATOR REPRESENTATIVE:	TYPE OF OPERATION:	
Shell Frontier Oil & Gas Inc.	Samantha Baker	MP - Mineral Prospecting	
REASON FOR INSPECTION:	BOND CALCULATION TYPE:	BOND AMOUNT:	
Normal I&E Program	None	\$2,656,462.00	
DATE OF COMPLAINT:	POST INSP. CONTACTS:	JOINT INSP. AGE	ENCY:
NA	None	U.S.BLM	
WEATHER:	INSPECTOR'S SIGNATURE:	SIGNATURE DAT	E:
Clear	Amy Geldell

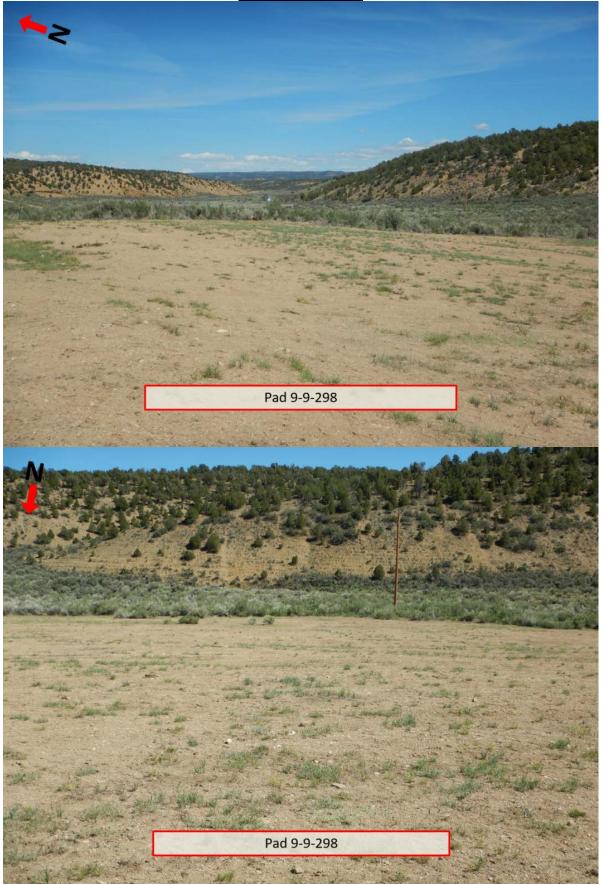
Pad 9-9-298: Pad is right off roadway and is fenced off from cattle. Evidence of horse grazing within fenced areas. Pad has very sparse vegetation, approx. 10% overall cover. Very few grasses have been established with a hand full of low rabbit brush. No sage shrubs have volunteered to date despite being surrounded by mature sagebrush. No noxious weeds were observed.

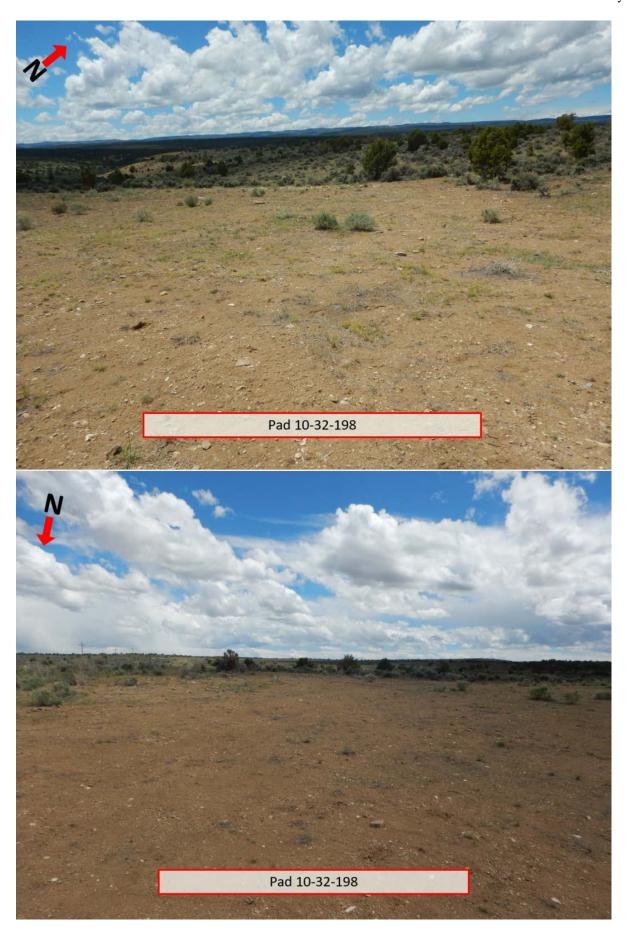
Pad 10-32-198: Russian Thistle has been extensively treated, very little new establishment was observed (still early yet). Pad is nearly barren with less than 5% overall cover. Mostly only shrubs (sagebrush) left, most of the remaining grasses has been grazed off. Of the remaining grasses some of them are showing a liming in color. This may be due to injury from residual chemical in the soil from treating weeds or a nutrient imbalance in the soil. Given this pads struggle to establish vegetation prior to grazing pressures, soil testing is recommended to see if there is an underlying cause.
