**COLORADO**Division of Reclamation,
Mining and Safety

PERMIT INFORMATION

Permit Number: C-1981-041 Mine Name: Roadside Portals Operator: Snowcap Coal Company, Inc. Operator Address: MS Tonya Hammond P.O. Box 1430 Palisade, CO 81526	County: Mesa Operation Type: Underground Permit Status: Active Ownership: Private
	Operator Representative Present: Tonya Hammond
Operator Representative Signature: (Field Issuance Only)

Inspection Start Date: June 6, 2022 Inspection Start Time: 09:35 Inspection End Date: June 10, 2022 Inspection End Time: 09:10		Inspection Type: Coal Partial Inspection Inspection Reason: Normal I&E Program Weather: Clear	
Joint Inspection Agency: None		Joint Inspection Contacts: None	
Post Inspection Agency: None		Post Inspection Contacts: None	
Inspector(s): Clayton Wein	Inspector's Signature: <i>Clayton Wein</i>		Signature Date: 6/13/2022

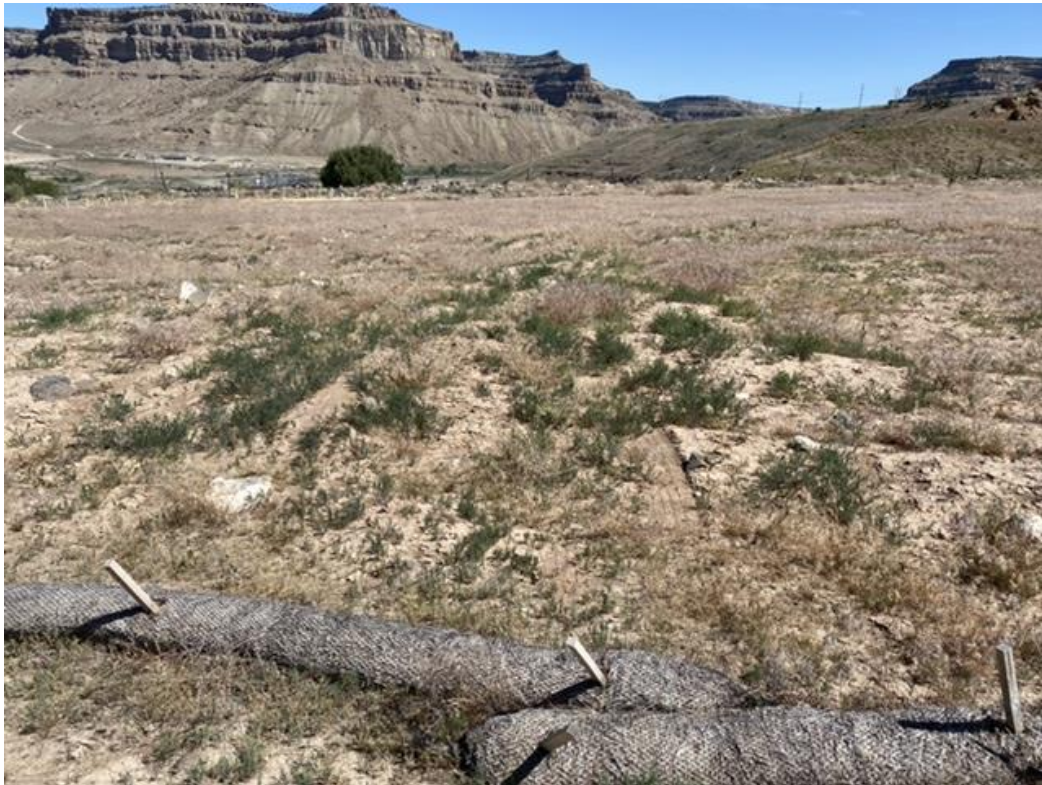
June 8, 2022: The morning of June 8th the Division conducted an inspection of the Roadside Mine with a focus on the hydrologic concerns observed near the TR-69 Repair Area. During the inspection there was no water discharging from the 4 inch pipe into the landowner's ditch. There was no evidence of recent flow in the ditch. The west, middle and east holes were in similar condition to that of what was observed on June 6th. There was no notable increase in the size of the holes. There was no water running out of the Landowner's risers on top of the Tract 70 Mesa at the time of the inspection. Tail water was observed flowing off of the northwest corner and west side of the landowner's middle field (Not within any DRMS permit area). There was no impact observed to either the C-1981-041 Coal permit or the M-1996-076 Minerals permit from the tail water. A new set of tire tracks was observed running through the west and north portions of the TR-69 Repair Area. The tracks entered the reclamation just to the left of the mine identification sign (going over the straw waddle) and went north to Mr. Fontanari's ditch. The tracks then turned east and followed the ditch out of the TR-69 Repair Area. The entire northern portion of the ditch had been cleaned since the inspection on Monday. Please see the photo below of the new set of tire tracks.

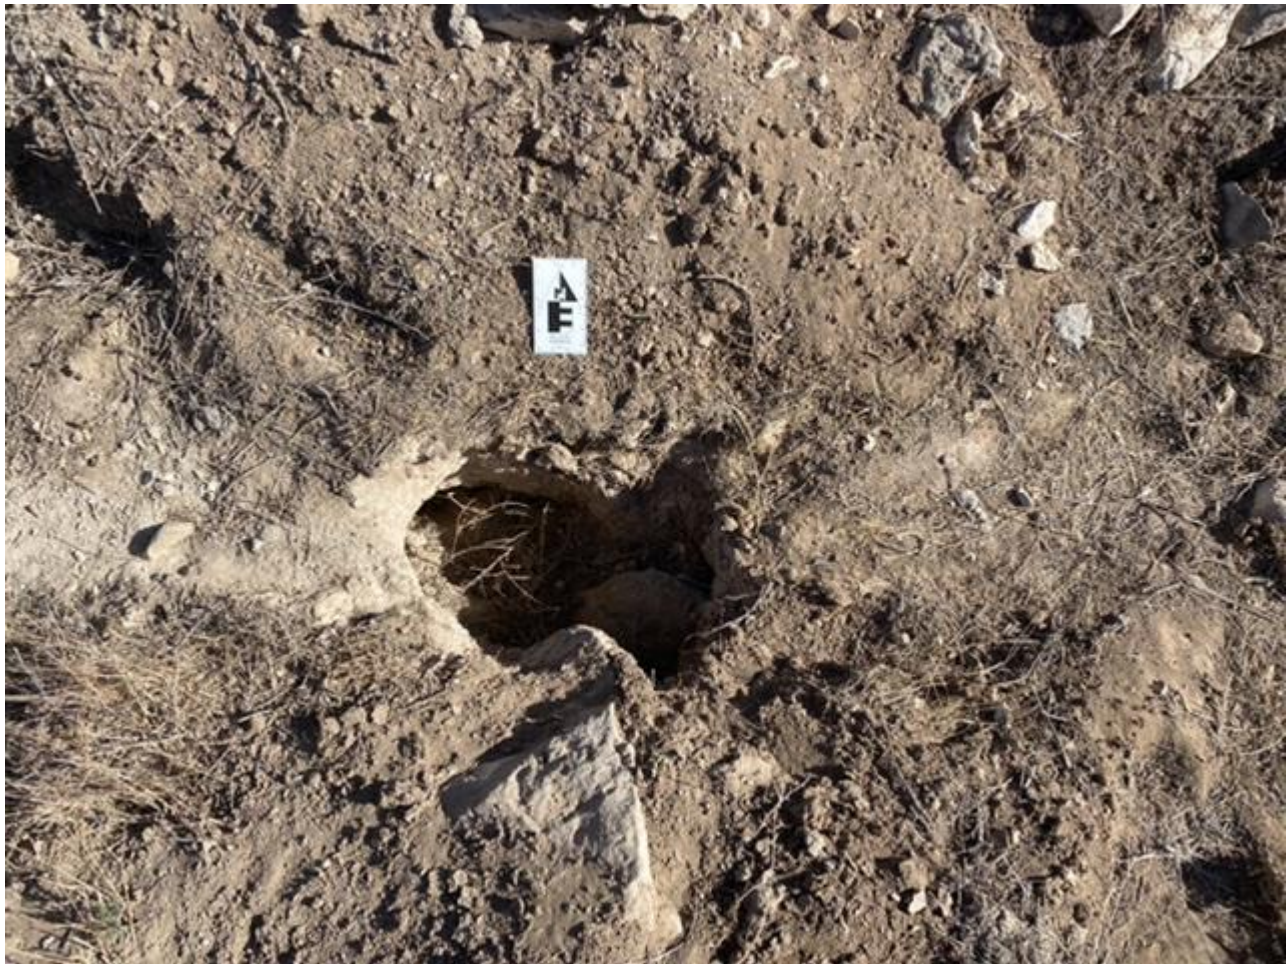
The west hole during the June 10, 2022 inspection. The size and depth of the hole remained similar to what was observed during previous Division Inspections.

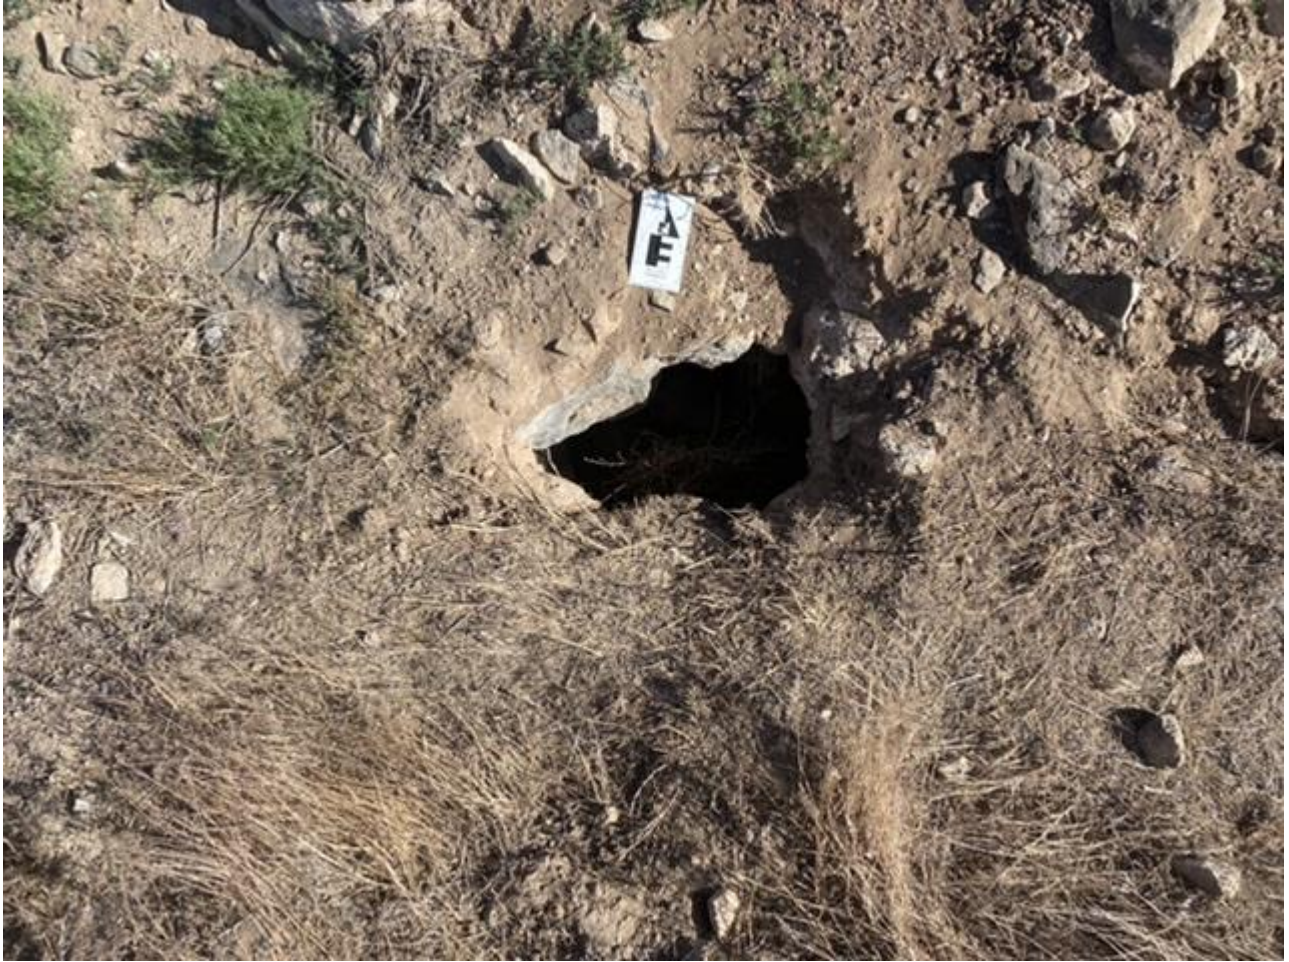
The photo above was taken of the middle hole. The hole was observed to be similar in size to that of previous Division inspections.

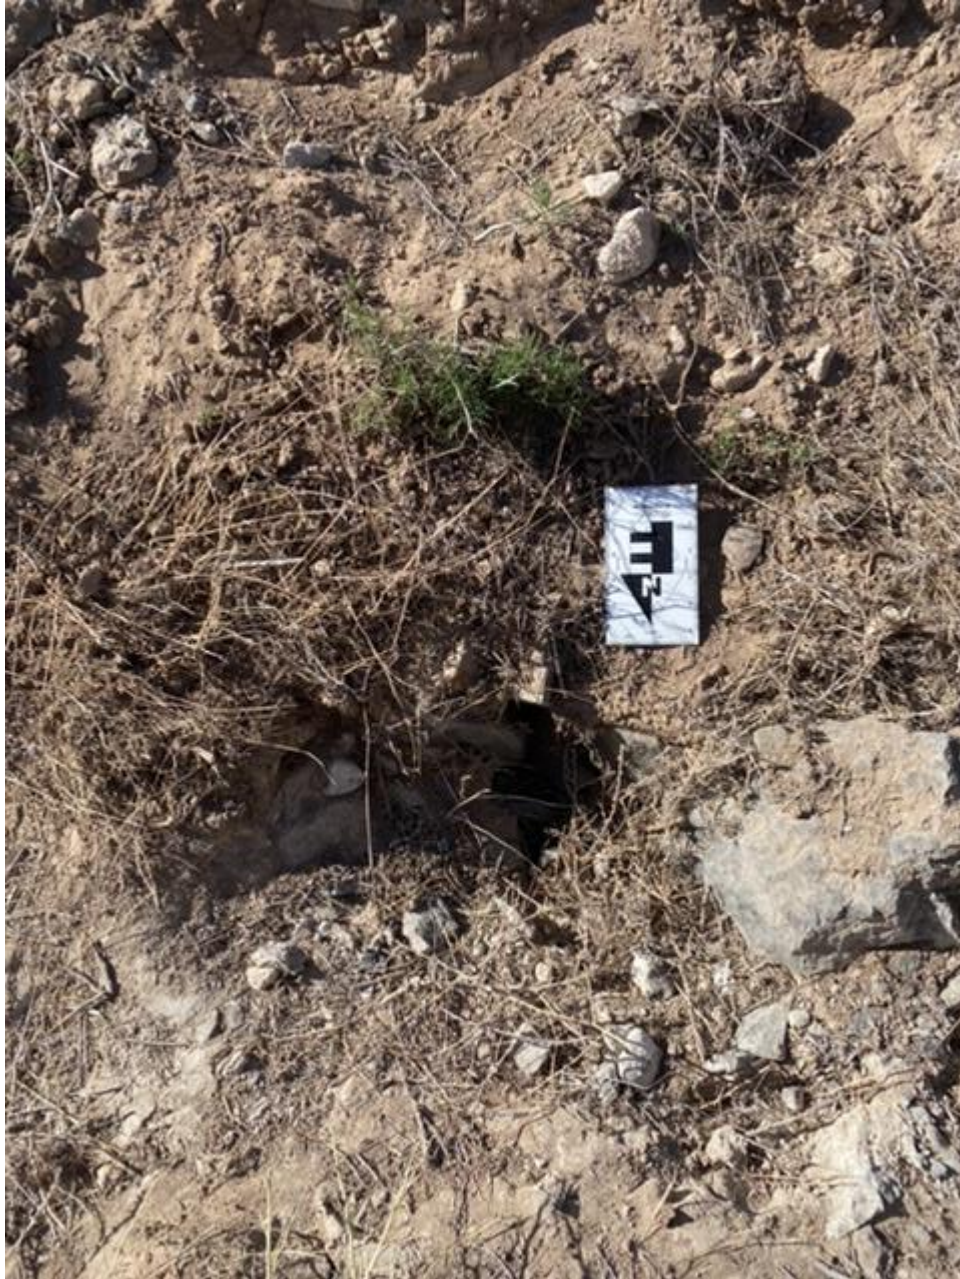
The photo above is of the east hole on June 10, 2022. The size had remained similar to observations made by the Division on previous inspections.
