MINERALS PROGRAM INSPECTION REPORT

MINE NAME: Schwartzwalder Mine	MINE/PROSPECTING ID#: M-1977-300	MINERAL: Uranium	COUNTY: Jefferson
INSPECTION TYPE: Monitoring	INSPECTOR(S): Amy Eschberger, Michael Cunningham	INSP. DATE: May 27, 2022	INSP. TIME: 09:00
OPERATOR: Colorado Legacy Land, LLC	OPERATOR REPRESENTATIVE: Elizabeth Busby, Jim Harrington	TYPE OF OPERATION: 112d-2 - Designated Mining Operation	
REASON FOR INSPECTION: Normal I&E Program	BOND CALCULATION TYPE: None	BOND AMOUNT: \$7,674,022.00	
DATE OF COMPLAINT: NA	POST INSP. CONTACTS: None	JOINT INSP. AGENCY: None	
WEATHER: Clear	INSPECTOR'S SIGNATURE:

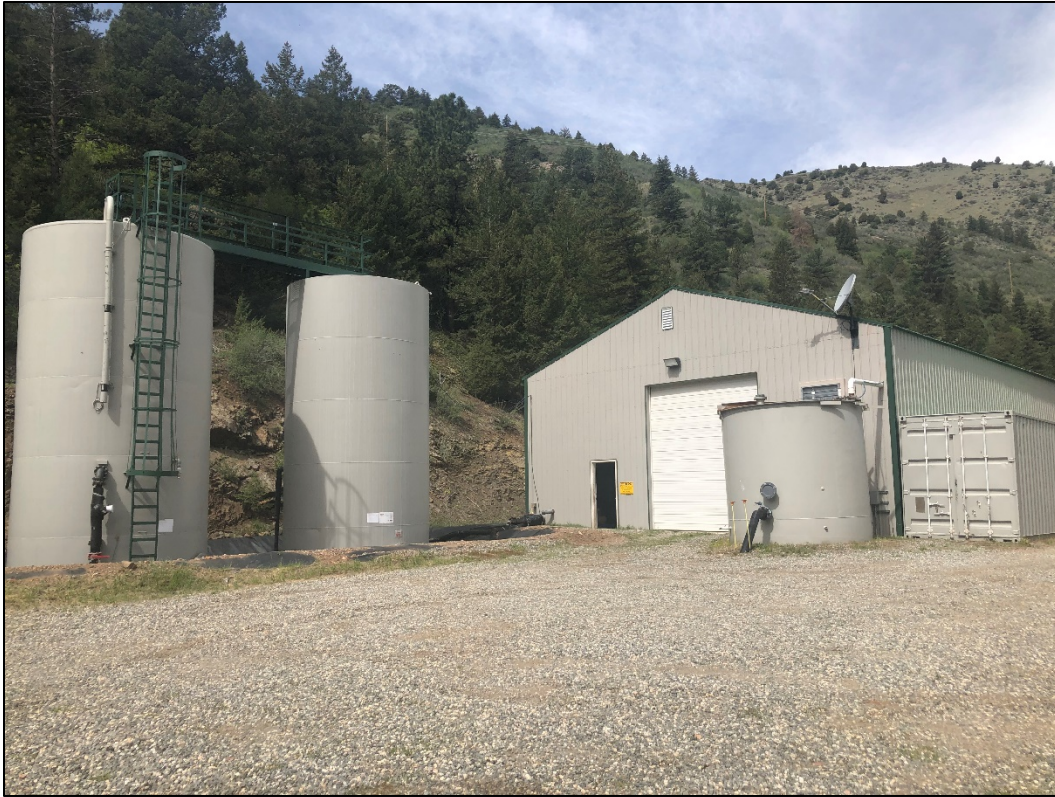
At the time of the inspection, the weather was warm and sunny. The mine pool was reported at 230 feet below Steve Level, which is 80 feet below the required 150 foot depth. The water treatment plant was brought back online on May 2, 2022 (after being shut down for the winter in September of 2021). The most recent in-situ treatment of the mine pool (the 5th treatment since 2013) occurred during the last week of September of 2021.

Photo 1. View looking northwest at water treatment plant (on top of mesa), which was brought back online on May 2, 2022.

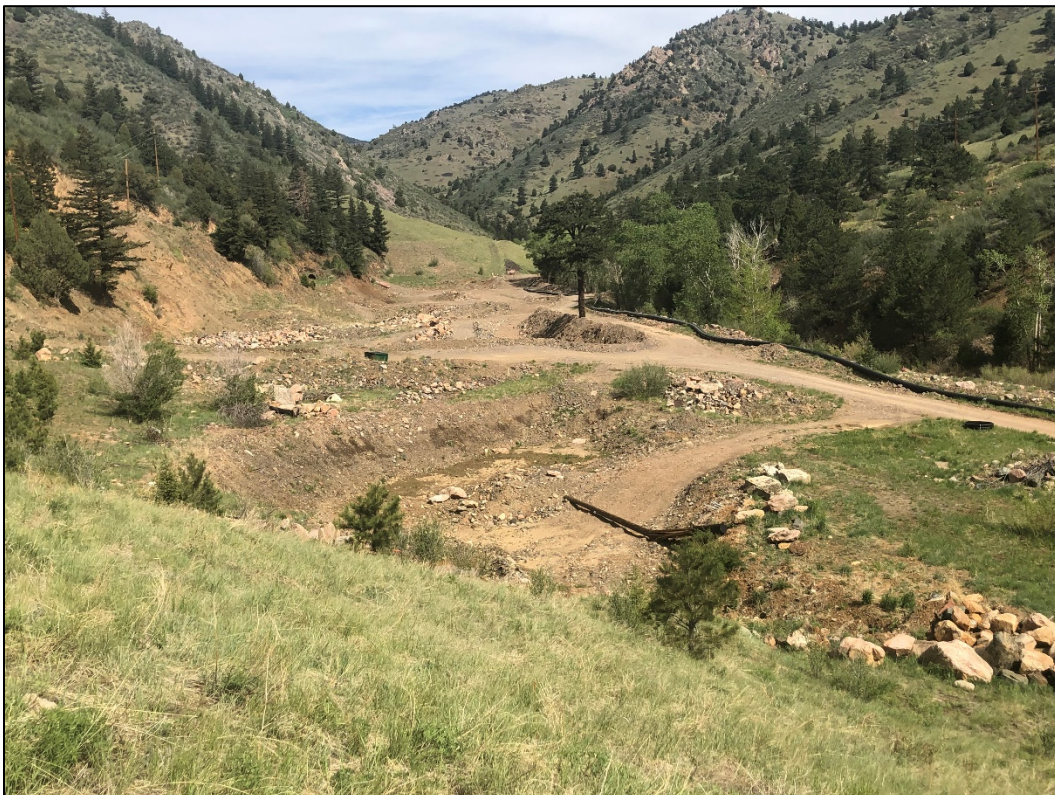
The valley excavation project in which radionuclide-impacted alluvial valley soils are excavated and disposed of underground (on site) had not recommenced. During the 2021 construction season, excavation activities were focused at the northwestern edge of the project area (near the South Waste Rock Pile; SWRP) and at the southeastern edge of the project area (near the site access). These areas appeared to be unchanged since the Division's last inspection on March 22, 2022. The operator plans to recommence with the excavation project this construction season. However, no additional excavated material can be placed into the two approved underground disposal locations (Black Forest Mine and CV Glory Hole in the Minnesota Mine), as they have both reached capacity. Therefore, any additional excavated material will be temporarily stored on the valley floor (and segregated from "clean" soils) per the approved plan, until the Division has approved an alternative disposal location through a Technical Revision. The operator is currently considering placing any additional excavated material onto the lower southeastern edge of the existing SWRP, and possibly tying it into the adjacent Black Forest Mine backfill area (once completed). This new disturbance would be "capped" with a minimum of one foot of growth medium and revegetated. The existing waste rock piles were reclaimed in this manner and now have an established vegetative cover. It should be noted, the main portal of the Black Forest Mine was partially backfilled in December of 2021, in accordance with AM-5 (approved on January 13, 2021). The operator anticipates that both Black Forest mine openings will be completely backfilled per the approved plan during this construction season, as the valley excavation project is completed.

Photo 2. View looking northwest (from top of mesa with water treatment plant) across valley excavation project area. The excavation project has not recommenced since its suspension in December of 2021.

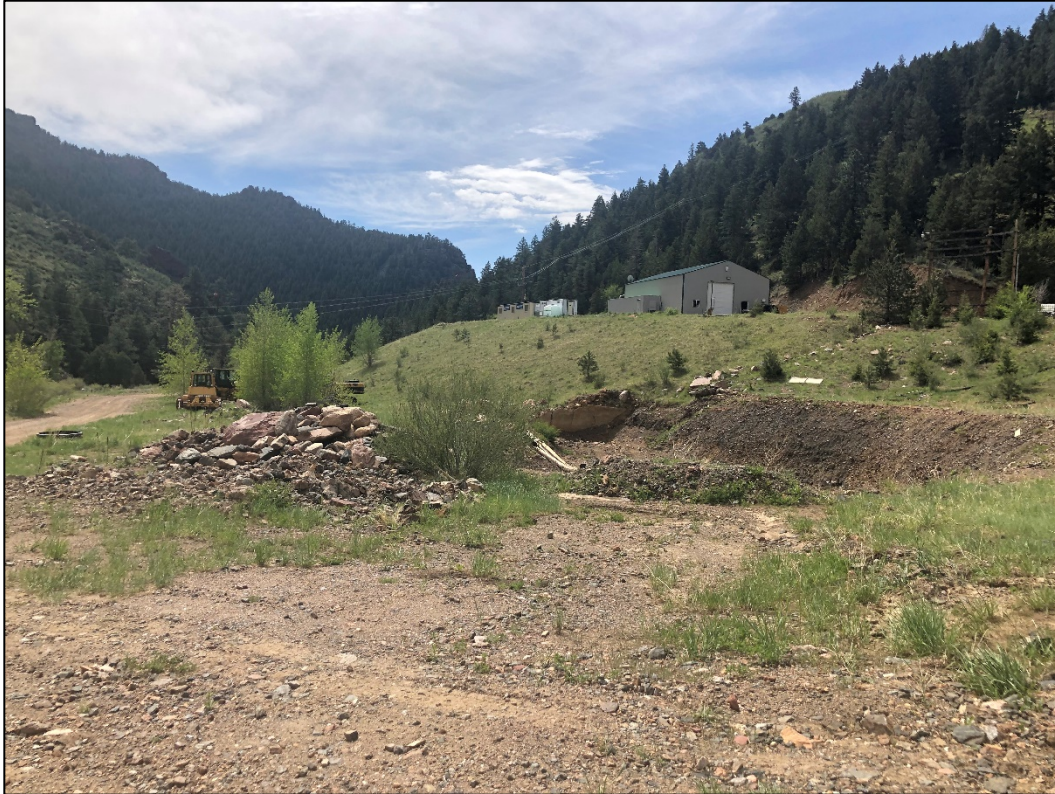
Photo 3. View looking southeast across valley excavation project area, near base of mesa with water treatment plant (visible in background).

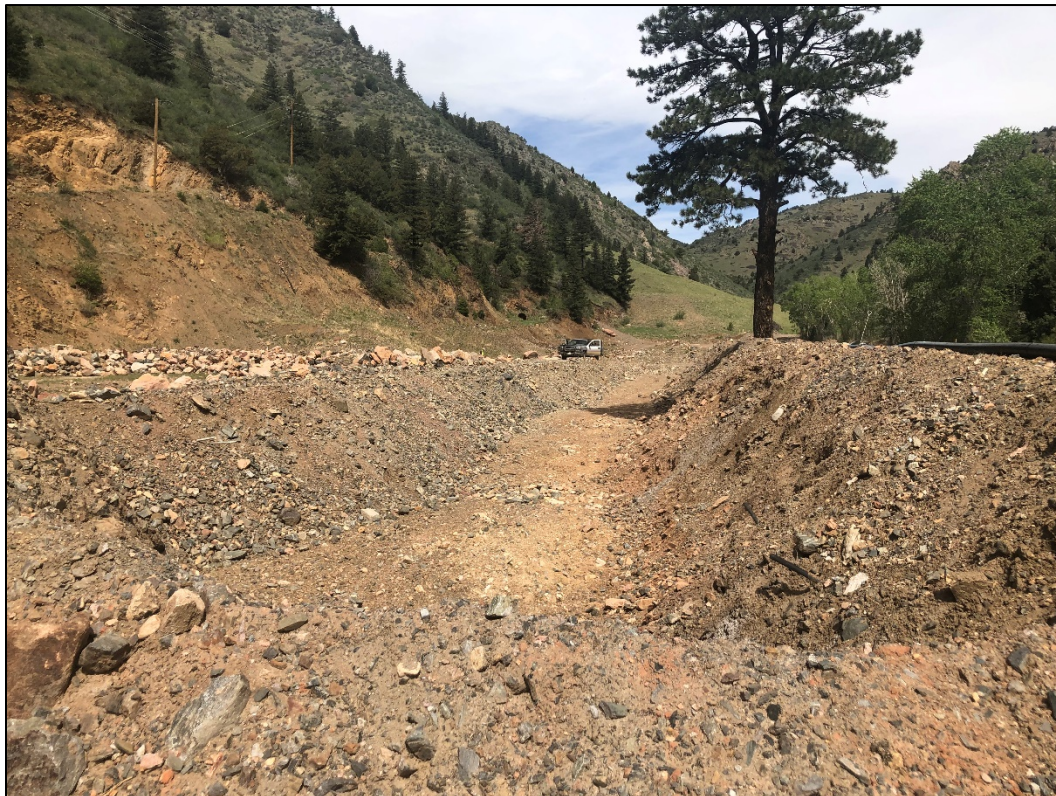
Photo 4. View looking northwest across valley excavation project area.

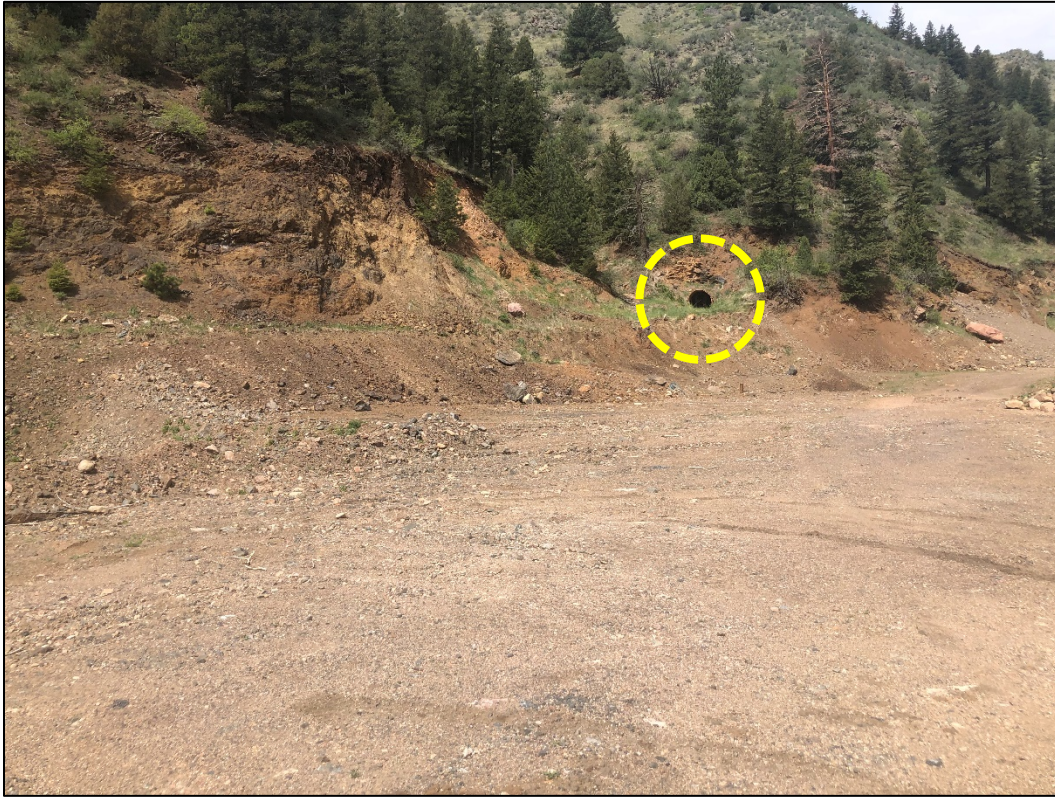
Photo 5. View looking west/northwest across western edge of valley excavation project area. Note Black Forest Mine escape adit visible in background (circled), which will be backfilled for reclamation, per AM-5.

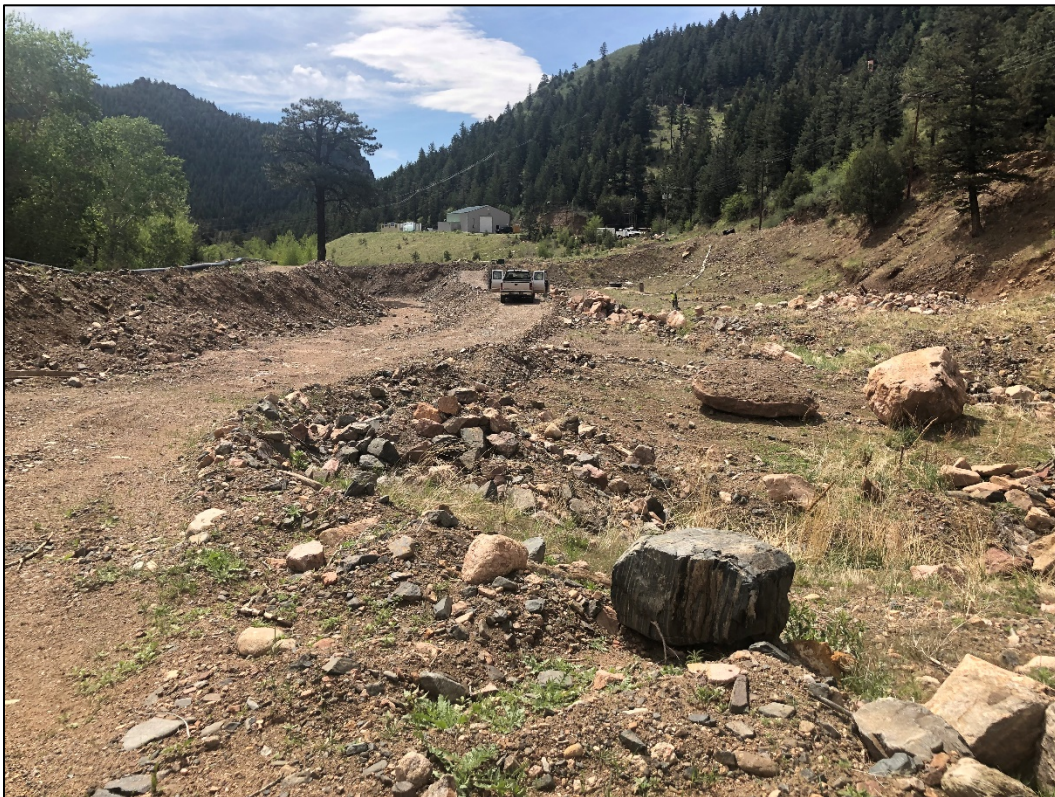
Photo 6. View looking southeast across valley excavation project area.

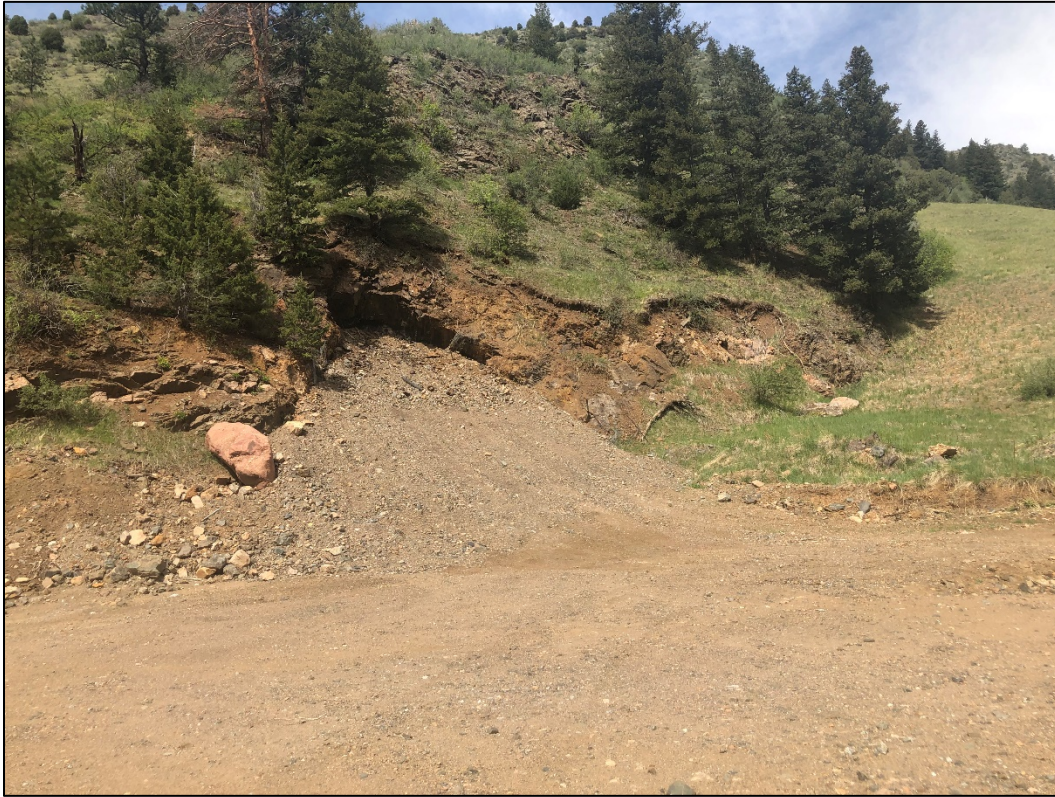
Photo 7. View looking west/northwest at main portal of Black Forest Mine which was partially backfilled in December of 2021, after the mine reached capacity for disposal of excavated materials.

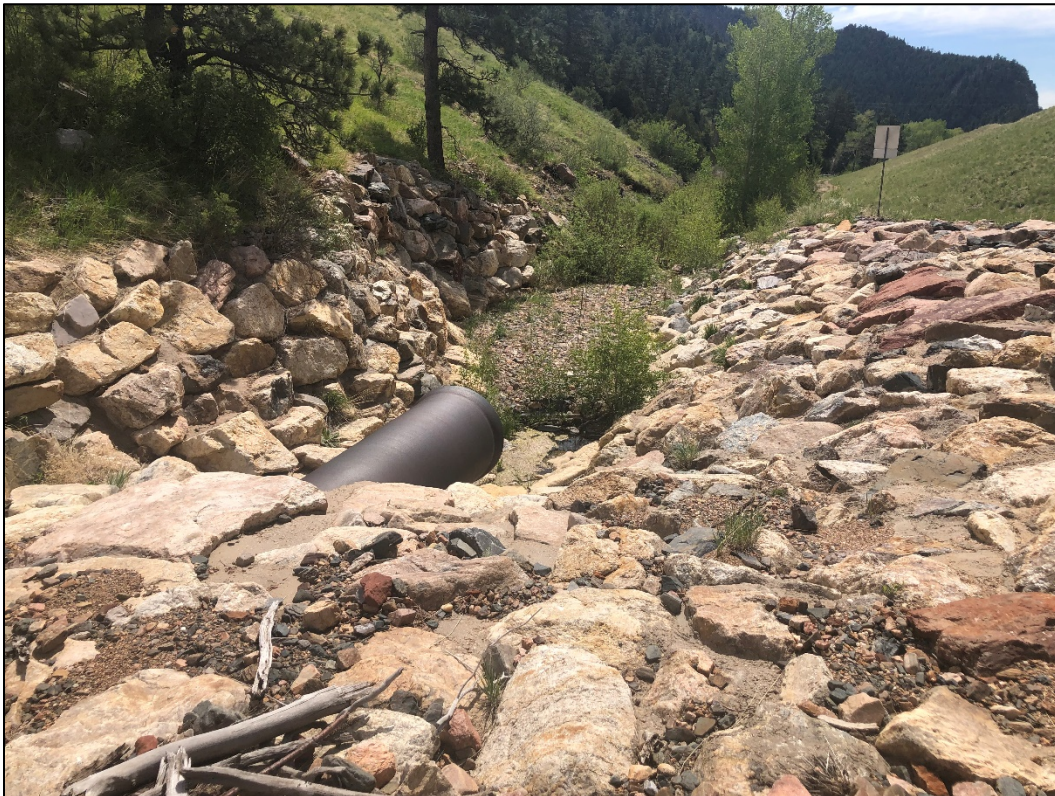
Photo 8. View looking downstream from upgradient cutoff wall/headgate in Ralston Creek, showing creek channel dry downstream of cutoff wall.

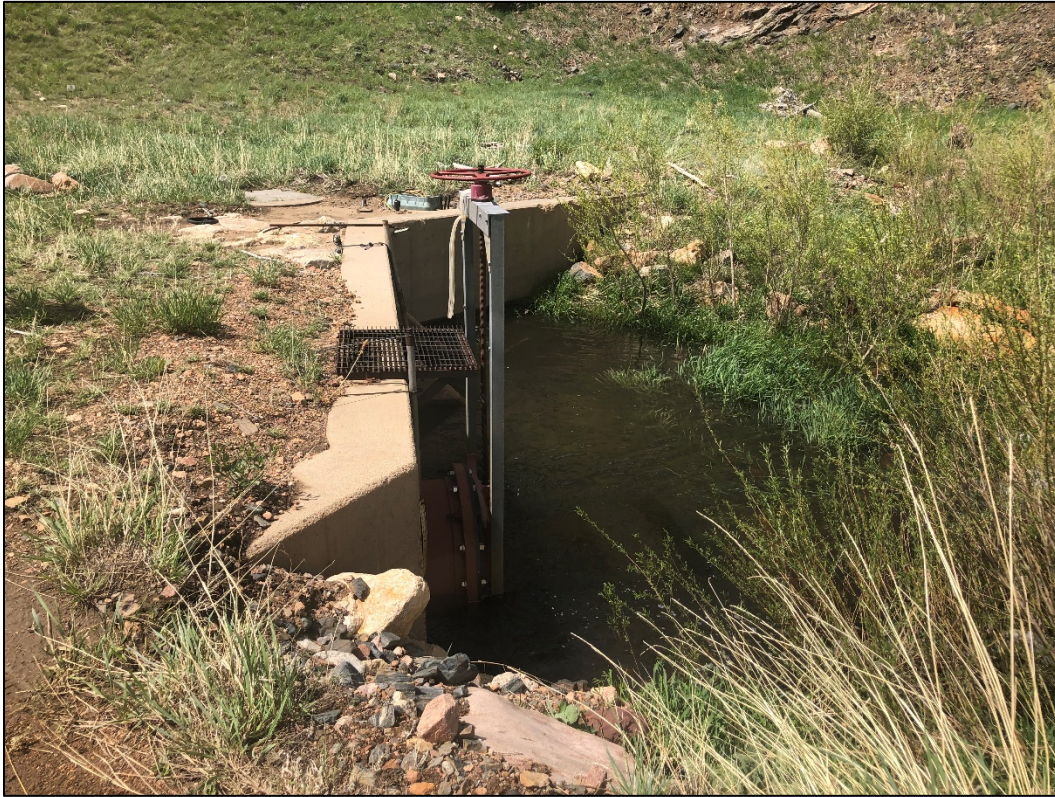
During the inspection, creek flows were being captured above the upgradient cutoff wall and routed around the mine site via the bypass pipeline. These flows are discharged into the creek downstream of the mine site at the operator's permitted outfall (SW-BPL). The Division also observed the downgradient portion of the stormwater diversion channel which was installed along the northern edge of the NWRP in 2020 (under TR-28; approved on March 27, 2020). No water was present in the channel. The channel appeared to be maintained and functional. The Division did not observe any seeps near the toe of the NWRP where seeps had been observed prior to installation of the diversion channel. It appears the diversion channel is functioning as intended to prevent water in the drainage above the NWRP from infiltrating the pile. While the top of the NWRP was not observed during this inspection, the operator sent a photo taken later that day of the area on top of this pile that was reseeded in late 2020 (after the channel installation project was completed). Based on the photo provided, it appears the revegetation in this area is off to a good start.

Photo 9. View of upgradient cutoff wall/headgate in Ralston Creek, showing creek flowing upstream of cutoff wall. Upgradient flows were being routed around the mine site via the bypass pipeline.

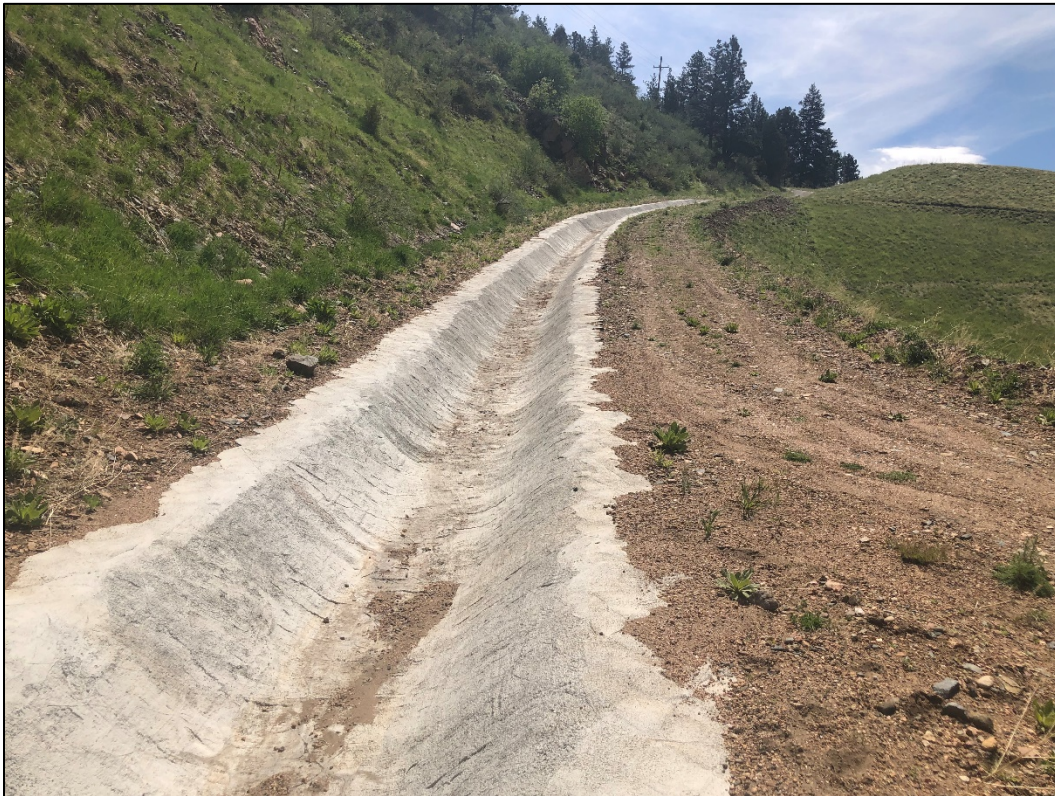
Photo 10. View looking upgradient at diversion channel installed along northern edge of NWRP in 2020.

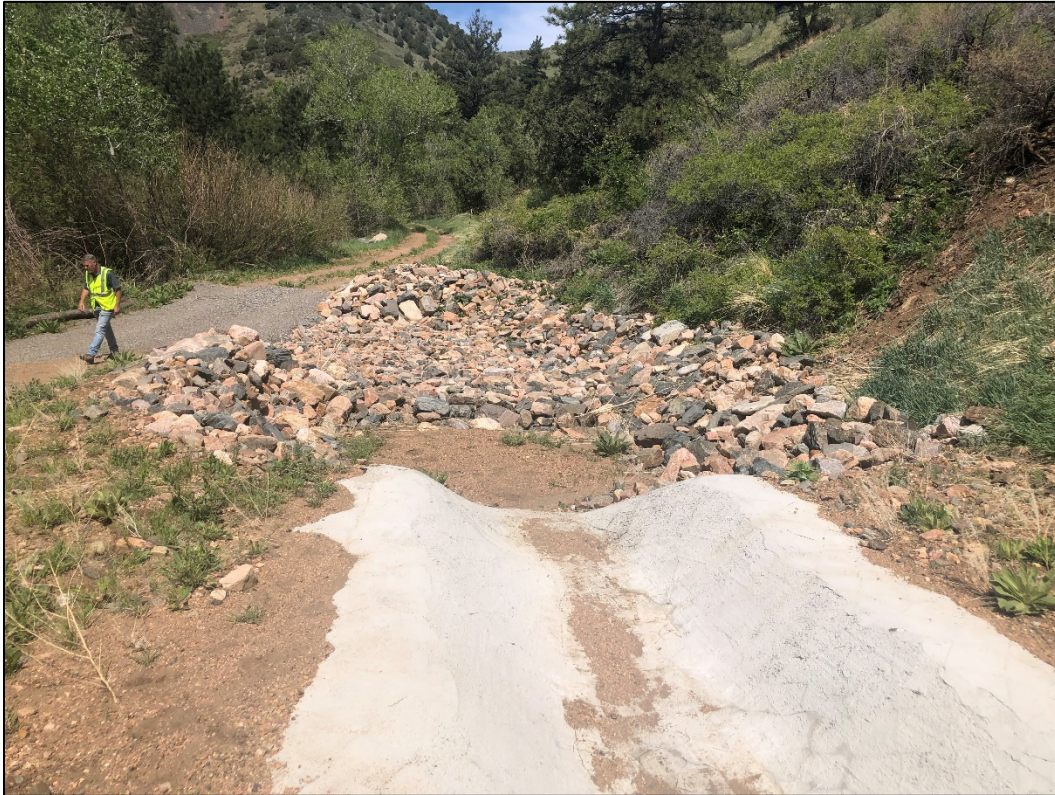
Photo 11. View looking west at riprap-lined energy dissipation basin constructed at downgradient end of NWRP diversion channel. This basin should be kept free of sediment and vegetation.

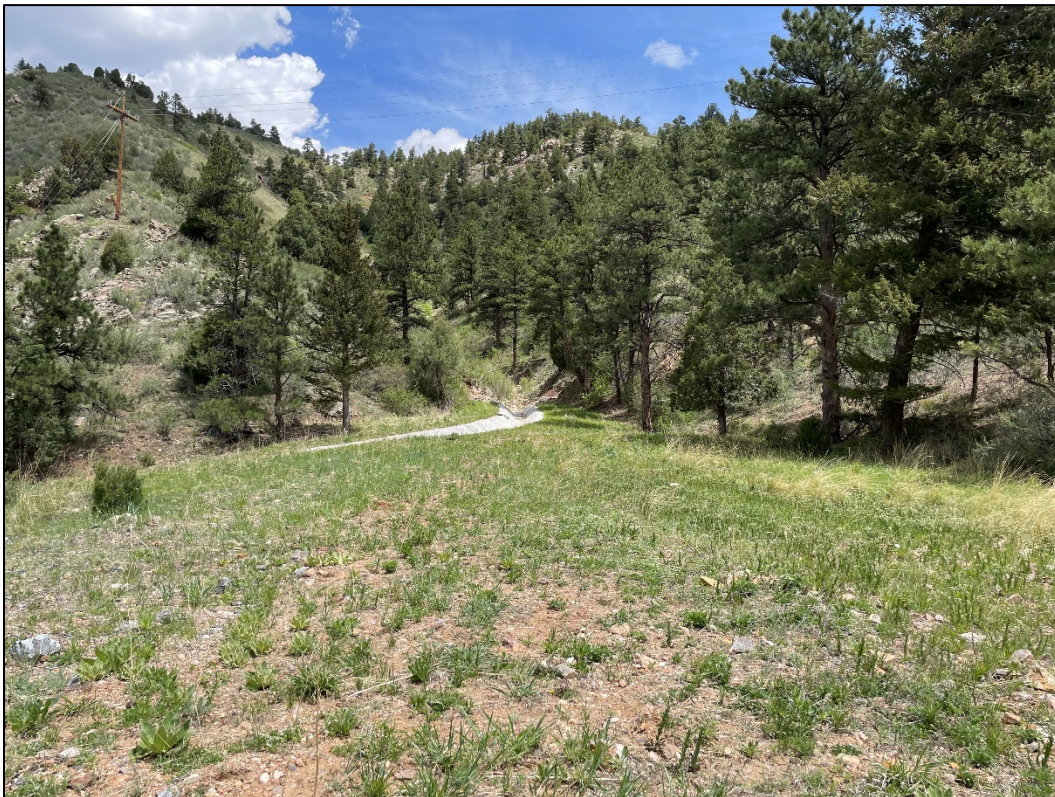
Photo 12. View looking north/northeast across top of NWRP, showing vegetation present in disturbed area that was seeded in fall of 2020 (photo provided by operator on May 27, 2022).

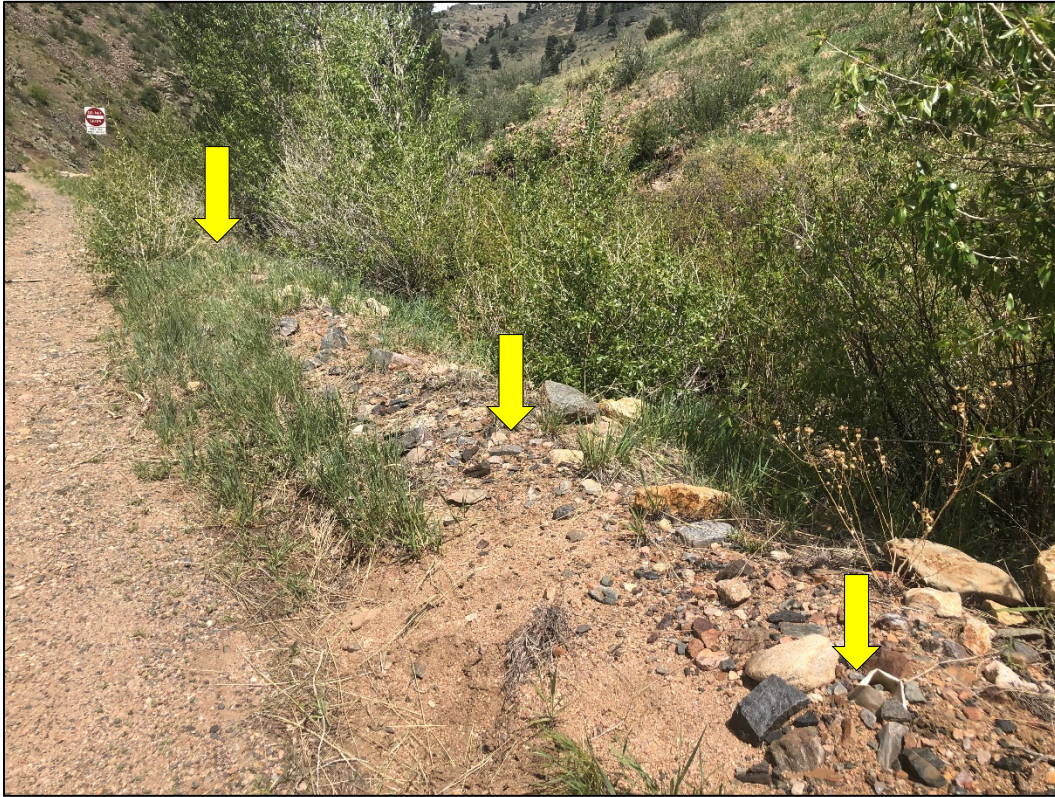
- The portion of the bypass pipeline immediately downstream of the upgradient cutoff wall (estimated by the Division to be approximately 330 feet in linear length) is buried. There was discussion during the inspection of possibly burying the rest of the bypass pipeline for final reclamation (estimated to be approximately 3,030 feet in linear length), primarily for aesthetic purposes. The pipeline could still be used to divert creek flows around the mine site, if needed. The Division informed the operator that details of this proposal would need to be included in AM-6.

Photo 13. View looking northwest across upper section of bypass pipeline that is buried (indicated).

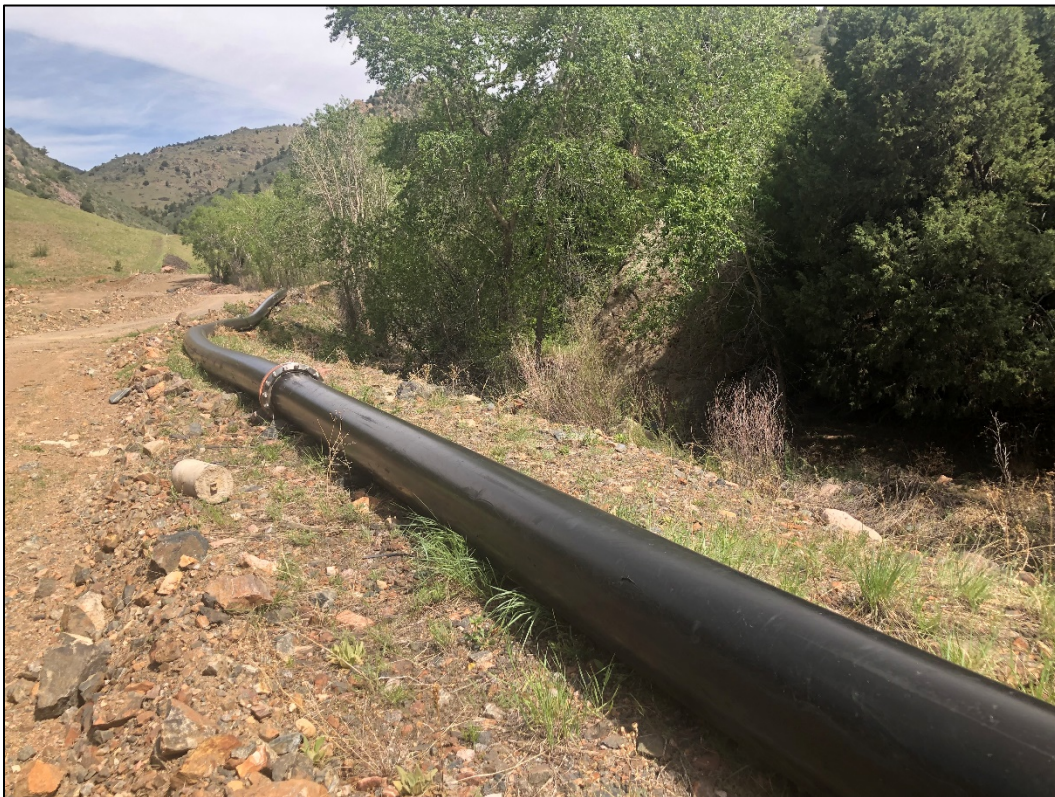
Photo 14. View looking northwest across bypass pipeline, the majority of which sits above ground (as shown).

- The operator is proposing to leave the bypass pipeline and other structures associated with the creek (e.g., upgradient cutoff wall, riprap/grouted boulder areas) in place for final reclamation. In order for these structures to remain for reclamation, the operator must provide demonstration that leaving these structures would be in compliance with the applicable regulatory agencies (e.g., USACE, USFWS). The operator indicated during the inspection they may not be able to obtain the requested documentation until after the AM-6 decision date. The Division informed the operator the bond estimate must include costs for removing these structures until sufficient demonstration has been provided.
