MINERALS PROGRAM INSPECTION REPORT
PHONE: (303) 866-3567

MINE NAME: Henderson Mine	MINE/PROSPECTING ID#: M-1977-342	MINERAL: Molybdenum	COUNTY: Clear Creek, Grand
INSPECTION TYPE: Monitoring	INSPECTOR(S): Brock Bowles	INSP. DATE: May 27, 2022	INSP. TIME: 09:00
OPERATOR: Climax Molybdenum Company	OPERATOR REPRESENTATIVE: Geoffrey Niggeler and Miguel Hamarat	TYPE OF OPERATION: 112d-3 - Designated Mining Operation	
REASON FOR INSPECTION: Citizen Complaint	BOND CALCULATION TYPE: None	BOND AMOUNT: \$135,204,778.00	
DATE OF COMPLAINT: NA	POST INSP. CONTACTS: None	JOINT INSP. AGENCY: None	
WEATHER: Clear	INSPECTOR'S SIGNATURE:

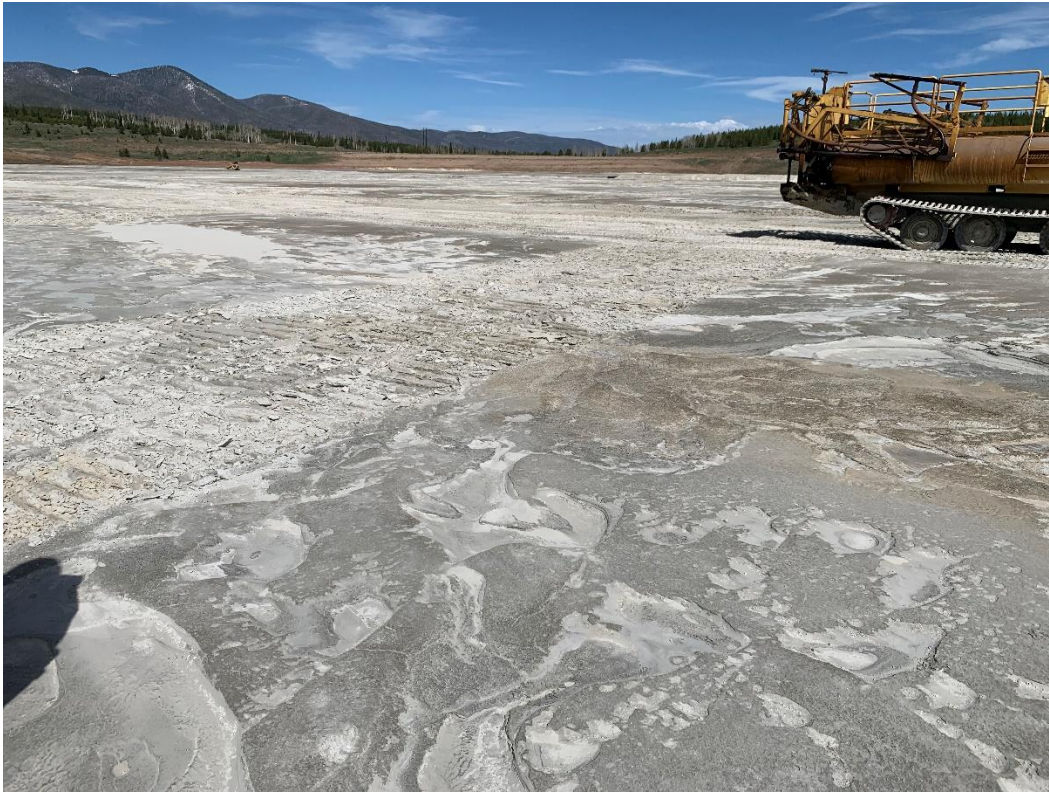
The Henderson Mine has a tailing storage facility (TSF) just northwest of the mill and adjacent to CR 3 and the Williams Fork River. The TSF is approximately 1,500 acres in size and contains a pond on the west side which covers about 300 acres, leaving 1,200 acres of exposed tailings. The tailings have a whitish/grey color and the texture ranges from a fine sand to a flour/ powdery consistency (photo 1). The TSF can be a source of dust with the right atmospheric conditions.

Photo 1 – Top of TSF, tailing are sandy and whitish/grey, no Coherex applied

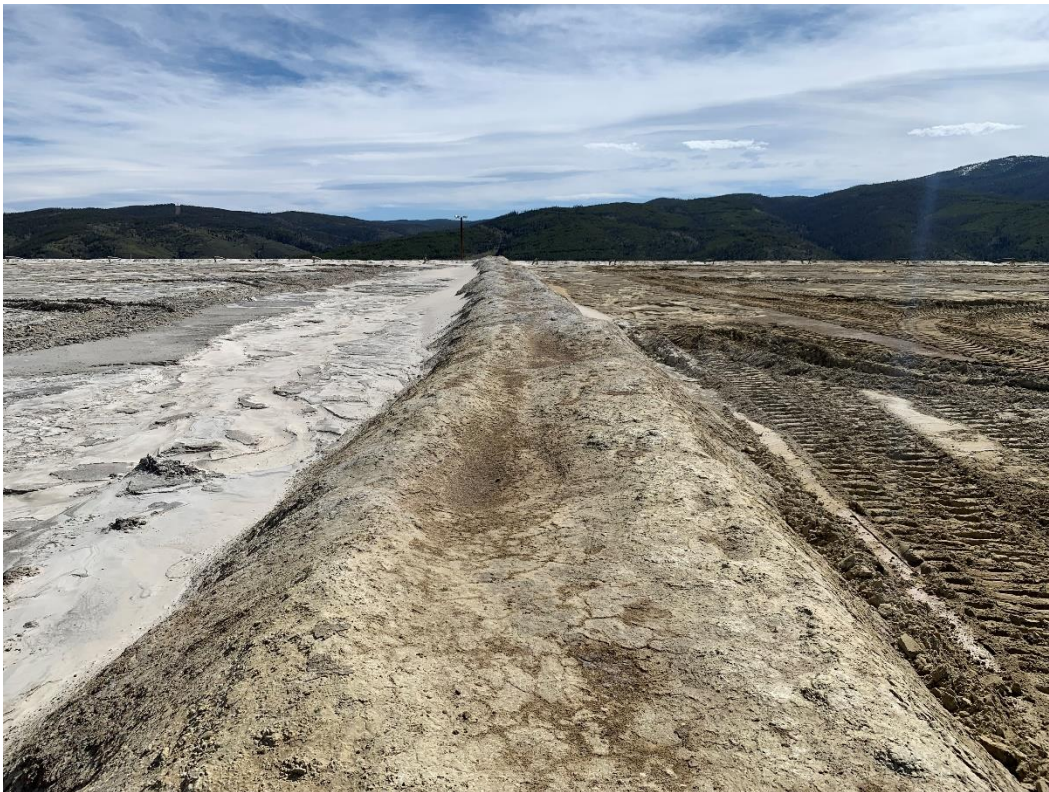
Photo 2 – Coherex applied on the right, giving the tailings an orange/brown color

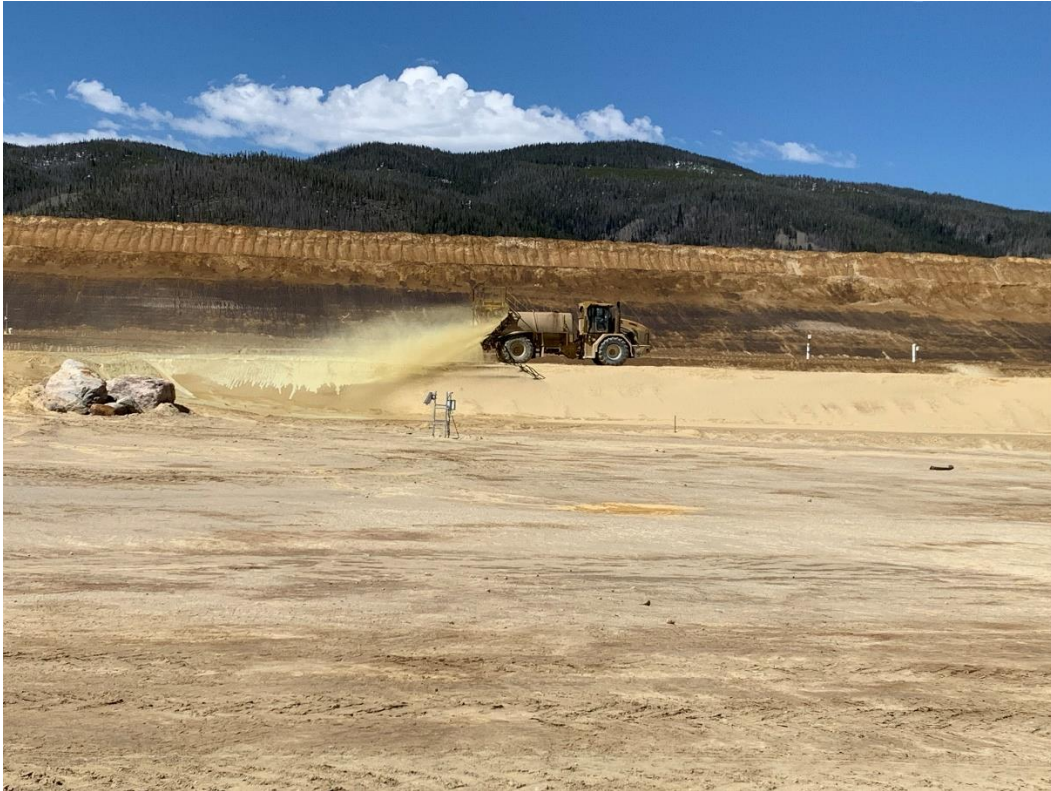
At the time of this inspection, about 90% of the top of the TSF was treated with Coherex. The treatment of the dam face had just begun and two sprayers were treating the dam face during the inspection (photo 3). Henderson estimates all areas of the TSF will be treated within 1 week. It usually takes about 3 weeks to treat the entire TSF each year. Treated areas were easily seen because the Coherex makes the tailing dark orange/brown (photo 4).

Photo 3 – Coherex application on 3-Dam

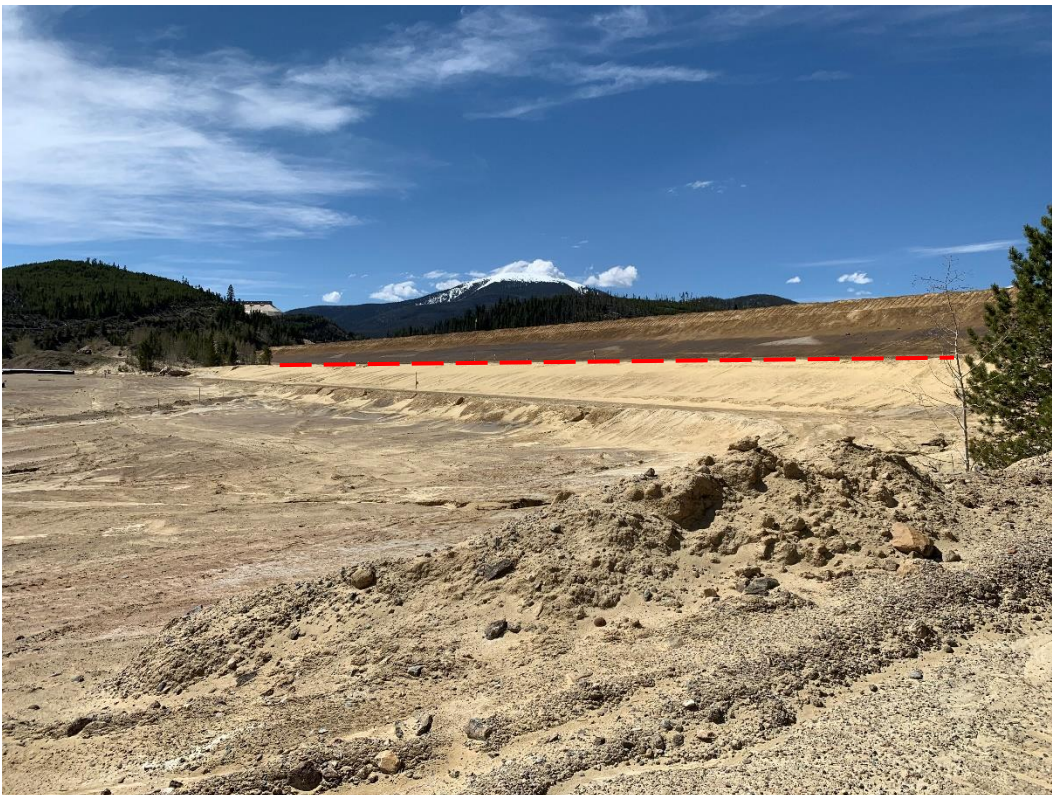
Photo 4 – Coherex applied above dashed line

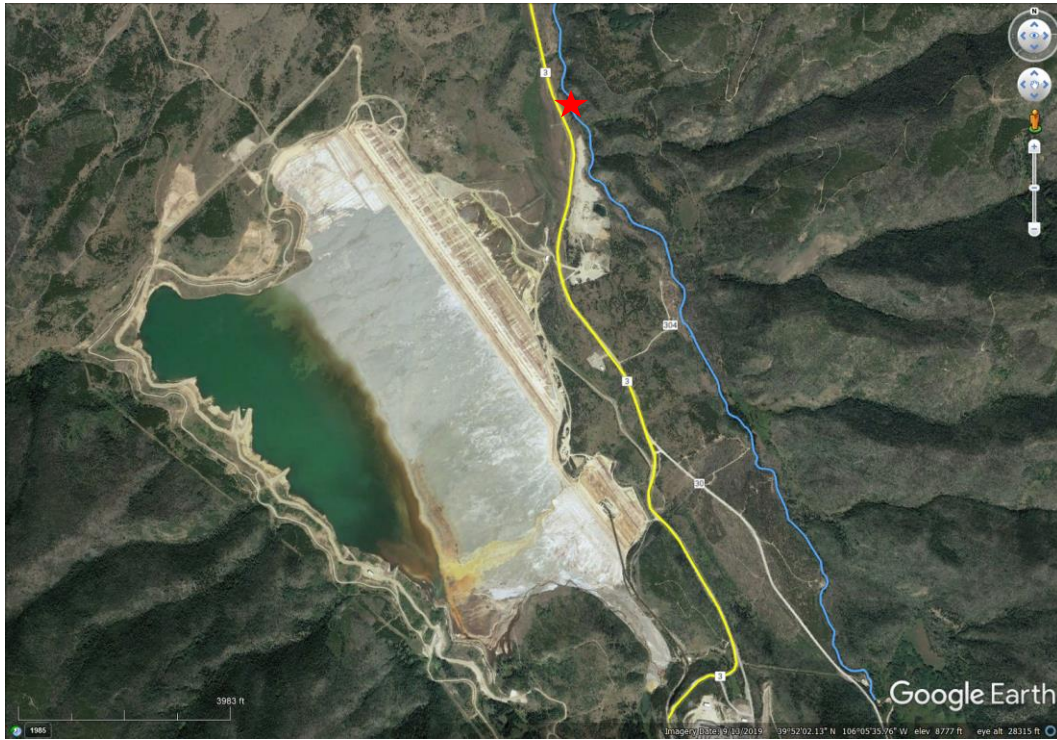
CR3 is located east of the TSF and both structures roughly parallel each other for 2 miles. At the southern end of the TSF they are about 150 feet apart and at the northern end they are about 4,000 feet apart (photo 5). The entire section of CR3 was inspected. No tailings were seen on the road or on the side of the road. Most of the area between CR3 and the TSF consists of native grasses and shrubs making tailing deposits easy to identify. No tailings were seen in the vegetation.

Photo 5 – TSF on left, yellow line- CR3, blue line- Williams Fork River, red star- river inspection point

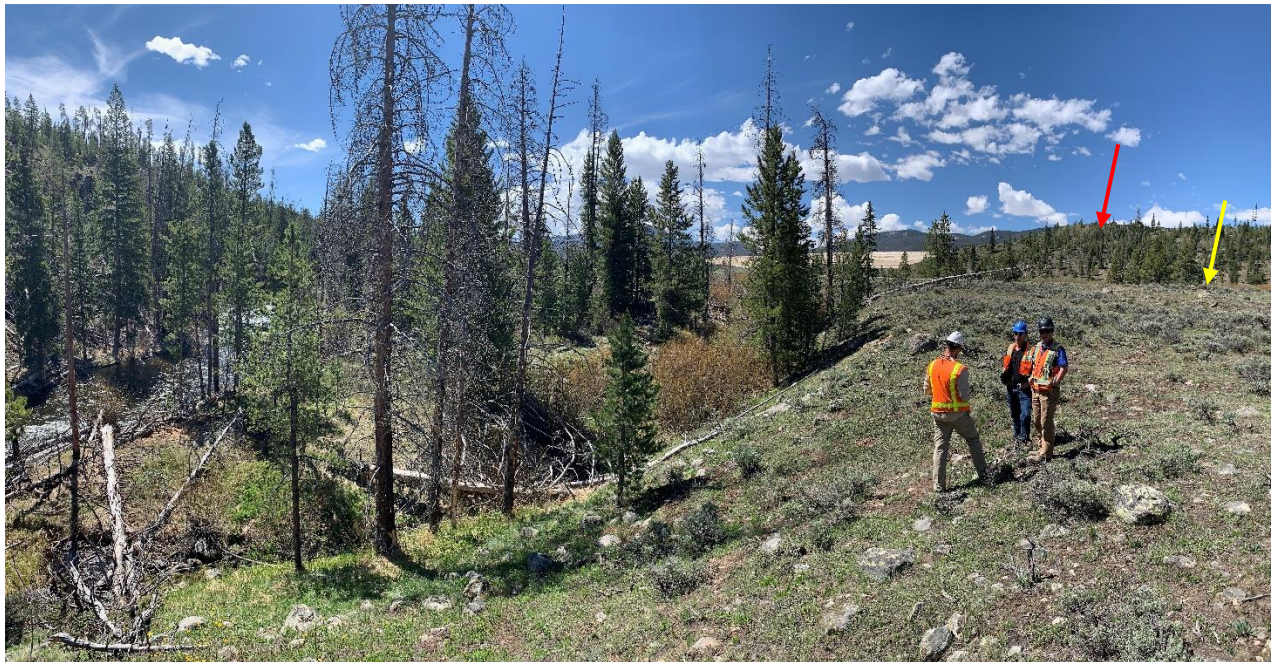
The Williams Fork River is located east of CR3 and they are also roughly parallel (photo 5). The distance between the river and the TSF is greater than 2,600 feet. Most of the area between the river and TSF contains an aspen/pine forest and the river is in a fairly deep ravine. Only one section of the river was inspected due to accessibility. The section of the river that was inspected had the least amount of trees to block the wind (photo 5, red star) and is the most likely area to see tailings deposits actually reaching the river (photo 6). No white crystalline material was seen

Photo 6 – Williams Fork River (left), TSF on other side of knoll (red arrow), CR3 (yellow arrow)

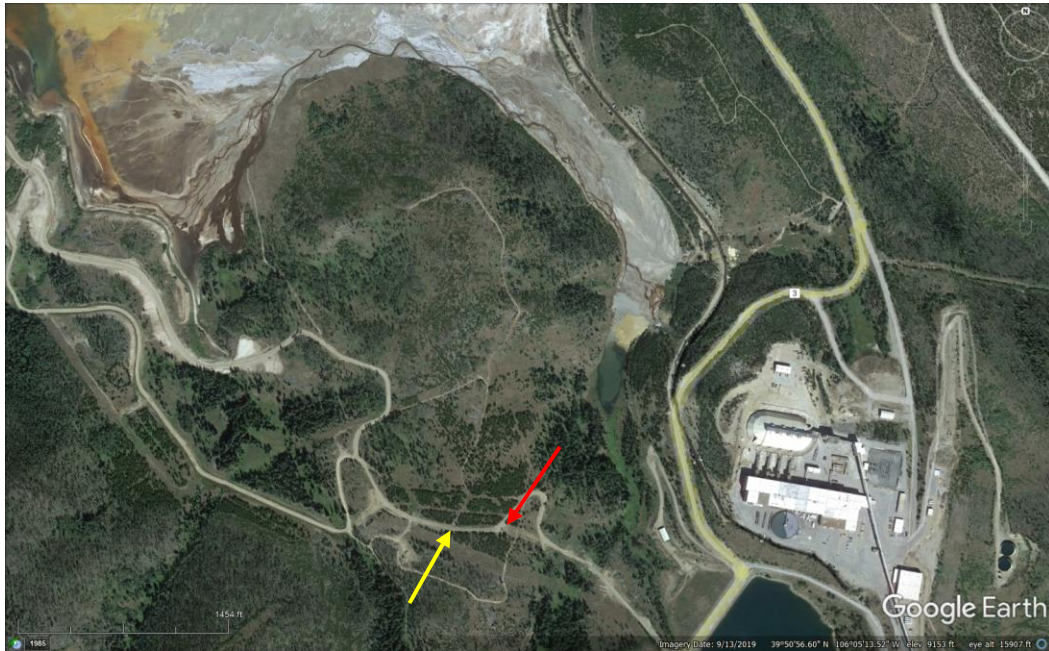
The locations of the valve and surface expression are within the permit boundary, south of the TSF. Both sites are within the drainage area below the East Branch dam and west of the mill (photo 7). The overall topography of the area slopes toward the TSF so there is no potential for off-site impacts. All the Mill Process Water is contained within the TSF area system.

Photo 7 – Red arrow- leaky valve, yellow arrow- water surfacing along road

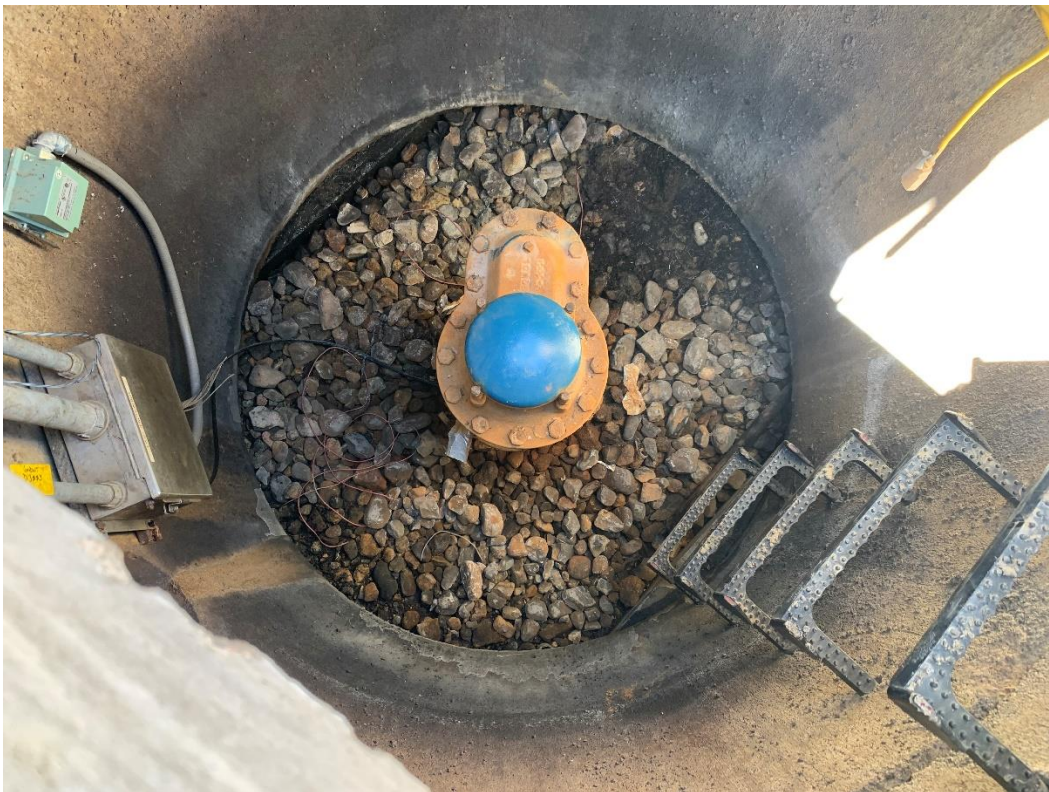
The leaky valve is part of the buried Mill Water Return Line which transports water from the TSF to the East Branch Reservoir. The route of the line roughly follows the west access road. The leaky valve is a vent valve located at the highest point along the line. Its purpose is to let air into the line when the pumps are turned off, preventing the hydrological force from collapsing the line. When the pumps are running, the water pressure in the line is used to close the valve. The valve is suspected to be stuck in the open position and when the pump is running, water escapes through the valve and fills the vault in which the valve is located (photo 8). Water was not being pumped through the Mill Water Return Line at the time of the inspection.

Photo 8 – Leaky vent valve on the Mill Water Return Line

The water was tested again since the incident report was filed and the amount of Mill Process Water seems to be decreasing. This indicates that the valve is the most likely source of the water. Henderson has a new valve on order which is expected to take a couple of months for delivery. When the new valve is installed, a leak check will be

performed on the entire Mill Water Return Line.

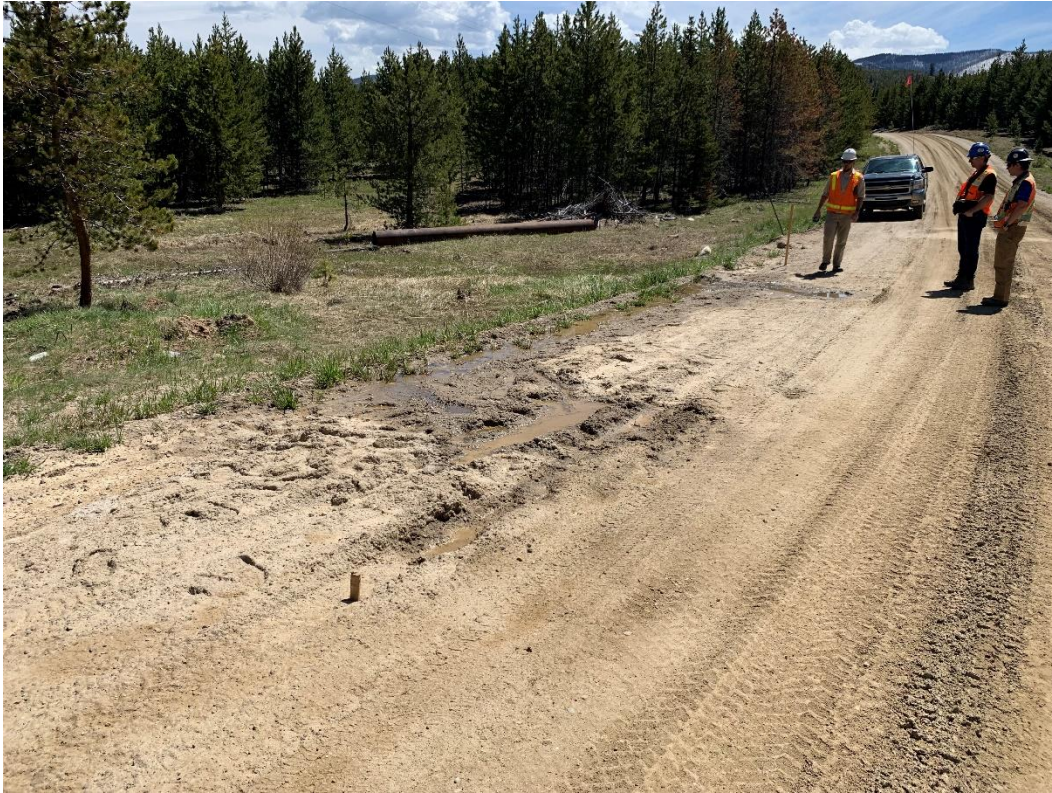
The Mill Water Return Line is about 15 feet deep and bedded in a stone-lined trench. When the water filled the vault, it seeped into the stone-lined trench and flowed down to the next low spot, filling the trench until it started expressing at the surface. The expression point is about 400 feet lateral and 15 feet below the valve (photo 9).

Photo 9 – Water expression along west access road, facing southeast, the leaky valve is just beyond the trees above the truck

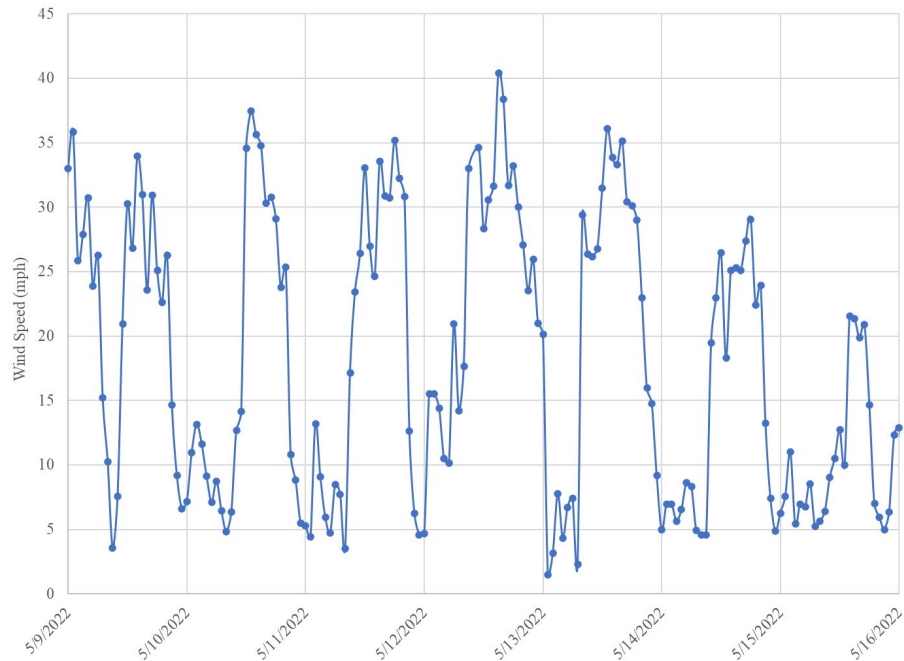
The spring of 2022 presented particularly difficult conditions for applying Coherex. Even though the spray trucks are specially designed with low ground pressure, the tailings beach saturation levels from the snow melt need to dissipate in order to ensure the trucks do not sink in the tailings. Snowpack peak is typically in mid-April and usually thaws over a period of 4-6 weeks. With snowpack at Henderson being below average this year, Henderson anticipated to start the Coherex campaign in mid-May. However, large storm events on May 3rd and 4th increased saturation levels within the tailings. The operations crew started to develop the needed access ramps and paths on the beach on May 6th. Unfortunately, the equipment persistently sank into the tailings on the 6th. The decision was made to wait until the 9th to start spraying Coherex. On the week of the 9th, it was determined that the beach was ready for truck traffic. The operations crew started spraying on the 11th. However, this week also correlated with very high winds throughout the State of Colorado, including in Grand County. The Henderson weather station measured wind speeds in excess of 40 mph during the week (Figure 3). The Henderson anemometer only collects data every 10 minutes, therefore, wind gusts in excess of those shown are likely. Due to the high winds, full crew spray operations were further delayed until May 16th.

Figure 3. Maximum measured wind speeds at the Henderson Mill for the week of May 9th.

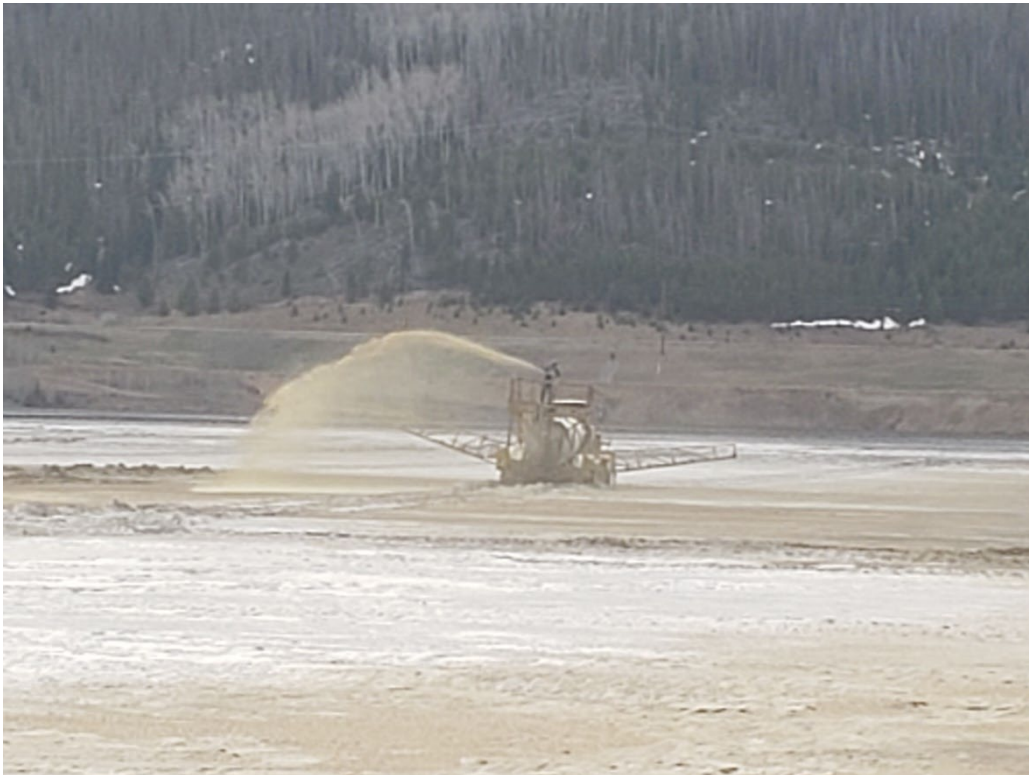
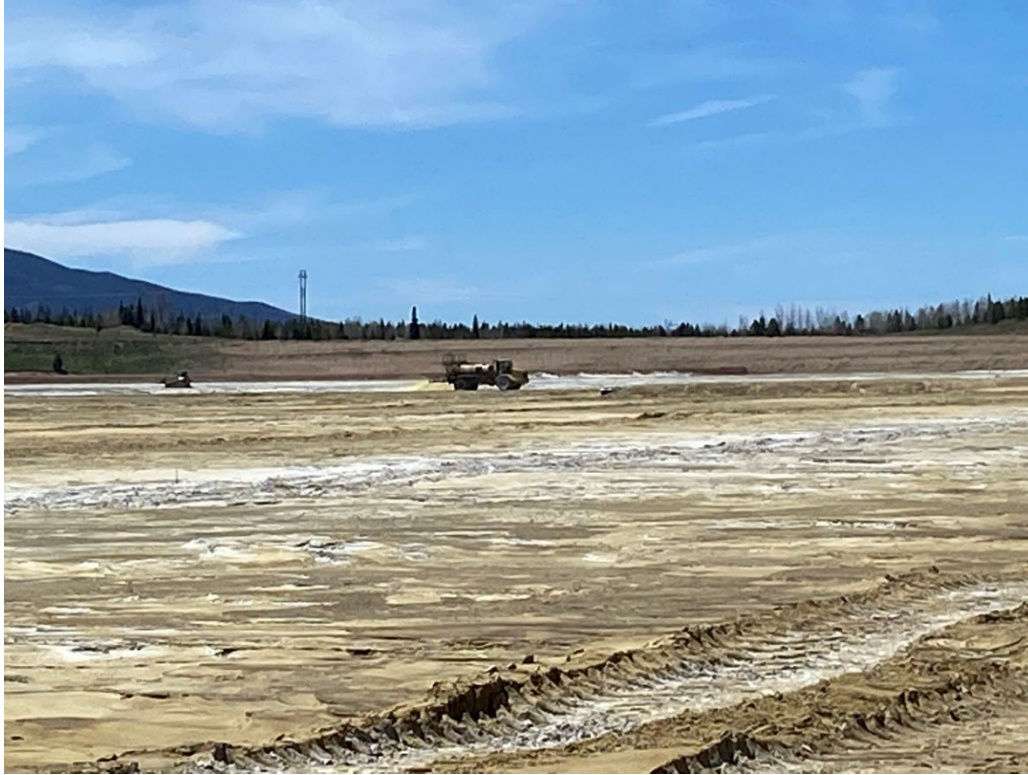
The crew of operators and mechanics work 10 hour shifts, 5 days a week throughout the summer season to maintain all aspects of the Tailings Storage Facility with dust suppression being a primary focus throughout the season. As of May 27th, the crew had applied just under 150,000 gallons of Coherex with ~65% of the facility covered (Figure 4). In a typical year, the application process takes close to 3 weeks, and utilizes ~250,000 gallons of Coherex.

Figure 4. Coherex spray truck on the tailings beach applying Coherex on May 16th (a) and 27th (b).
