June 14, 2022  
Project No.: 19125

Aggregate Industries – WCR, Inc  
1687 Cole Boulevard, Suite 300  
Golden, CO 80401

Regarding: Daniels Sand Pit 2, Permit No. M-1973-007-SG  
Slope Stability Monthly Monitoring Report

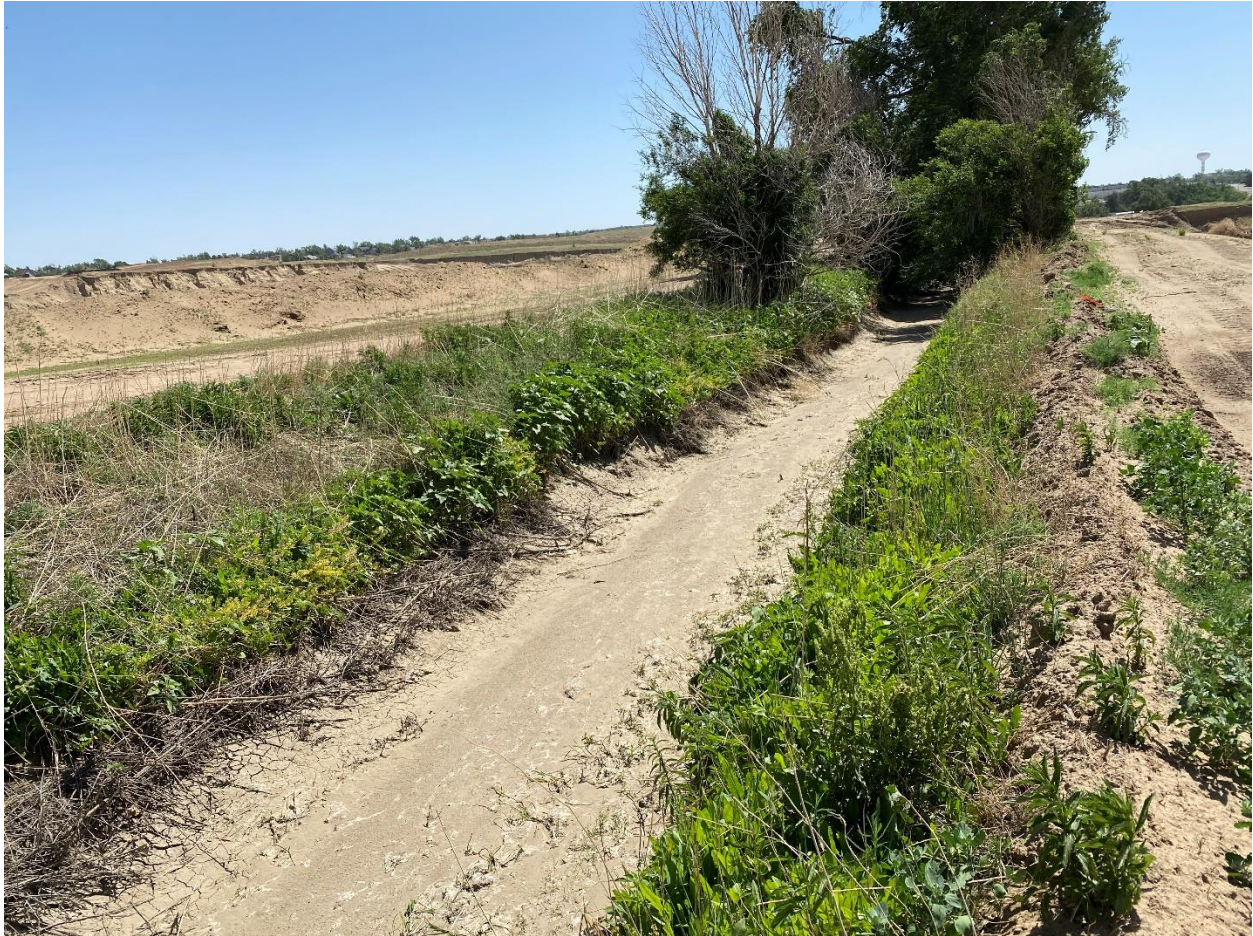
Photo 1. Fountain Mutual Ditch looking east

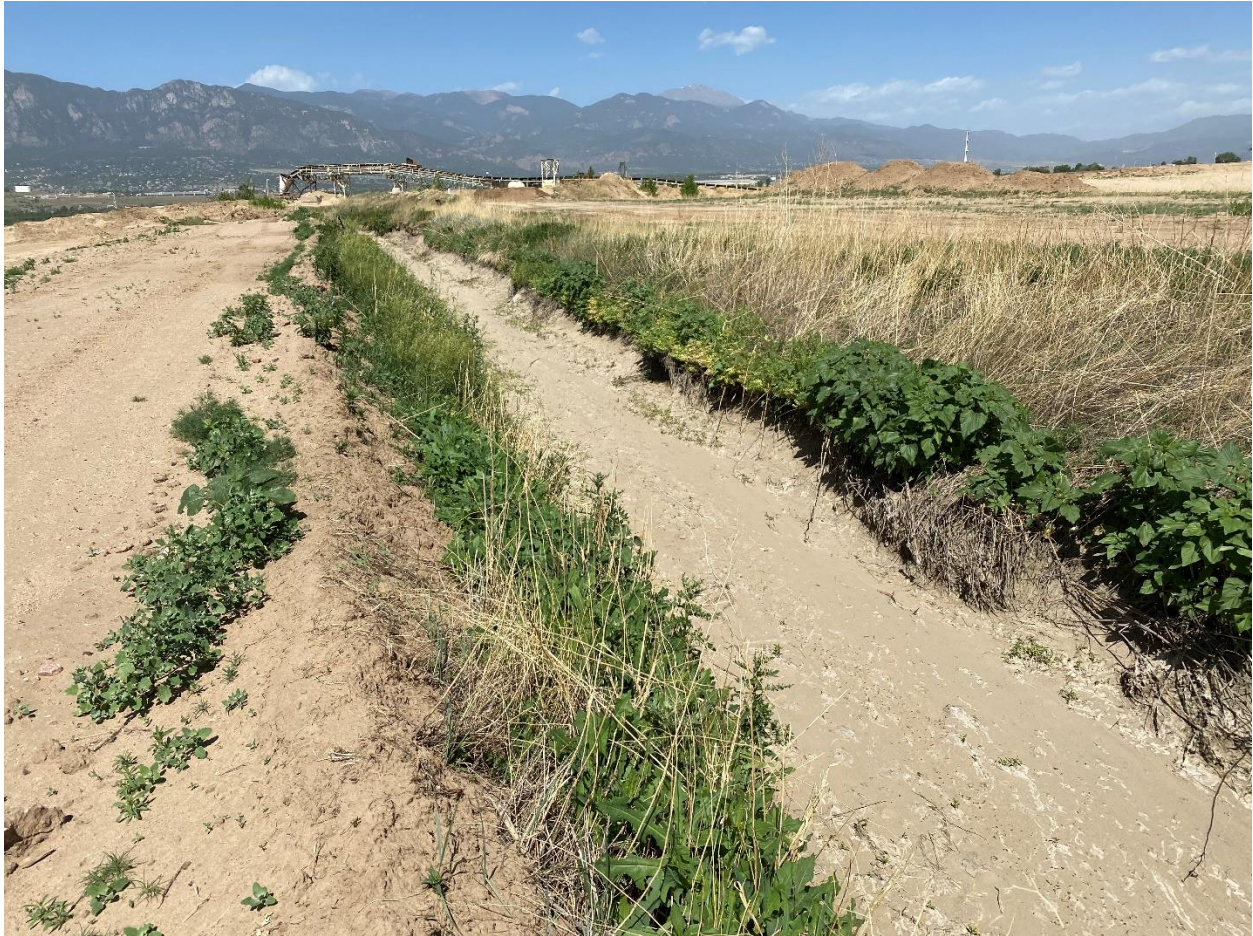
Photo 2. Fountain Mutual Ditch looking west

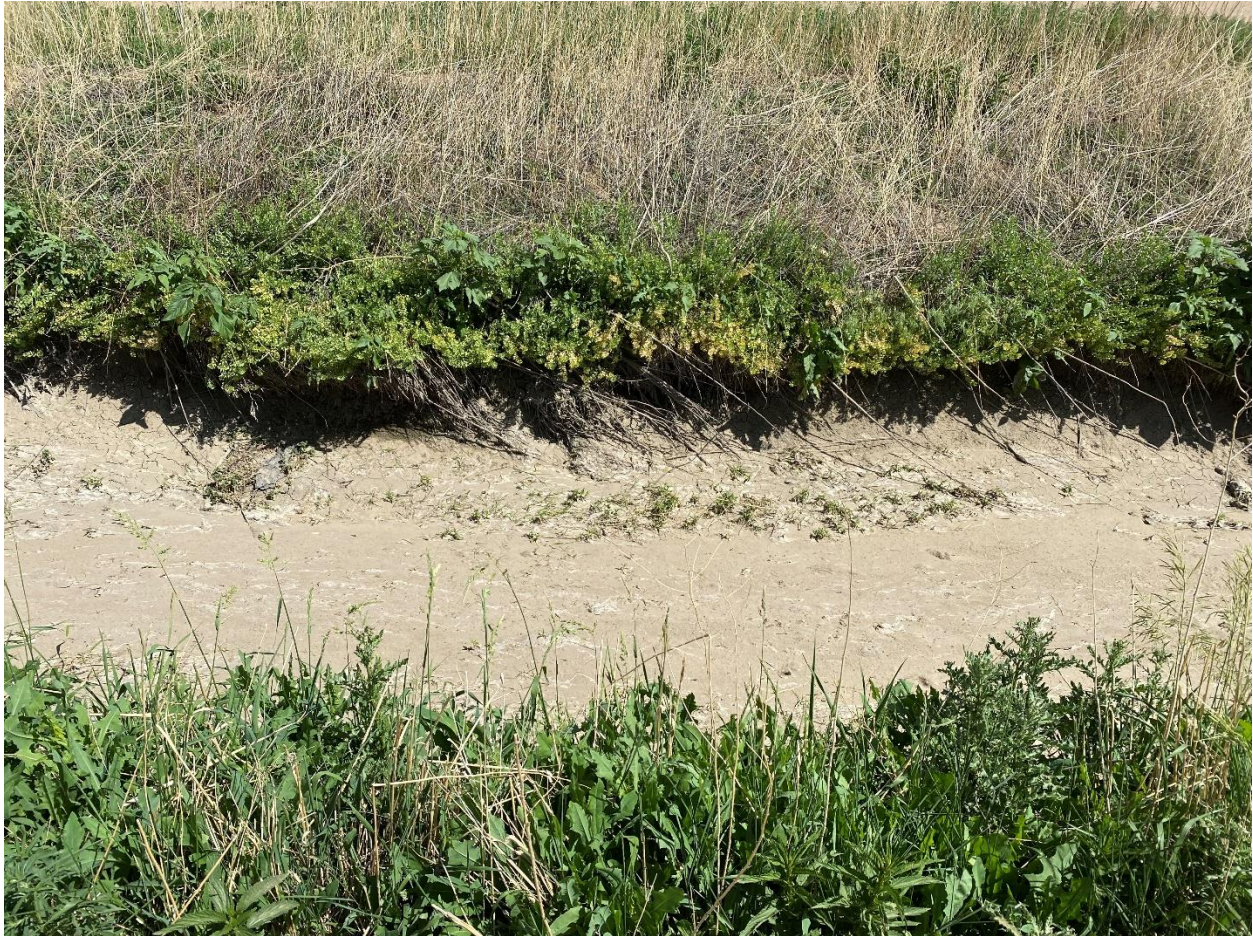
Photo 3. Fountain Mutual Ditch invert looking north (note vegetation)

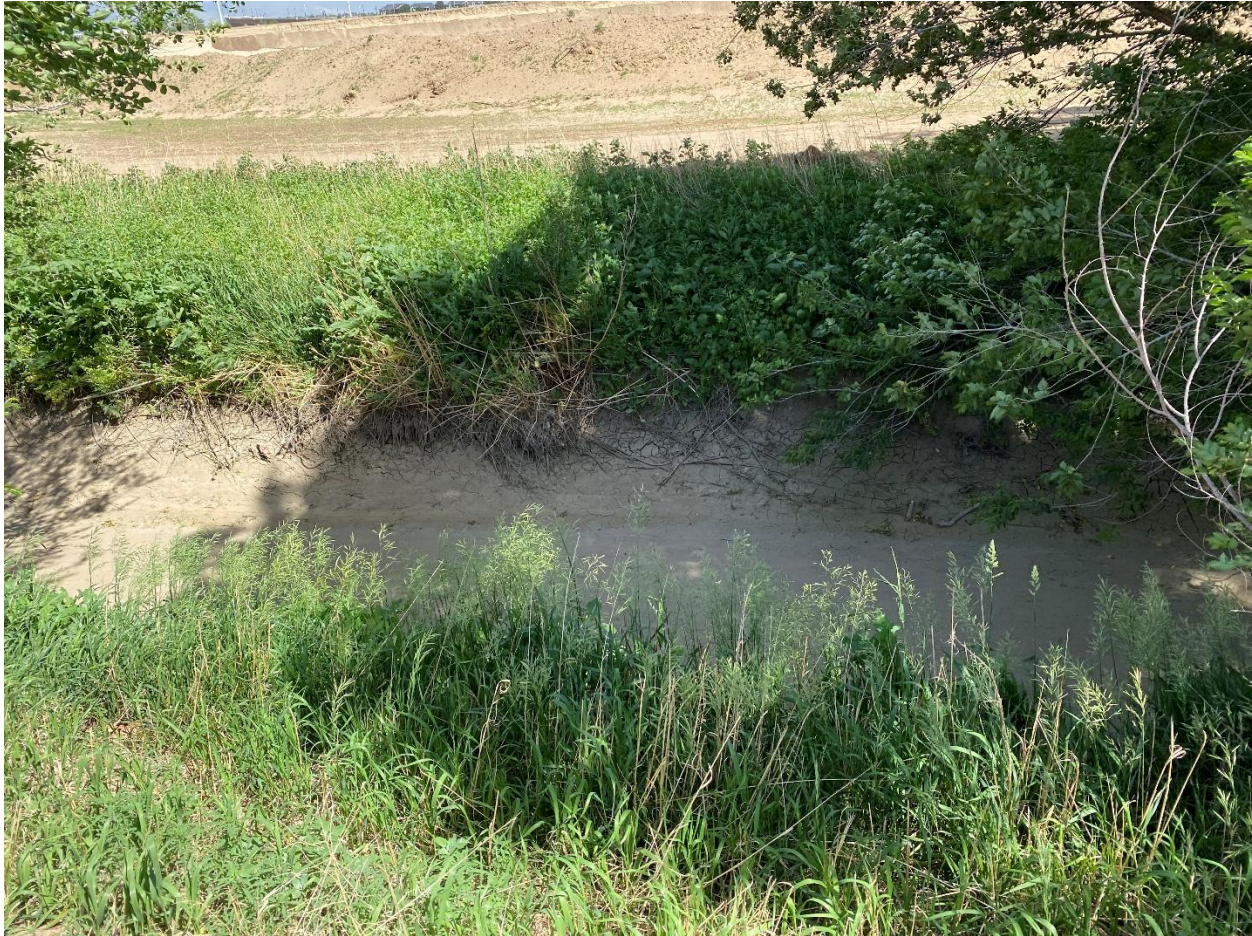
Photo 4. Fountain Mutual Ditch looking north

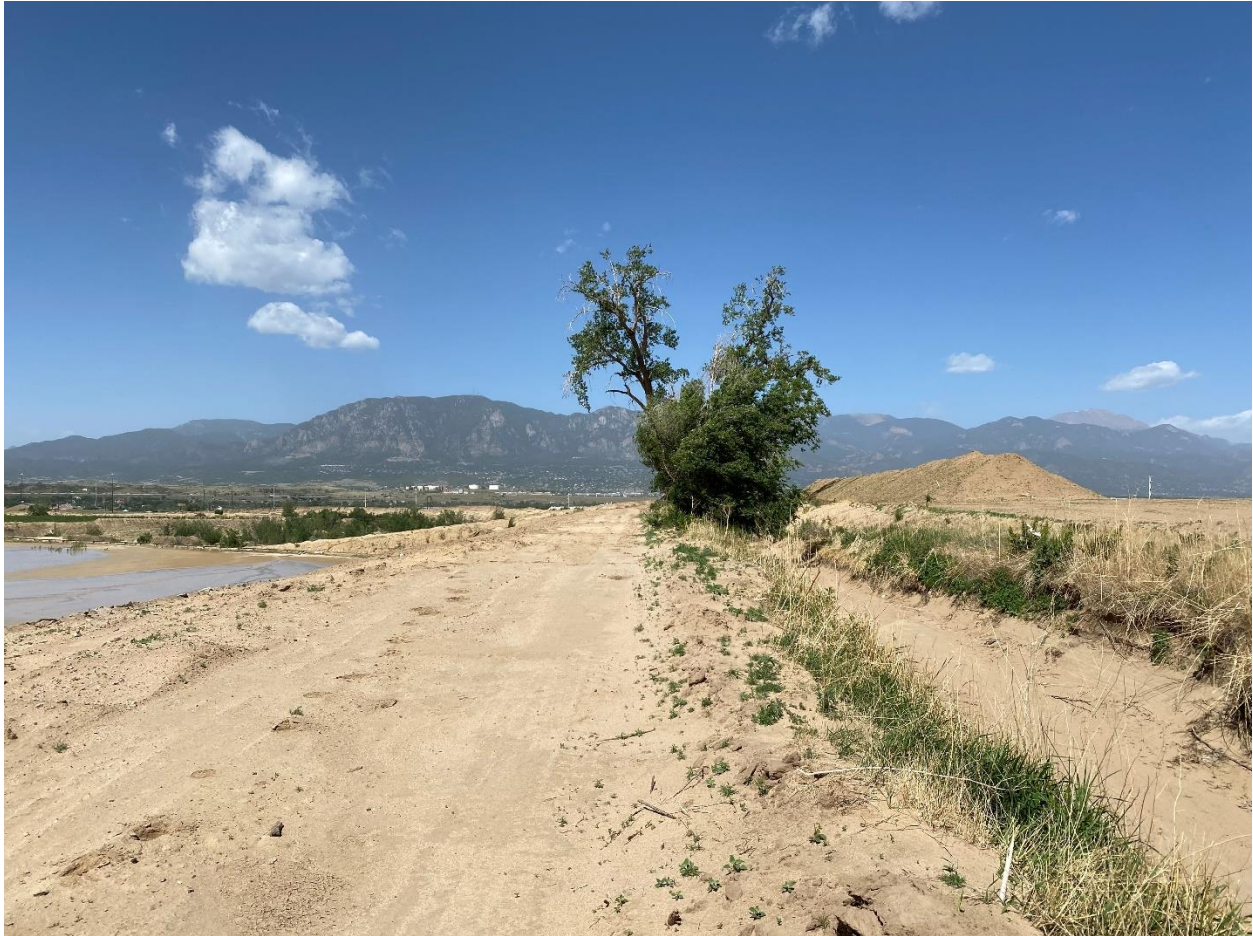
Photo 5. Buttress slope, access road and ditch (looking west)

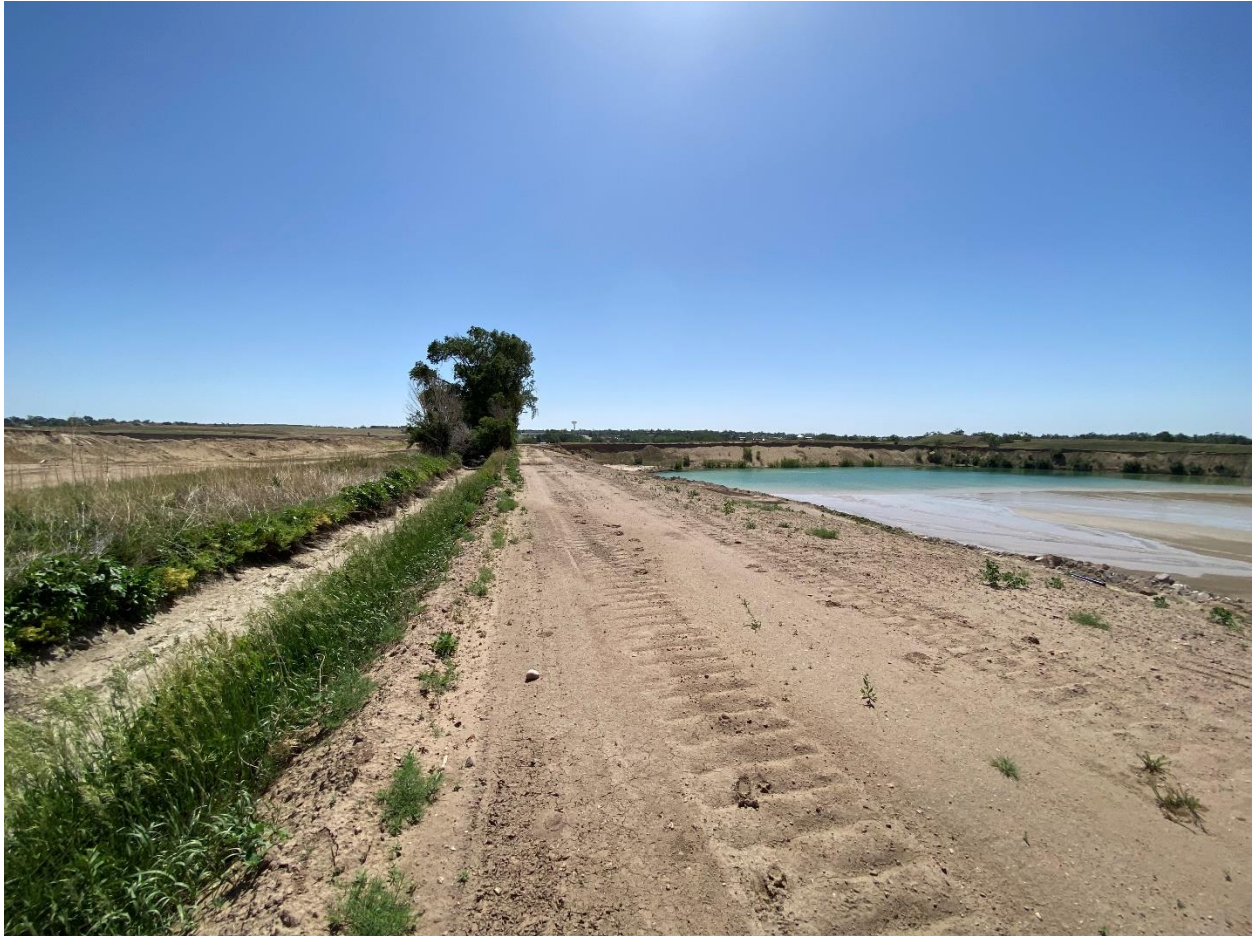
Photo 6. Buttress slope looking east from crest

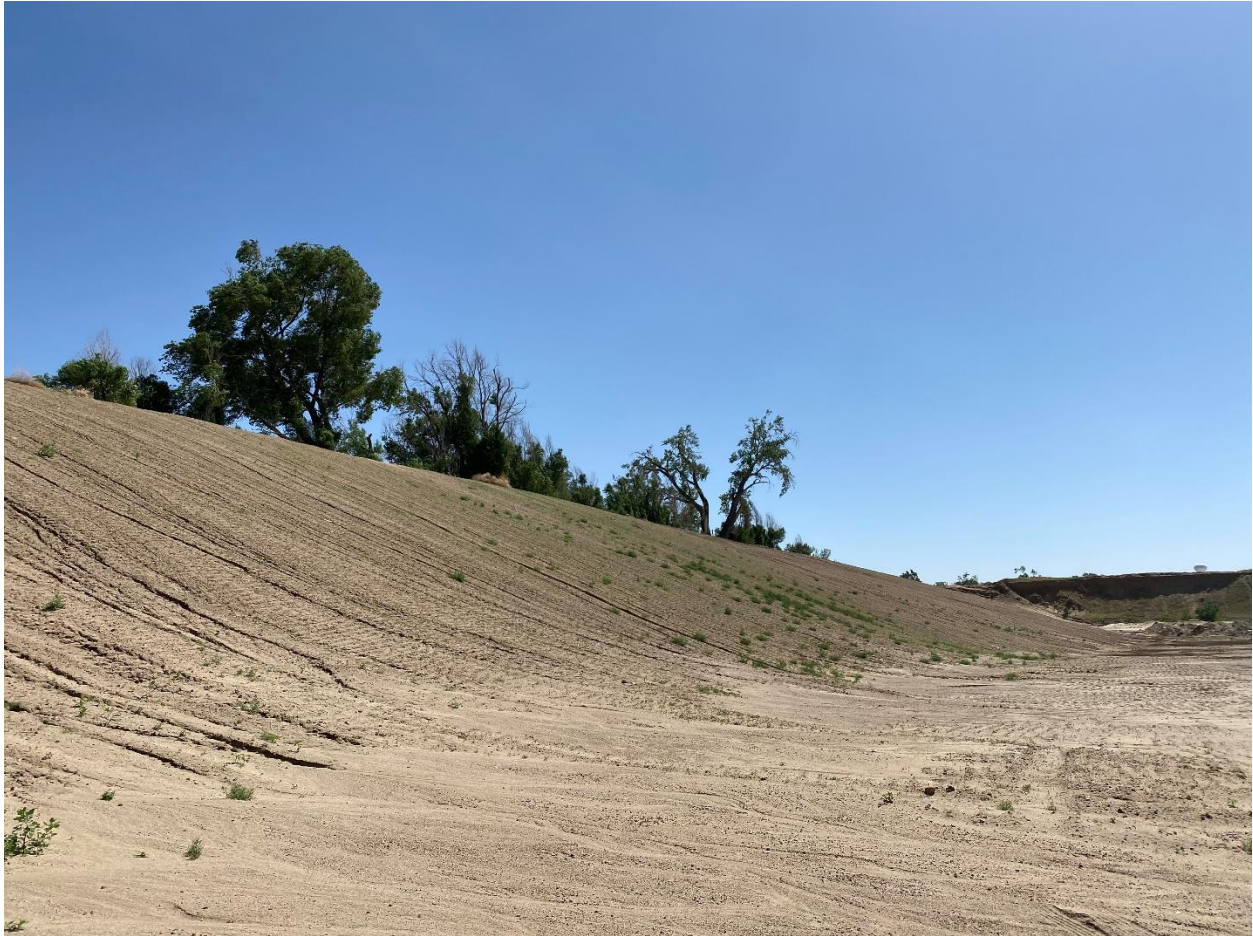
Photo 7. Buttress slope looking east from toe

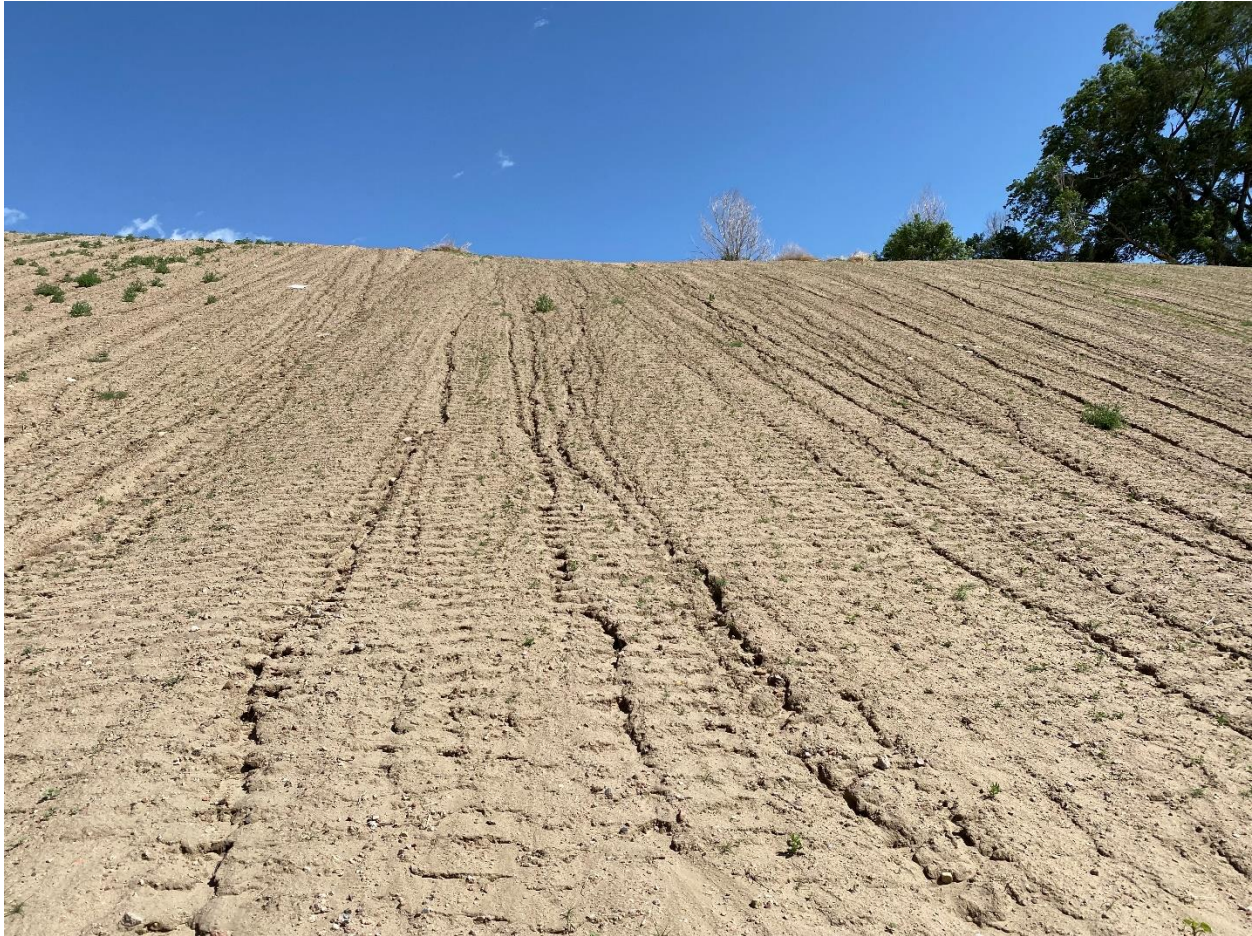
Photo 8. Buttress slope looking north, evidence of surface water drainage

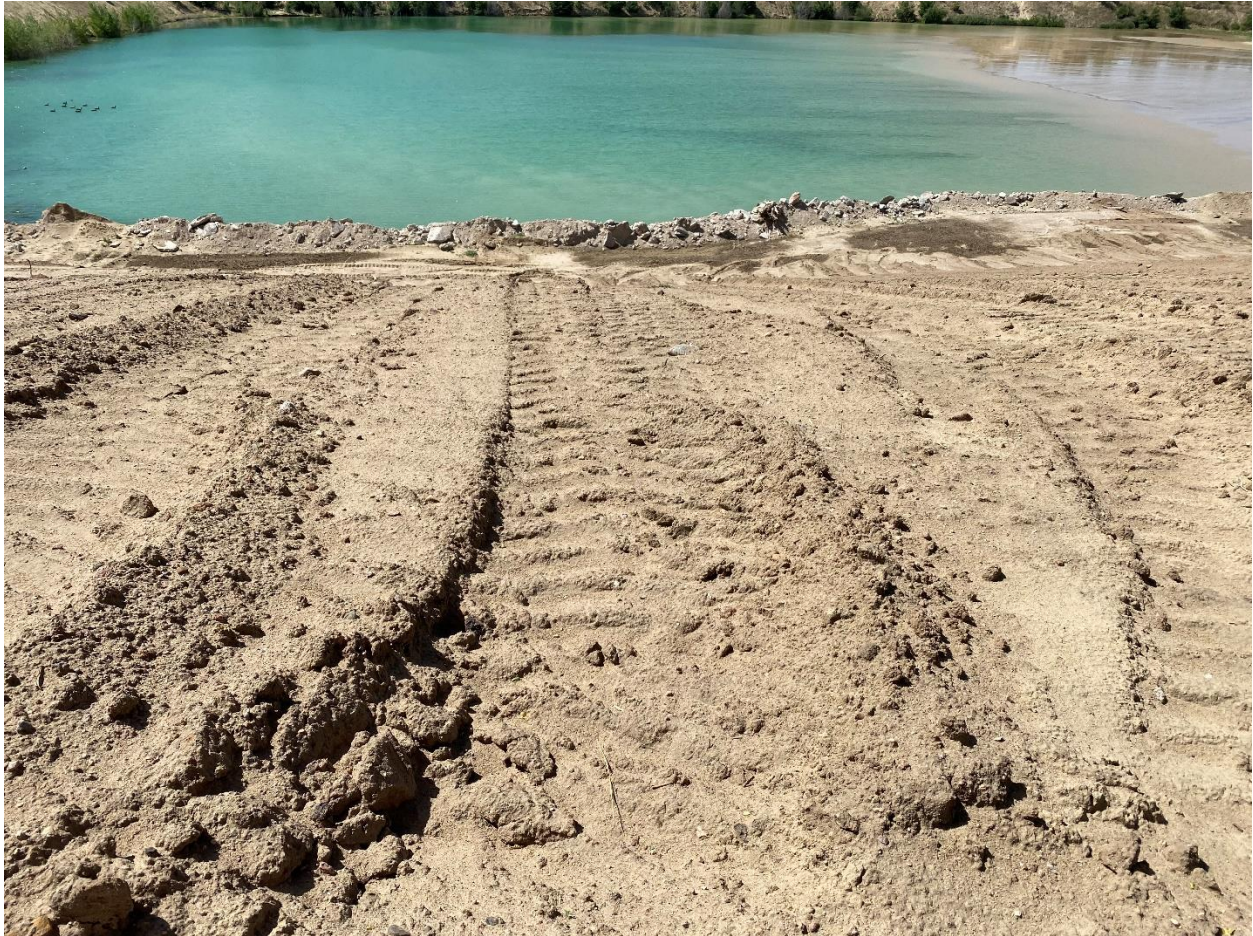
Photo 9. Butress slope looking south, area needs regrading

- Construction sequence
  - The buttress slope varies from 3H:1V to 4H:1V
  - The remaining stockpile material has been placed on the buttress (final lift)
  - The majority of the fallen tree has been removed from the access road and buttress (a few branches remain)
  - The final lift needs to be regraded on the eastern side of the buttress
  - Vegetation (mainly weeds) are growing through the final lift on the western side of the buttress
  - Evidence of previous ponding water near the toe of the buttress
  - On the western side of the buttress, evidence of surface water runoff
  - Crew planning vegetation on slope per reclamation plan

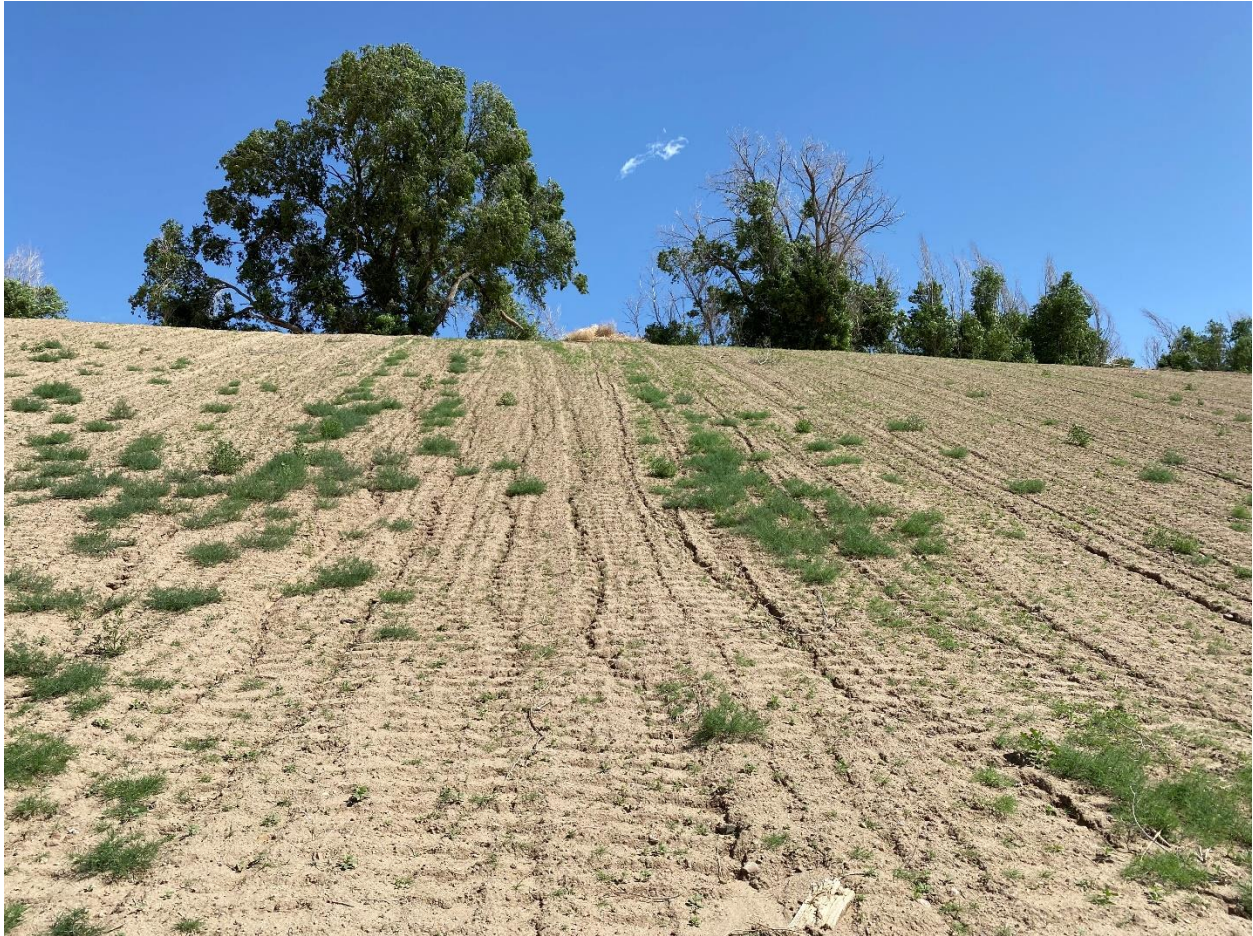
Photo 10. Buttress slope looking north, weeds and potential trees growing

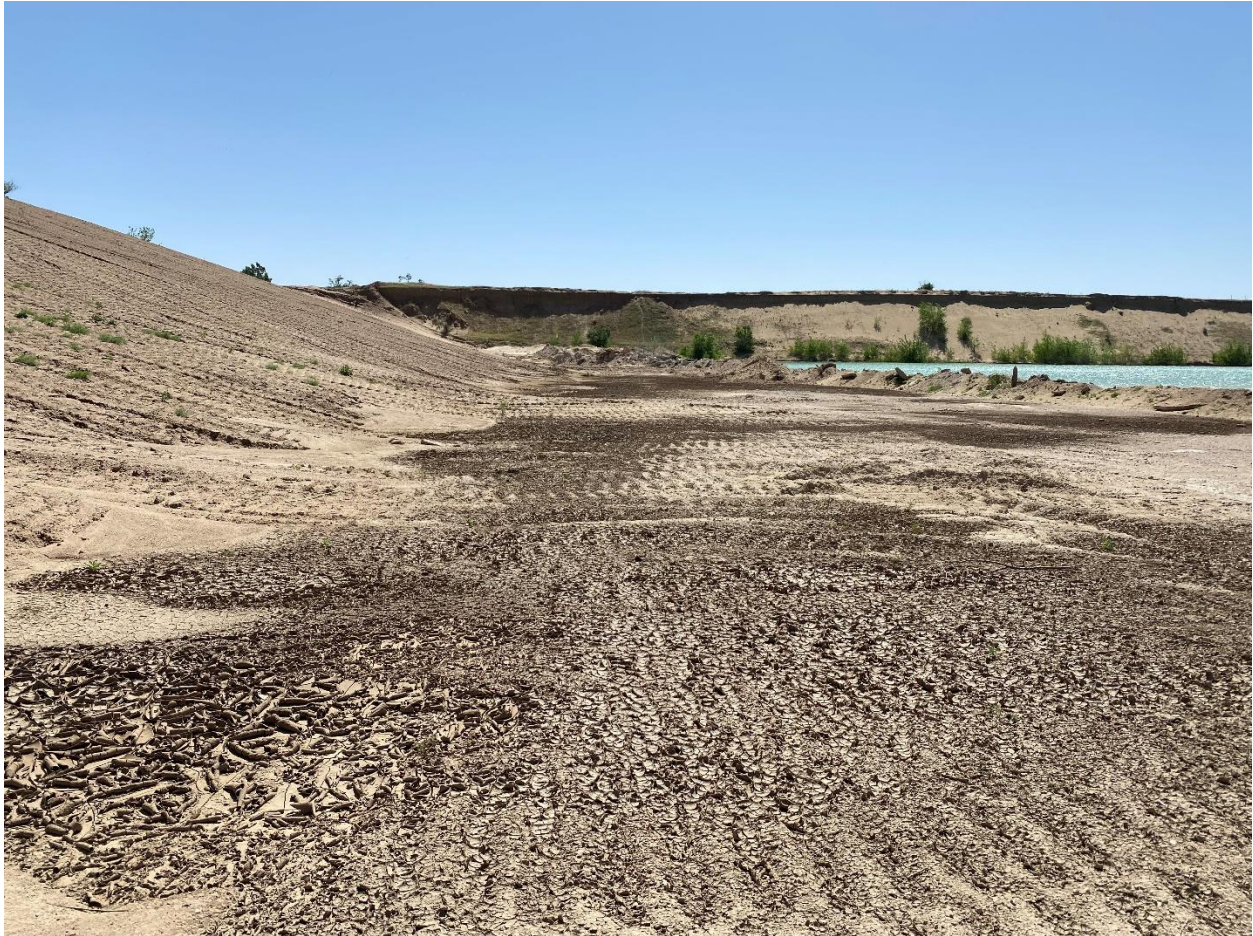
Photo 11. Evidence of previous ponding water near toe of buttress
