### PERMIT INFORMATION

<b>Permit Number:</b> C-1981-014 <b>Mine Name:</b> Southfield Mine <b>Operator:</b> Energy Fuels Coal, Inc. <b>Operator Address:</b> Mr John Adams P.O. Box 773457 Steamboat Springs, CO 80477	<b>County:</b> Fremont <b>Operation Type:</b> Underground <b>Permit Status:</b> Revoked <b>Ownership:</b> Private
	<b>Operator Representative Present:</b>  N/A
<b>Operator Representative Signature: (Field Issuance Only)</b>

### INSPECTION INFORMATION

<b>Inspection Start Date:</b> June 15, 2022 <b>Inspection Start Time:</b> 08:10 <b>Inspection End Date:</b> June 15, 2022 <b>Inspection End Time:</b> 08:30		<b>Inspection Type:</b> Coal Complete Inspection <b>Inspection Reason:</b> Normal I&E Program <b>Weather:</b> Clear	
<b>Joint Inspection Agency:</b>  None		<b>Joint Inspection Contacts:</b>  None	
<b>Post Inspection Agency:</b>  None		<b>Post Inspection Contacts:</b>  None	
<b>Inspector(s):</b>  Zach Trujillo	<b>Inspector's Signature:</b>

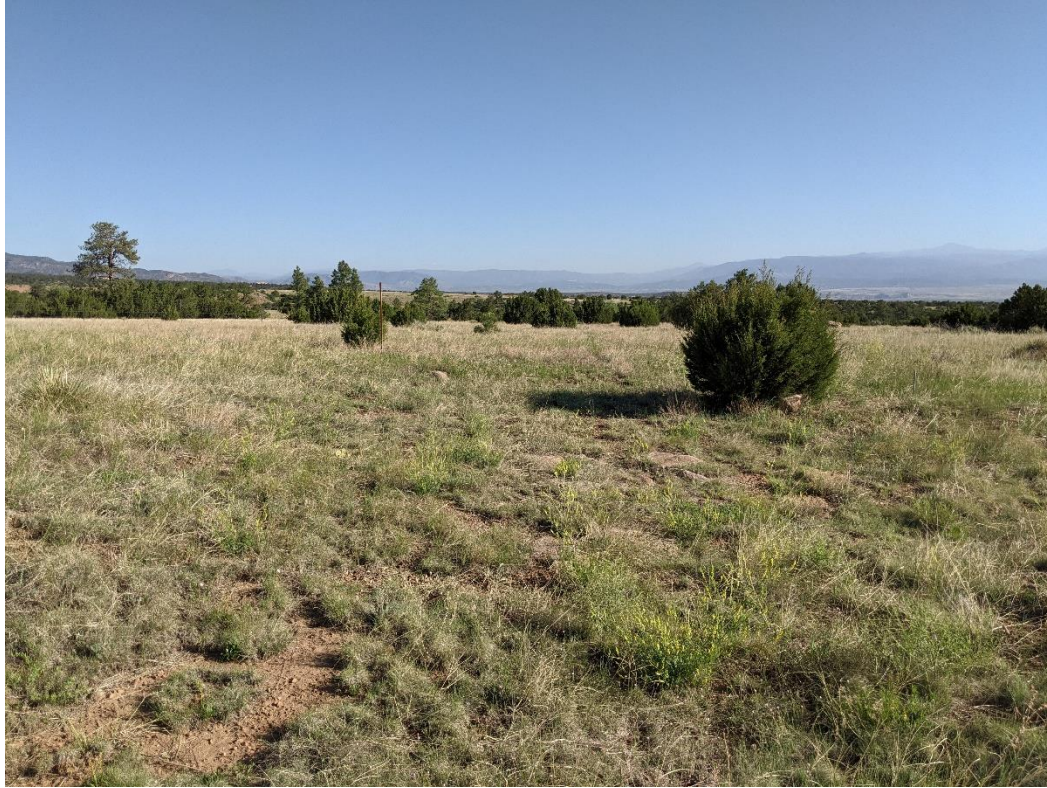
The reclaimed road spur and access road to the NW-MW well were inspected. The road spur is established with great vegetation and blends well with adjacent undisturbed land. The access road for the NW-MW well continues to show increased vegetation as well as the NW-MW well pad. The road spur and disturbance associated with the NW-MW well are beginning to be indistinguishable to the adjacent undisturbed area.

NW-MW well pad.

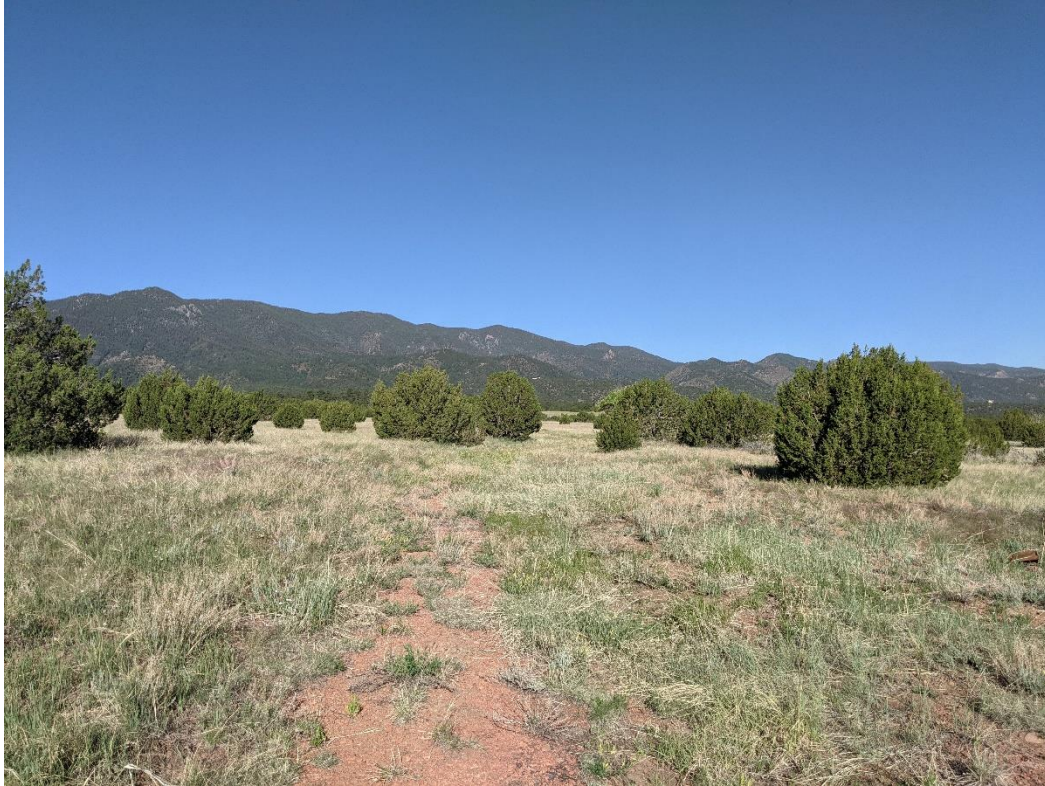
The two track road off County Road 51 was inspected. This portion of the remaining disturbance was not reclaimed however vegetation continues to establish itself along the road. Cactus, shrubs and grasses have naturally encroached from the surrounding undisturbed area. No signs of use was observed on the road as well as erosion.

Two track road.
