MINERALS PROGRAM INSPECTION REPORT PHONE: (303) 866-3567

MINE NAME:	MINE/PROSPECTING ID#:	MINERAL:	COUNTY:
Mahogany Research-Freeze Wall Test	P-2005-017	Oil shale	Rio Blanco
INSPECTION TYPE:	INSPECTOR(S):	INSP. DATE:	INSP. TIME:
Monitoring	Amy Yeldell	May 31, 2022	09:00
OPERATOR:	OPERATOR REPRESENTATIVE:	TYPE OF OPERATION:	
Shell Frontier Oil & Gas Inc.	Samantha Baker	MP - Mineral Prospecting	
REASON FOR INSPECTION:	BOND CALCULATION TYPE:	BOND AMOUNT:	
Normal I&E Program	None	\$2,158,429.00	
DATE OF COMPLAINT:	POST INSP. CONTACTS:	JOINT INSP. AGENCY:	
NA	None	None	
WEATHER:	INSPECTOR'S SIGNATURE:	SIGNATURE DA	TE:
Clear	Amy Geldell	June 16, 2022

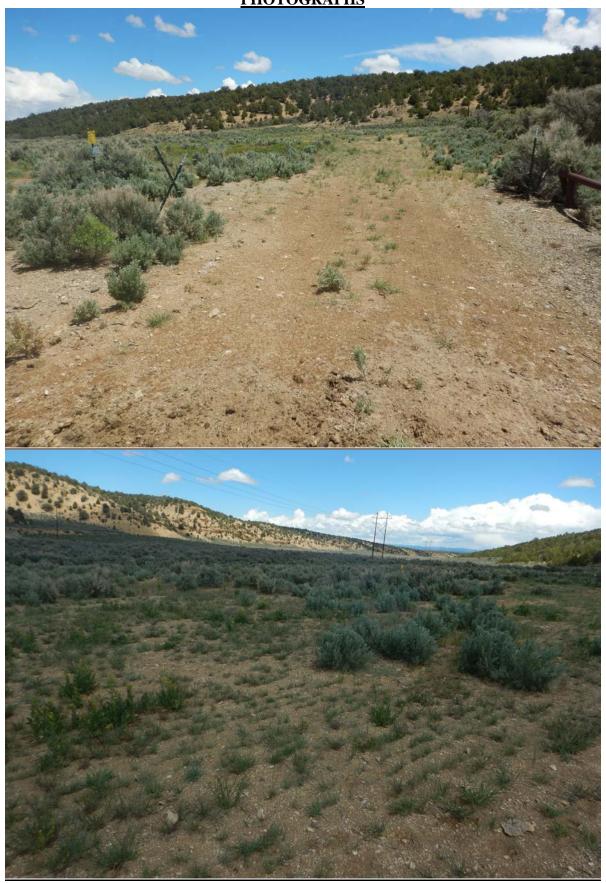
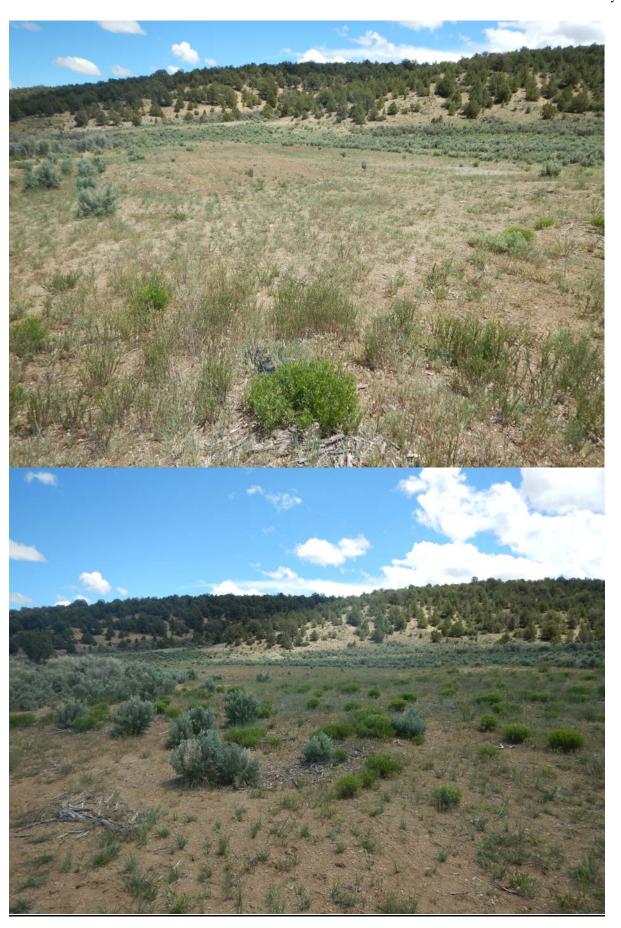
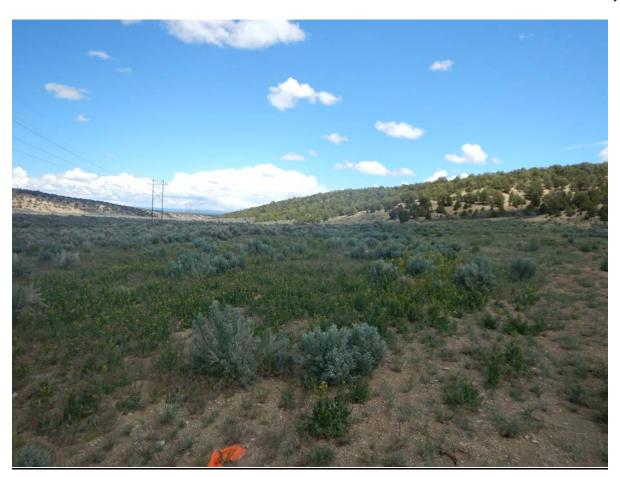
This spring/ early summer has been very cold with limited precipitation. Generally plants are behind schedule in germination and inspection timing is more comparable to typical March/April site conditions. Wild horse populations have significantly increased and vegetation throughout the Piceance Basin is showing signs of overgrazing. All hydrology wells have been abandoned and pads have been reclaimed. Over all pads are stable with no signs of erosion. All mining related debris has been removed from the site(s) where required.

Due to an extensive cheatgrass infestation pads were cleared using 'bare ground' and allowed to rest. They were reseeded in the spring of 2021. Sage and shrubs were left in place and have continued to thrive. Grasses have begun to germinate and initial success looks promising. There are a fair amount of undesirable annuals on site and a few patches of listed weeds. In general any undesirable plants should be effectively managed so that establishment of desirable plants is not impacted.
