MINERALS PROGRAM INSPECTION REPORT
PHONE: (303) 866-3567

MINE NAME: Stone Canyon Quarry	MINE/PROSPECTING ID#: M-2012-018	MINERAL: Stone	COUNTY: Boulder
INSPECTION TYPE: Monitoring	INSPECTOR(S): Patrick Lennberg	INSP. DATE: June 9, 2022	INSP. TIME: 09:45
OPERATOR: Stone Canyon Quarry, LLC	OPERATOR REPRESENTATIVE: Bernard Buster	TYPE OF OPERATION: 112c - Construction Regular Operation	
REASON FOR INSPECTION: Normal I&E Program	BOND CALCULATION TYPE: Partial Bond	BOND AMOUNT: \$2,125.00	
DATE OF COMPLAINT: NA	POST INSP. CONTACTS: None	JOINT INSP. AGENCY: None	
WEATHER: Clear	INSPECTOR'S SIGNATURE:

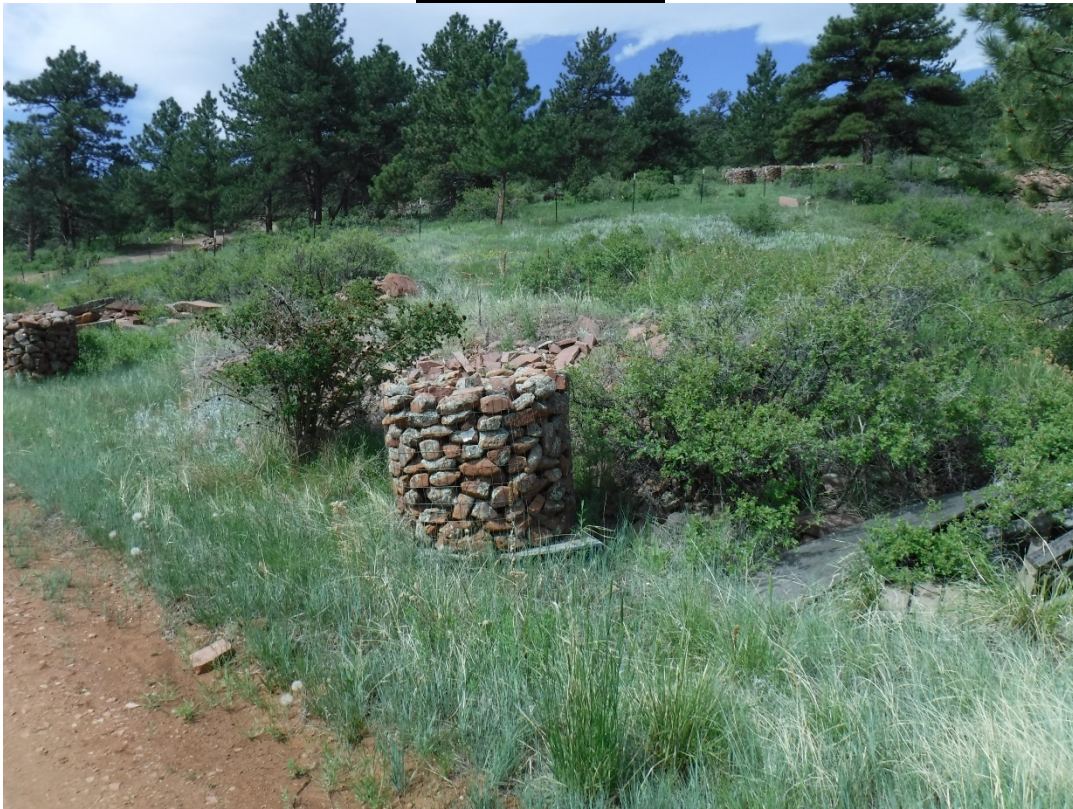
Photo 1: Palletized marketable material

If the operator wants to be released from the permit, the Division recommends the operator remove all marketable product from the site or sign a notarized affidavit. The affidavit would indicated that all marketable material will only be used onsite and if the materials were sold, after permit release, it would be considered an illegal mining operation subject to civil penalties and a possible violation by the Mined Land Reclamation Board. The operator could also do a combination of these two items in seeking permit release. The Division also recommends taking steps towards permit release as soon as possible.

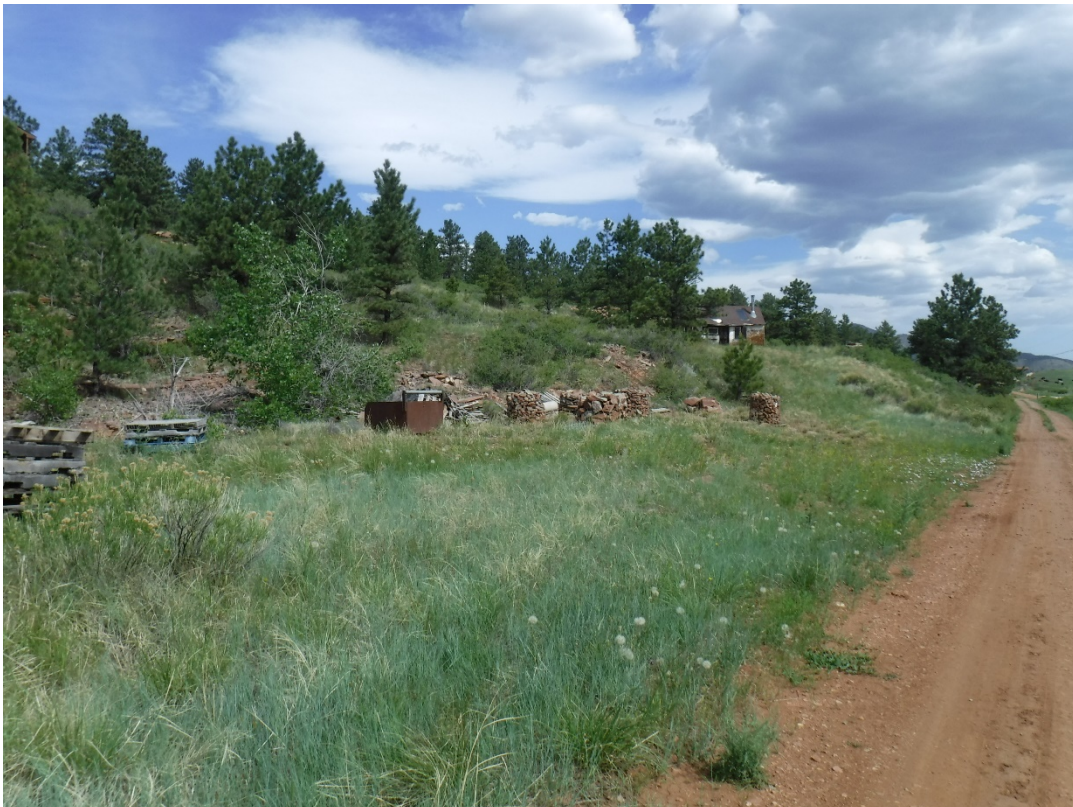
Photo 2: Storage area for marketable material, naturally reclaimed and road to right of picture to remain after reclamation

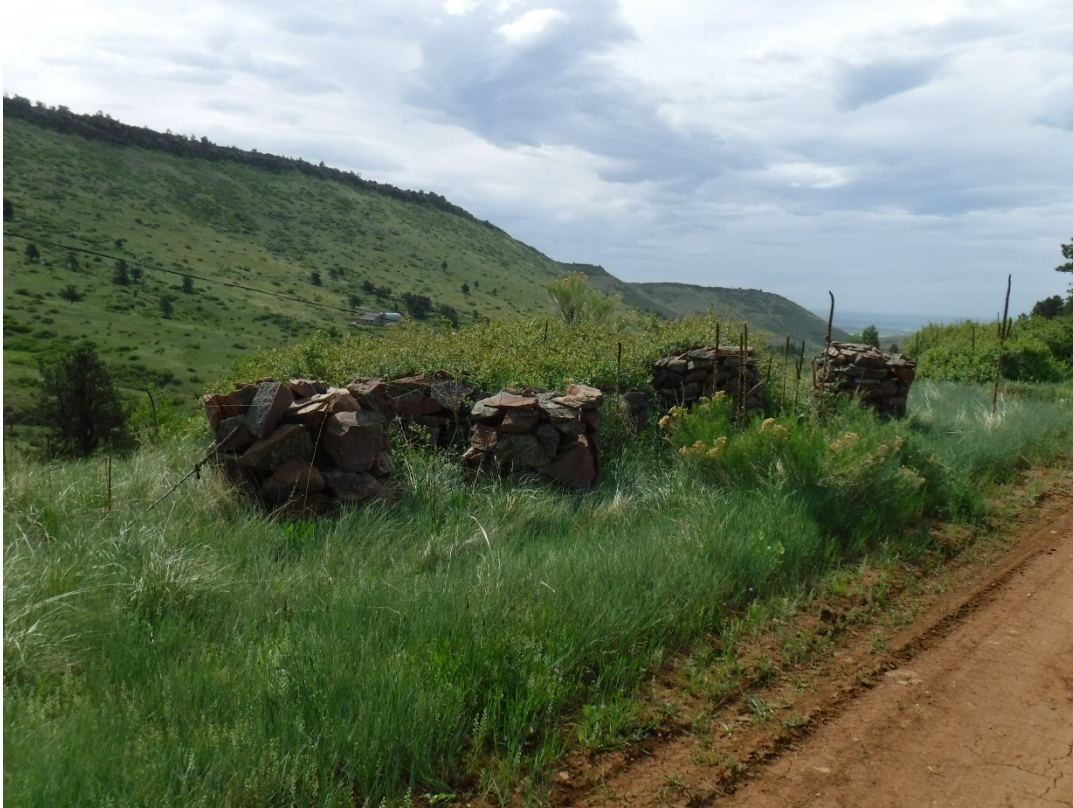
Photo 3: Palletized marketable material

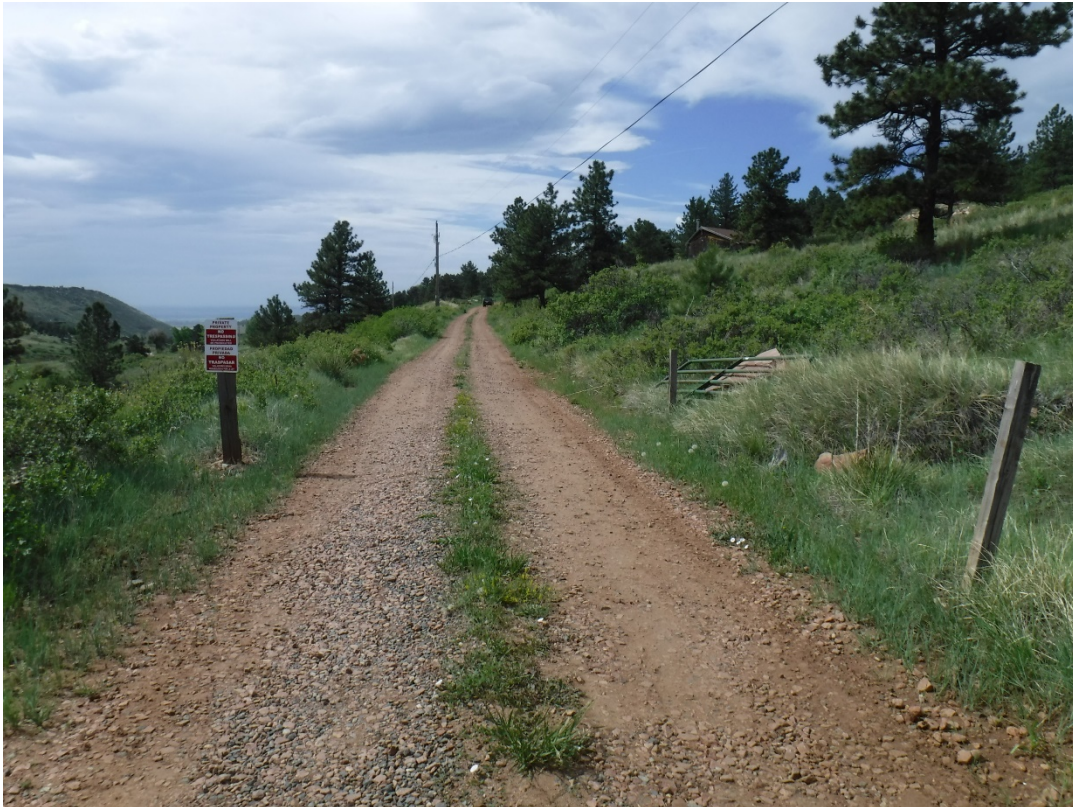
Photo 4: Road to remain after reclamation

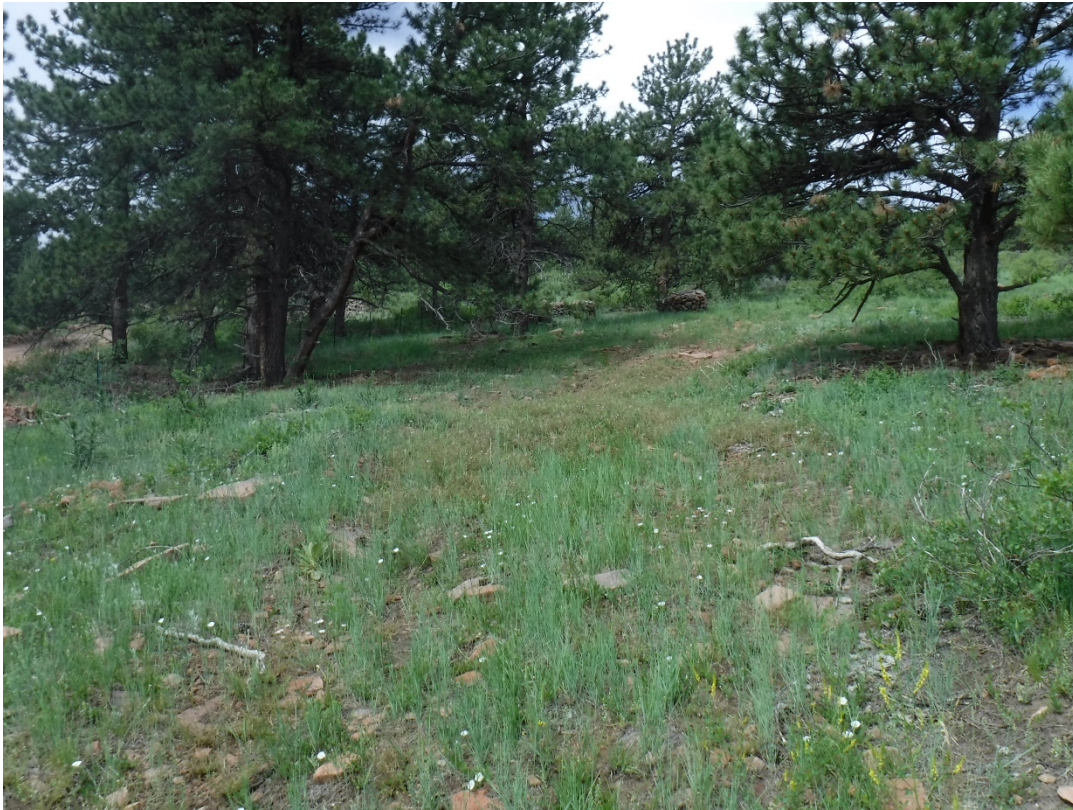
Photo 5: Road along southern portion of permit area, naturally reclaimed, note pallets of material near center of picture

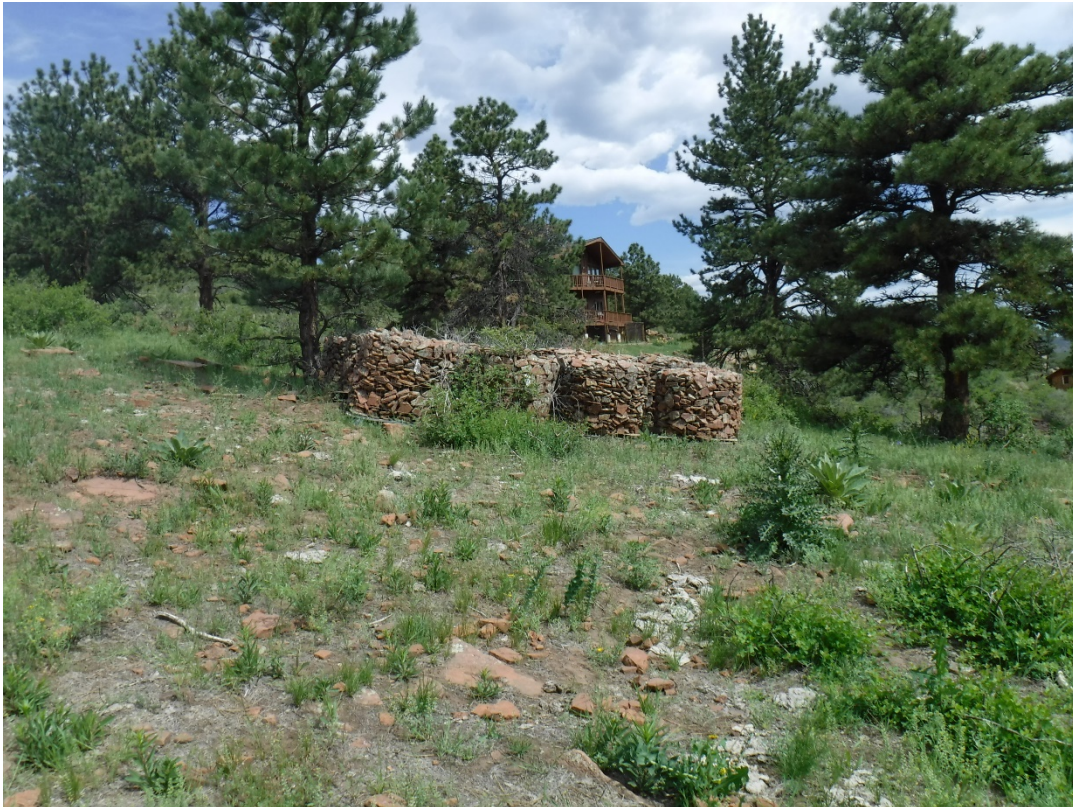
Photo 6: Additional pallets of material along the southern portion of permit boundary, operator's residence in background

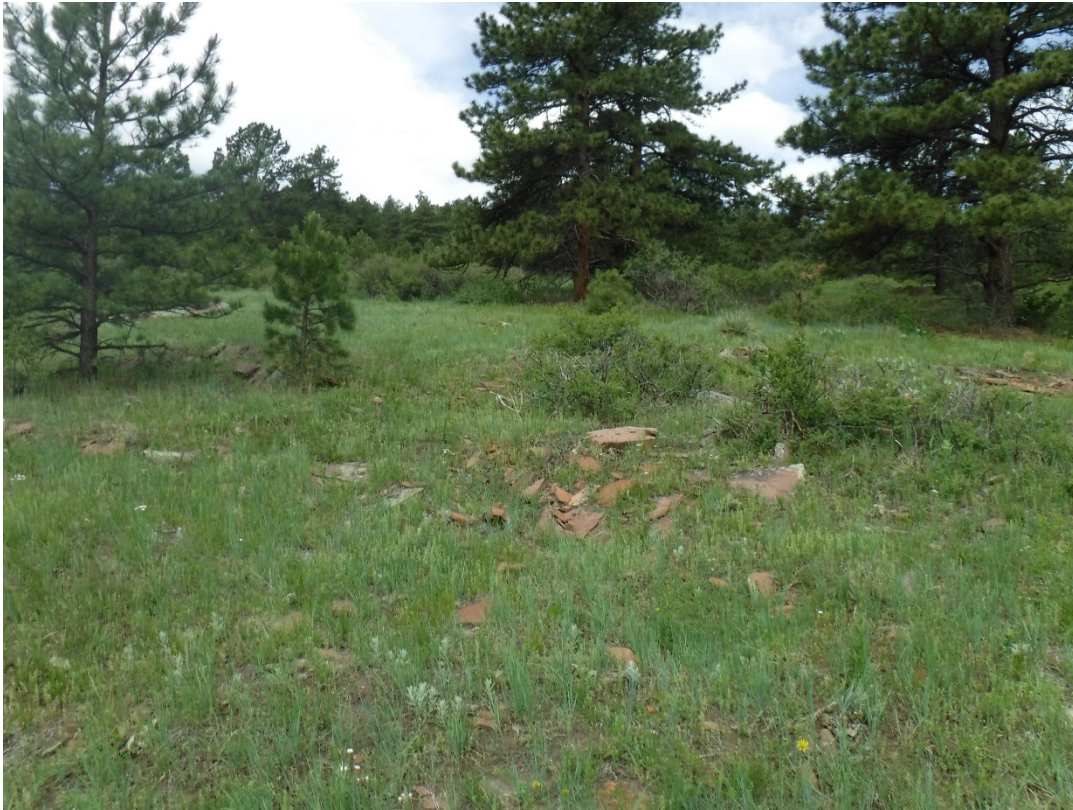
Photo 7: Typical vegetation in areas where the moss rock was removed

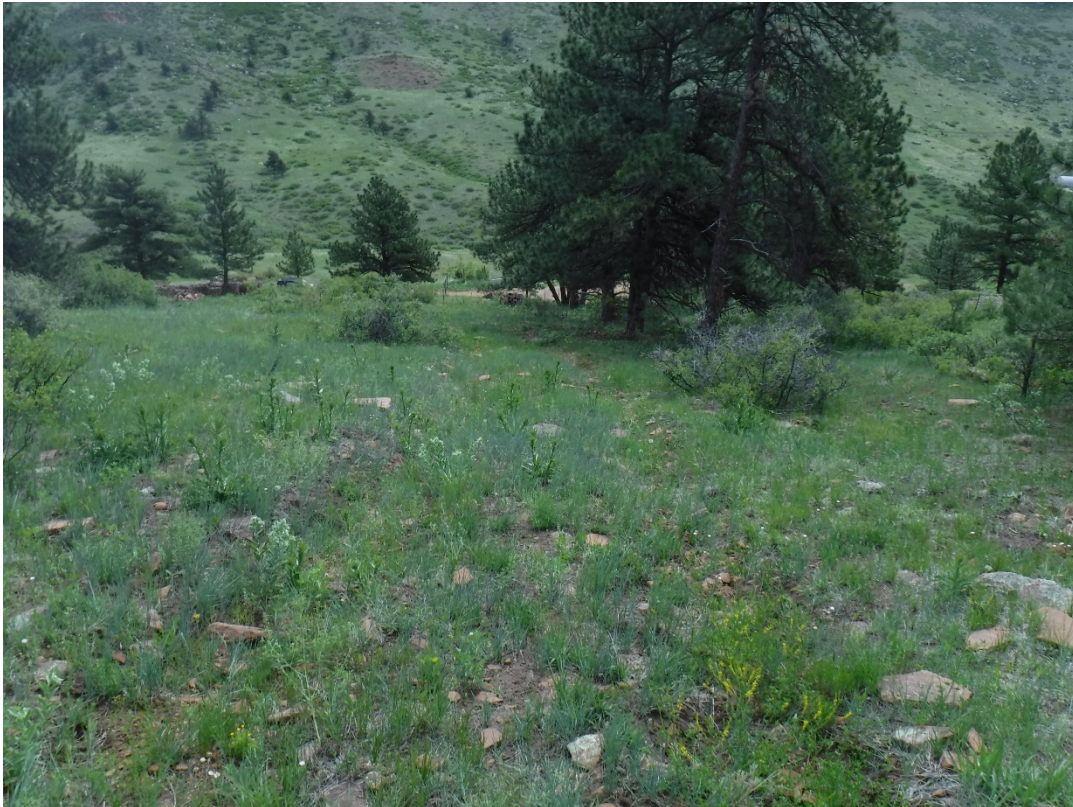
Photo 8: Typical vegetation in areas where the moss rock was removed
