MINERALS PROGRAM INSPECTION REPORT

MINE NAME: Perdue	MINE/PROSPECTING ID#: M-2000-089	MINERAL: Sandstone (silica, st quartzite)	COUNTY: Boulder
INSPECTION TYPE: Monitoring	INSPECTOR(S): Patrick Lennberg	INSP. DATE: June 9, 2022	INSP. TIME: 11:00
OPERATOR: Mary Vasquez	OPERATOR REPRESENTATIVE: None	TYPE OF OPERATION: 110c - Construction Limited Impact	
REASON FOR INSPECTION: Normal I&E Program	BOND CALCULATION TYPE: Complete Bond	BOND AMOUNT: \$12,500.00	
DATE OF COMPLAINT: NA	POST INSP. CONTACTS: None	JOINT INSP. AGENCY: None	
WEATHER: Clear	INSPECTOR'S SIGNATURE:

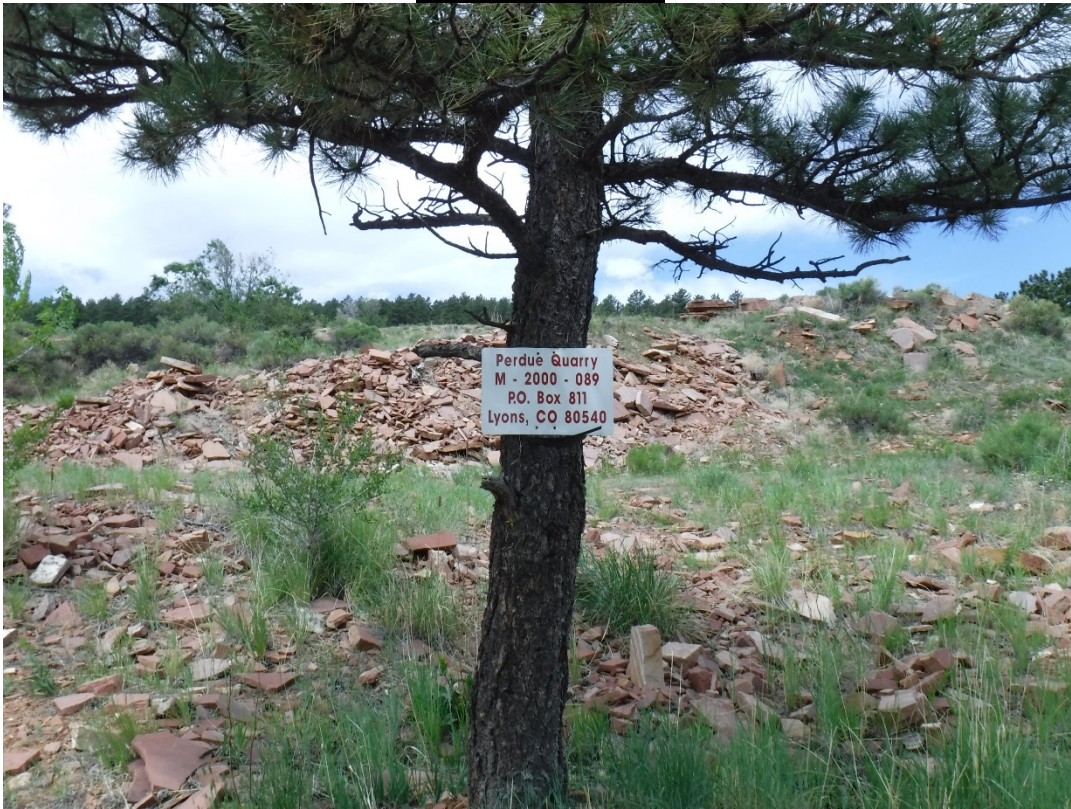
Photo 1: Mine sign at entrance

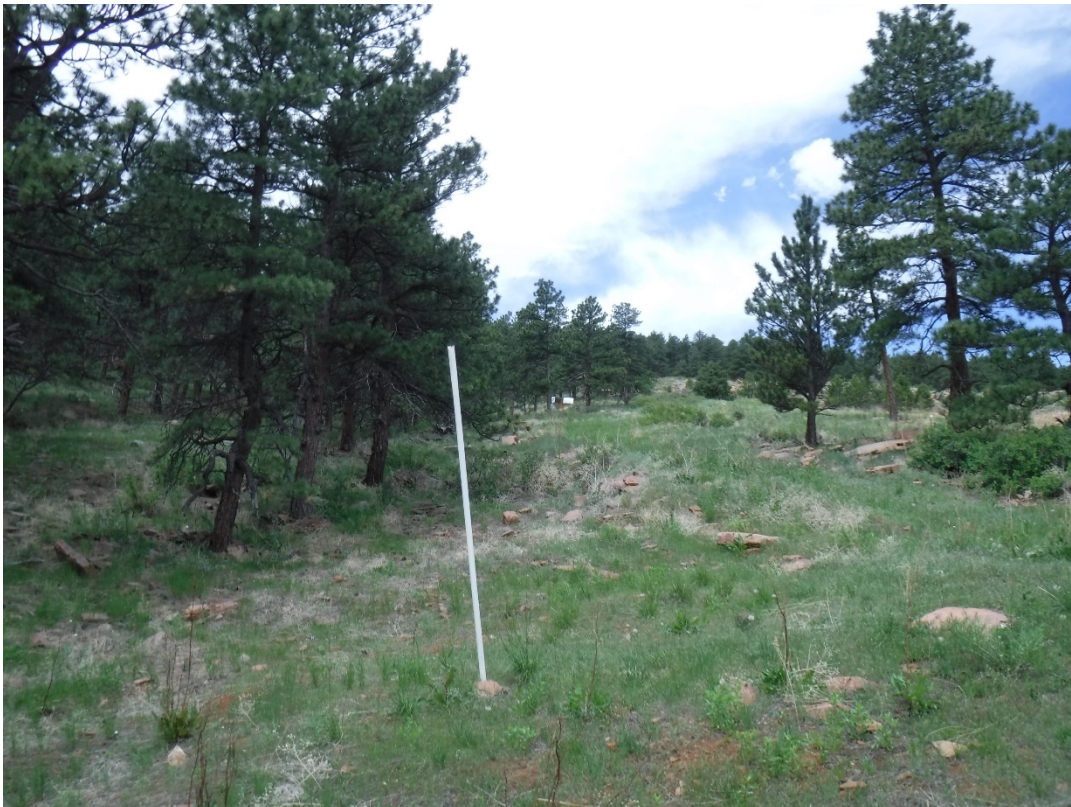
Photo 2: Typical permit boundary marker

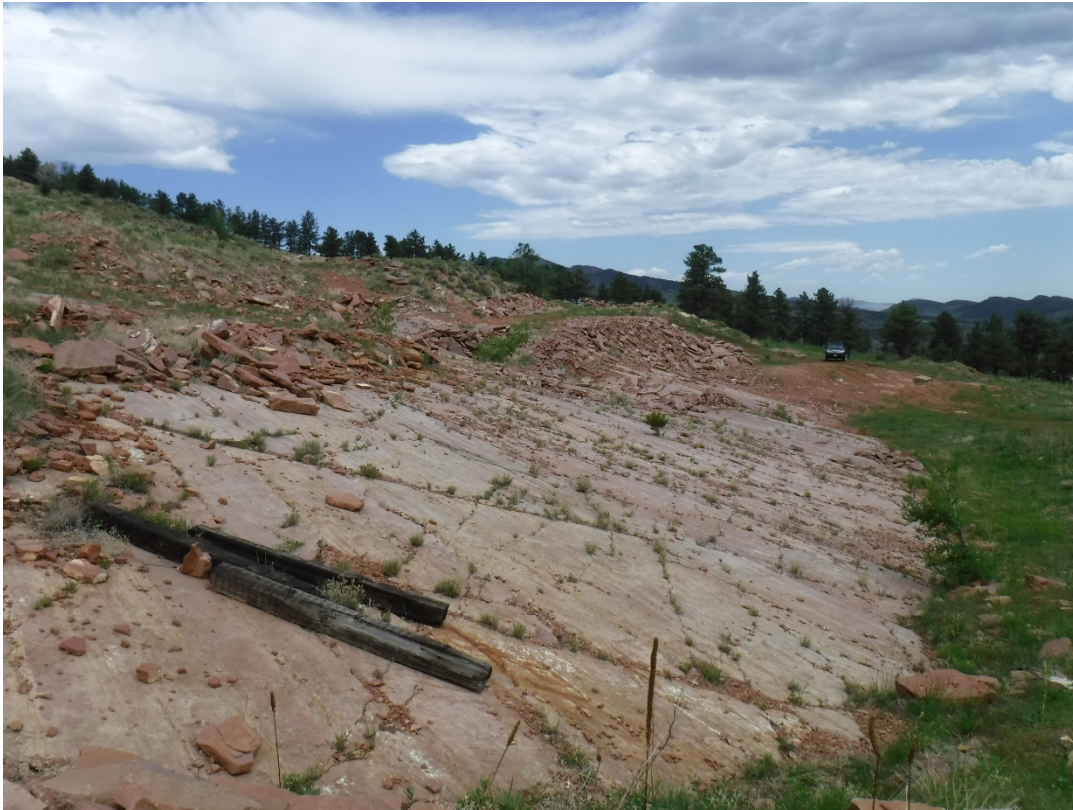
Photo 3: Pit area in the southeastern portion of the site

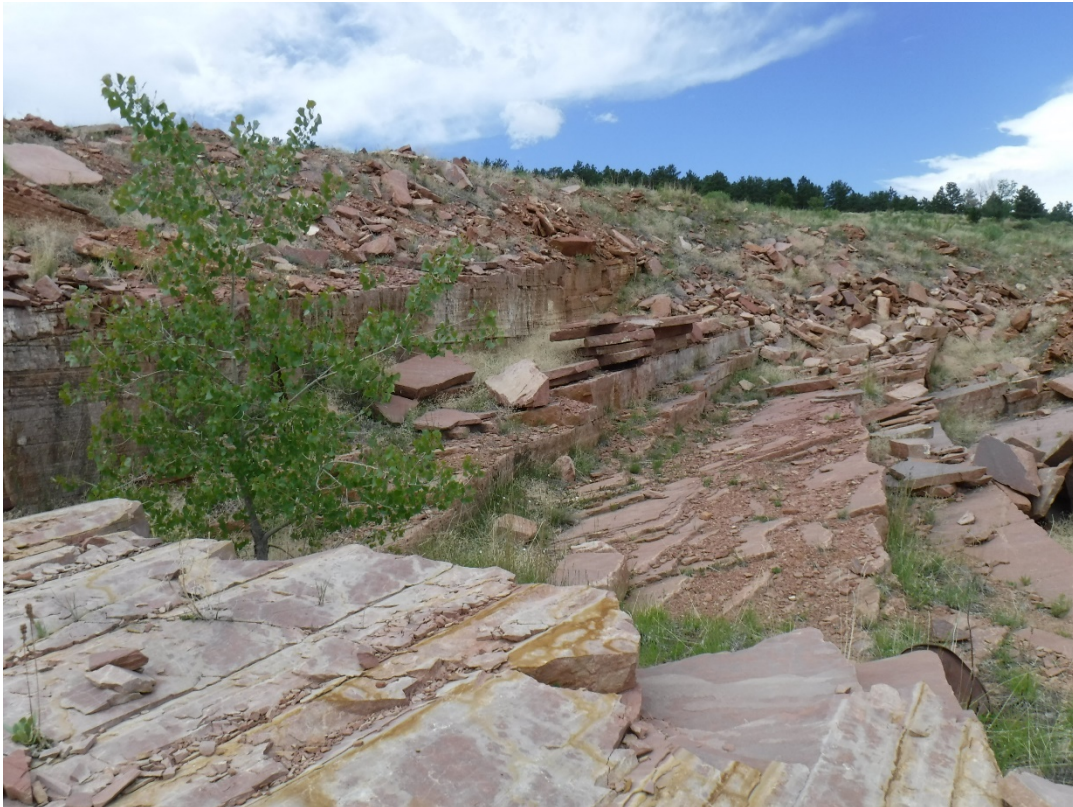
Photo 4: Pit area in the southeastern portion of the site needs to be graded to 3H:1V

The approved reclamation plan calls for backfilling mined areas with overburden and/or waste rock to a 3H:1V or flatter slope gradient, replacing topsoil on disturbed land at a minimum depth of 3 inches, and revegetating the site for rangeland use. The existing driveway used to access the site from Stone Canyon Drive will remain after reclamation for use by the landowner. There are several steep mine faces that need to be backfilled in the southeast and southwestern areas of the permit. Along with backfilling any available topsoil needs to be spread and seeded with approved seed mix. Additionally, there are several piles and stacks of marketable material that remain onsite.

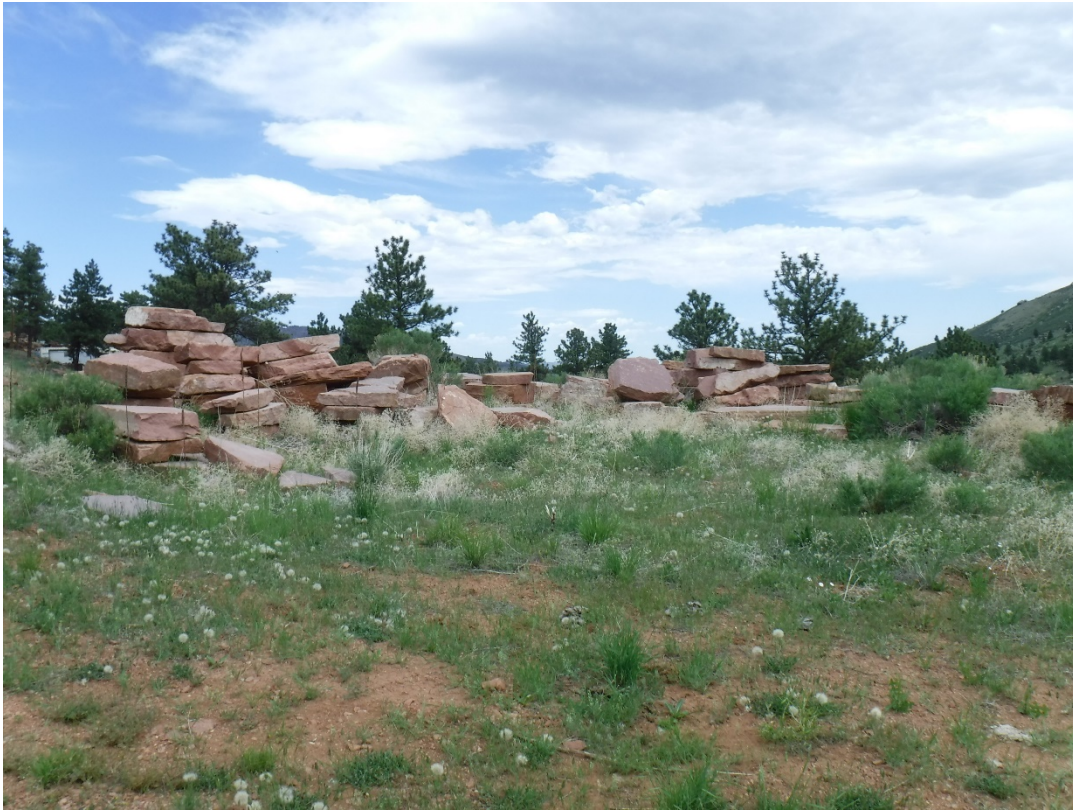
Photo 5: Marketable material stacked along haul road

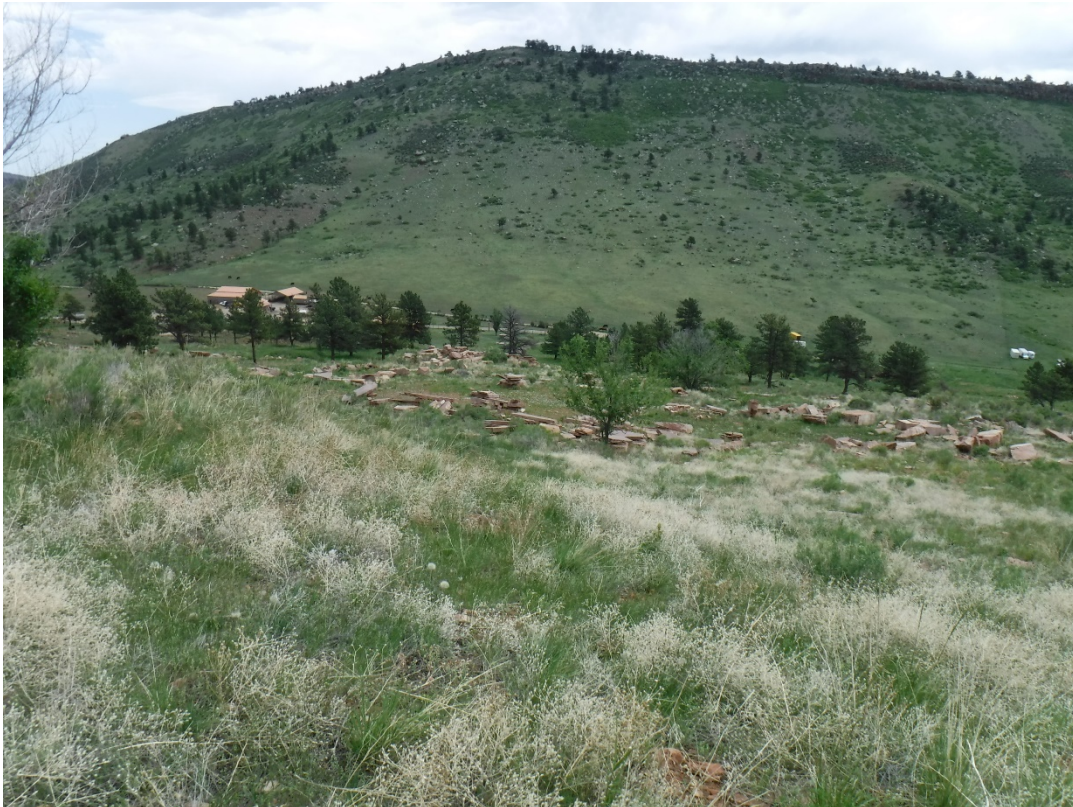
Photo 6: Marketable material stacked in the permit area

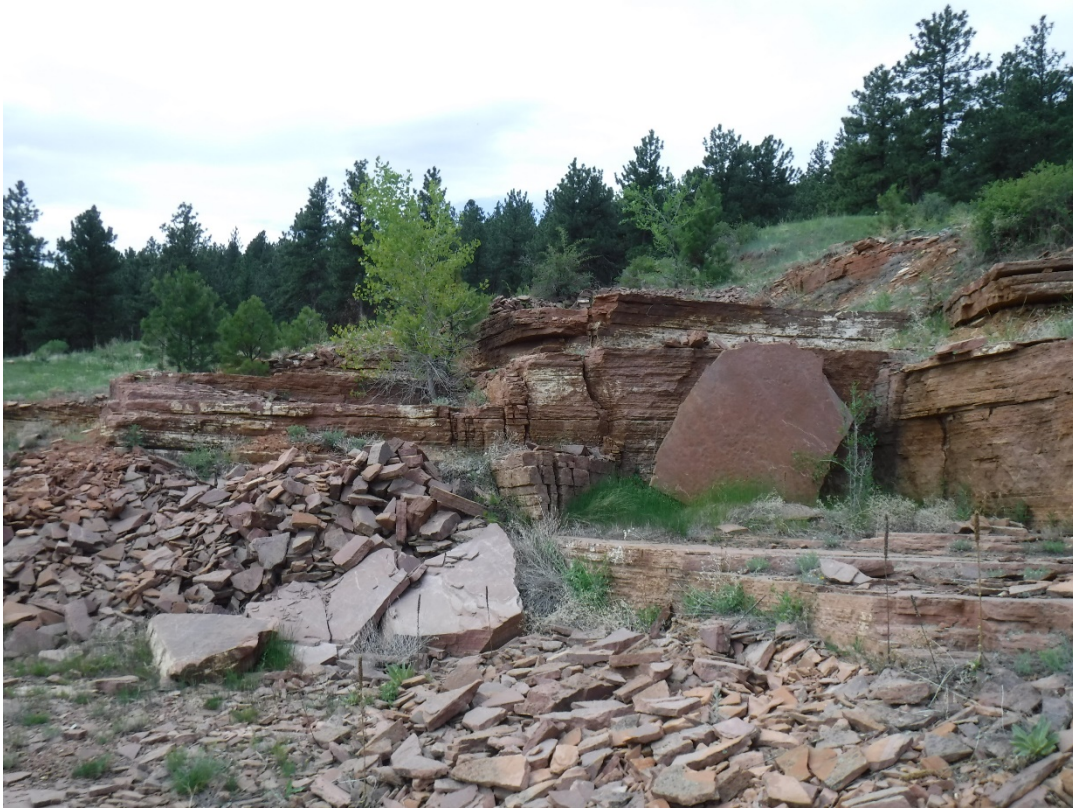
Photo 7: Pit area in the southwestern portion of the site

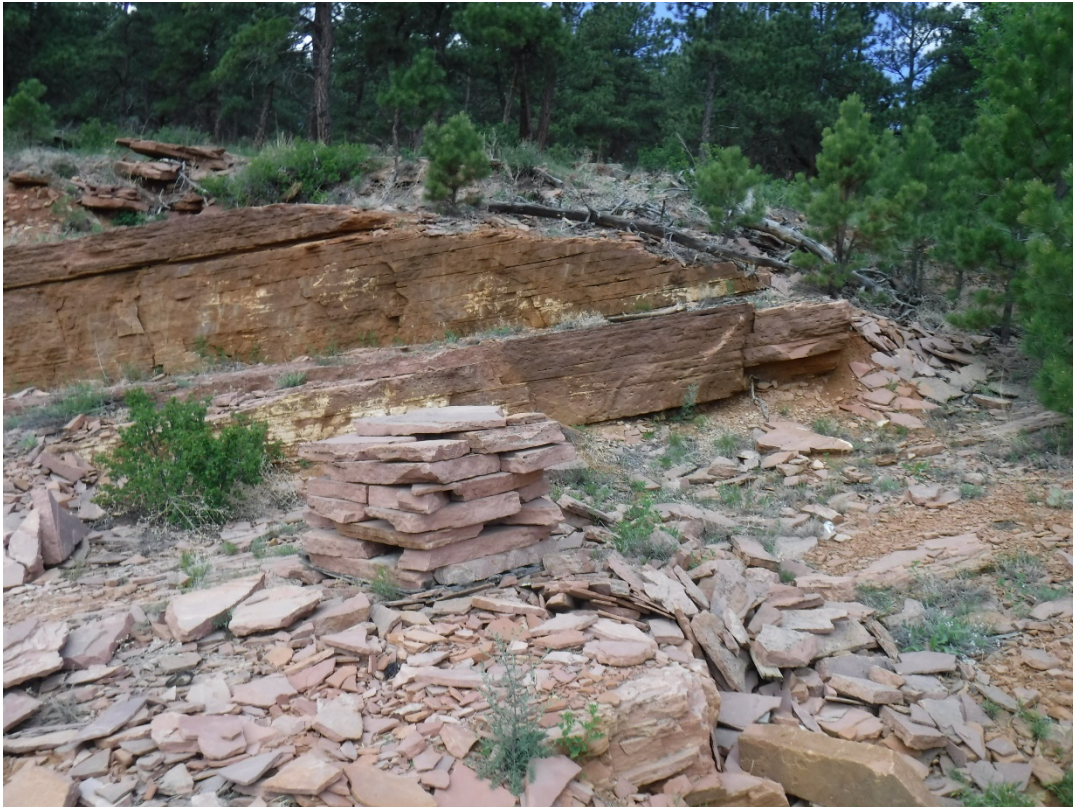
Photo 8: Material placed on a pallet to be sold

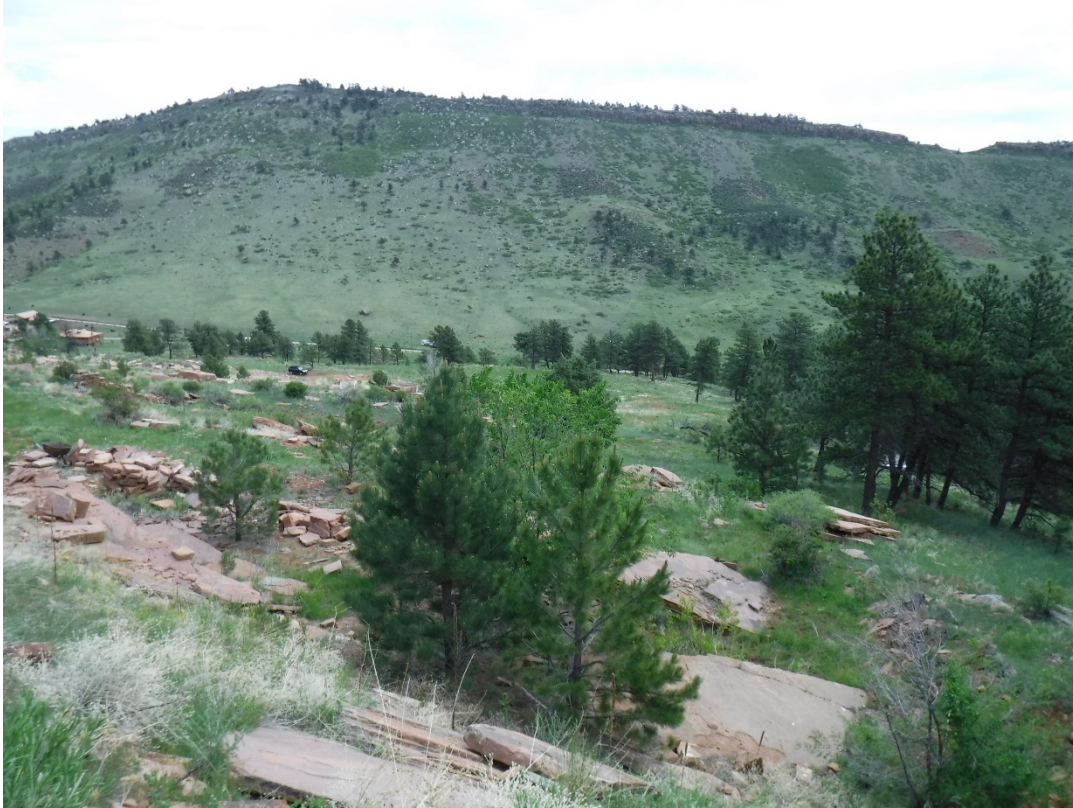
Photo 9: Looking towards the southeastern pit area, note stacked material to be sold

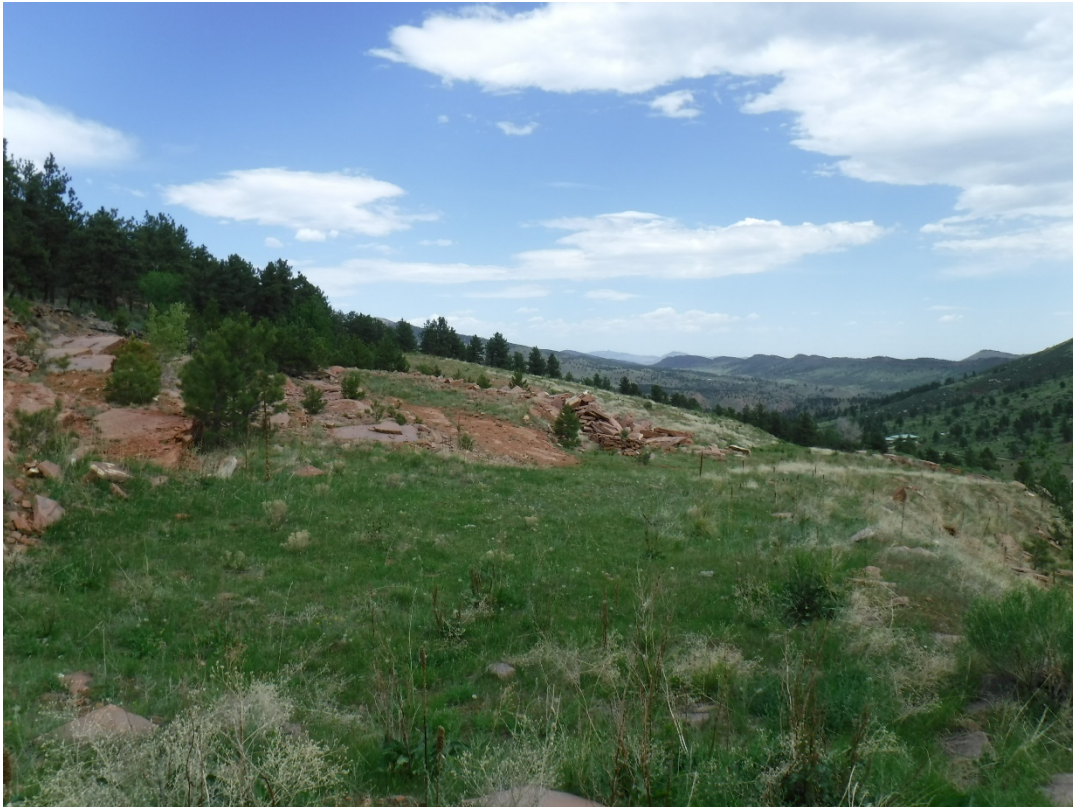
Photo 10: Looking towards the southwestern pit area, note stacked material in the center and the right of center of picture
