TRAPPER MINING INC.
CRAIG, COLORADO

HORSE GULCH FILL
QUARTERLY FILL CERTIFICATION

Horse Gulch Fill Quarterly Inspection Report

Second Quarter 2022

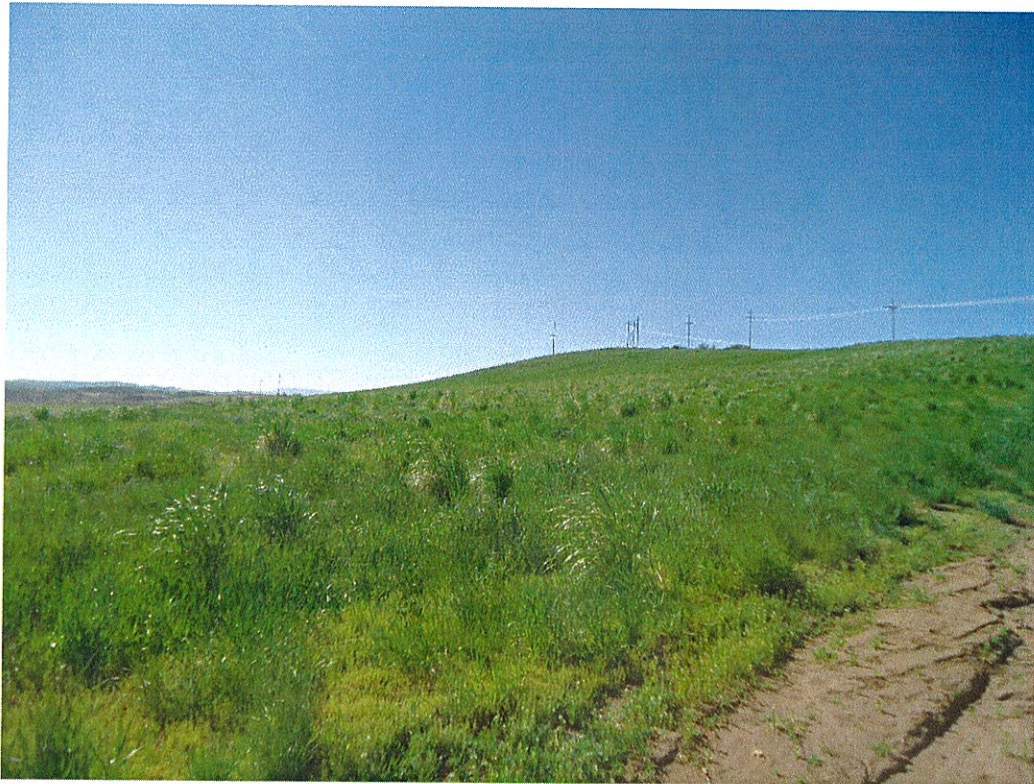
No appearances of instability, structural weakness, or other hazardous conditions were observed. The south west side, north east side (Photograph 1) and south east side (Photograph 2) of the fill were inspected this quarter. The area where cracks were detected on the top south portion of the dump during the first quarter of 2013 inspection was checked. There was no additional cracking found.

Photograph 1: North East Side Looking South (6/15/2022)

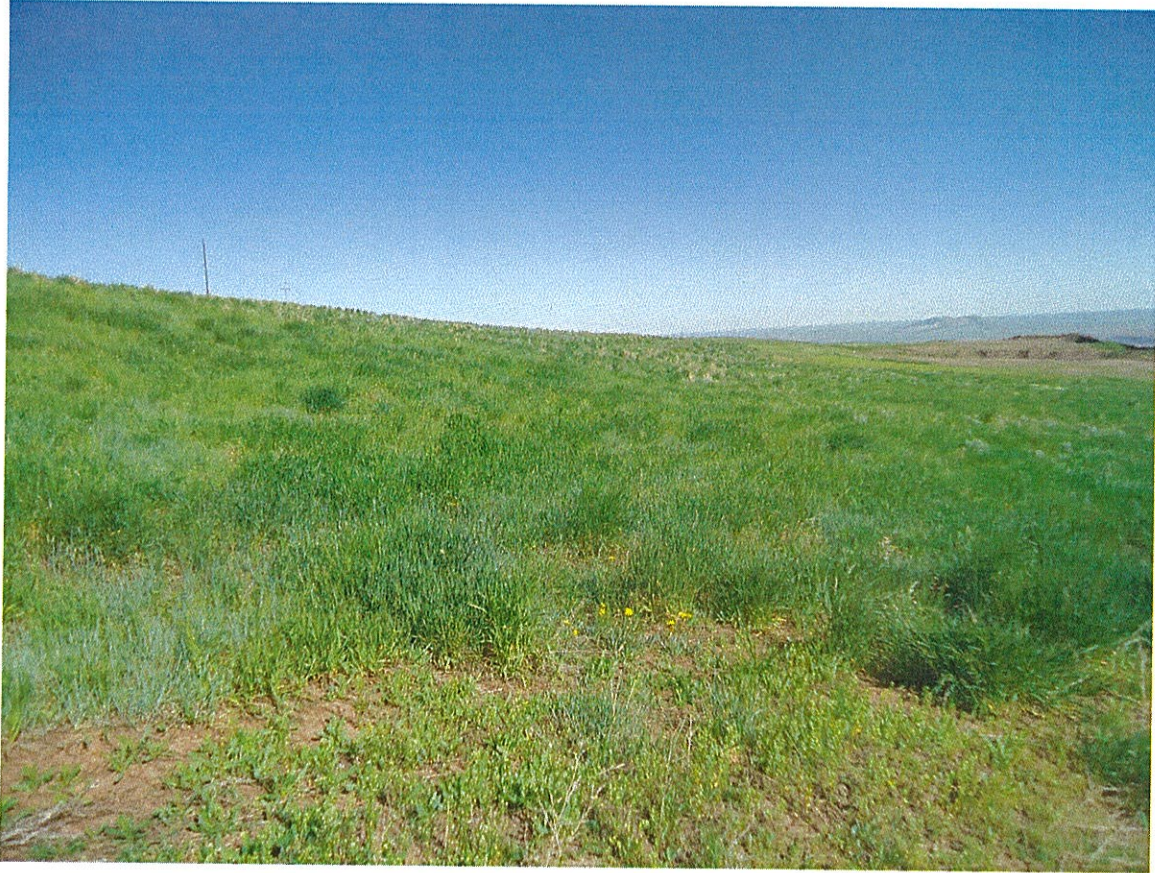
Photograph 2: South East Side Looking North (6/15/2022)

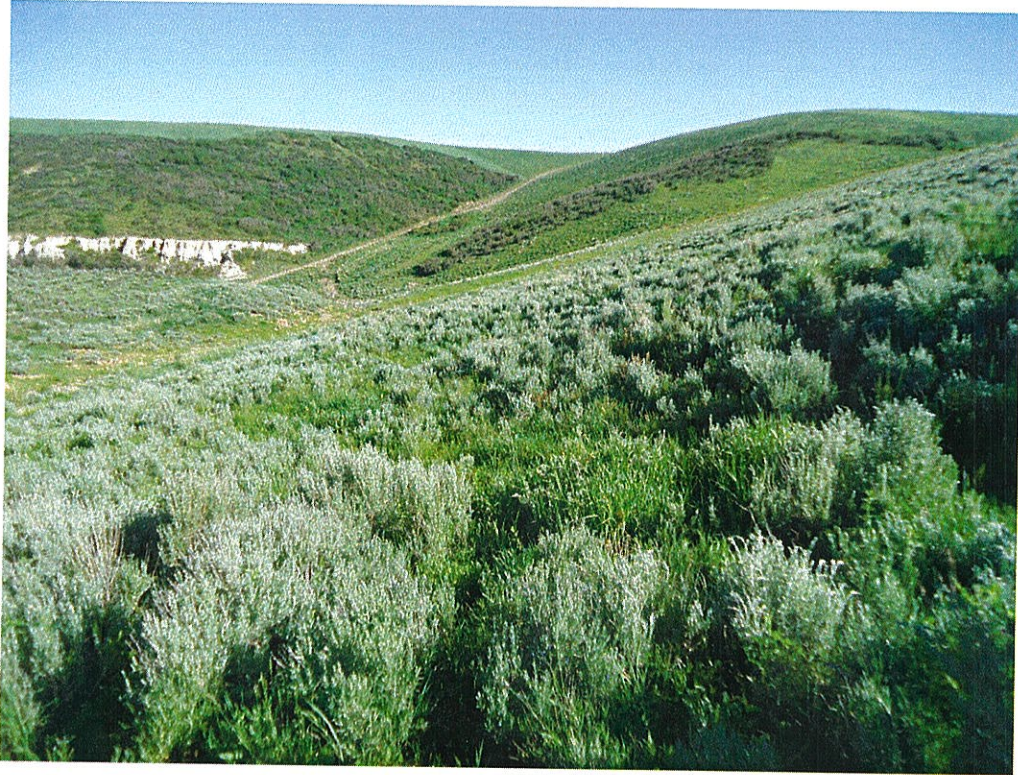
The two spots above the 7350' elevation on the south side of the dump that showed some differential settling in the second quarter of 2013 were inspected and there was no additional settling (Photographs 3 and 4).

Photograph 3: South Site above the 7350 Bench Elevation (6/15/2022)

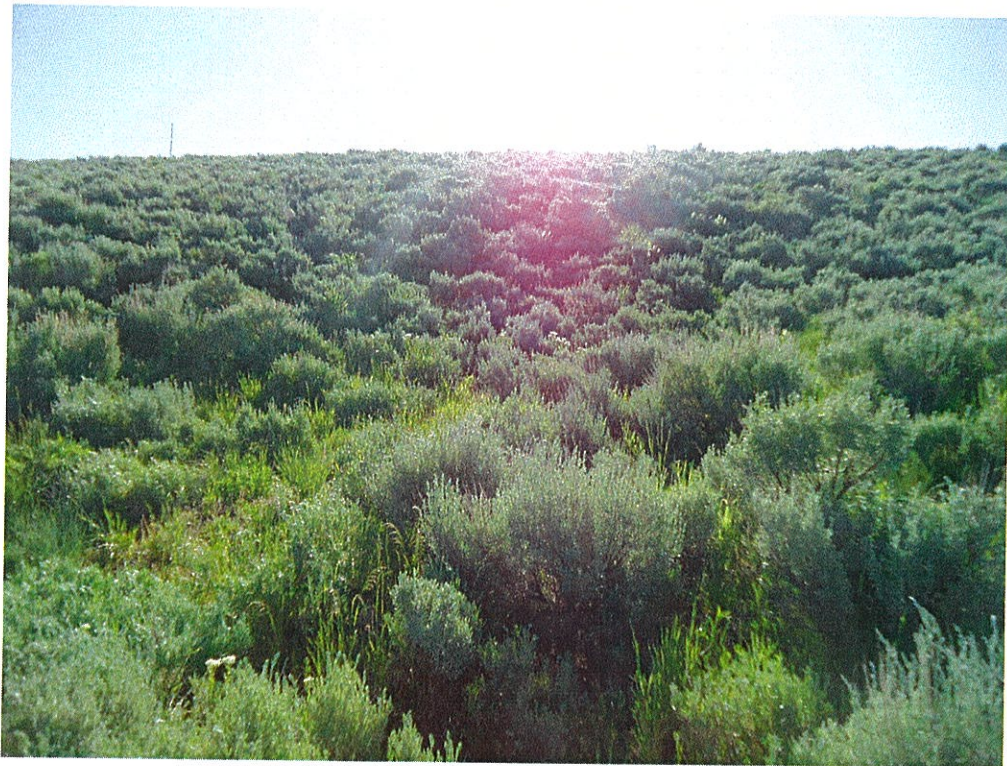
Photograph 4: North Site above the 7350 Bench Elevation (6/15/2022)

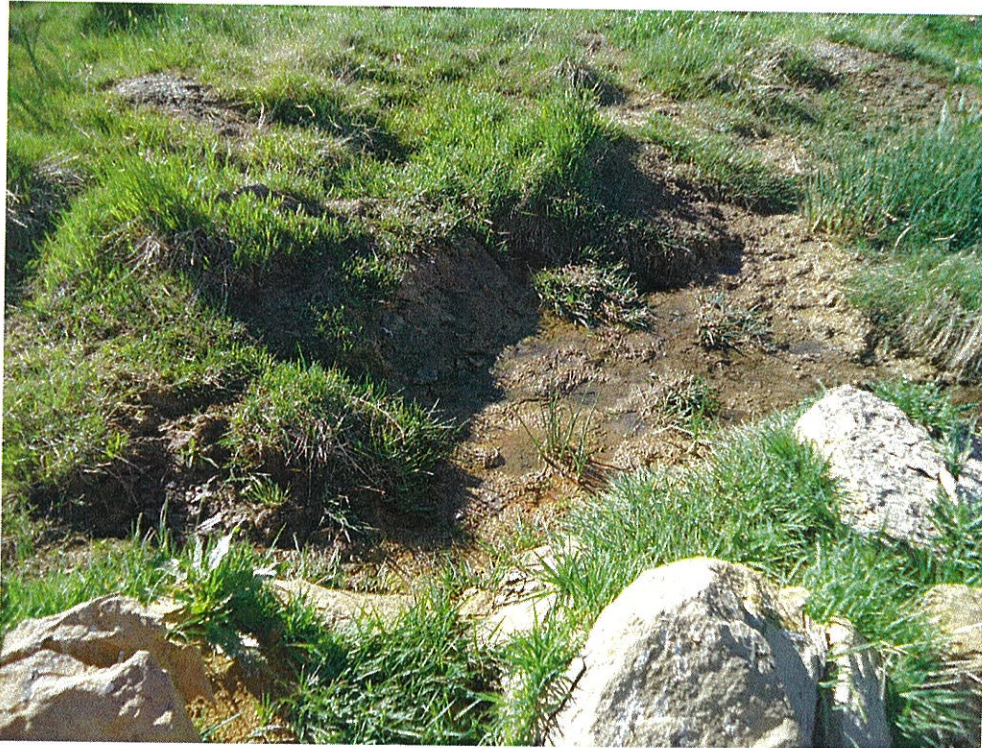
The underdrainage system was completed in the first quarter of 2010; additional work on this system is not anticipated. During the time of the inspection, there was approximately a half of a gallon per minute of water flow. (Photograph 5).

Photograph 5: Water from the Underdrainage System (6/15/2022)

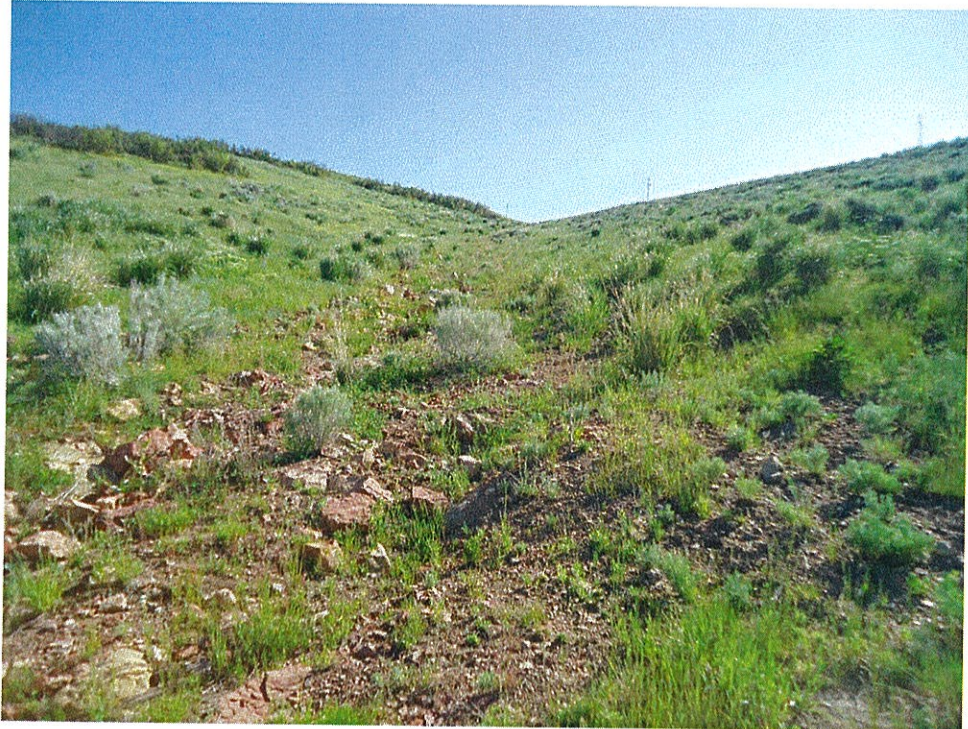
Both the north and south surface drains were inspected (Photographs 6 and 7). At the time of the inspection there was no water flow.

Photograph 6: North Surface Drain Looking East (6/15/2022)

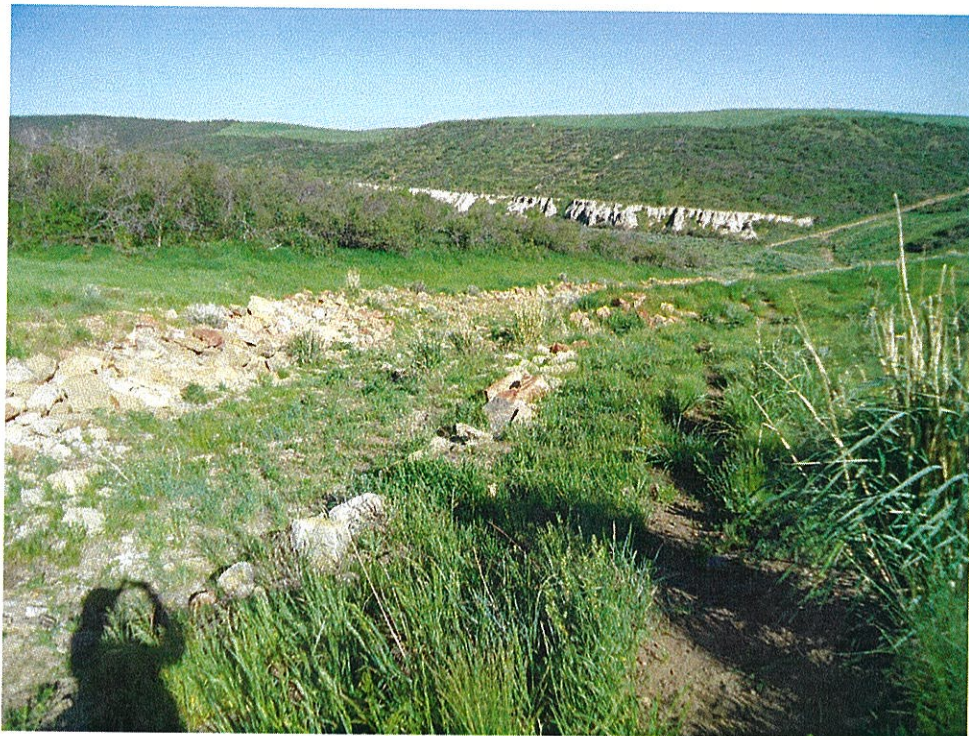
Photograph 7: South Surface Drain Looking North-west (6/15/2022)

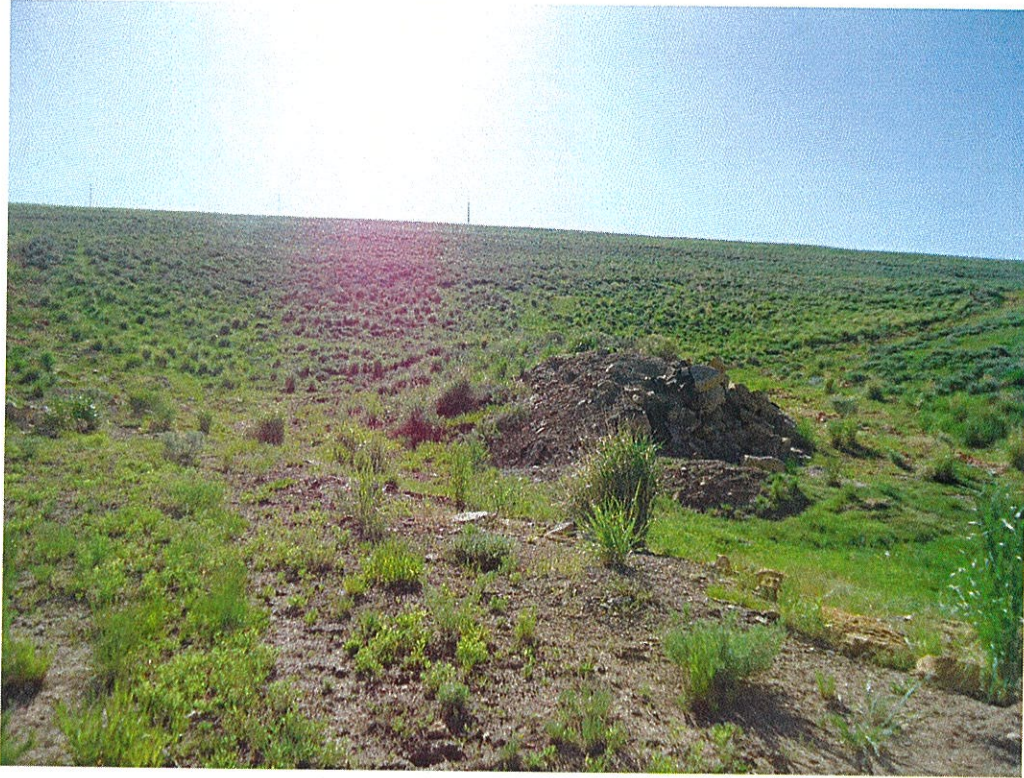
Photograph 8 depicts the west facing slope of the fill in the area where the slope of the fill is at 3H: 1V and Photograph 9 depicts the east facing slope of the fill.

Photograph 8: West Side Fill 3H: 1V Face Looking East (6/15/2022)

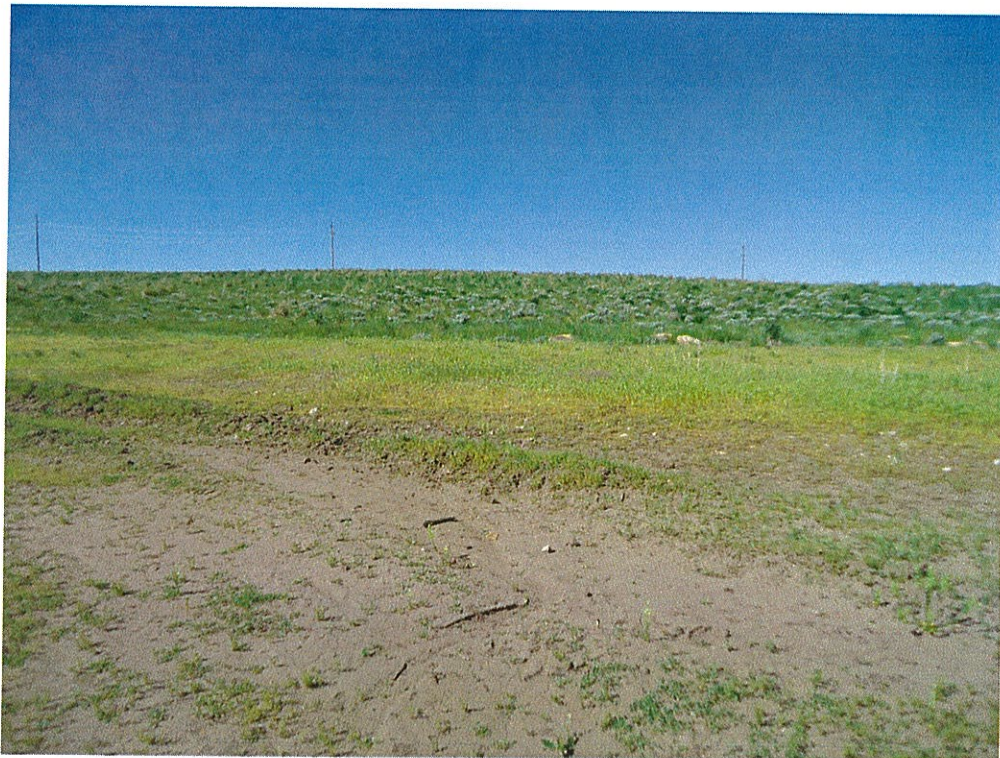
Photograph 9: East Side of the Fill Looking West (6/15/2022)
